MAP OF SURFACE CRACKS AND DAMAGE IN THE BULL CANYON AREA RESULTING FROM THE JANUARY 17, 1994 NORTHRIDGE EARTHQUAKE

Suzanne Hecker, Daniel J. Ponti, Cristofer D. Garvin, Thomas J. Powers, Thomas E. Fumal, John C. Hamilton,
Robert V. Sharp, Michael J. Rymer, Carol S. Prentice, and Francesca R. Cinti

1995

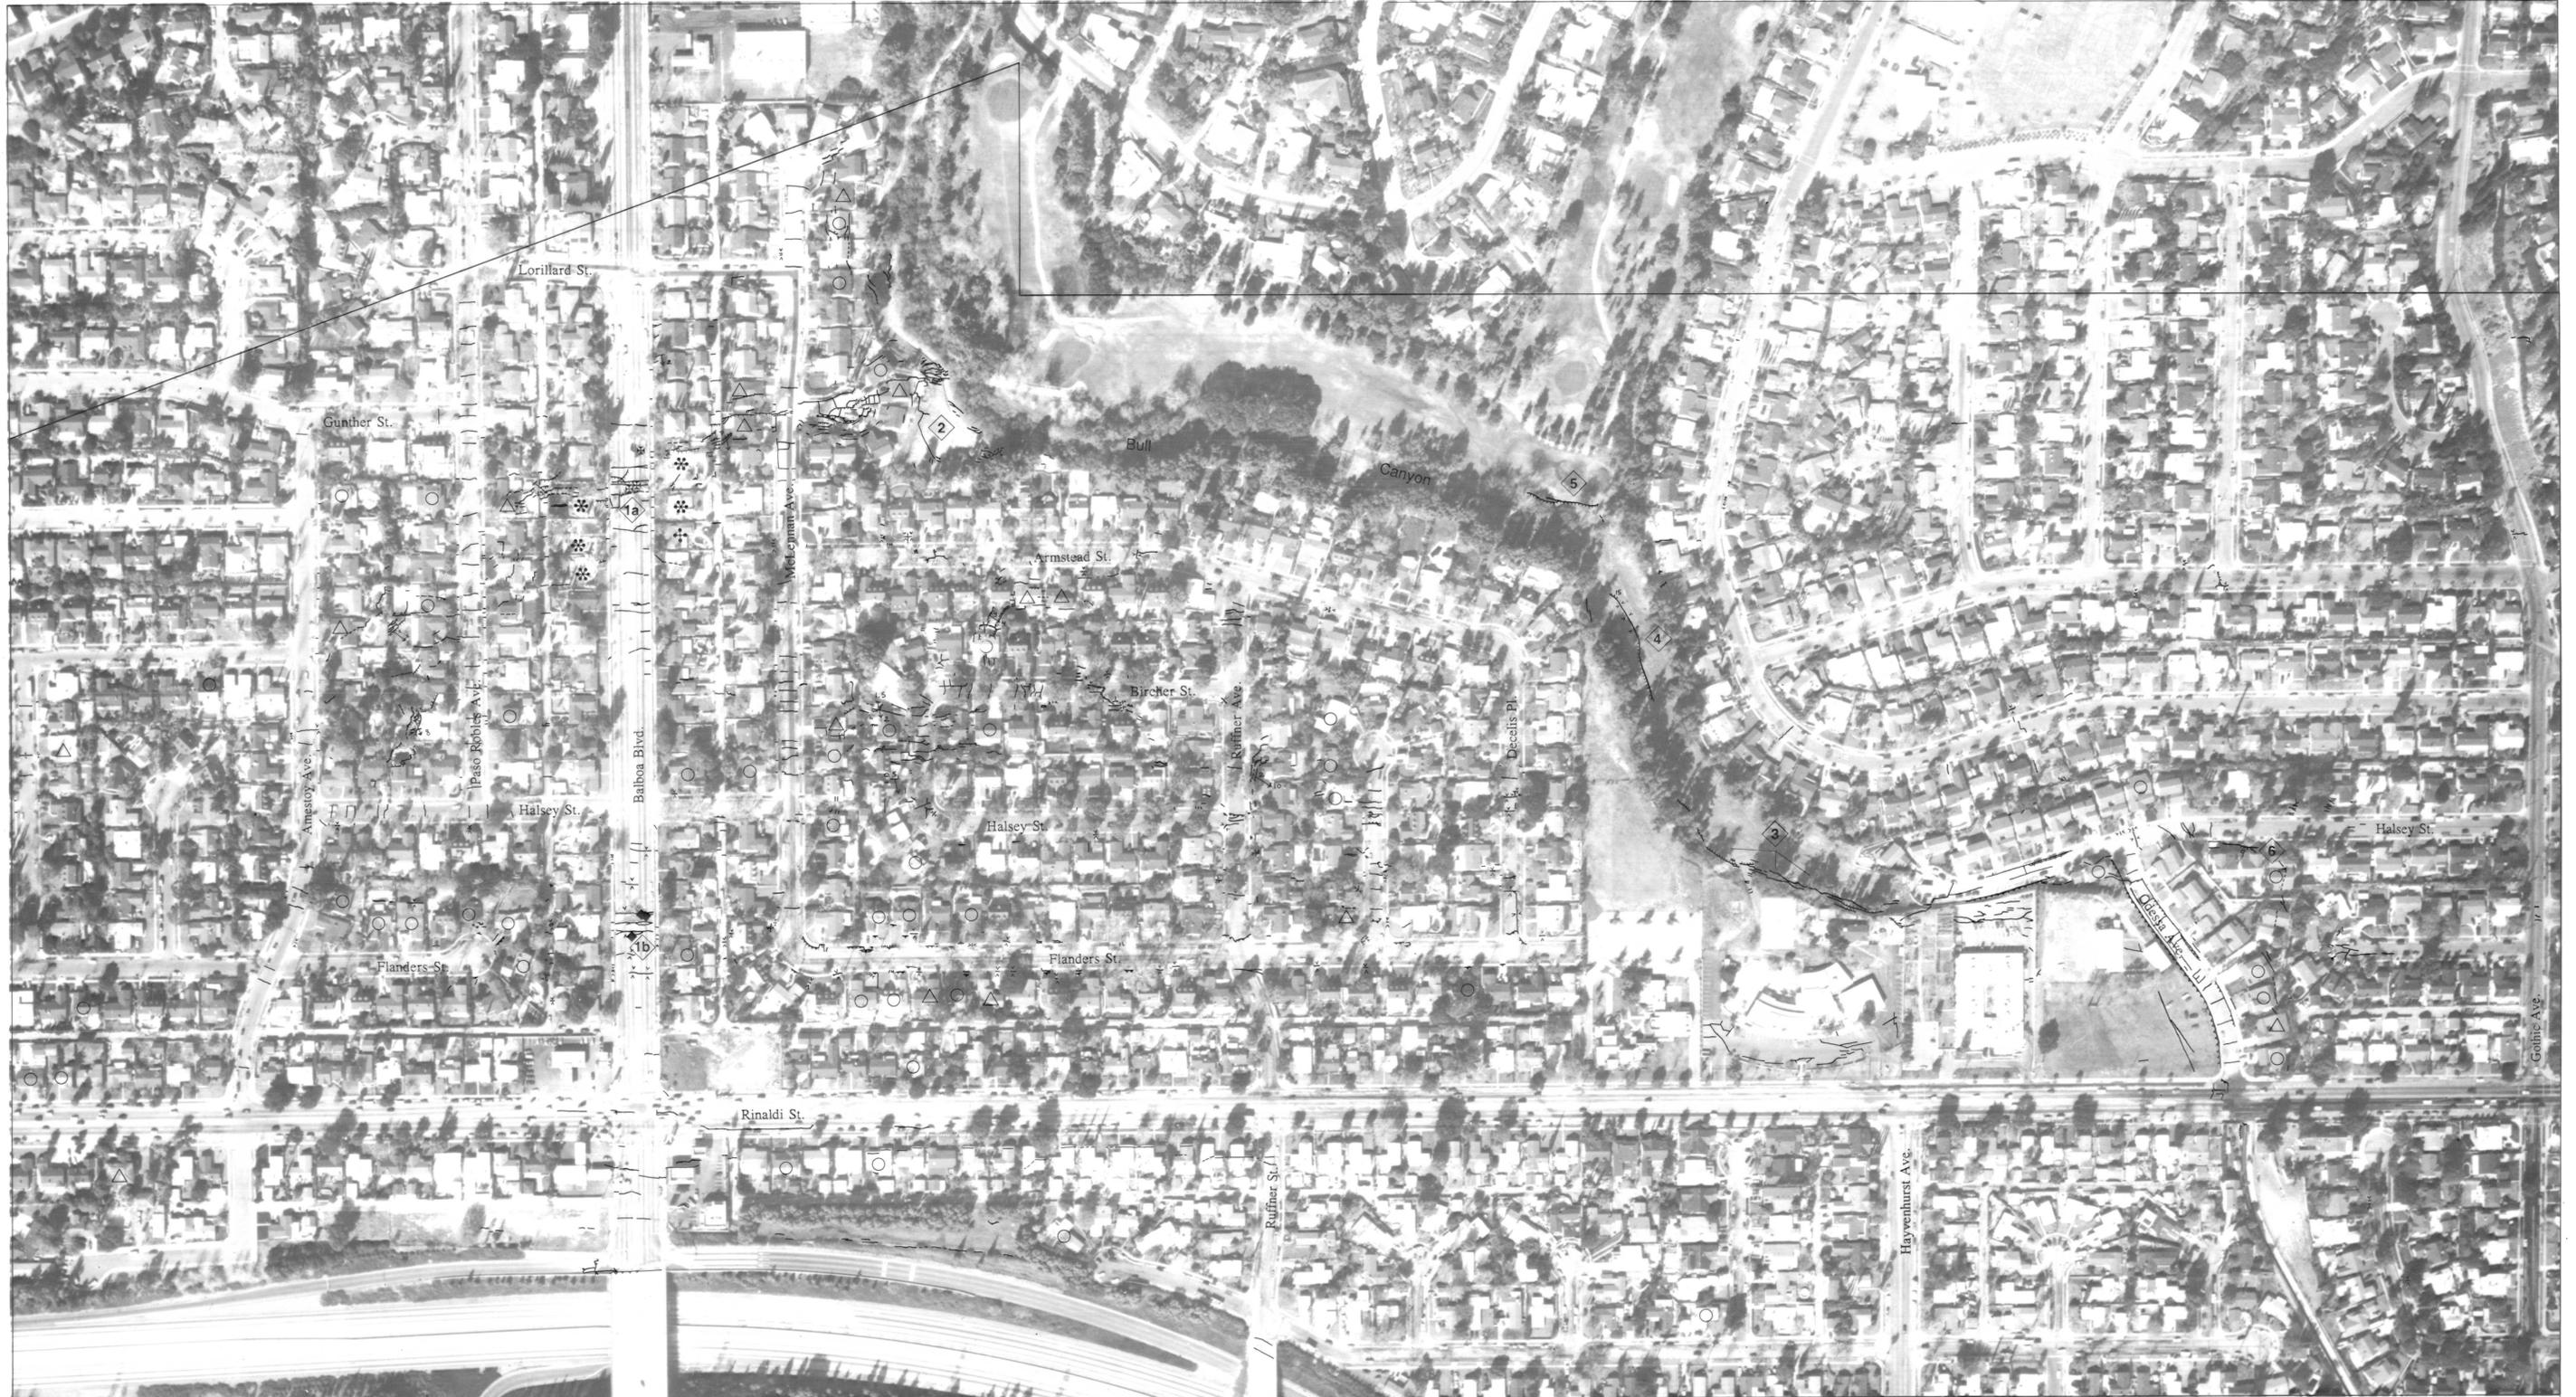
Base photography not orthometrically rectified, contains spacial distortions.
