UNITED STATES DEPARTMENT OF THE INTERIOR
GEOLOGICAL SURVEY

Historical Shoreline Changes at Rincón, Puerto Rico

Open-File Report

95-72

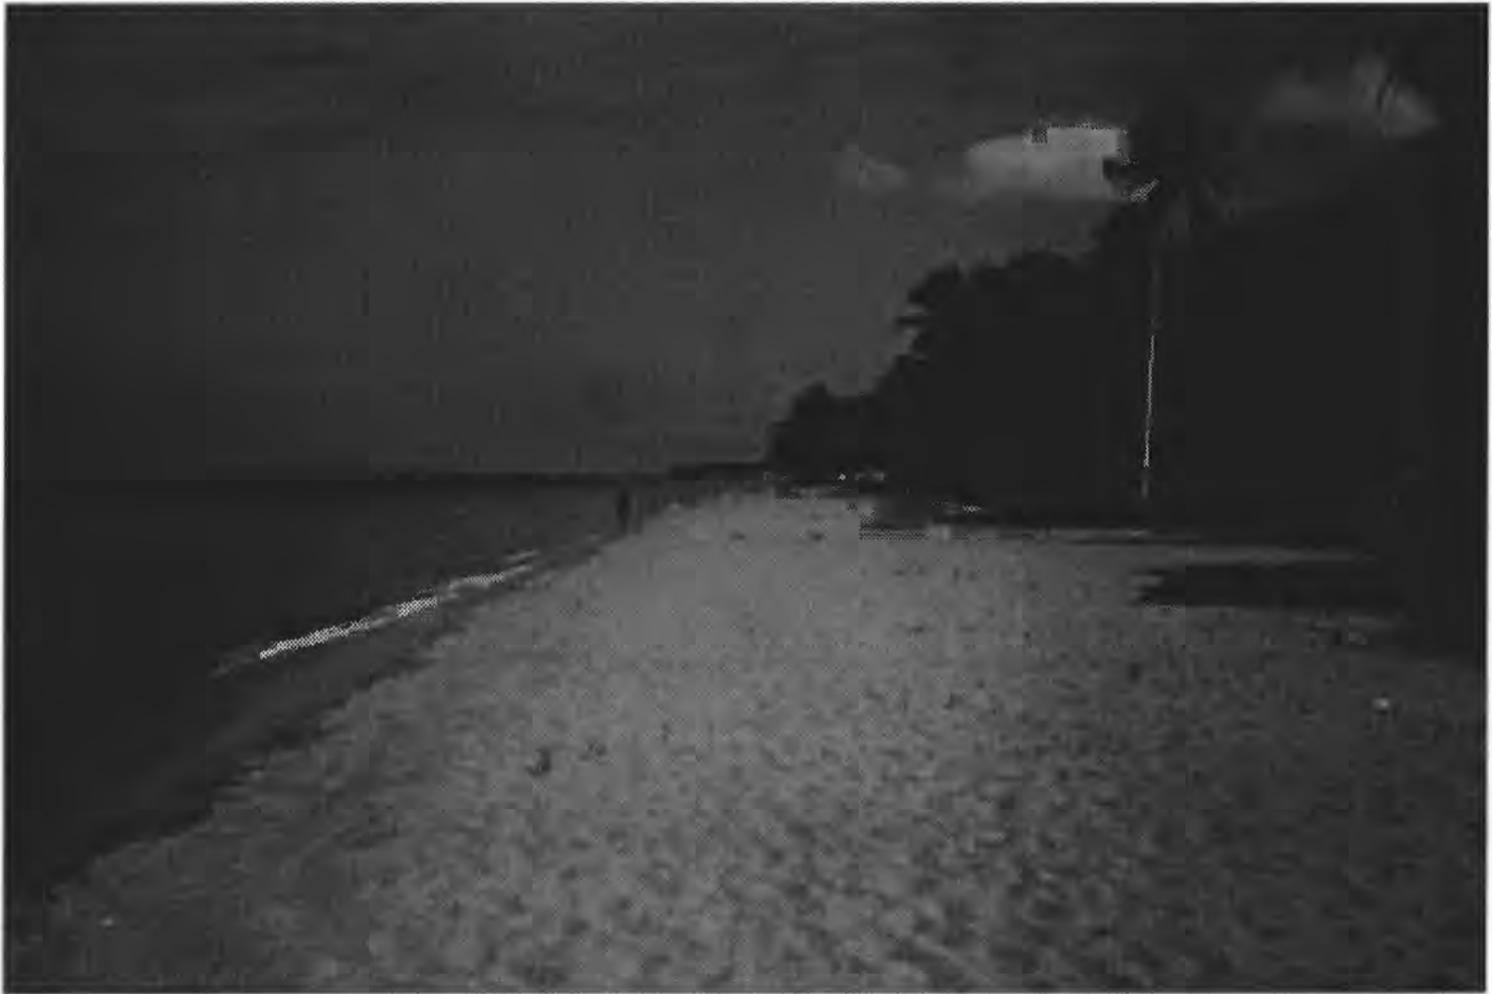
Figure 3

- Fig. 3) Much of the shoreline between Punta Higüero and Punta Cadena is part of a low-lying alluvial plain fronted by a sandy beach. The beach near Córcega, in the southern part of the study area, is shown here.

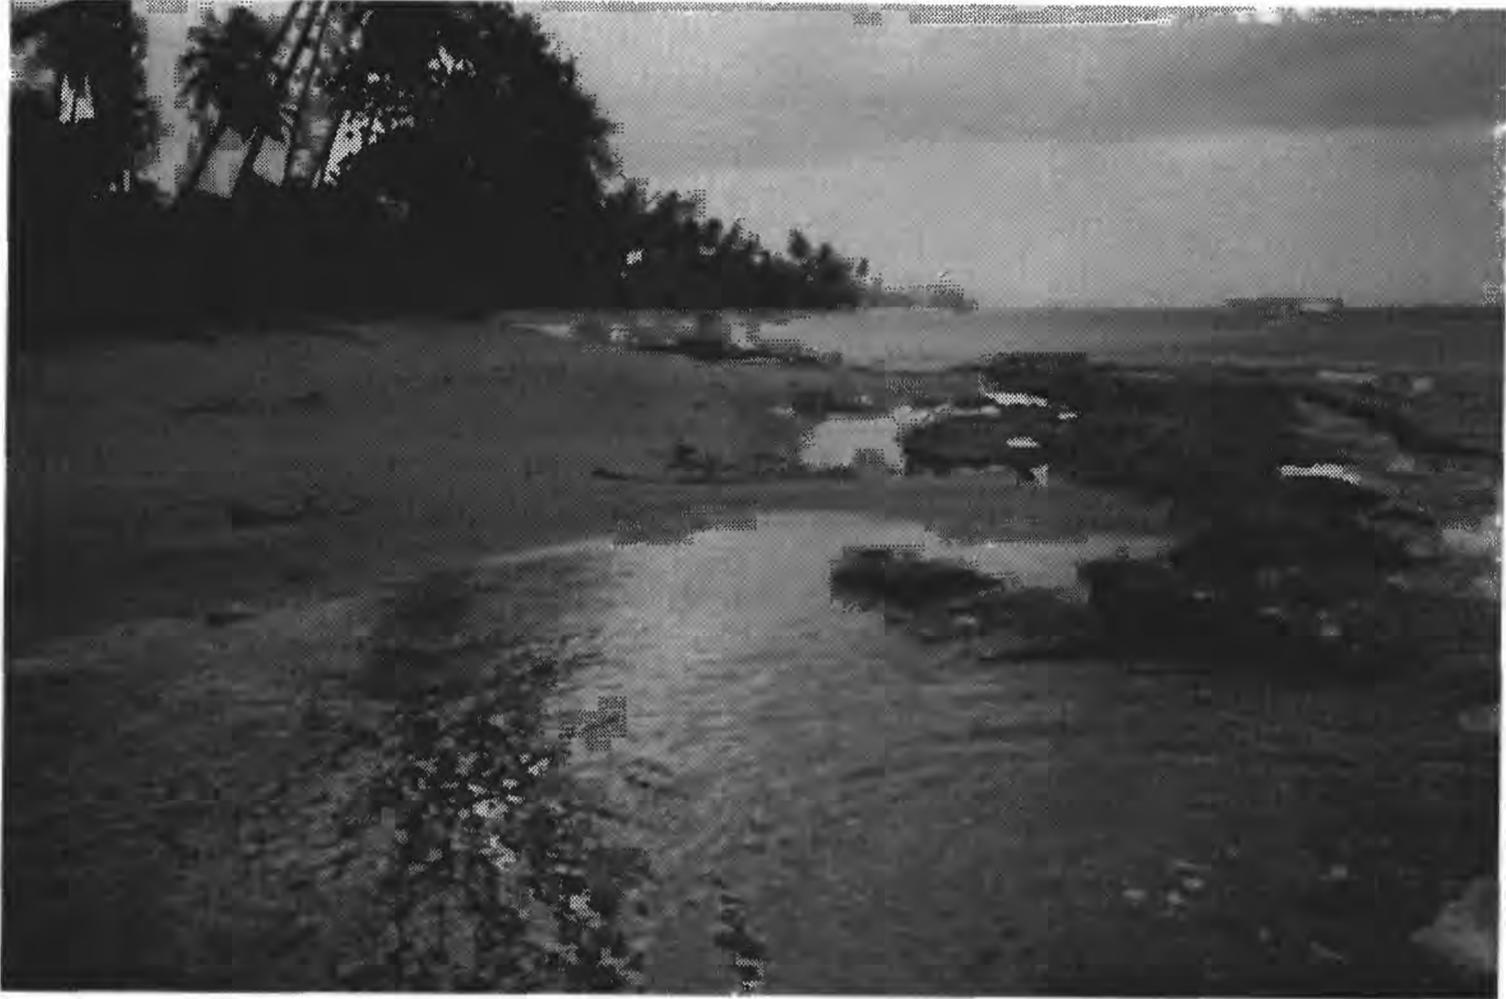
Figure 4

- Fig. 4) From Punta Higüero to Punta Ensenada, the beach is underlain by beachrock, eolianite and metasedimentary rocks. Here, a beachrock deposit, characterized by low-angle, seaward-dipping planar bedding, forms the seaward end of a small tombolo. At different locations in this reach of shoreline, the beachrock sits unconformably on either eolianite or metasedimentary rocks. These three units comprise a low-relief terrace across which a relatively small prism of sand (the active beach) moves in response to seasonal changes in wave energy and long-term erosion.

The study area at Rincón extends from Punta Higüero to Punta Cadena. These rocky headlands are extensions of the central mountain belt that runs the width of Puerto Rico, and form the boundaries of the Rincón-Córcega littoral cell (Morelock, 1987). The shoreline between the headlands is a low-lying alluvial plain with a sandy beach (Fig. 3). From Punta Higüero to Punta Ensenada, however, abundant outcrops of beachrock, eolianite and metasedimentary rocks are present along the shoreline (Fig. 4).

As shown in Figure 4, portions of the shoreline are composed of Recent beachrock deposits. In addition, there are exposures of Pleistocene eolianite (Kaye, 1959) extending northward from Punta Ensenada for several hundred meters. Near Punta Higüero, the metasedimentary rocks of the adjacent mountains either crop out or form a shallow, terrace-like subcrop along the shoreline.

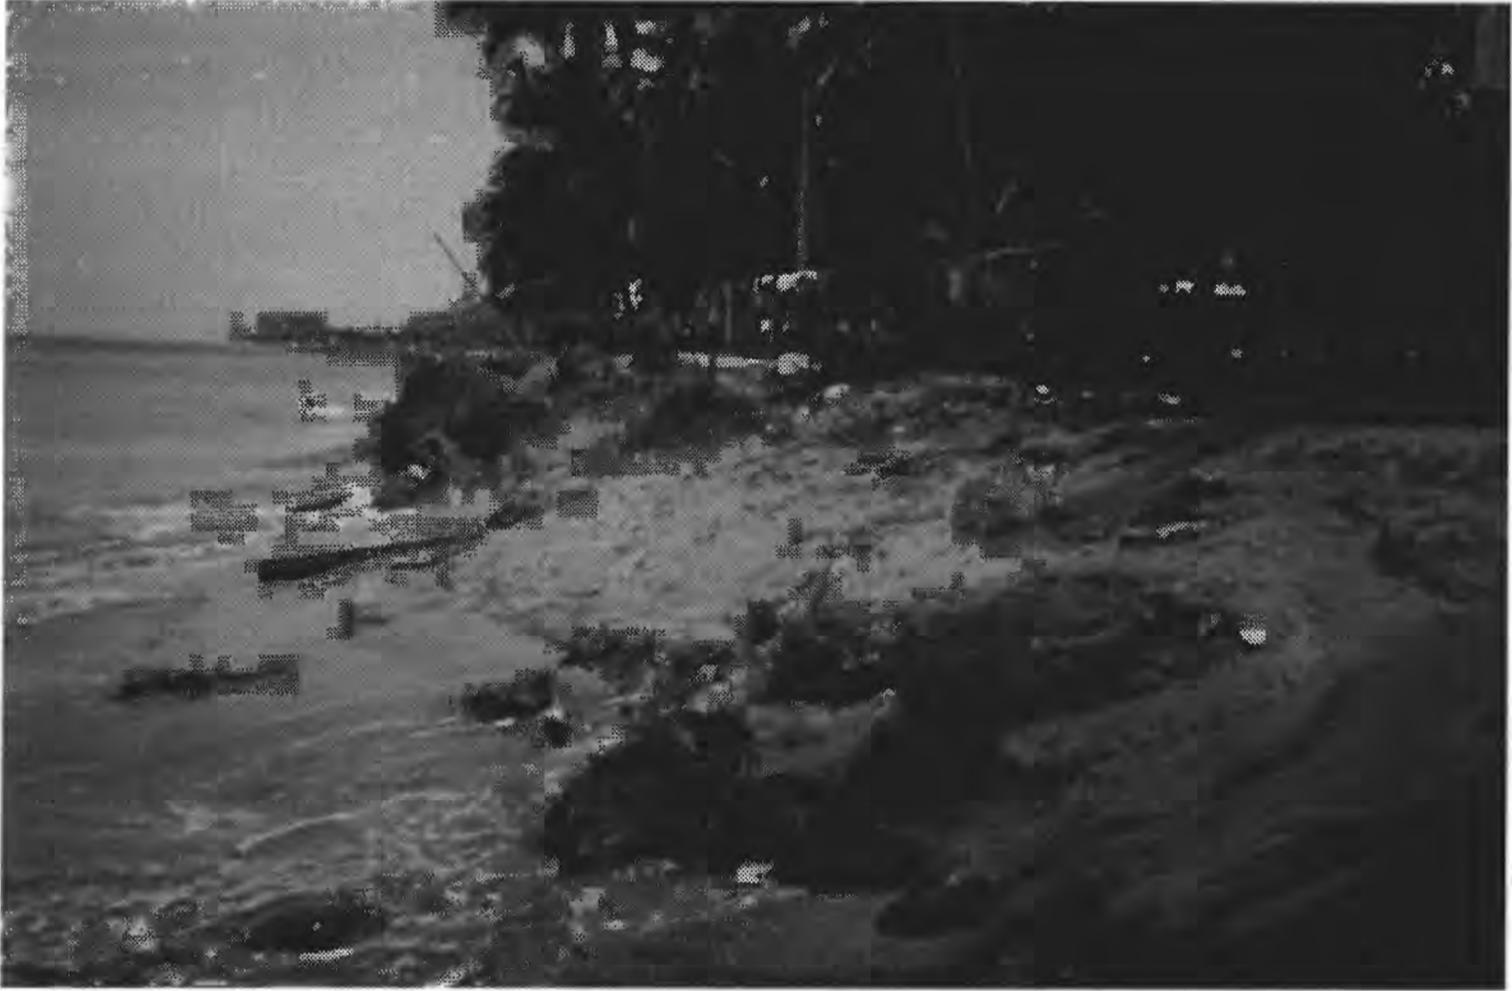
Figure 6

- Fig. 6) Shoreline erosion at Rincón has resulted in the construction of small seawalls and revetments in front of threatened buildings. The revetment shown here is partially covered by trucked-in sand and loose construction debris.

and seawalls have been built (see Fig. 6). This response is probably reducing the availability of new sediment to the system. The following example illustrates this point.

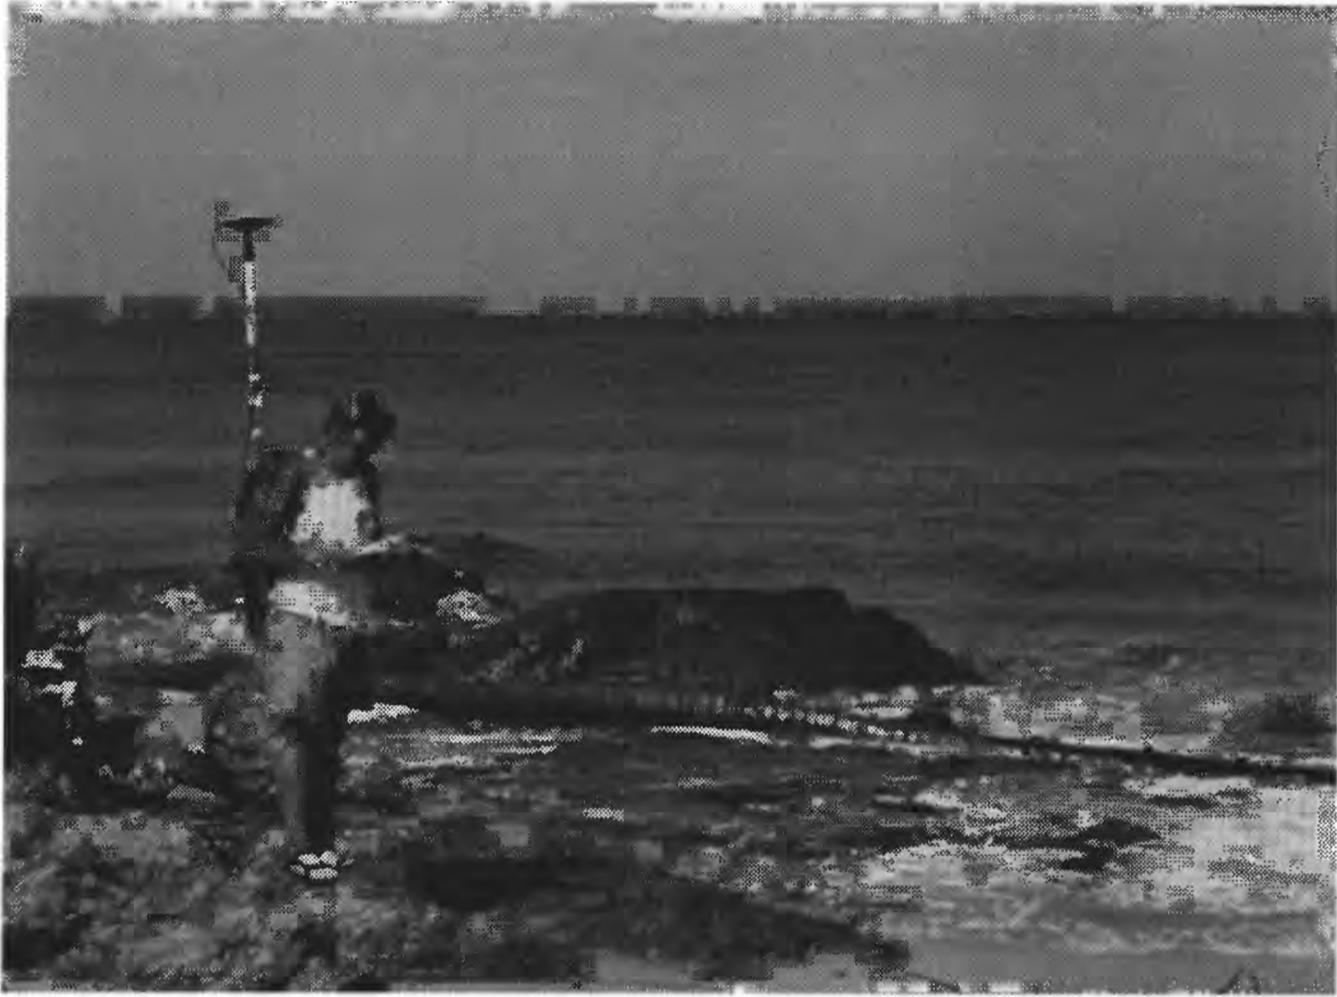
Figure 7

- Fig. 7) Two field surveys of wet/dry shoreline position were conducted in February and August of 1994 using a backpack-mounted GPS receiver. The receiver logged positions at 5-second intervals as the backpacker walked along the wet/dry line. The GPS data were real-time and post-processed for differential correction, yielding a horizontal accuracy of about 2-3 meters. The rocky shoreline near Punta Cadena is shown here.

Two field surveys of wet/dry shoreline position were conducted on 06 February and 24 August 1994. These surveys utilized a backpack-mounted GPS receiver logging positions at 5-second intervals as the backpacker walked along the wet/dry line (Fig. 7). The data were differentially corrected in real-time in the field. Further post-processing yielded a positioning accuracy of 2-3 m. The GPS data were imported directly into the GIS for display with the shorelines obtained from the photographs.

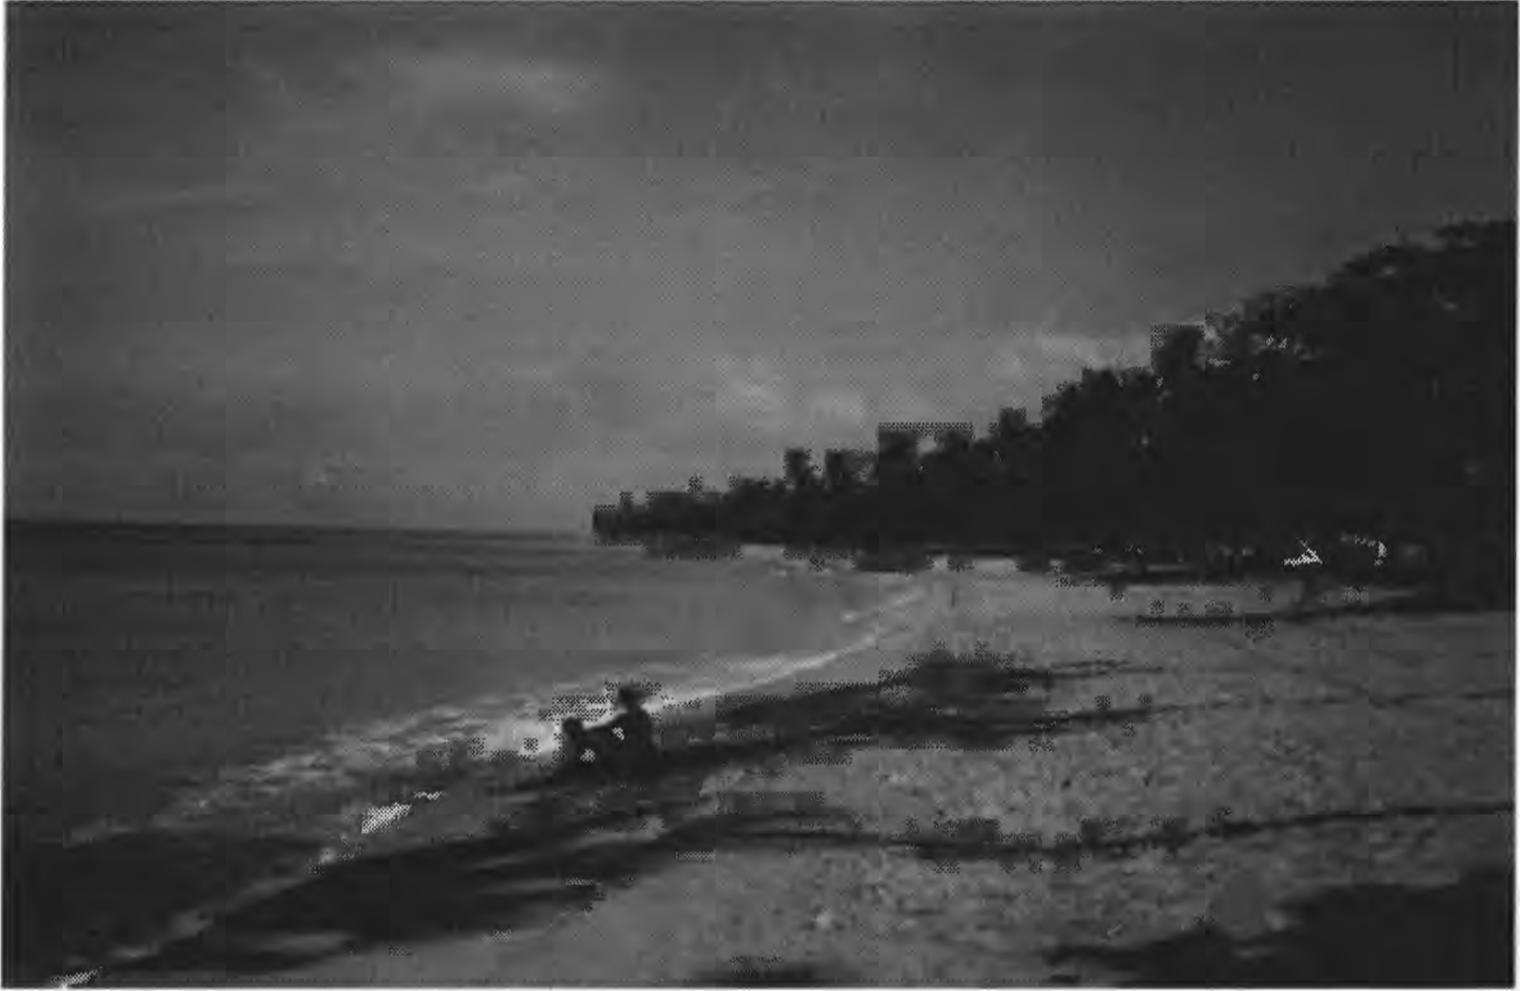
Figure 12

Fig. 12) The beach in the southern part of Reach C is wide, and appears "healthy" (large sand volume, no large active scarps or exposed tree roots). This is in spite of an erosion rate of nearly 1.0 m/yr. This apparent health is probably due to an increased sediment supply coming from accelerated erosion in Reach B. Part is also surely due to the timing of the photograph itself (taken at the end of the fair-weather summer period).

For the area south of Transect 56, the decrease in erosion rate over the period 1987-1994 is probably the result of increased sediment supply from the eroding alluvial sediments updrift in the southern part of Reach B and the northern part of Reach C. It appears that beaches downdrift of the zone of maximum erosion in Reach B are benefiting from an increased sand supply. As shown in Figure 12, the beach here is quite "healthy," although it is eroding over the long-term at nearly 1.0 m/yr.
