**U.S. DEPARTMENT OF THE INTERIOR
U. S. GEOLOGICAL SURVEY**

**INTENSITY DISTRIBUTION AND ISOSEISMAL
MAPS FOR THE NORTHRIDGE, CALIFORNIA,
EARTHQUAKE OF JANUARY 17, 1994**

Open-File Report 95-92

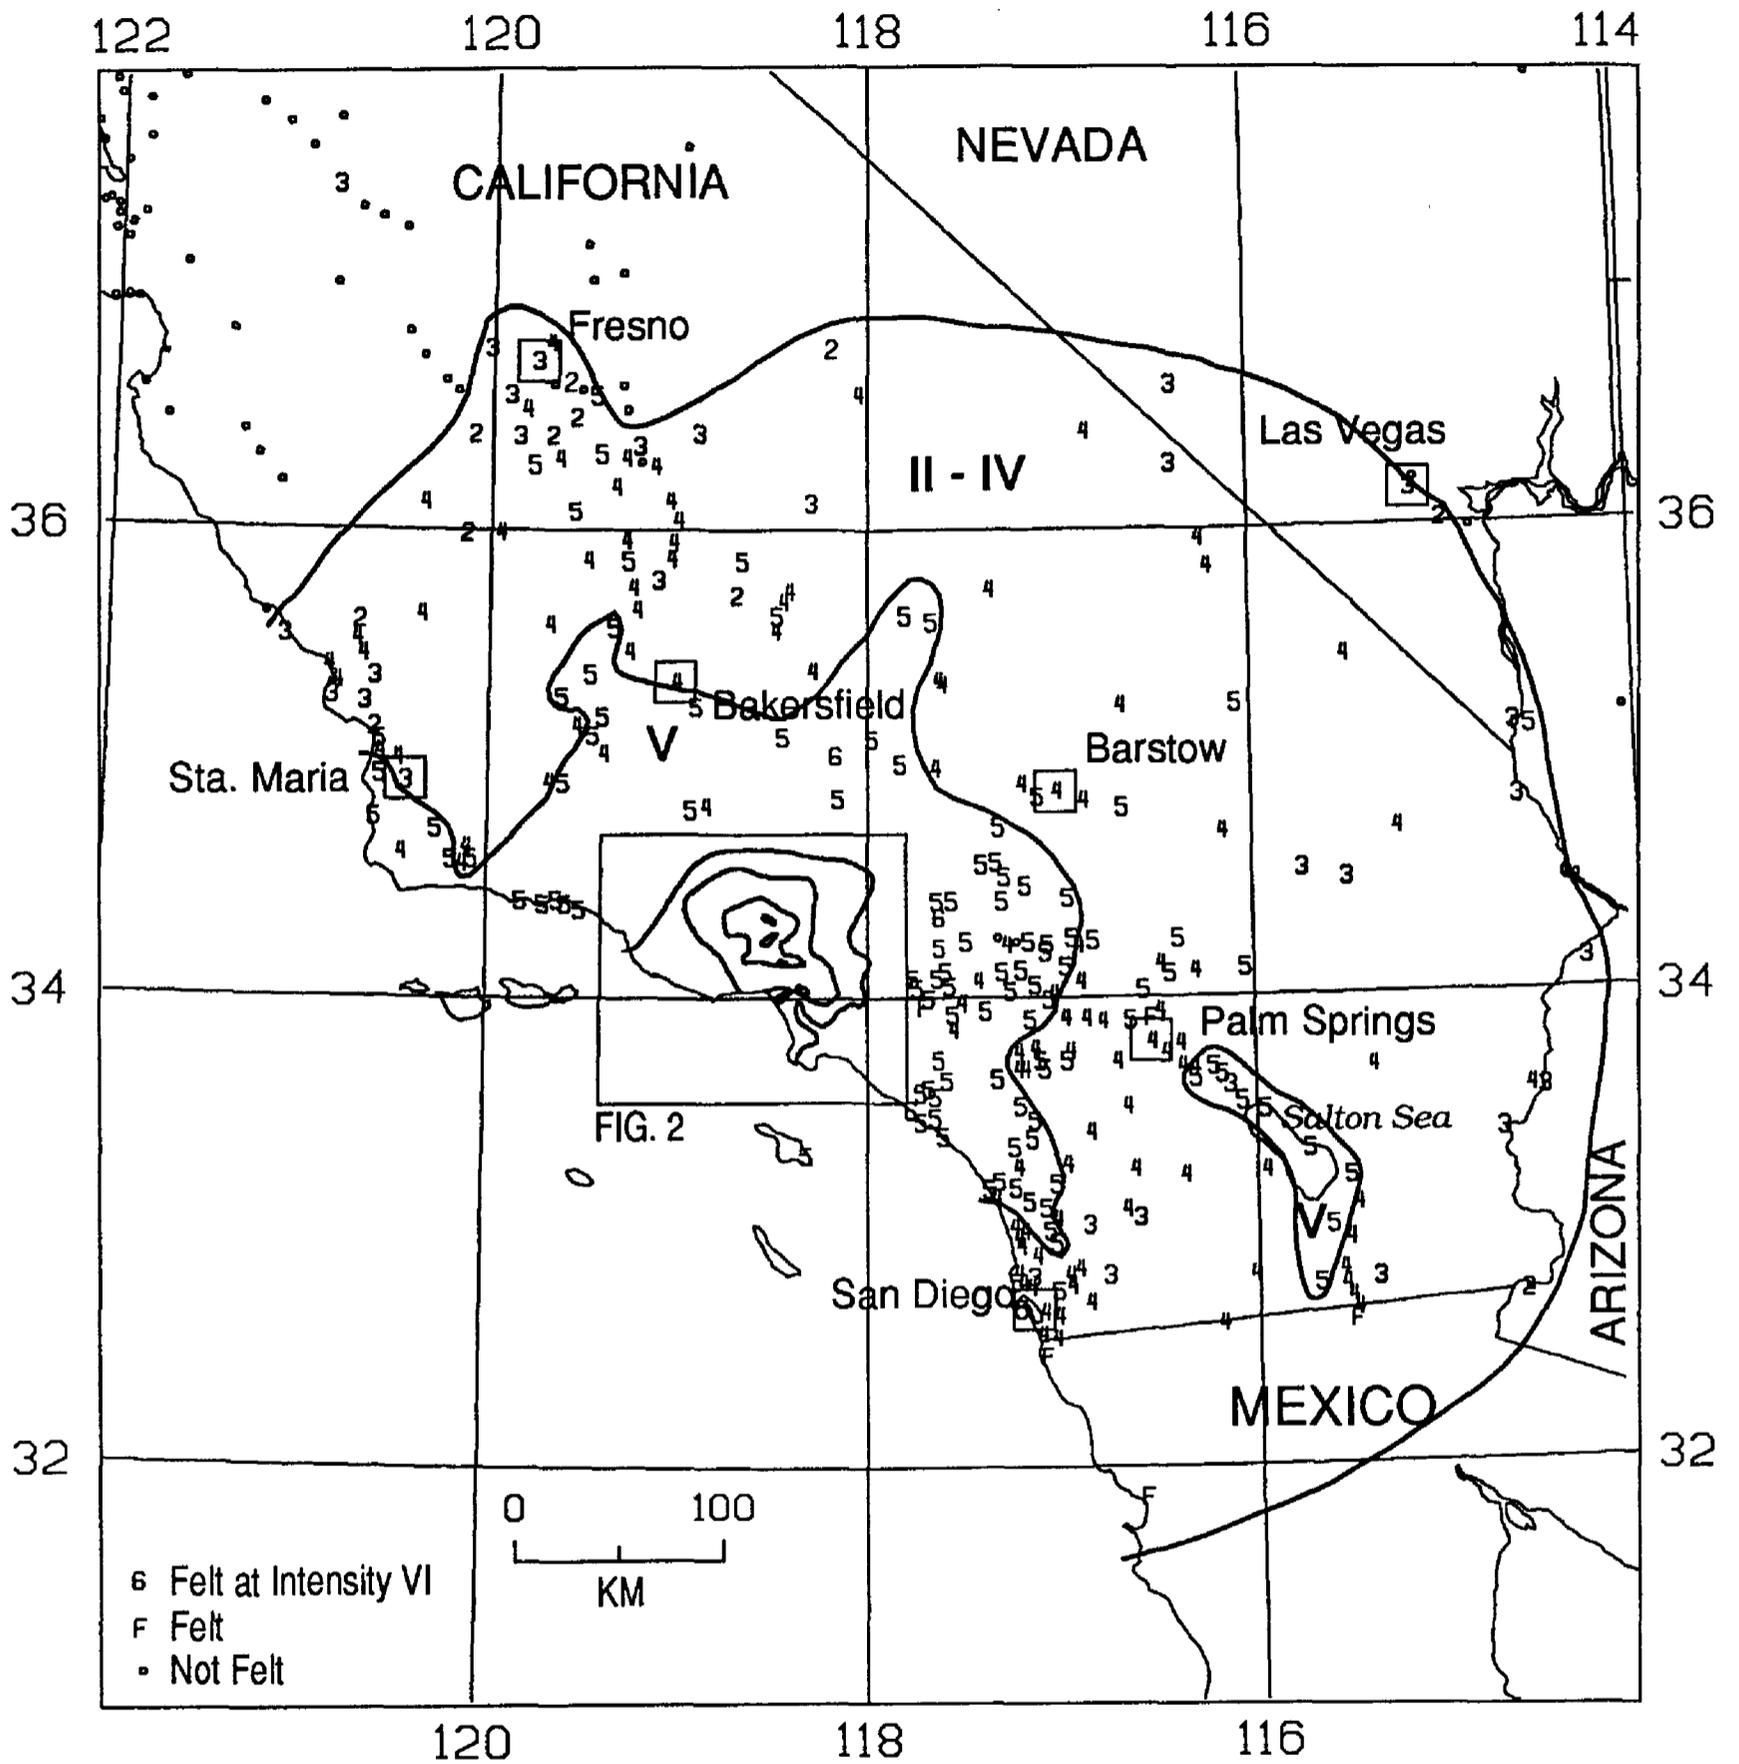
Figure 1. Isoseismal map for the Northridge earthquake. Roman numerals give average Modified Mercalli intensities for the regions between isoseismals; Arabic numerals represent intensities in individual communities. Squares denote towns labeled in the figure. Box labeled "FIG. 2" identifies boundaries of that figure.

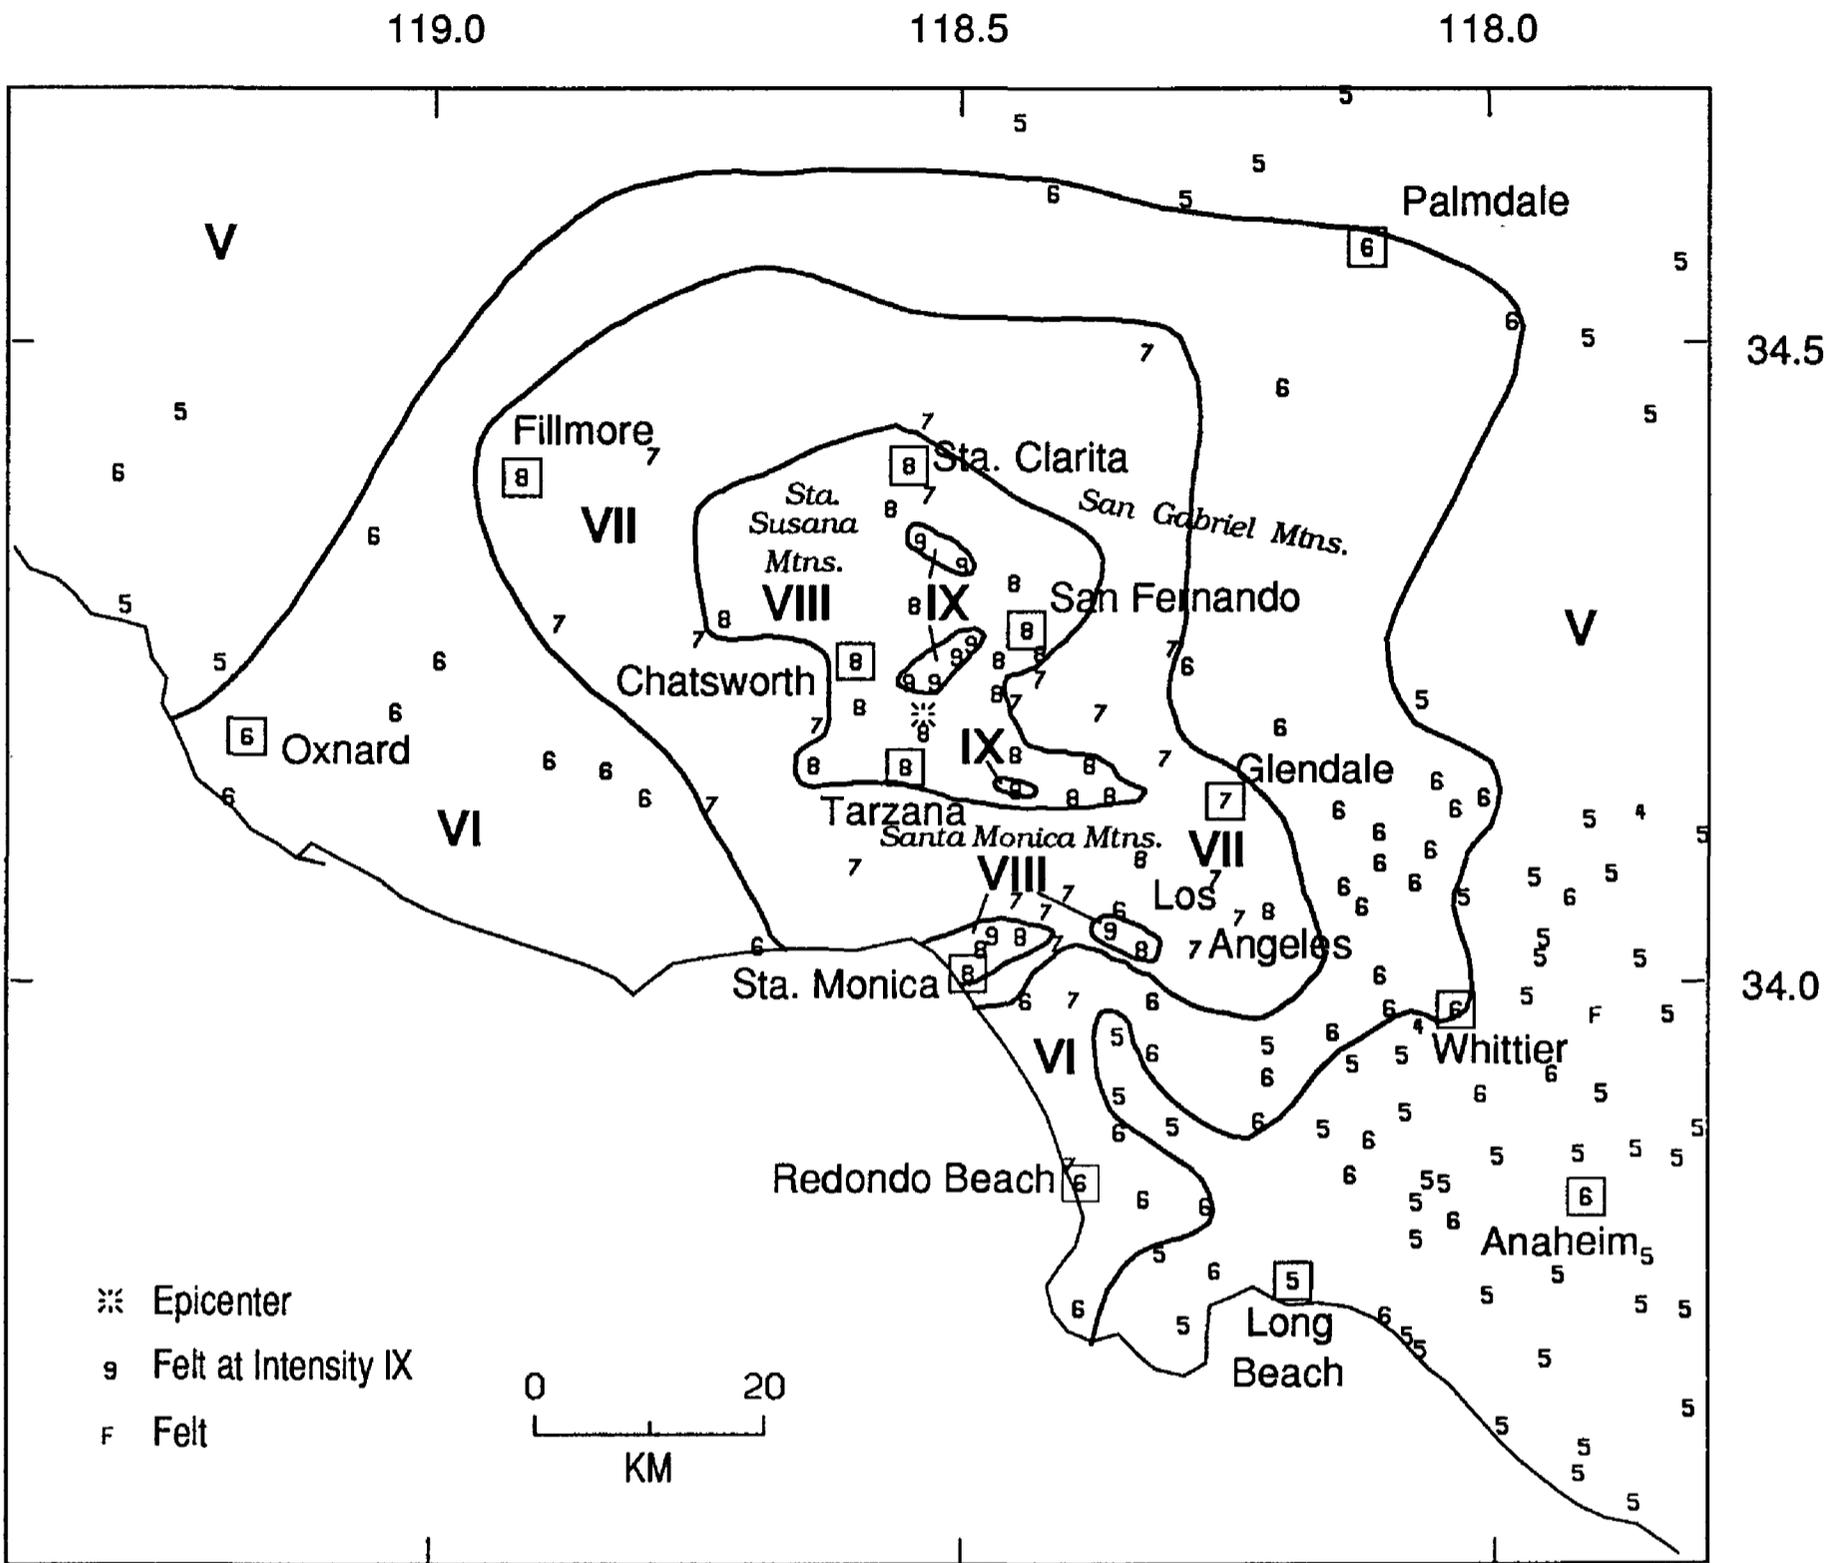
Figure 2. Distribution of Modified Mercalli intensities in the epicentral region. Roman numerals give average intensities within isoseismals. Arabic numerals represent intensities at specific locations. Squares denote towns labeled in the figure.

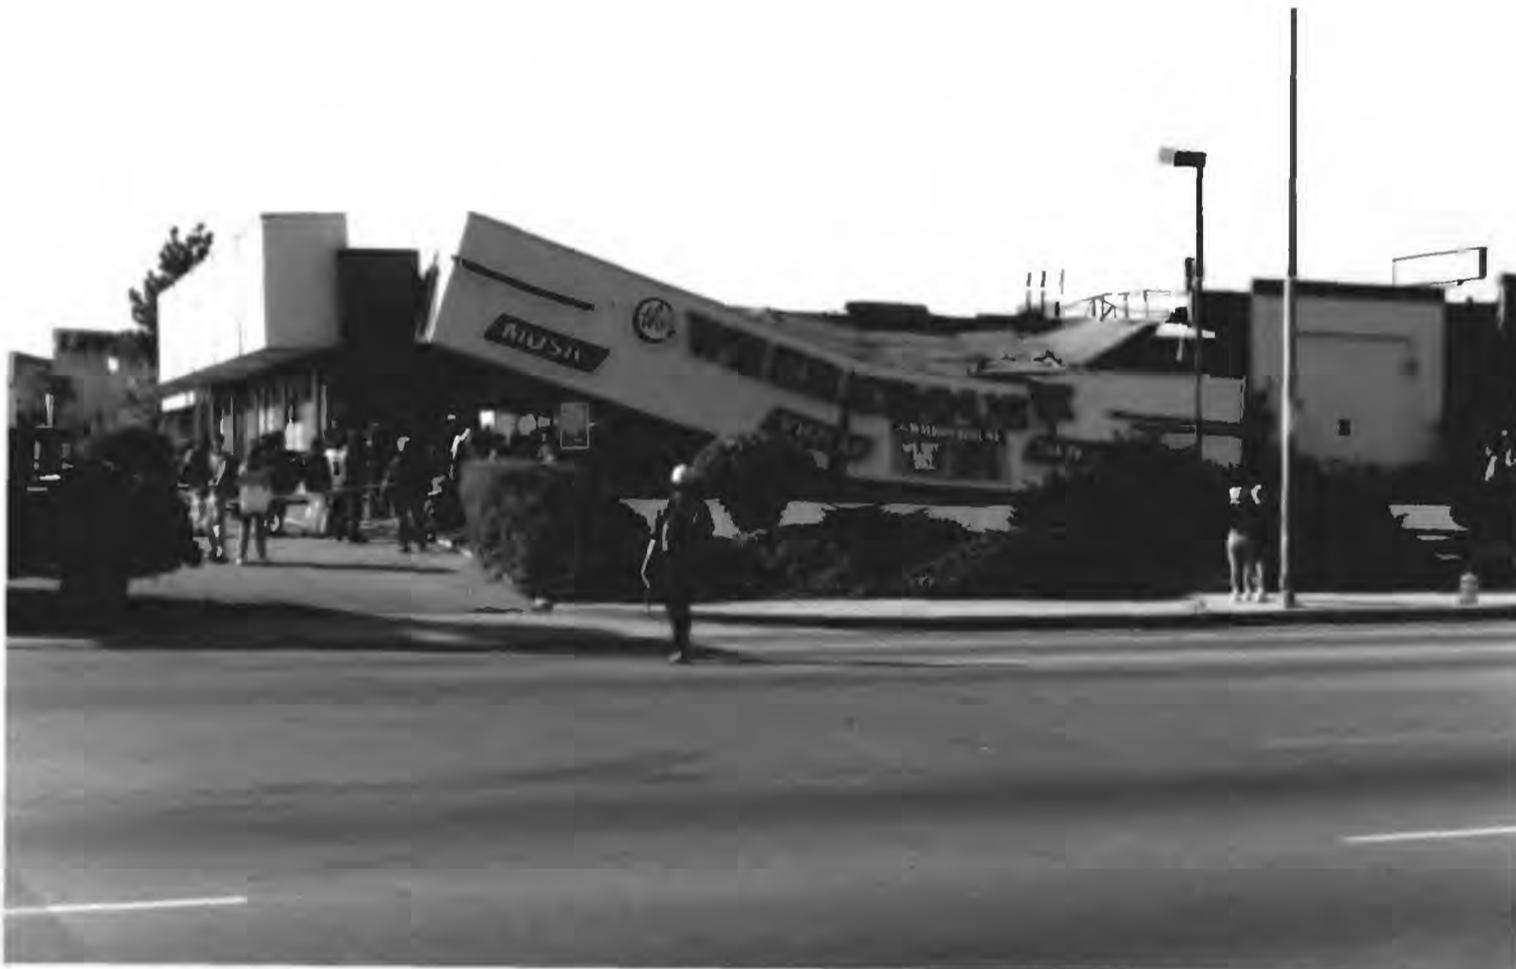
Northridge- Severe damage occurred to stores and parking structures of the Northridge Fashion Mall. Bullocks department store sustained failure at slab-to-column connections and collapsed (fig. 6) (Hall, 1994). Most of one parking structure collapsed, another had collapsed sections, and a third was severely damaged (Hall, 1994). Non-structural damage in stores of the mall was intense and would likely have caused casualties had the earthquake occurred during business hours (Hall, 1994). Satellite shopping areas near the Northridge Fashion Mall suffered extensive structural and non-structural damage, with some buildings experiencing partial collapse (fig. 7).

Figure 6. Collapse of Bullocks department store at the Northridge Fashion Mall, Northridge (listed under intensity IX). The notch on the standing column shows where a floor slab had been attached.

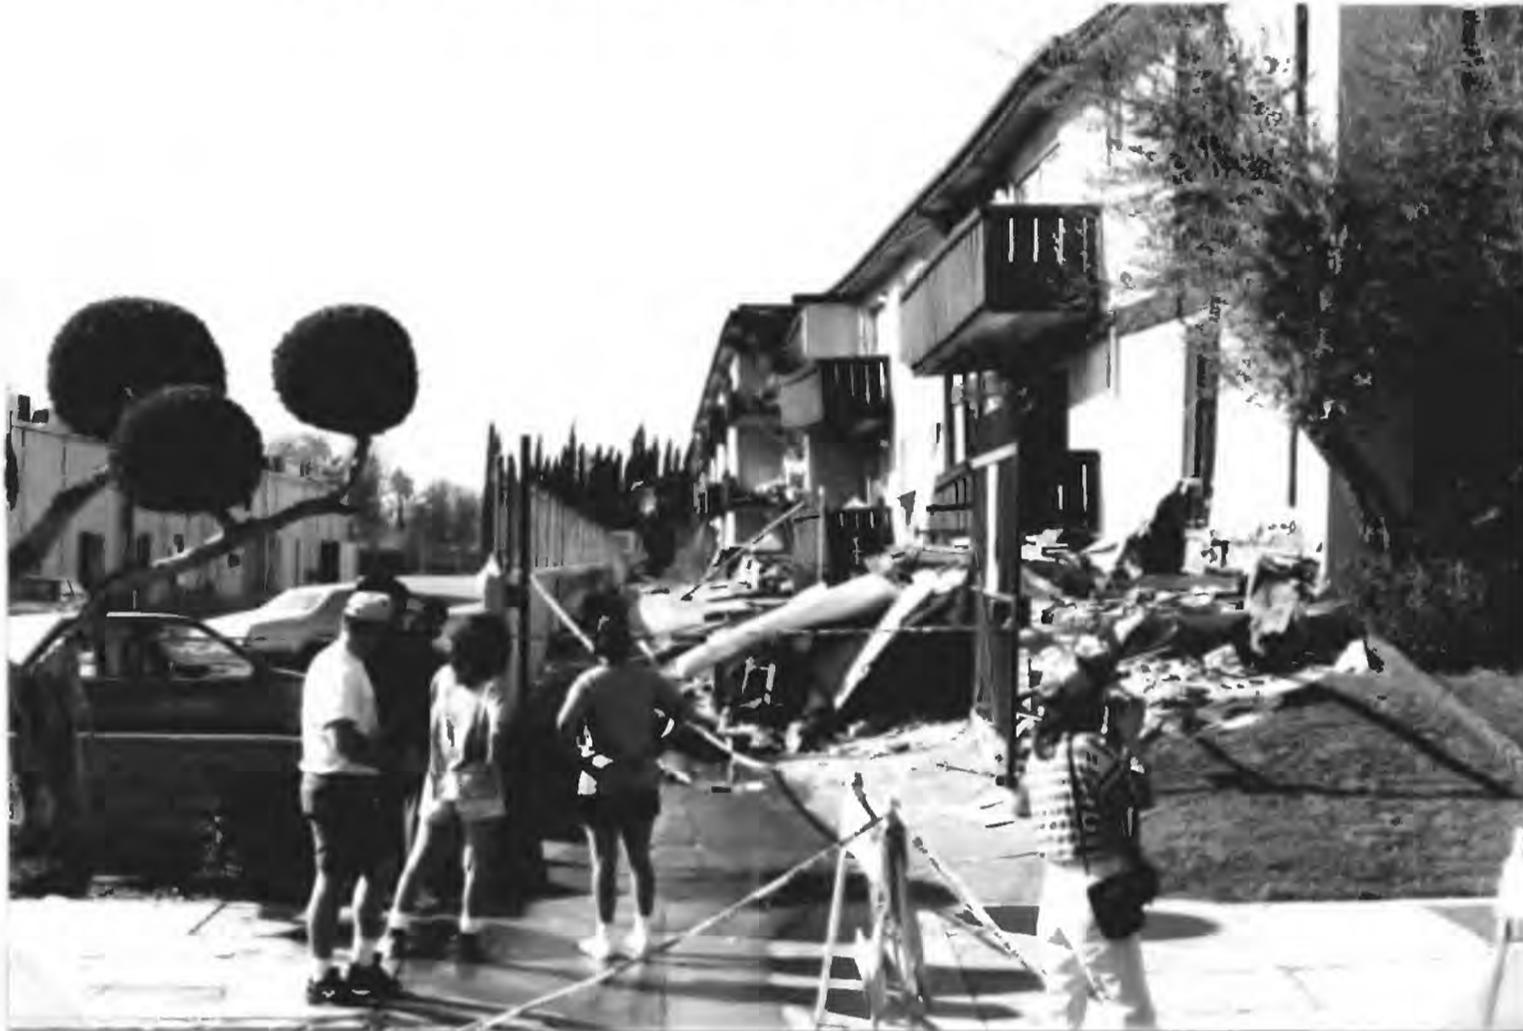
Figure 7. Partial collapse of a store building in a shopping center near the Northridge Fashion Mall, (listed under intensity IX).

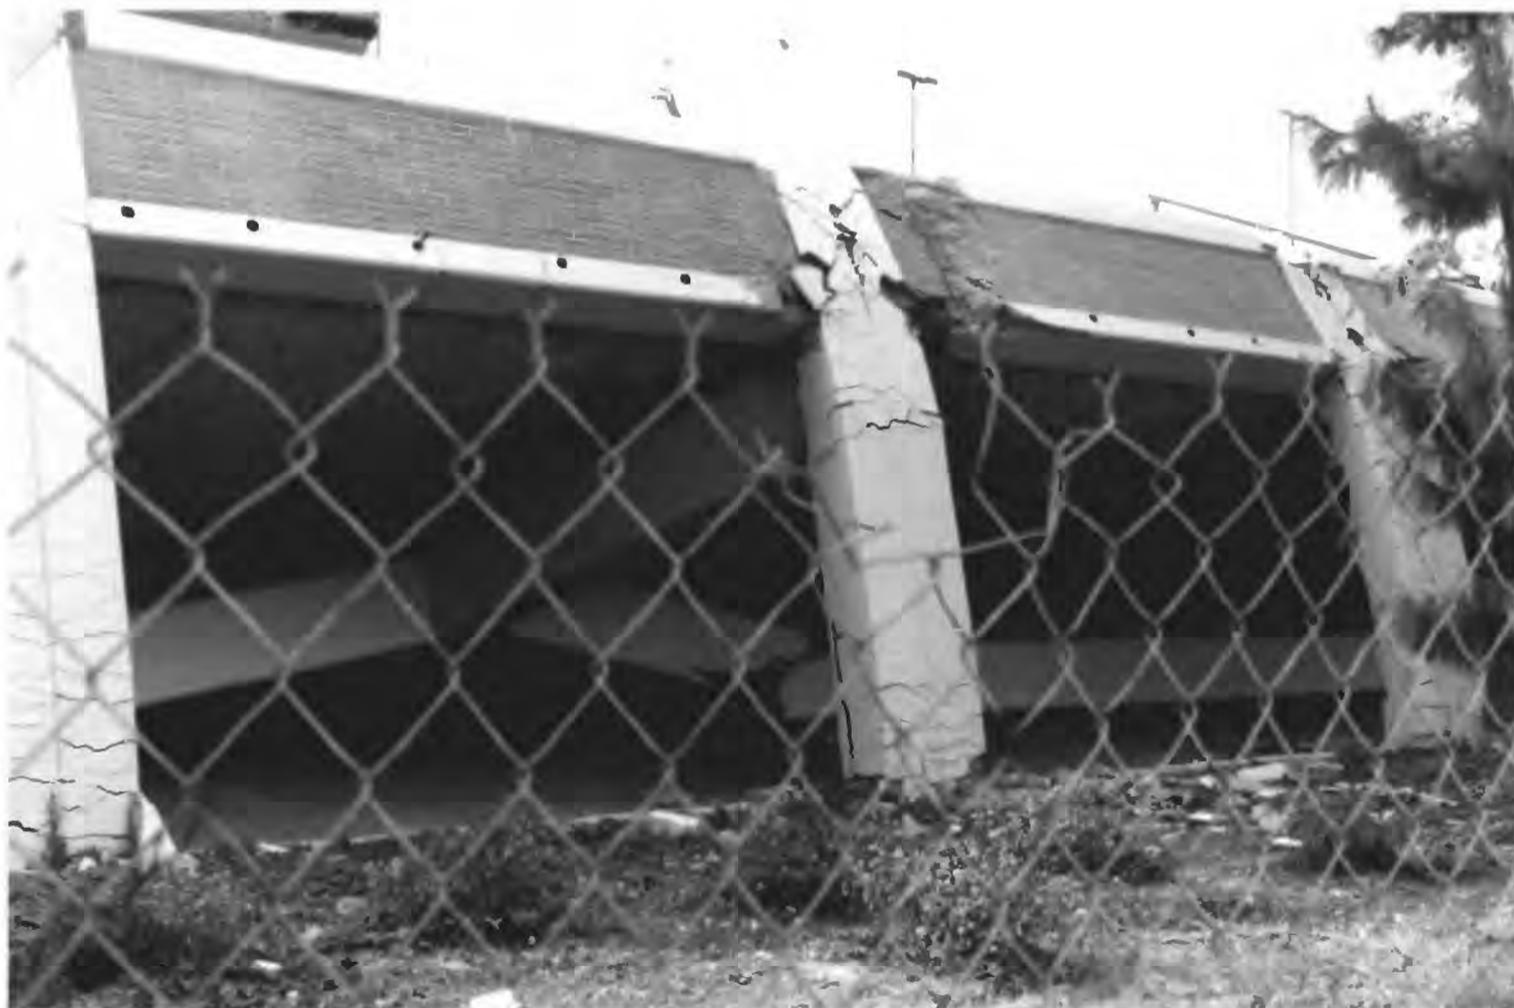
Many multi-unit wood-frame residences were destroyed. Sixteen people were killed in the partial collapse of buildings in the Northridge Meadows Apartment complex (fig. 8): the casualties occurred in apartment units that shared the first-stories with parking areas. This was the worst loss of life associated with failure of any single building complex in the earthquake.

Figure 8. Northridge Meadows apartment complex, Northridge(listed under intensity IX). Collapsed building in right foreground was formerly at same height as, and aligned with, uncollapsed building in middle background.

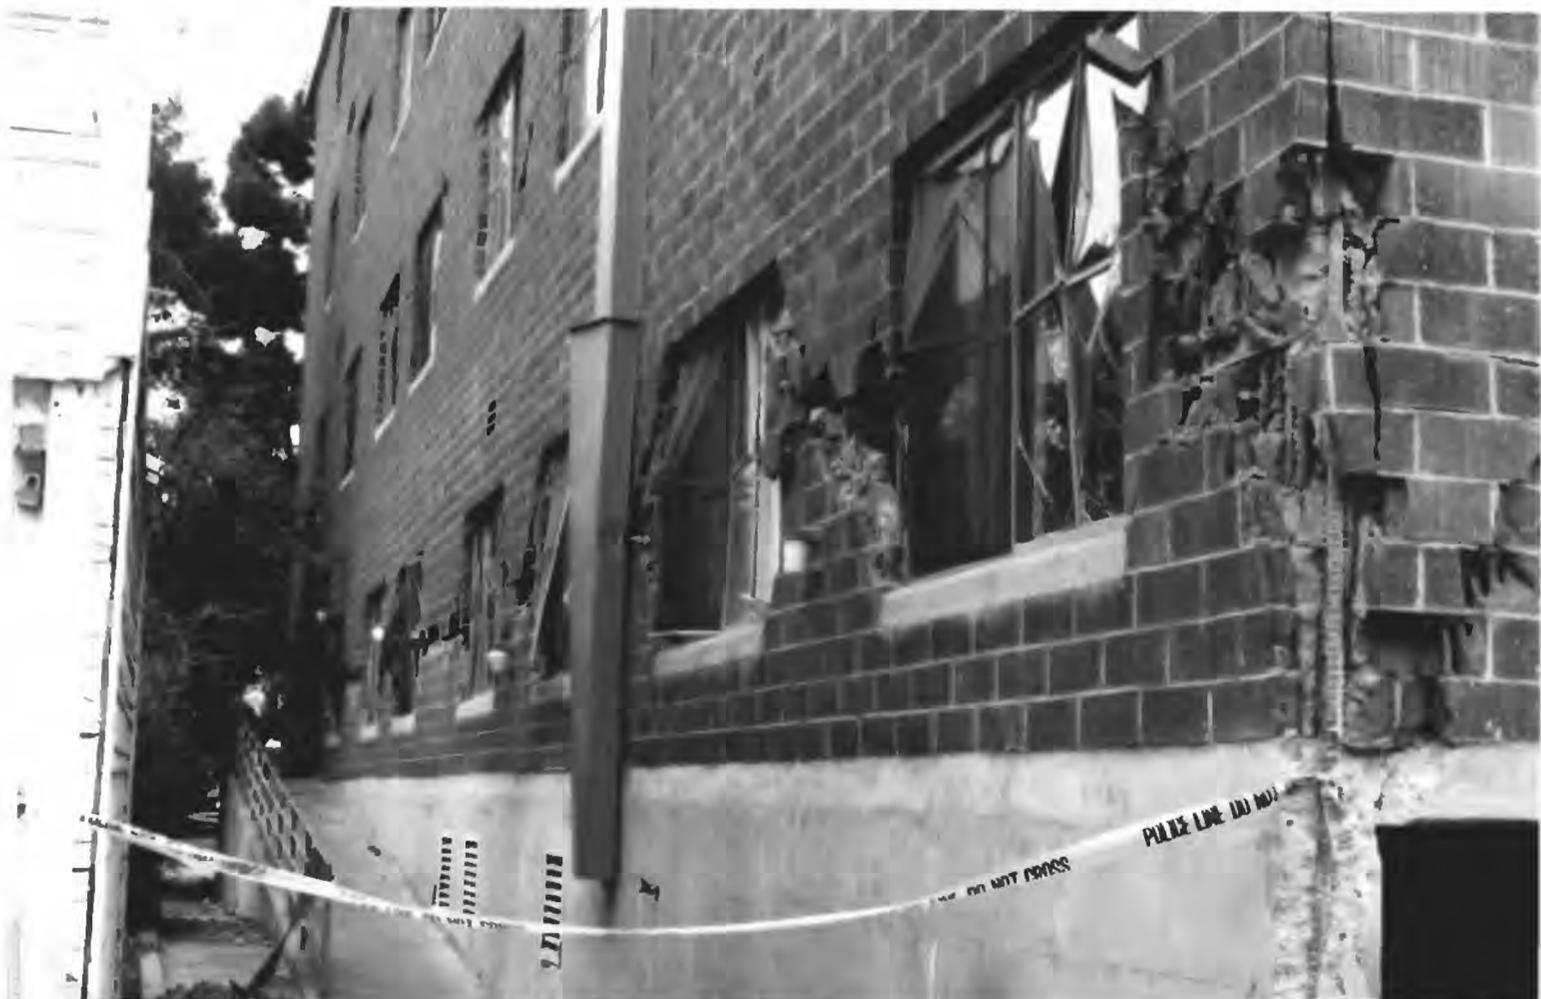
Figure 10. St. Johns Hospital, Santa Monica (this part of Santa Monica listed under intensity IX), showing diagonal shear cracks in piers at the second story level.

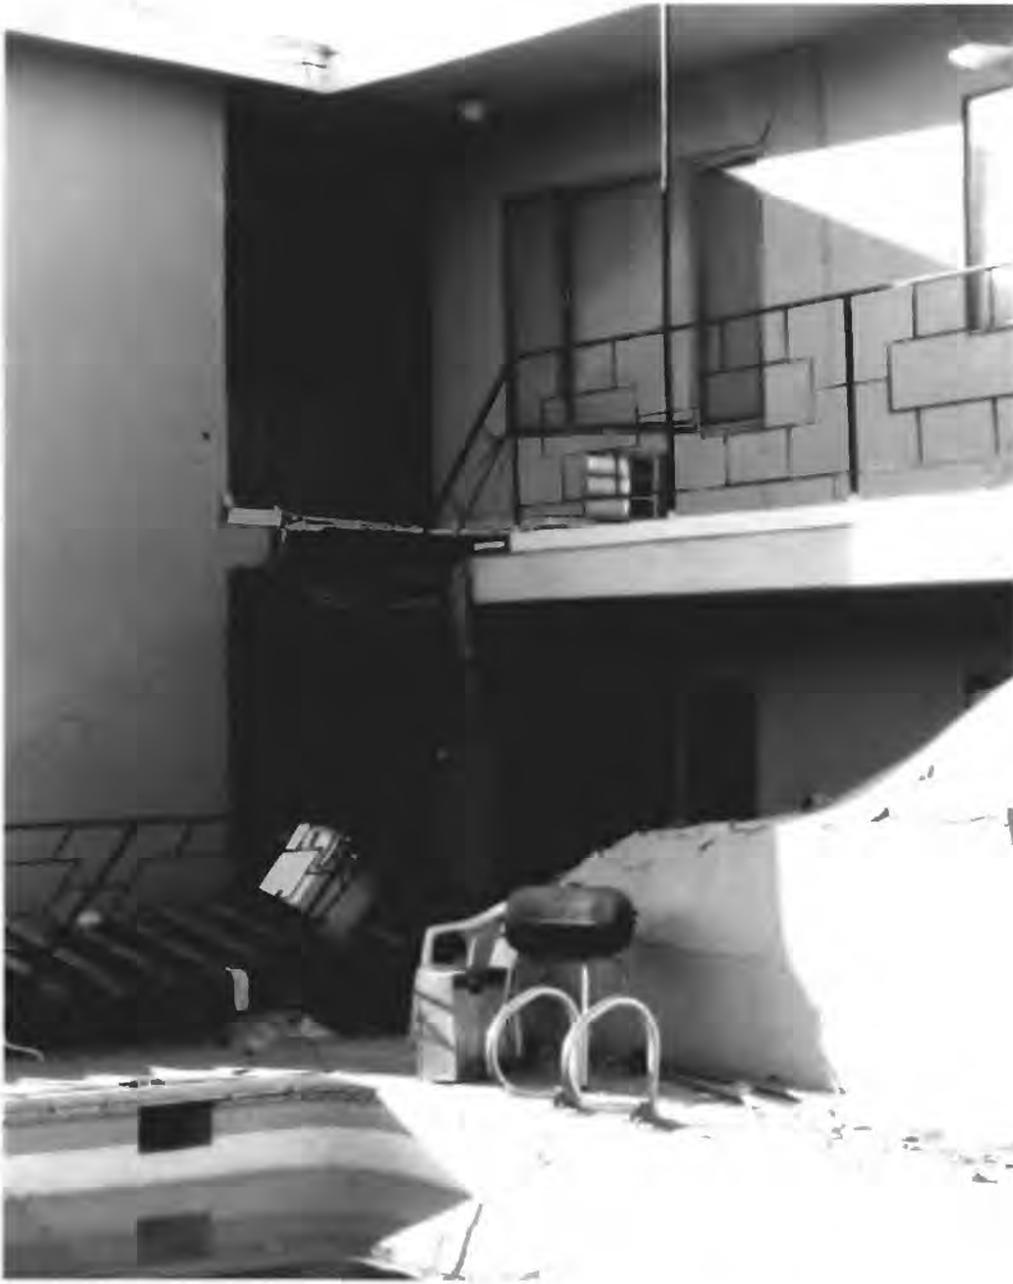
There was extensive damage to wood-frame apartment buildings in an area north of Ventura Boulevard and south of US 101, between Kester Avenue and Woodman Ave (fig. 13 and 14). One person in this area was electrocuted by a fallen power line.

Figure 13. Displacement of upper stories of an apartment building over ground-floor parking area, Sherman Oaks (listed under intensity IX).

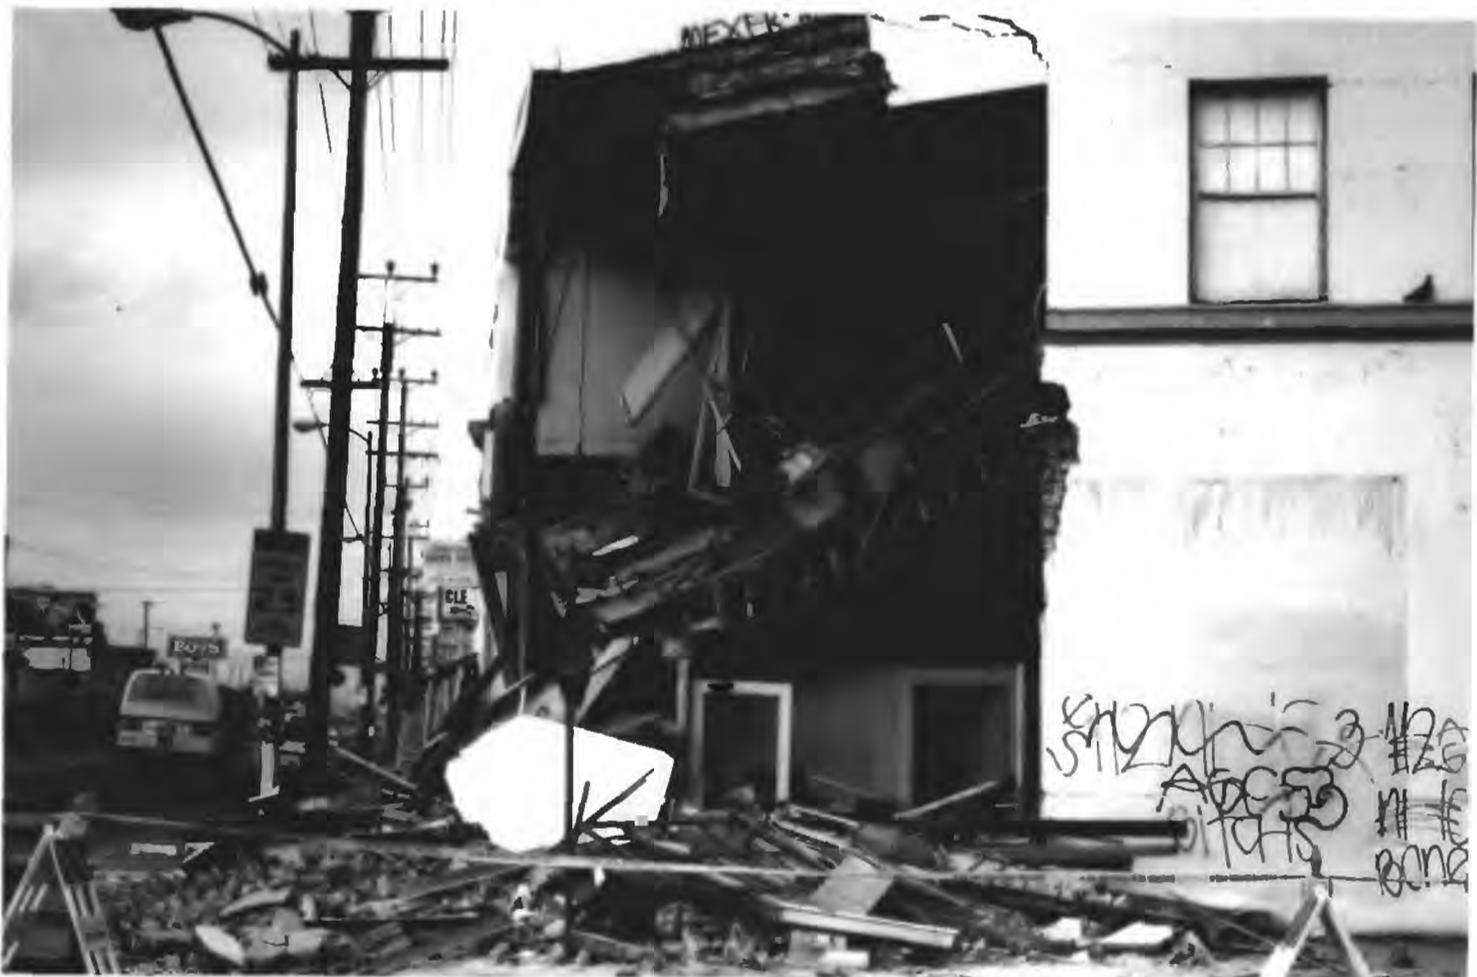
Figure 16. Damage to unreinforced masonry building, Hollywood Boulevard, Hollywood (listed under intensity VIII). At the time this picture was taken, most bricks and other debris on the sidewalk had been removed.

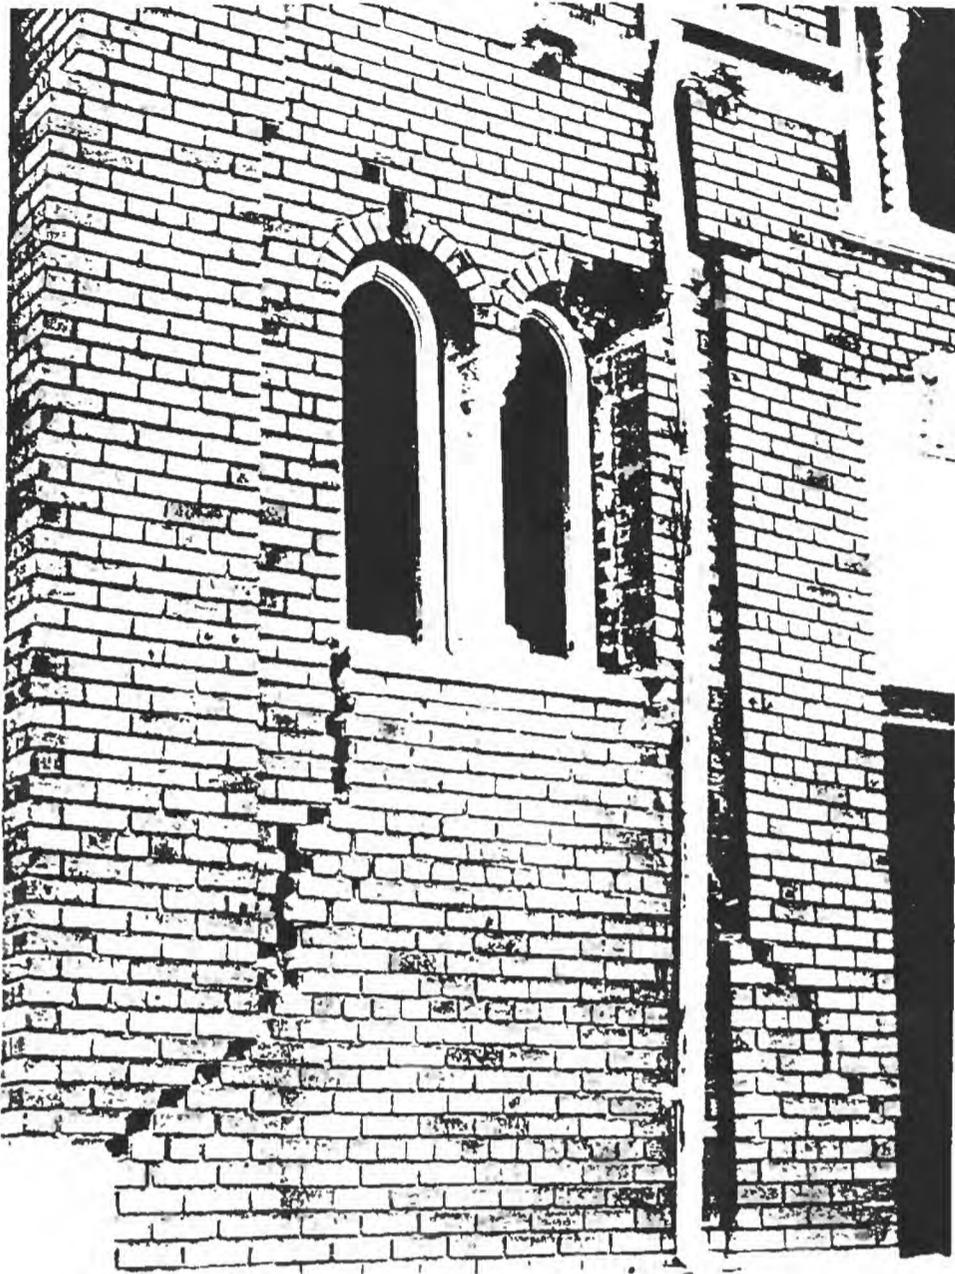
Figure 17. Damage to unreinforced masonry building, Los Angeles (West Adams) (listed under Intensity VIII).
