Plate 1. MAP SHOWING TYPE AND DISTRIBUTION OF DAMAGE IN NORTHERN SANTA CLARA AND SOUTHERN SAN MATEO COUNTIES, CALIFORNIA

By  
Earl H. Pampeyan  
1995

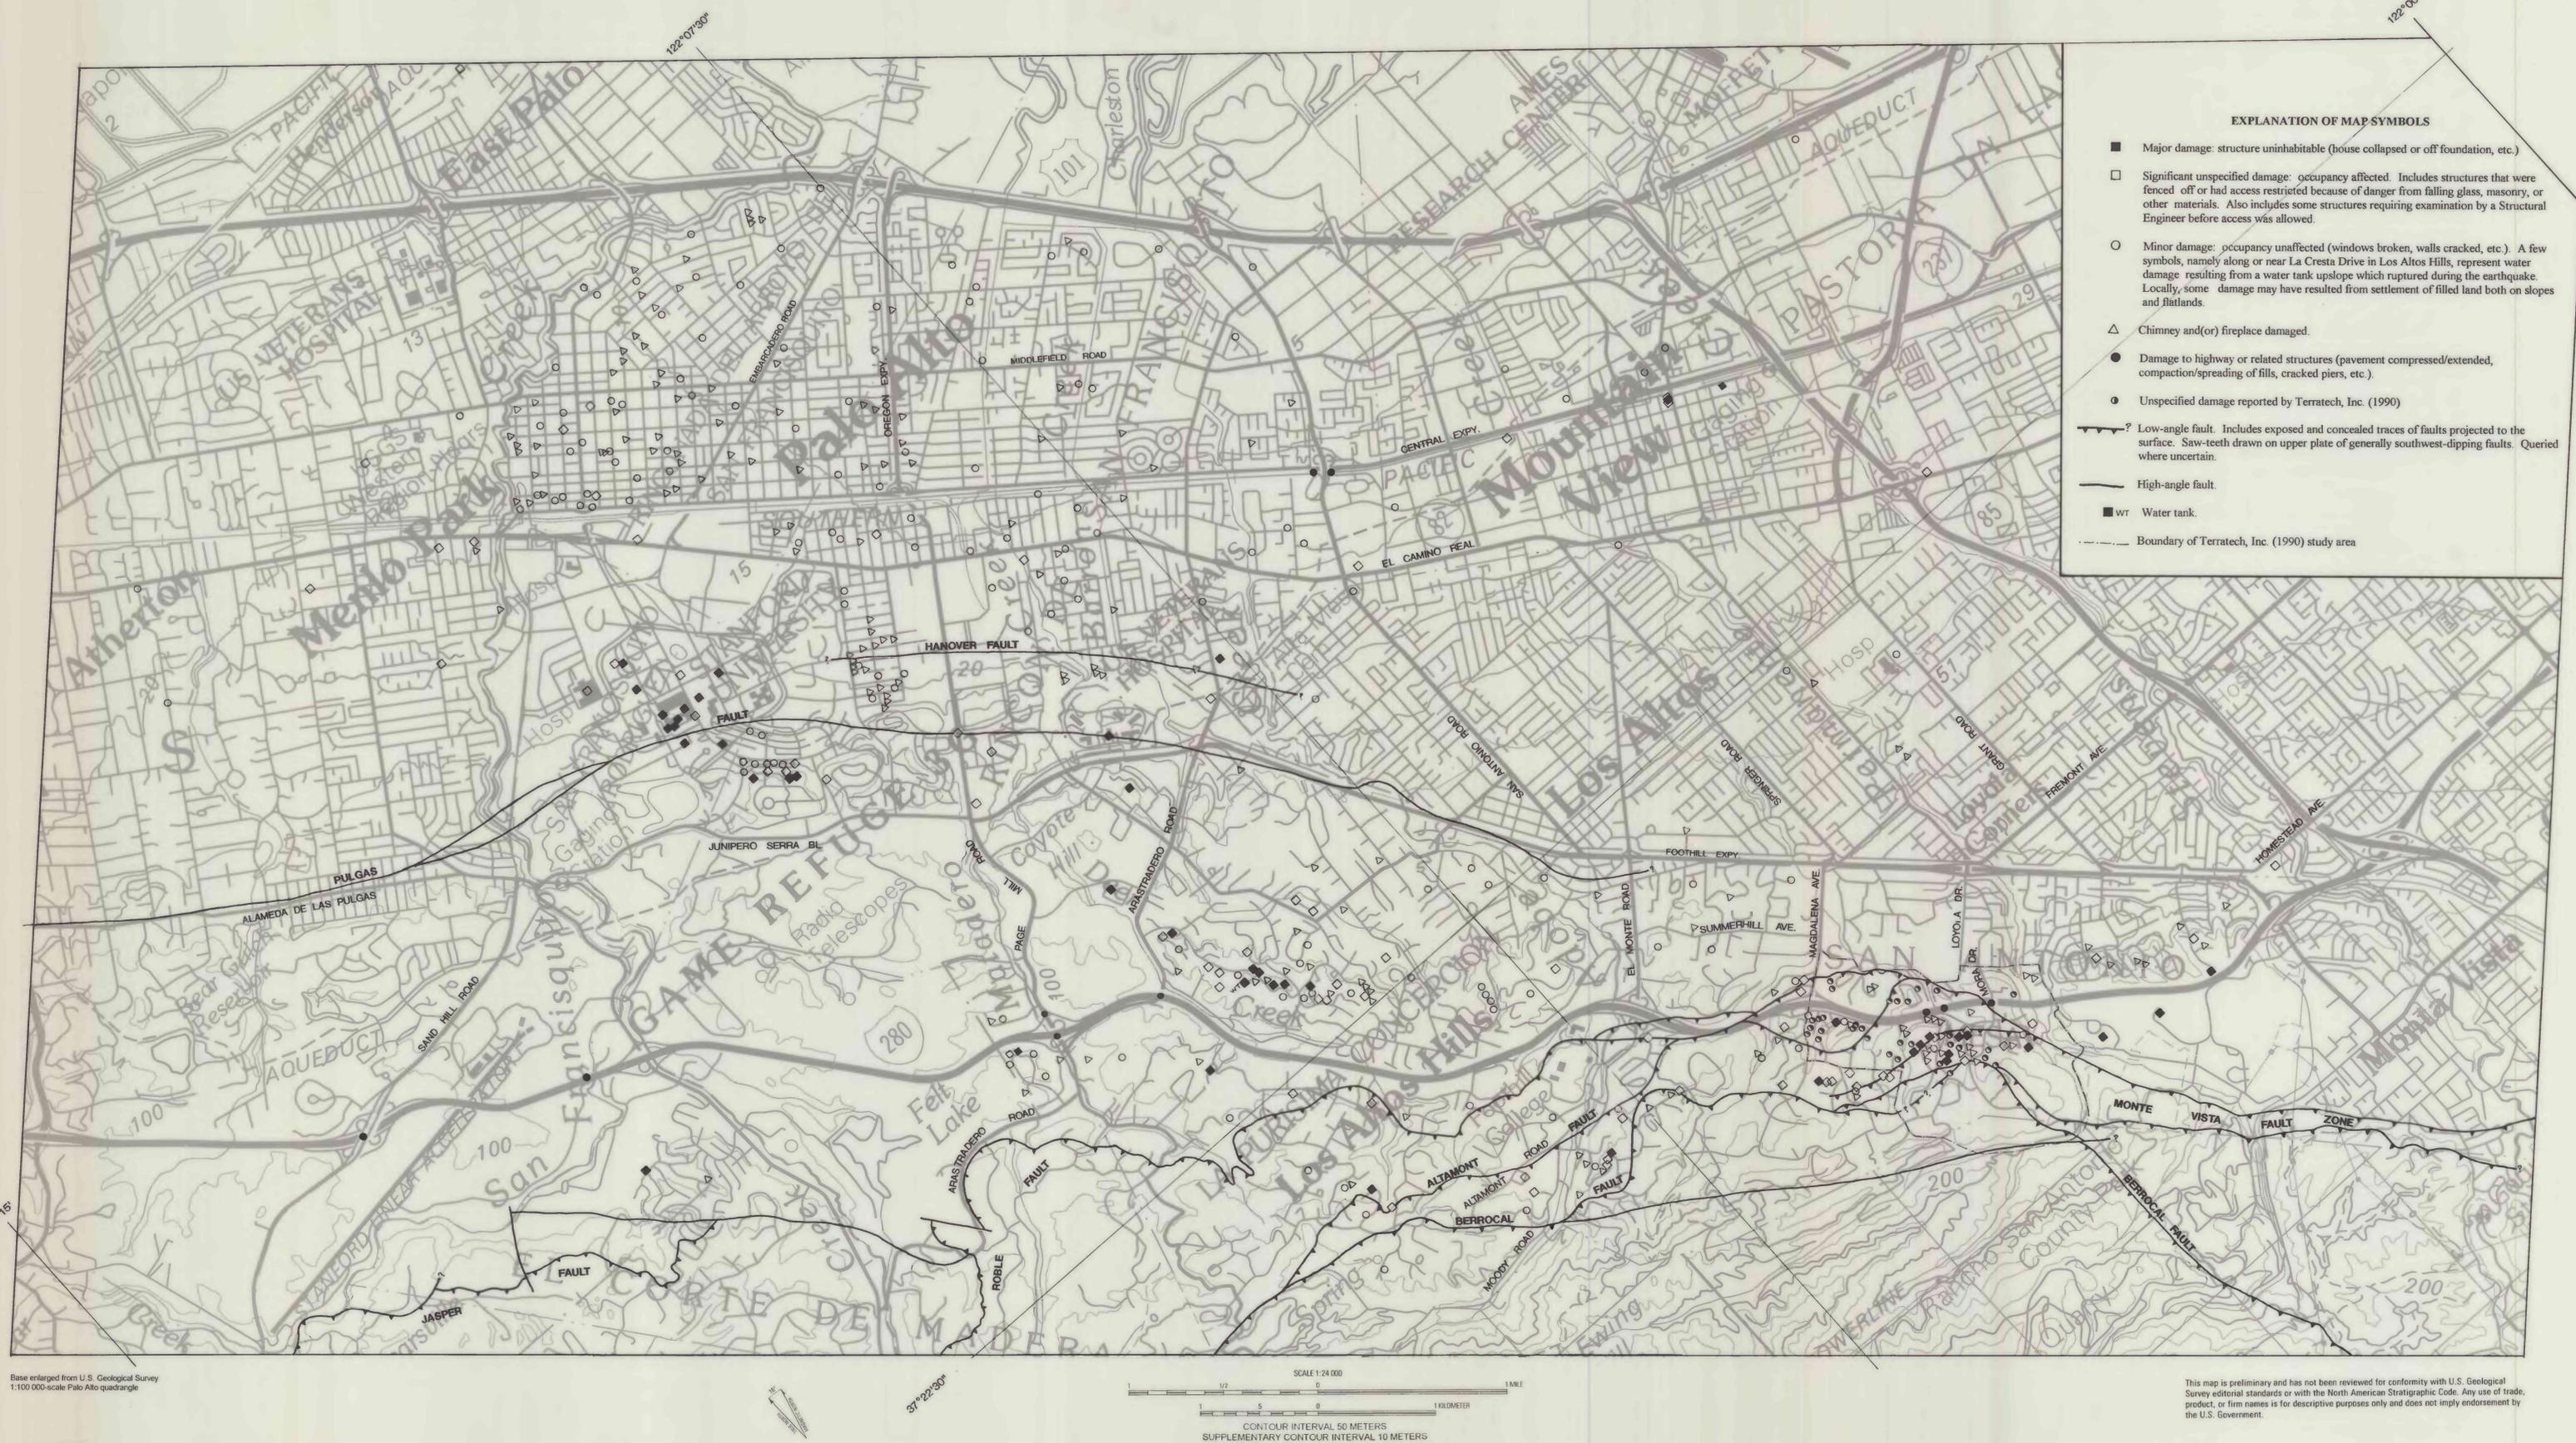
- Major damage: structure uninhabitable (house collapsed or off foundation, etc.)
- Significant unspecified damage: occupancy affected. Includes structures that were fenced off or had access restricted because of danger from falling glass, masonry, or other materials. Also includes some structures requiring examination by a Structural Engineer before access was allowed.

- Minor damage: occupancy unaffected (windows broken, walls cracked, etc.). A few symbols, namely along or near La Cresta Drive in Los Altos Hills, represent water damage resulting from a water tank upslope which ruptured during the earthquake. Locally, some damage may have resulted from settlement of filled land both on slopes and flatlands.

- △ Chimney and/or fireplace damaged.
- Damage to highway or related structures (pavement compressed/extended, compaction/spreading of fills, cracked piers, etc.)

- Unspecified damage reported by Terratech, Inc. (1990)
- ? Low-angle fault. Includes exposed and concealed traces of faults projected to the surface. Saw-teeth drawn on upper plate of generally southwest-dipping faults. Queried where uncertain.

- High-angle fault.
- wt Water tank.
- Boundary of Terratech, Inc. (1990) study area
