A TECHNIQUE FOR PRELIMINARY APPRAISAL OF POTENTIAL AND OBSERVED SCOUR AS APPLIED TO STATE-MAINTAINED HIGHWAY BRIDGES IN MARYLAND

Open-File Report 95-135

MARYLAND STATE HIGHWAY ADMINISTRATION

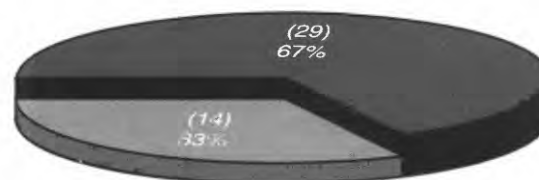
Figure 23. Pier-footing exposures for bridges in the Great Valley Province division.

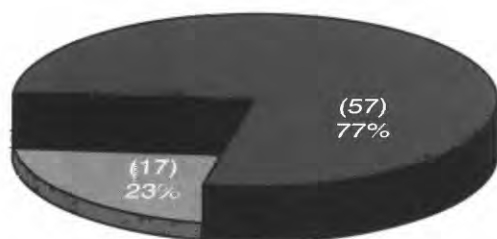
Figure 22. High-flow angle of approach of greater or less than 10 degrees in magnitude for bridges in the Piedmont Western Province division.
