# Bridge-Scour Instrumentation and Data for Nine Sites in Oregon, 1991–94

U.S. GEOLOGICAL SURVEY  
Open-File Report 95–366

Prepared in cooperation with the  
OREGON DEPARTMENT OF TRANSPORTATION

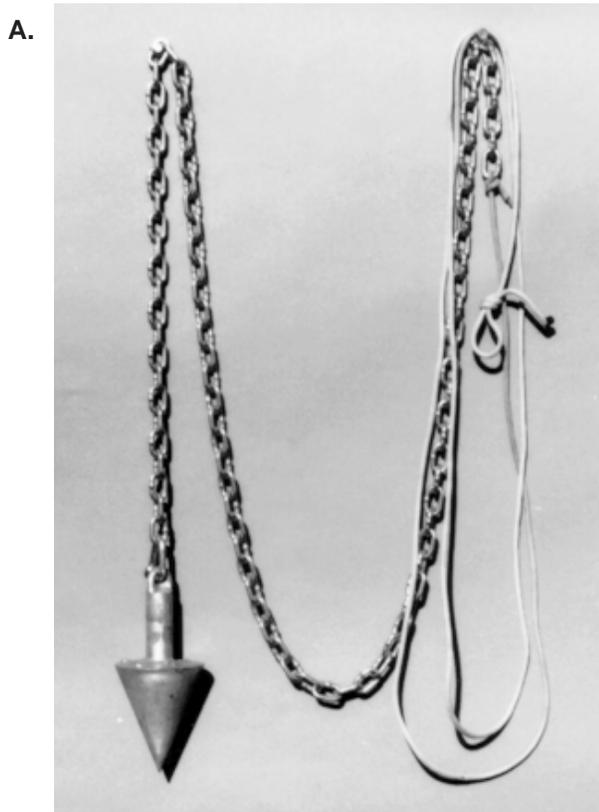
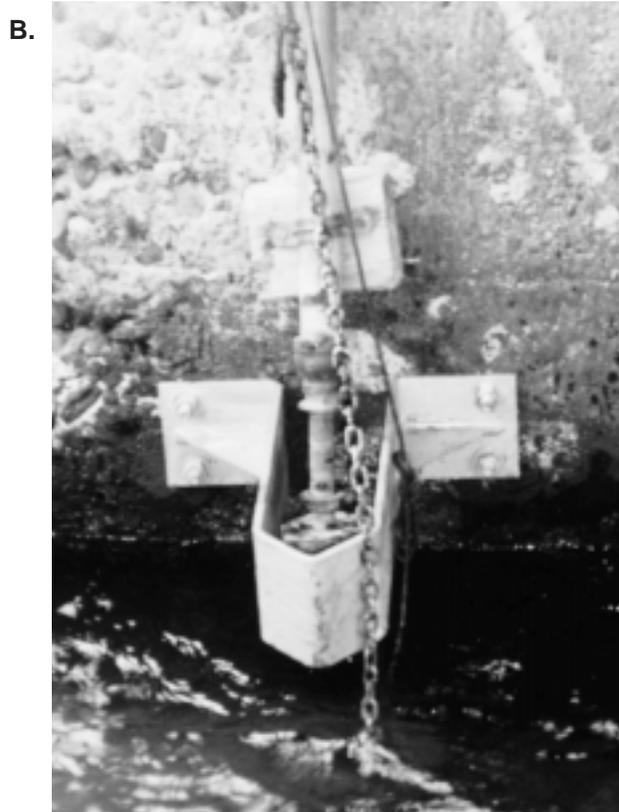
**Figure 1.** (A) Scour chain attached to driving point and nylon cord.  
 (B) Scour chain installed at the Cow Creek scour-monitoring site. (During normal operation, the scour chain is lying along the streambed and is not extended upward as shown in this photograph. Also shown in this photograph are the sonar transducer and transducer guard.)

A scour chain is a chain attached to an anchor that is driven vertically into a scour hole (figure 1). The chain is cut off near the stream bed, and about 10 feet of small cord is attached to the last link. The elevation of the exposed end of the chain and scour hole is determined by leveling measurements. When scour occurs, the chain links collapse or are pulled horizontally towards the stream bed, and are often buried by bed material. After the high water season, the chain is relocated by "following" the cord back to the chain. The collapsed portion of the chain is dug out to the point where the chain links remain vertical. The length of collapsed chain represents the amount of scour that has occurred at that location. This method of scour measurement is limited to small streams, and scour elevations cannot be continuously monitored using this method. Scour chains were used in the Alsea Bay study to determine sand dune migration within Alsea Bay (Crumrine, 1991). A scour chain was installed at the Cow Creek scour-monitoring site for comparison with the sonar scour monitor (fig. 1).

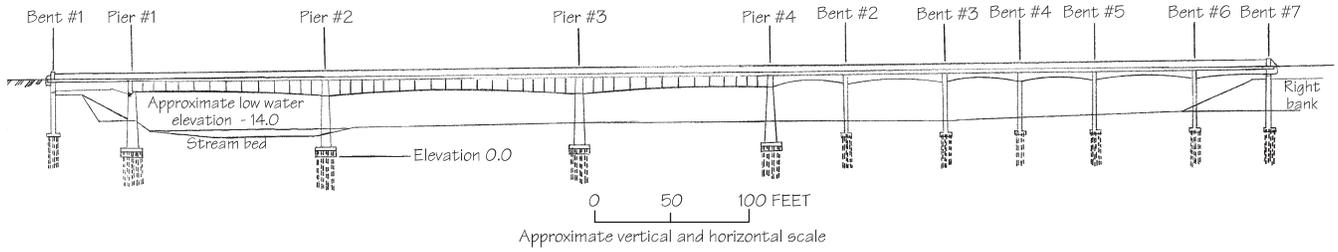
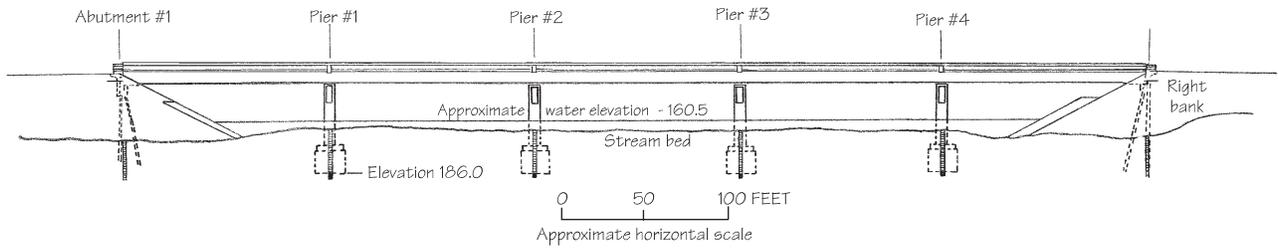
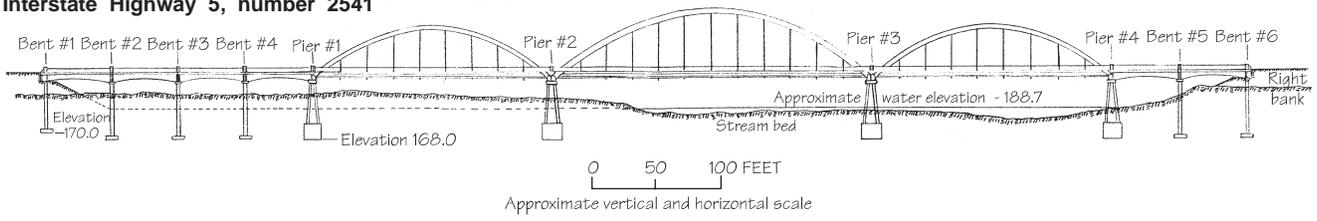
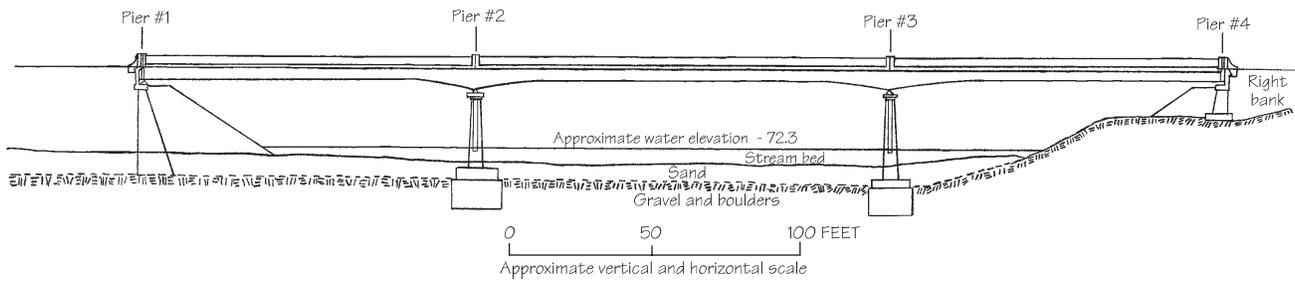
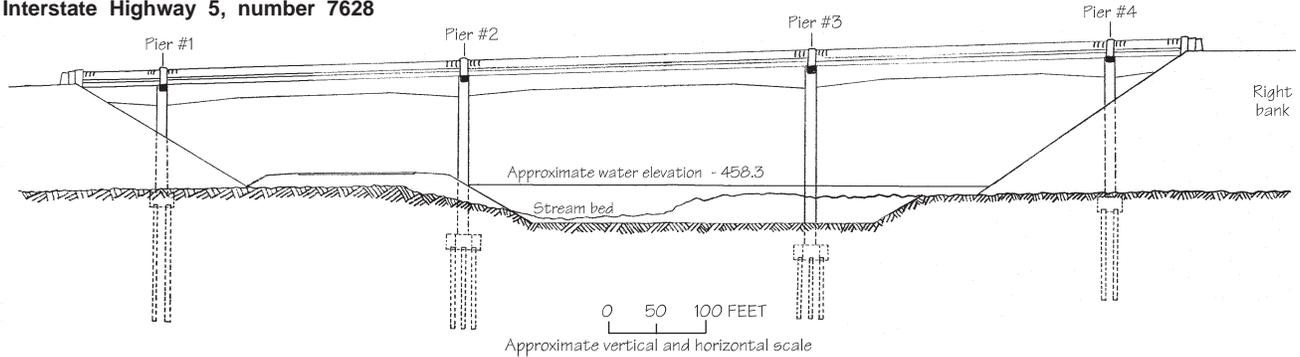
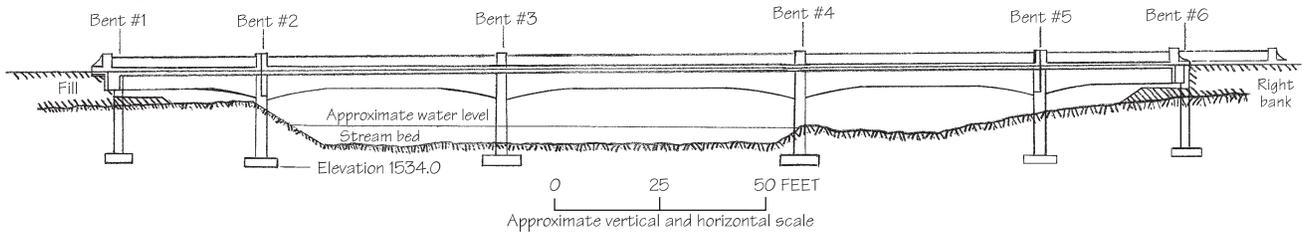
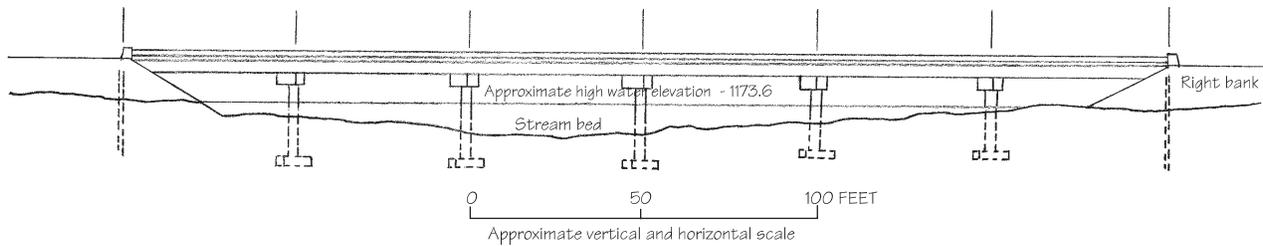
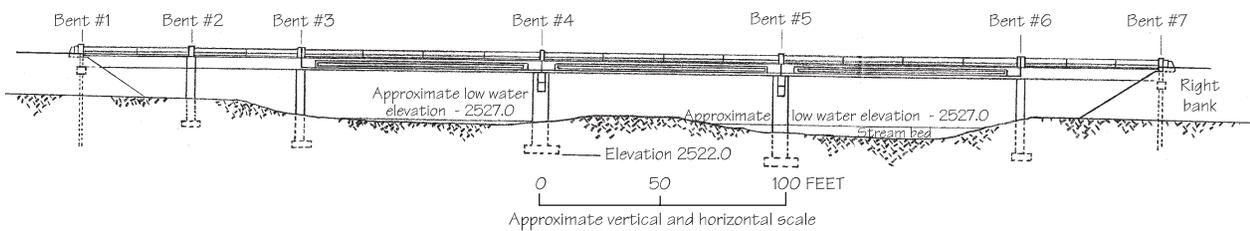
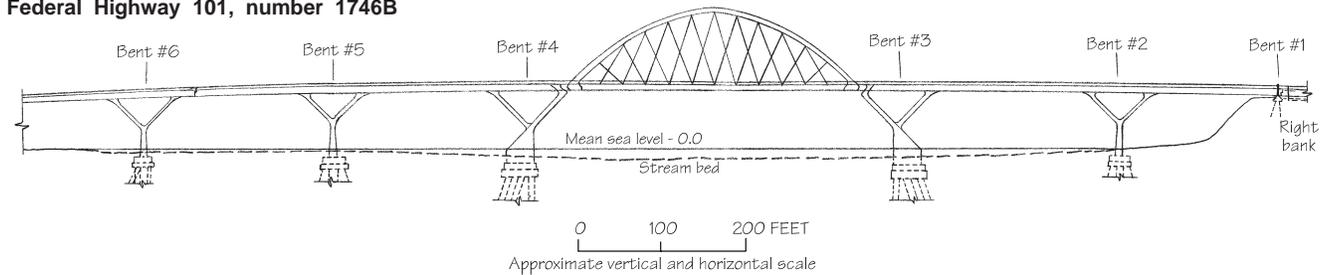
**Figure 3. Schematic drawings of bridges selected for bridge-scour monitoring in Oregon.**

**Figure 3.** Schematic drawings of bridges selected for bridge-scour monitoring in Oregon—Continued.

The Sandy River at Troutdale, Oregon, bridge-scour monitoring site is located at pier 2 on the Interstate Highway 84 eastbound bridge (6875), (figs. 3 and 4). This site was also selected for a previous bridge-scour study (Crumrine, 1990). Continuous scour monitoring began at this site in October 1991 at pier 2A; two scour holes located at the upstream corners of pier 2A were monitored (fig. 4). In October 1992 the scour-monitoring site was changed to the scour hole located at the upstream side of pier 2B. Both sites 2A and 2B had live-bed scour at times during high flow (fig. 5).

The Deschutes River near Biggs, Oregon, bridge-scour monitoring site was located at pier 4 of the Interstate Highway 84 bridge (332C) (fig. 3). This site was equipped with a sonar depth sounder and a datalogger. Water stage was determined by a staff gage at the site and by a gaging station 1 mile upstream. This site was included in an earlier bridge-scour study (Crumrine, 1990). Continuous scour monitoring began at this site in October 1991 and ended in the summer of 1992. No scour has been observed at this site.

The Santiam River near Albany, Oregon, bridge-scour monitoring site was located on Interstate Highway 5 northbound bridge (2541) (fig. 3). Attempts to monitor scour at the upstream end of the pier, beginning October 1991, failed because of entrained air in the water due to turbulence in the vicinity of the scour hole. Sonar devices are ineffectual when air bubbles are in the water, because sonar signals are absorbed by

major scour hole was located at the downstream end of pier 3 (fig. 3). Usually maximum scour occurs at the upstream edge of a bridge pier or footing, but in this case the bridge is situated at an angle to the flow. The pier wall instead of the upstream edge of the pier obstructs the flow. This site was instrumented with a sonar depth sounder and a datalogger, which was

The Sutherlin Creek bridge-scour monitoring site was located at the Interstate Highway 5 bridge over Sutherlin Creek (bridge number 7628), at pier 3 (fig. 3). Continuous monitoring of stage and scour-hole elevations at this site began October 1992 and ended after the high-water season in 1994. Scour data recorded during high water that indicated that there was scour to the top of the footing (fig. 6). The sonar scour record also showed debris movement into and out of the scour hole. This site was equipped with a sonar depth sounder, down-looking stage transducer, and datalogger. This was the first site at which a stage transducer was used; therefore, a small stilling well was installed to verify the stage transducer data.

The Grave Creek bridge-scour monitoring site was located at the Interstate Highway 5 bridge spanning Grave Creek (bridge number 6493A) at bent 5 (figs. 3 and 9). This site was instrumented with a sonar depth sounder and down-looking stage transducer, both of which were connected to a datalogger. Continuous monitoring of stage and scour-hole elevations at this site began October 1992 and ended after the high-water season in 1994. There was no local scour recorded during high water at this site.

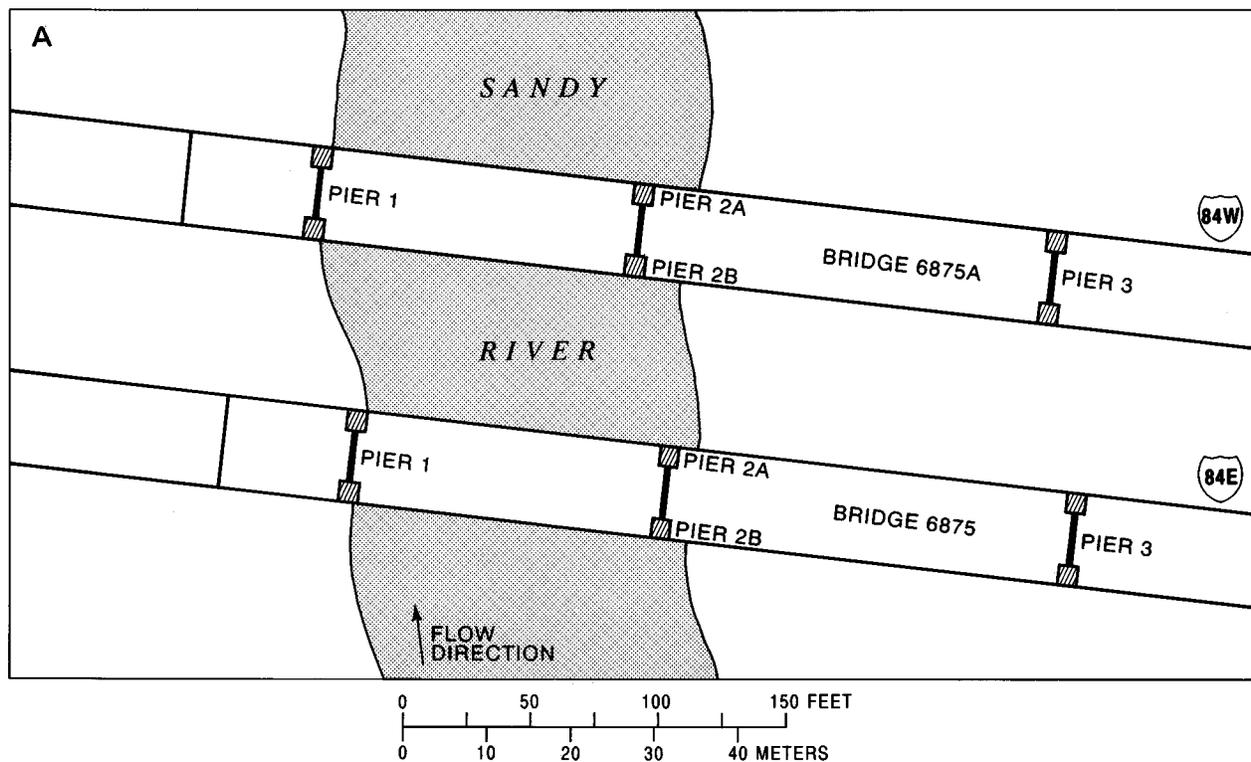
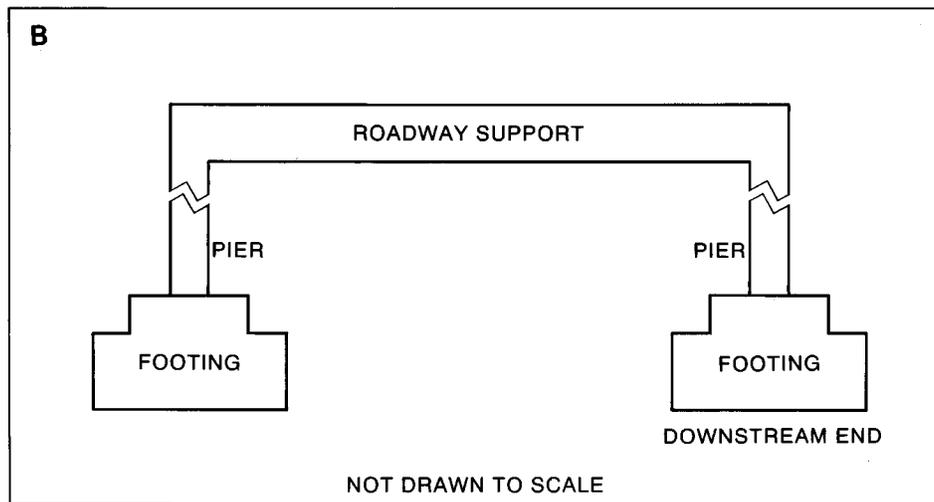
**Figure 4.** Configuration (A) and pier design (B) of Sandy River bridges 6875 and 6875A near Troutdale, Oregon.

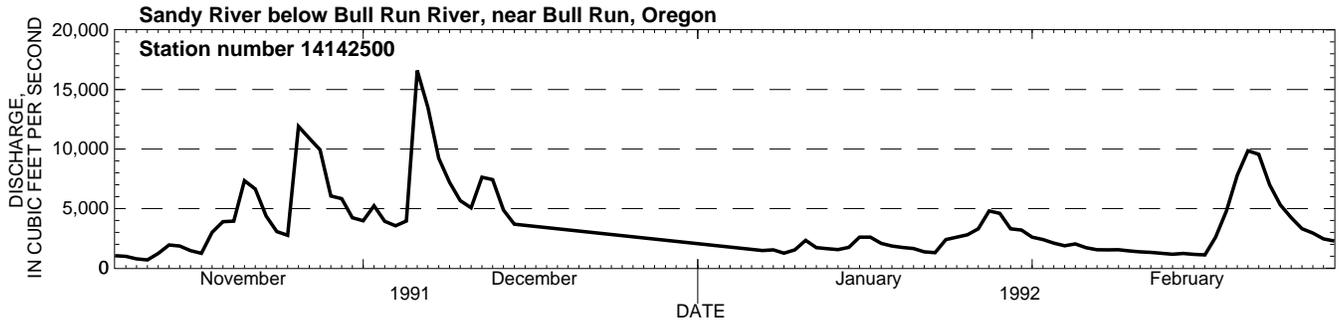
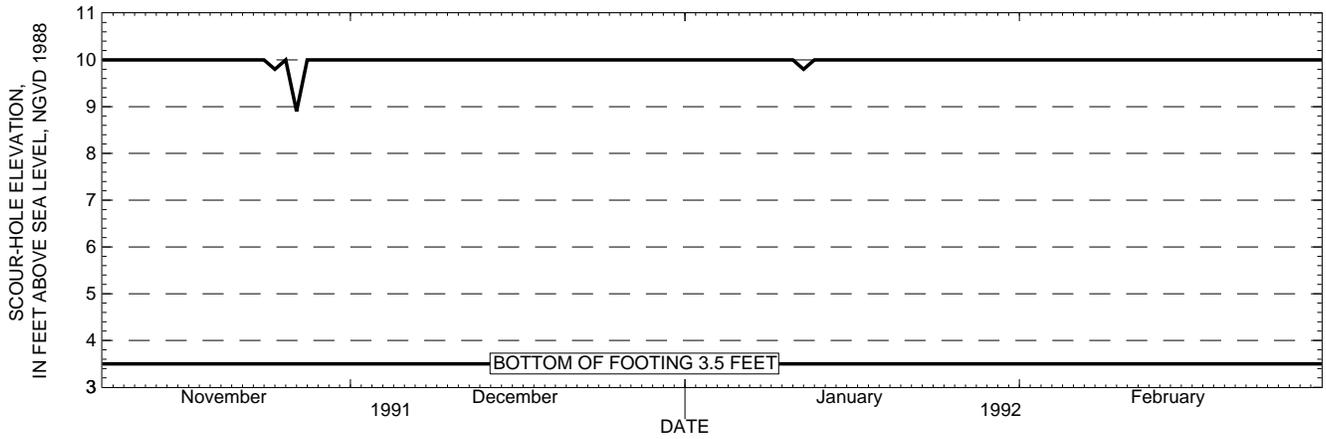
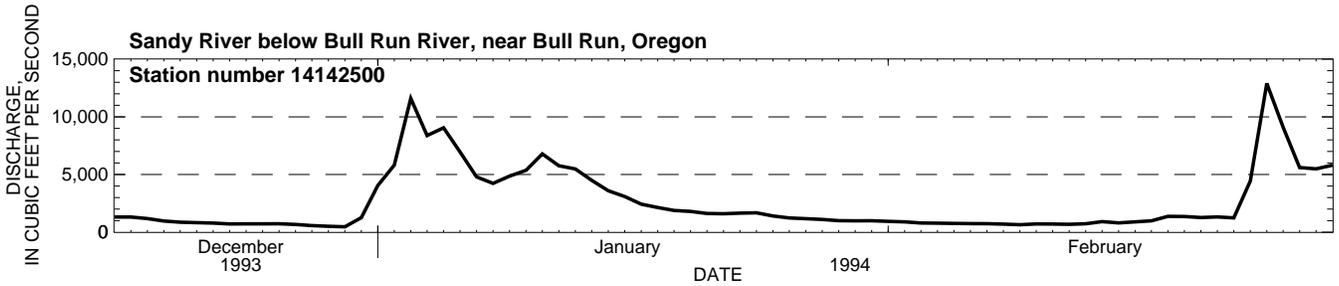
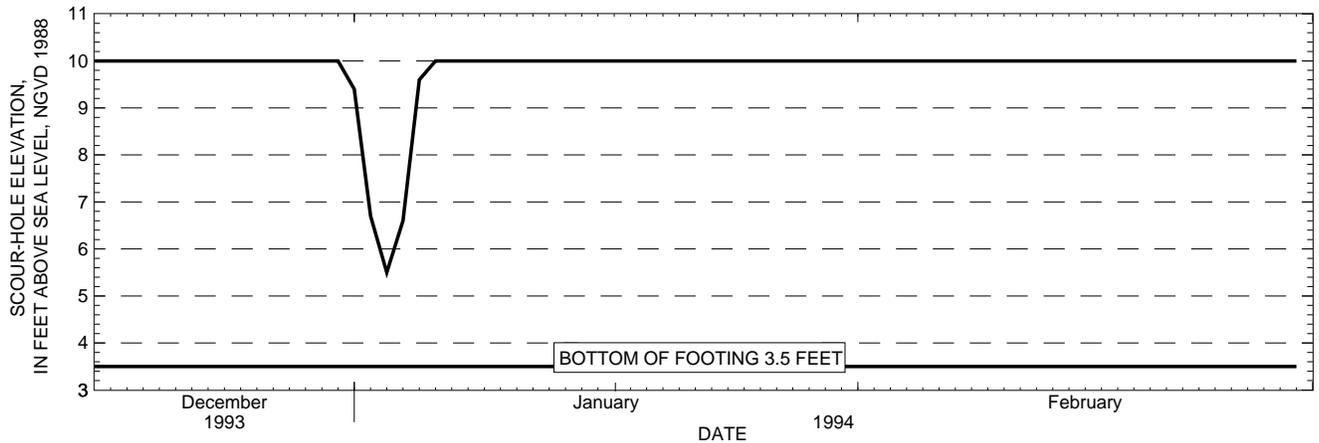
**Figure 5.** Daily mean discharge and scour-hole elevation at pier 2A of the Interstate 84 bridge (number 6875) over Sandy River near Troutdale, Oregon, November 1991–February 1992, and December 1993–February 1993. Sea level for this site is the National Geodetic Vertical Datum of 1988.

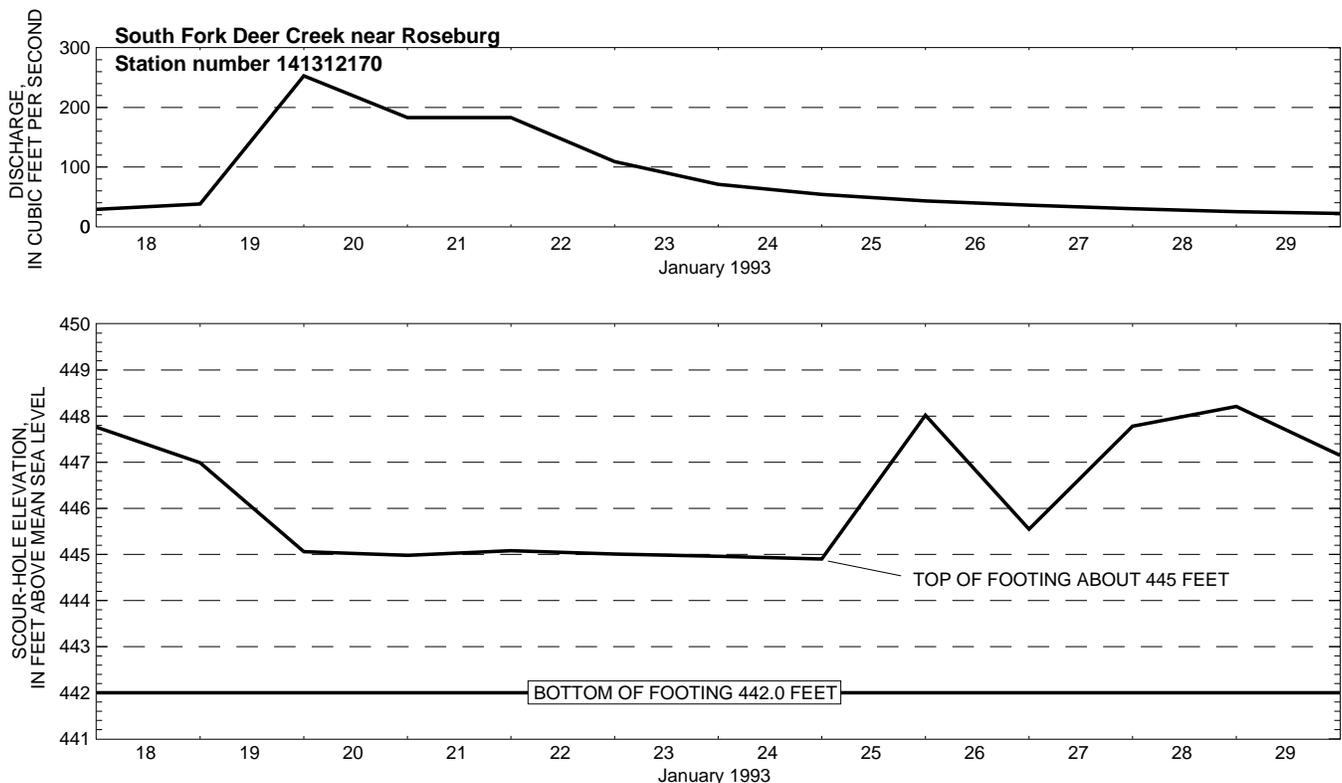
**Figure 6.** Daily mean discharge and scour-hole elevation at pier 3 of the Interstate Highway 5 bridge over Sutherlin Creek at Wilbur, Oregon, January 18–29, 1993.

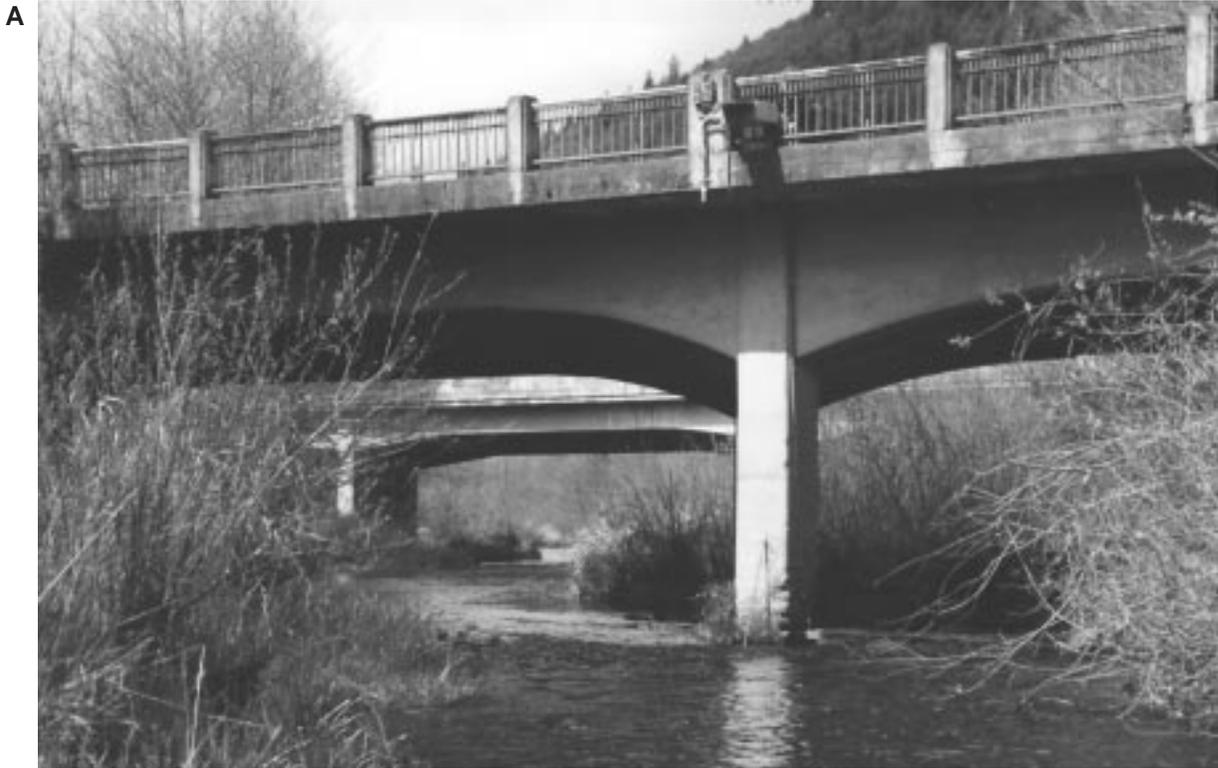
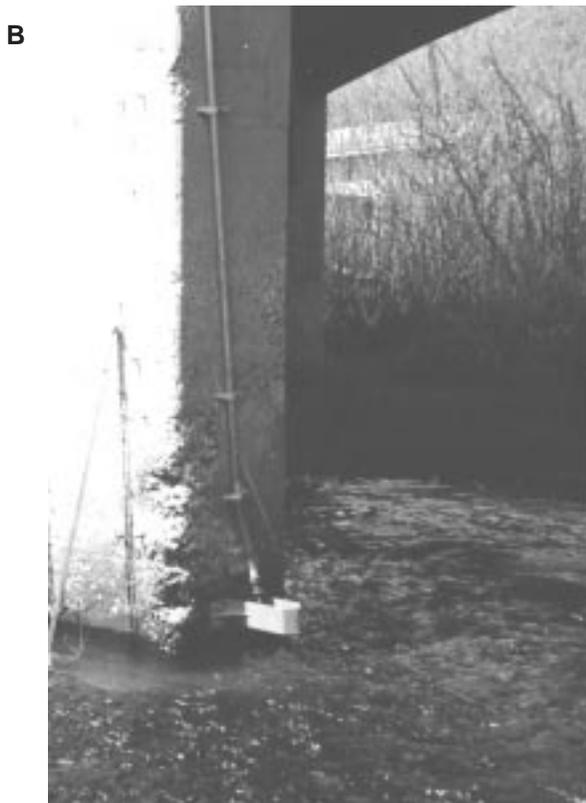
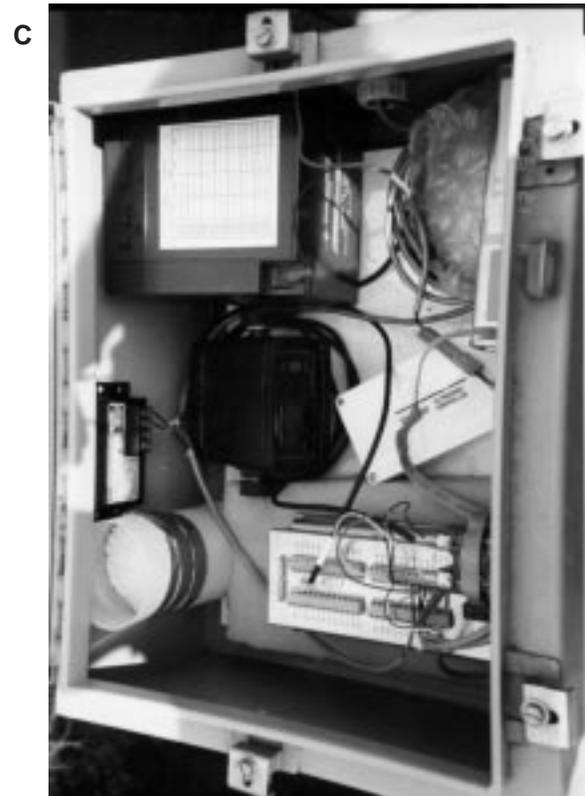
**Figure 7.** (A) Cow Creek bridge with attached scour-monitoring apparatus.  
(B) Pier of Cow Creek bridge with attached scour-monitoring apparatus.  
(C) Scour-monitoring and recording equipment.

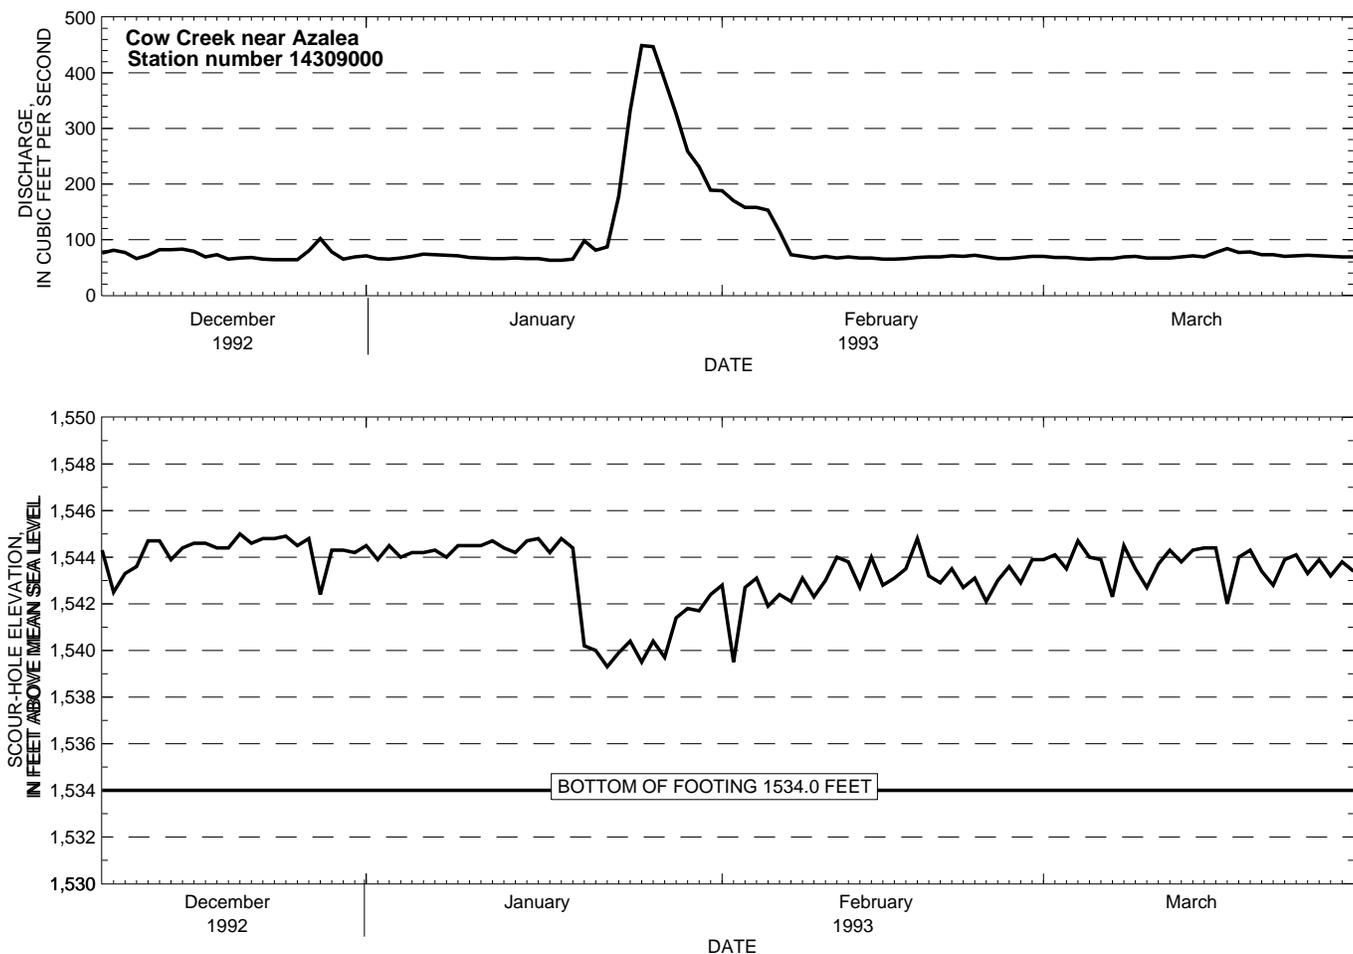
**Figure 8.** Daily mean discharge and scour-hole elevation at bent 4 of the Interstate Highway 5 bridge (number 6782) over Cow Creek near Quines Creek, Oregon, December 1992–March 1993.

transducer connected to a datalogger. The stage monitor was verified using an upstream gaging station. Local scour was recorded during high water at this site during the 1993 water year (fig. 8). During the 1994 water year, a scour chain was installed to test the scour-chain method of determining maximum scour. No scour was observed by the scour chain or the depth sounder. Continuous monitoring of stage and scour-hole elevations began October 1992 and ended after the high-water season in 1994.

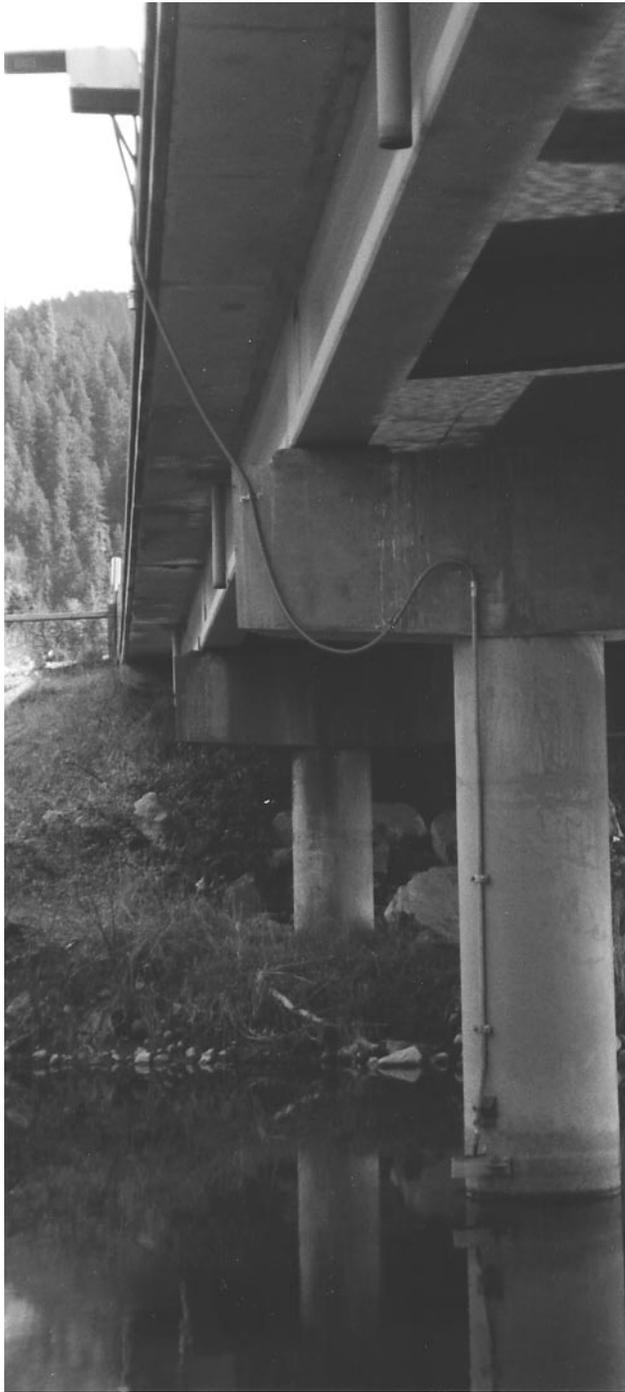
**Figure 9.** Scour-monitoring equipment on the Grave Creek bridge pier.

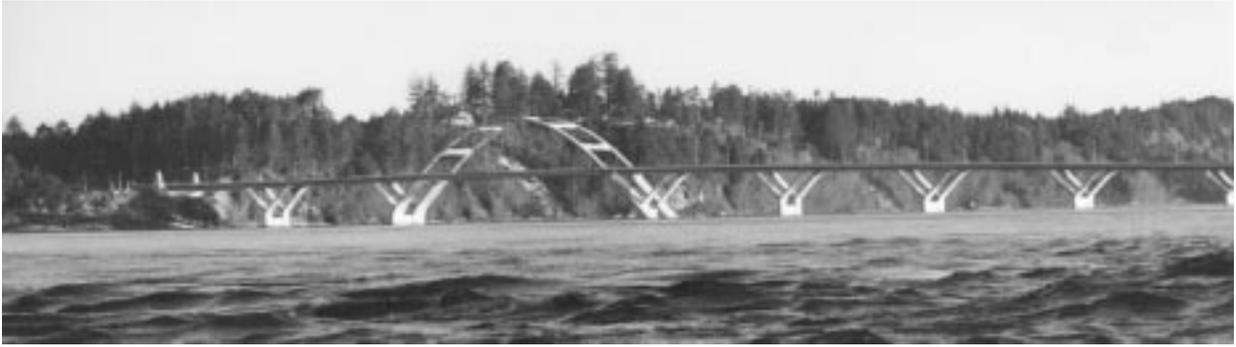
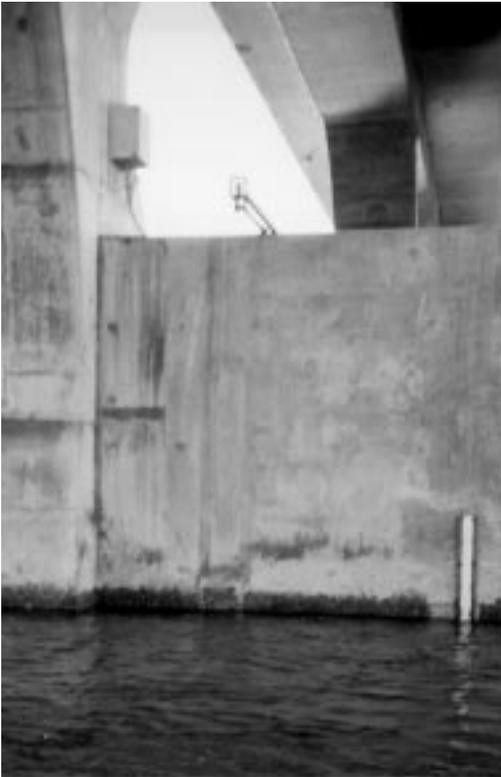
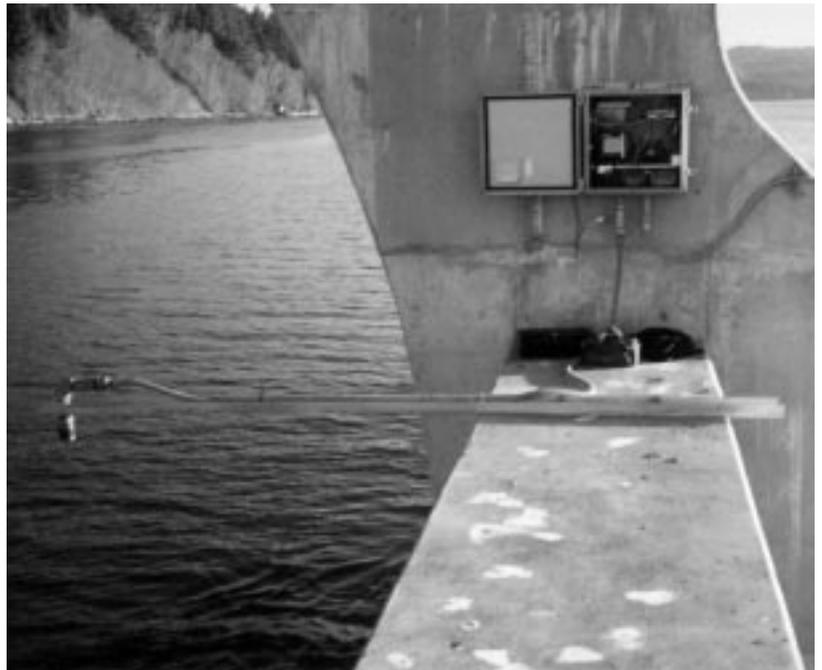
**Figure 10.** (A) The Asea Bay bridge, Waldport, Oregon.

(B) Staff gage and scour-monitoring equipment on the Asea Bay bridge.

(C) Data-recording and monitoring equipment on the Asea Bay bridge.

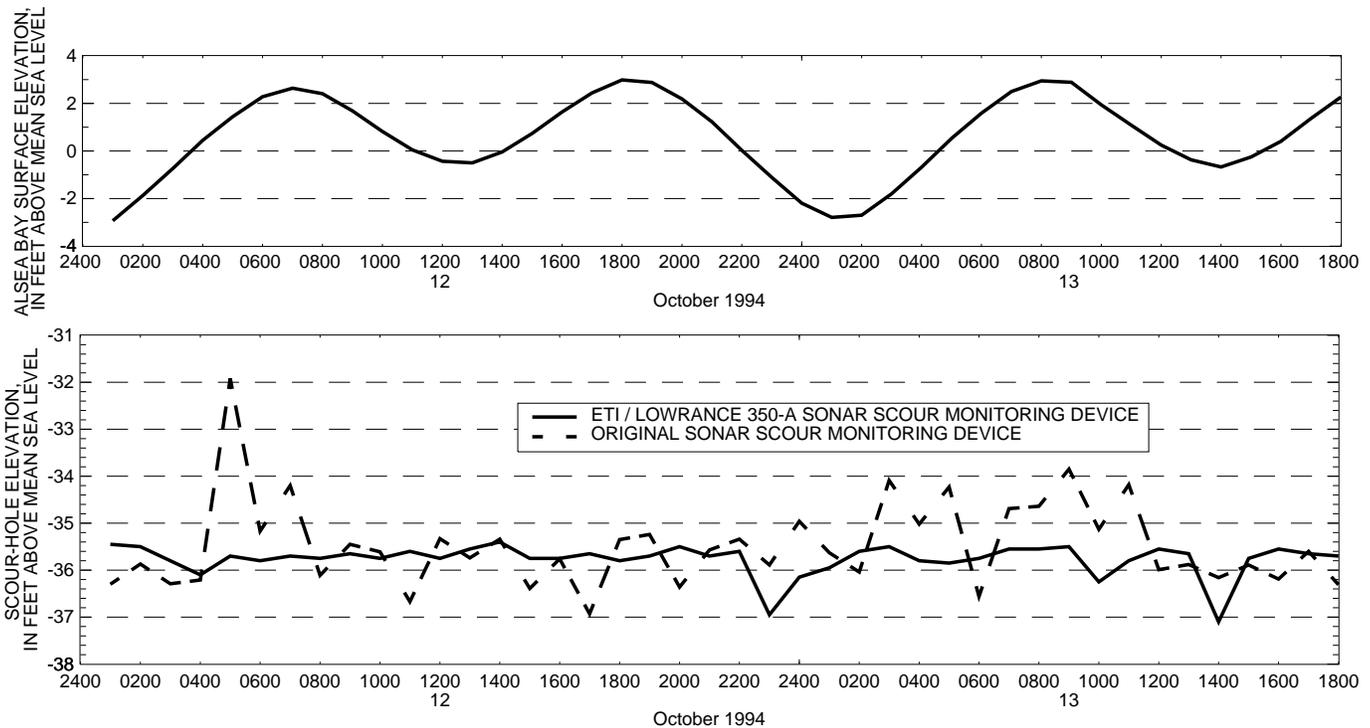
**Figure 11.** Hourly water level and scour-hole elevation from two scour-monitoring devices on the southeastern corner of bent 4 of the Highway 101 bridge (number 1746B) over Alsea Bay at Waldport, Oregon, October 12–13, 1994.
