GEOMORPHIC HISTORY OF THE VIRGIN RIVER IN THE ZION NATIONAL PARK AREA, SOUTHWEST UTAH

U.S. GEOLOGICAL SURVEY OPEN-FILE REPORT 95-515

*Prepared in Cooperation with the
National Park Service*

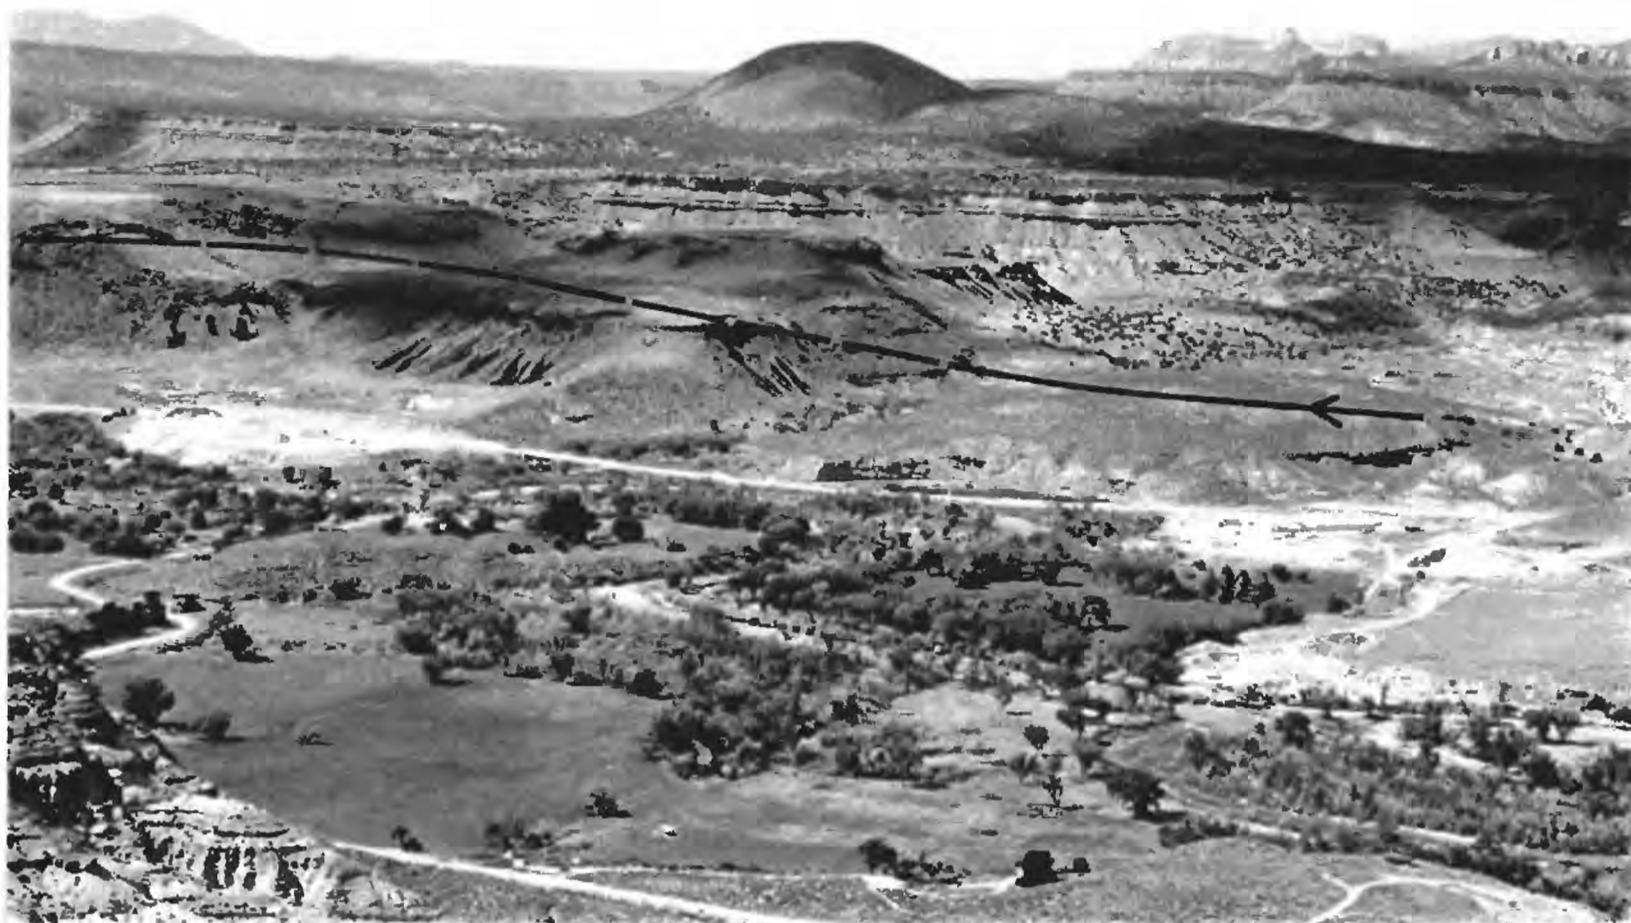
Figure 2. Photograph of Crater Hill volcanic field and Virgin River valley. Dark hill in upper center is Crater Hill. Basaltic lava flows are dark, smooth, and flat areas above river. Base of youngest lava flow is 20-30 m (66-98 ft) above channel of Virgin River. Line indicates axis of ancestral Virgin River, dashed where covered by lava flows.

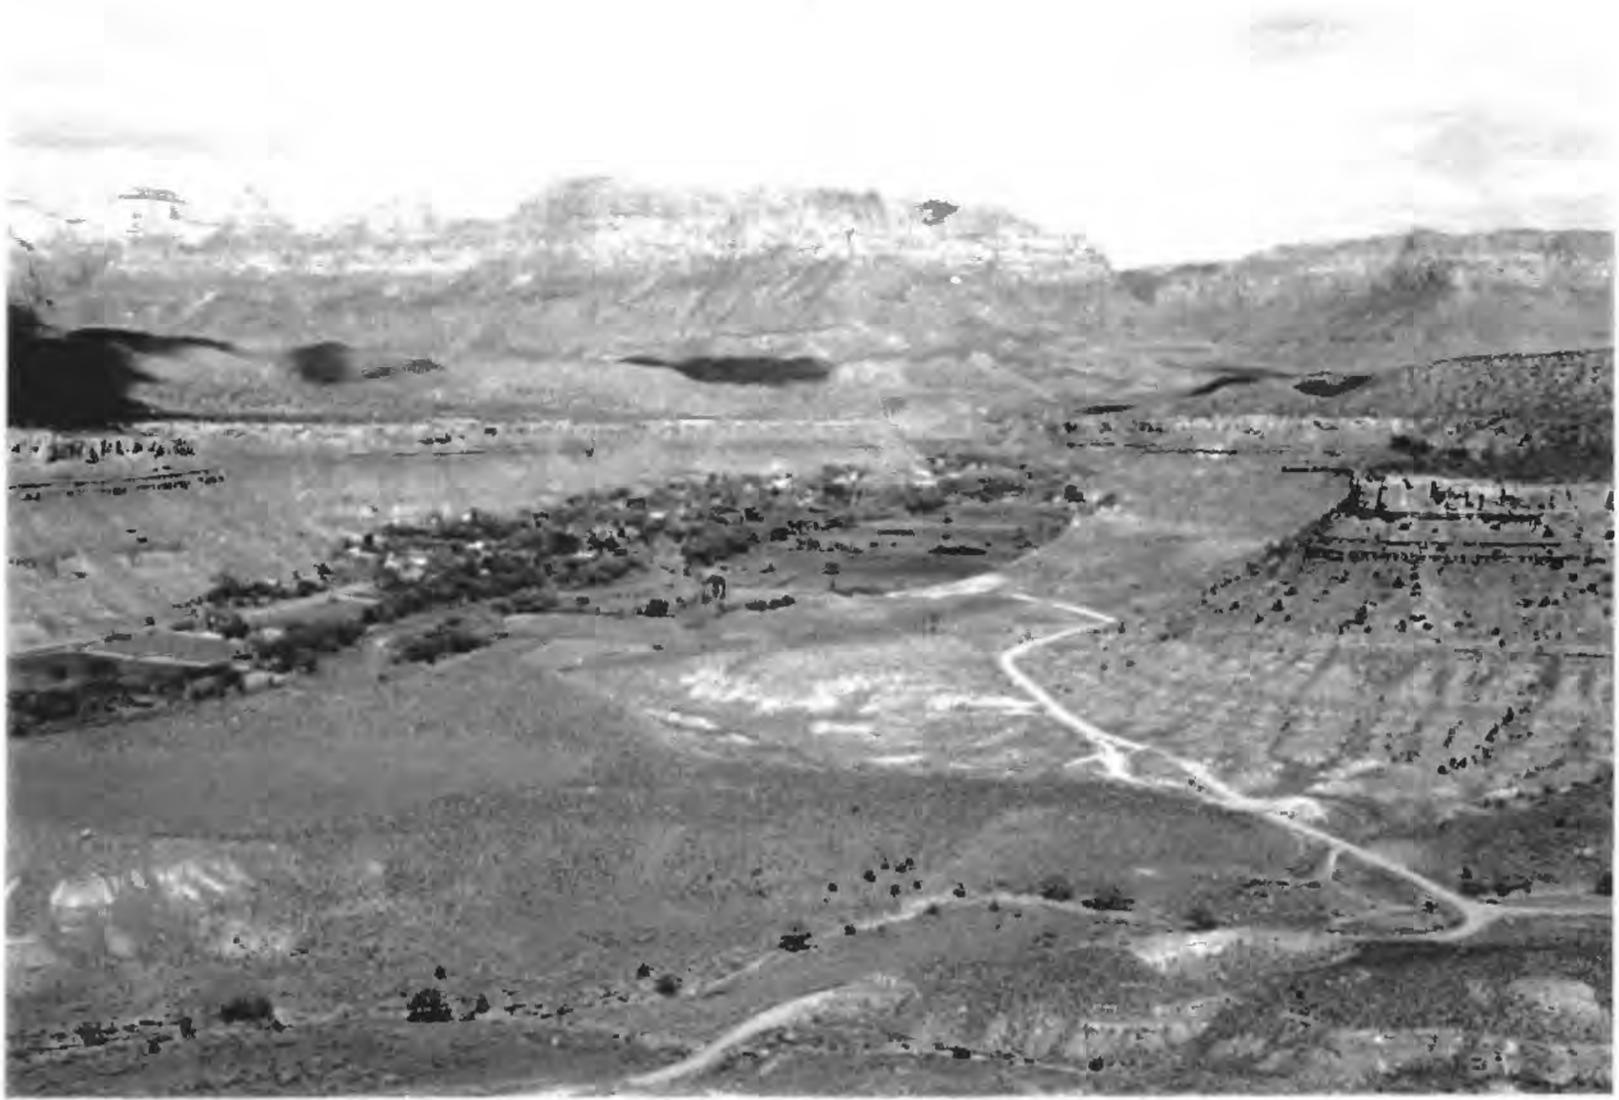
Figure 3. Photograph (upstream) of alluvial valley of Virgin River in Rockville area. Alluvial valley is flat, vegetated area extending diagonally across mid-ground. Moenkopi Formation borders valley, resistant sandstone bed in right mid-ground is Shinarump Sandstone Member of Chinle Formation (Late Triassic). Late Pleistocene gravel deposits form terrace to right of road junction in foreground.

Figure 3 illustrates the alluvial valley of the Virgin River in the Rockville area. The width of the valley is controlled by the underlying bedrock. In this area (fig. 3), the valley is wide as the river flows across the non-resistant, slope-forming Moenkopi Formation. Generally, the valley is relatively wide where the river crosses the less resistant

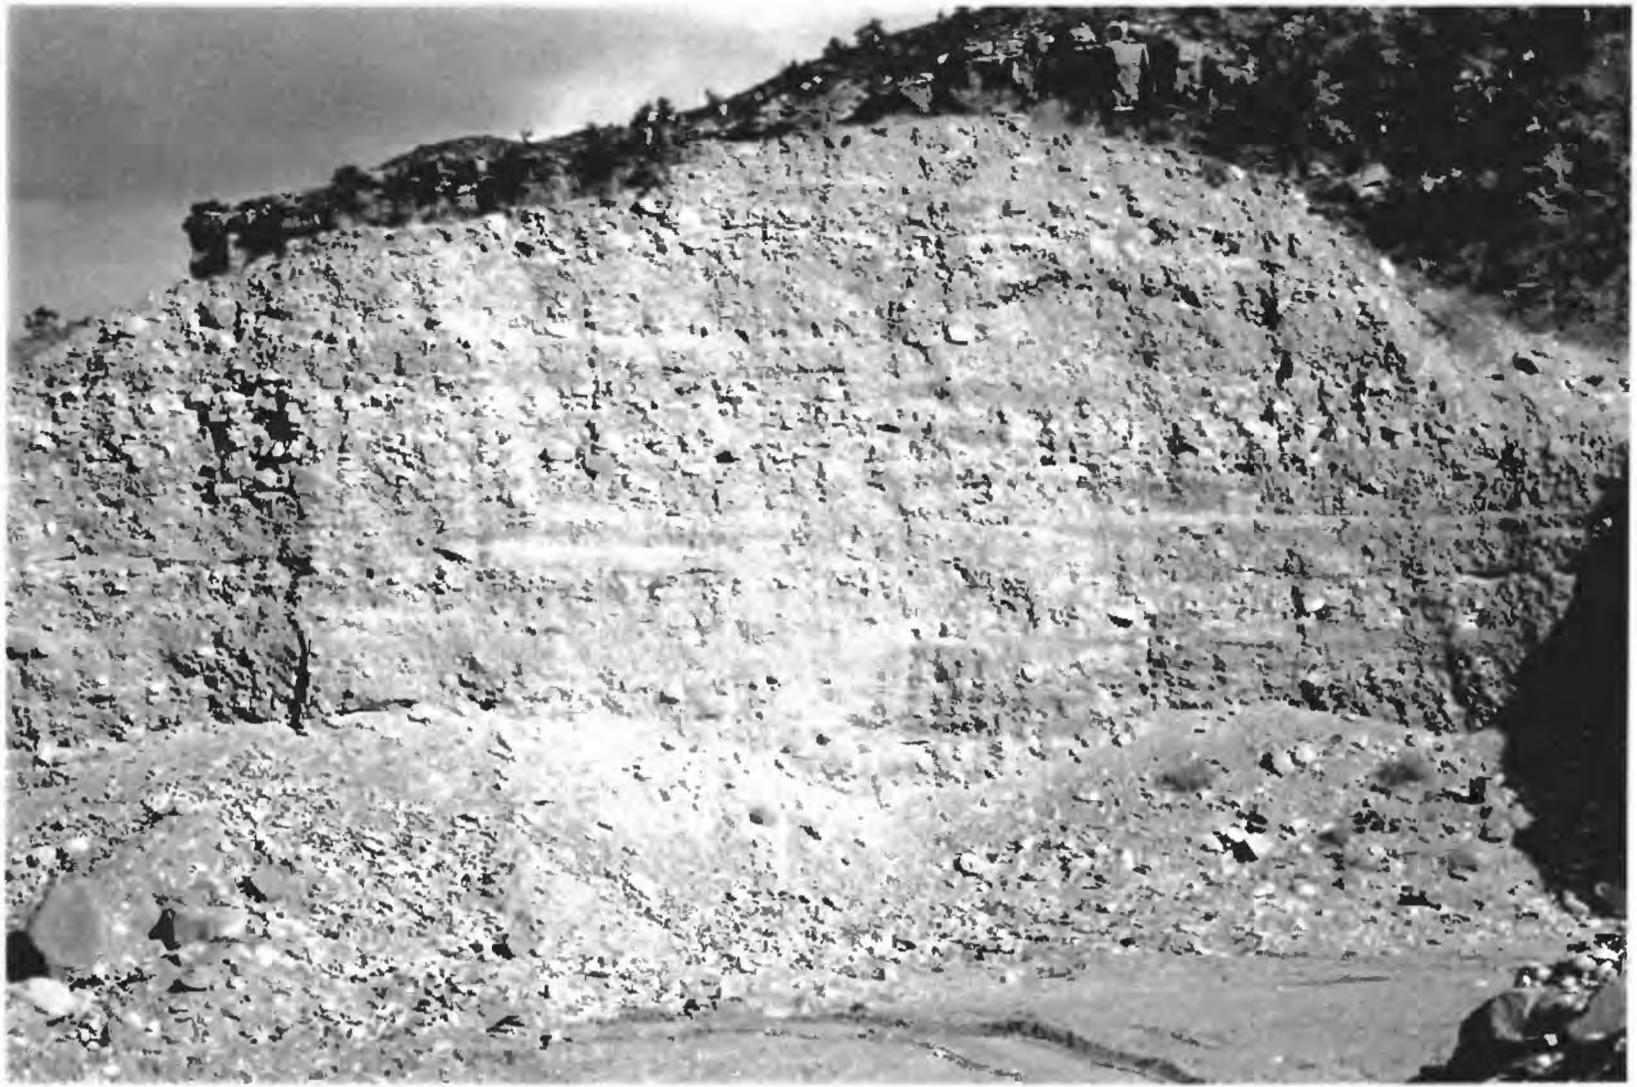
Figure 4. Photograph showing late Pleistocene gravel with interbedded sand in quarry south of Rockville. Note scale on left, 1.4 m (4.6 ft) long with 20 cm (5.08 in) divisions. This is topographically the lowest and youngest gravel.

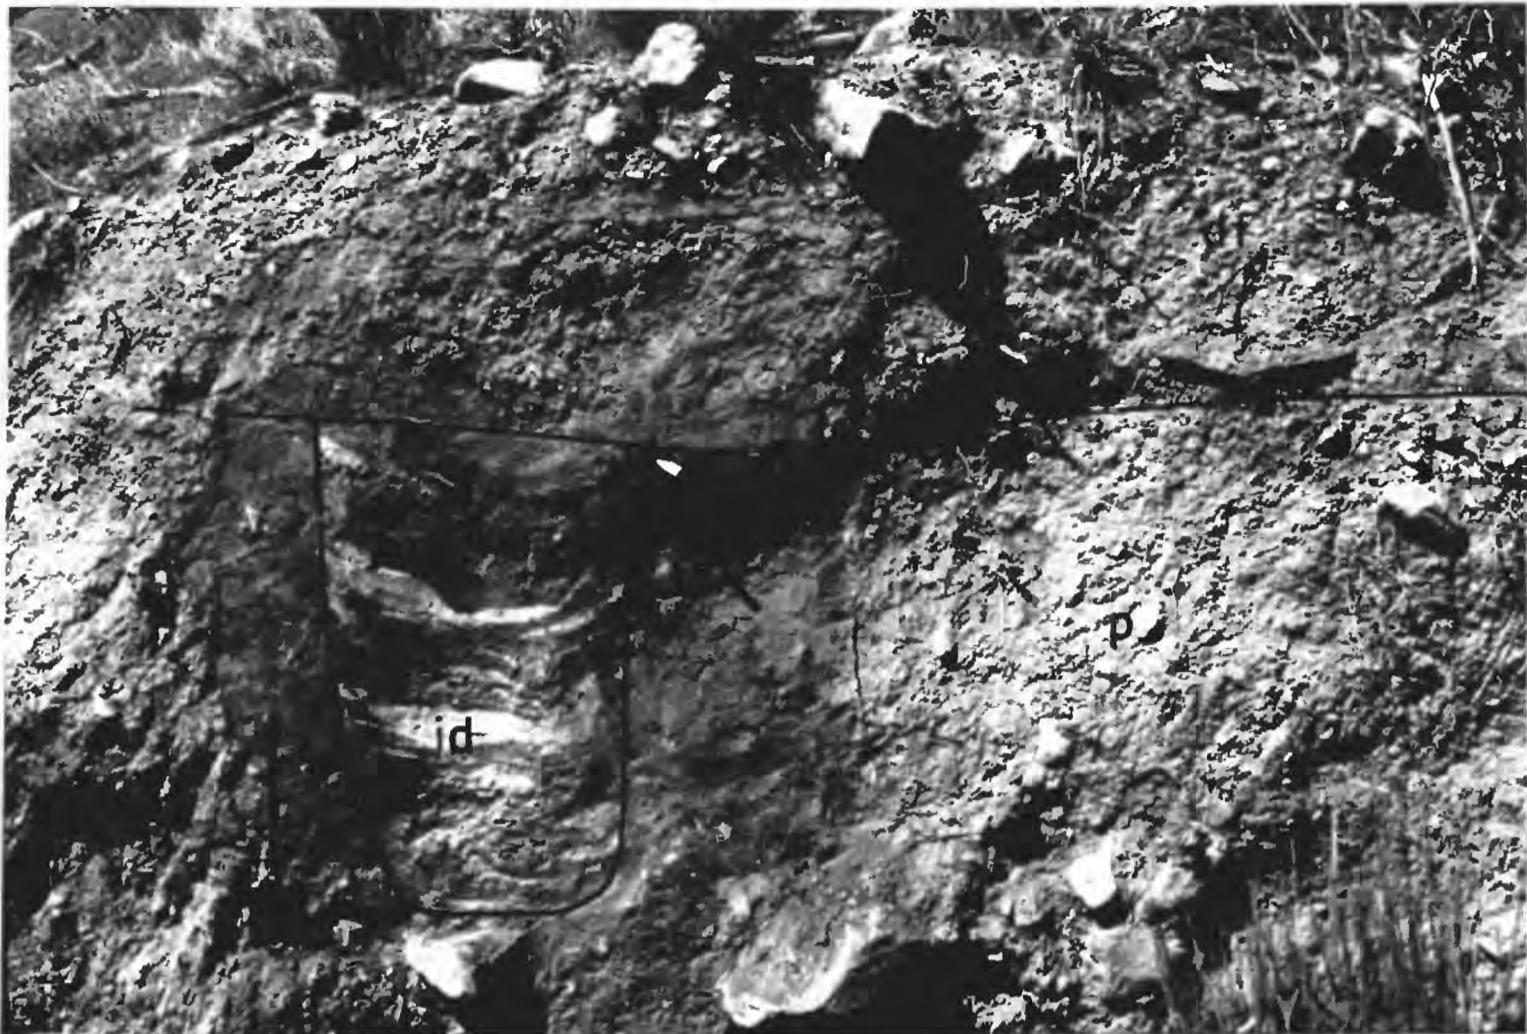
Figure 6. Photograph showing irrigation ditch filled with sediment and overlain by debris-flow deposits. id = cross-section of irrigation ditch; df = debris-flow deposits; p = prehistoric alluvium interbedded with debris-flow sediment.

The north-side ditch is well exposed in a gully near survey control point 1215.07 m (fig. 5); figure 6 is a cross-section of the ditch exposed in the west side of the gully. The light-colored sand beds outline the perimeter of the ditch, which extends vertically from the base of the collapsible shovel to the trowel. Deposits in the ditch are light-colored mainstem alluvium interbedded with dark-

colored tributary deposits. The mainstem deposits accumulated when streamflow was diverted into the ditch; the tributary deposits resulted from sheetwash originating on the nearby bedrock hillslope. The present physical setting of the ditch demonstrates the rapid and extensive changes that affected the alluvial valley. Sometime after 1862 and before at least 1903, the top of the ditch, which corresponds with the prehistoric terrace, was covered by 2 m (7 ft) of debris-flow sediment; enlargement of the tributary channel then eroded through the debris-flow sediment, irrigation ditch, and terrace; this erosion was probably coincident with entrenchment of East Fork between 1883 and 1893.

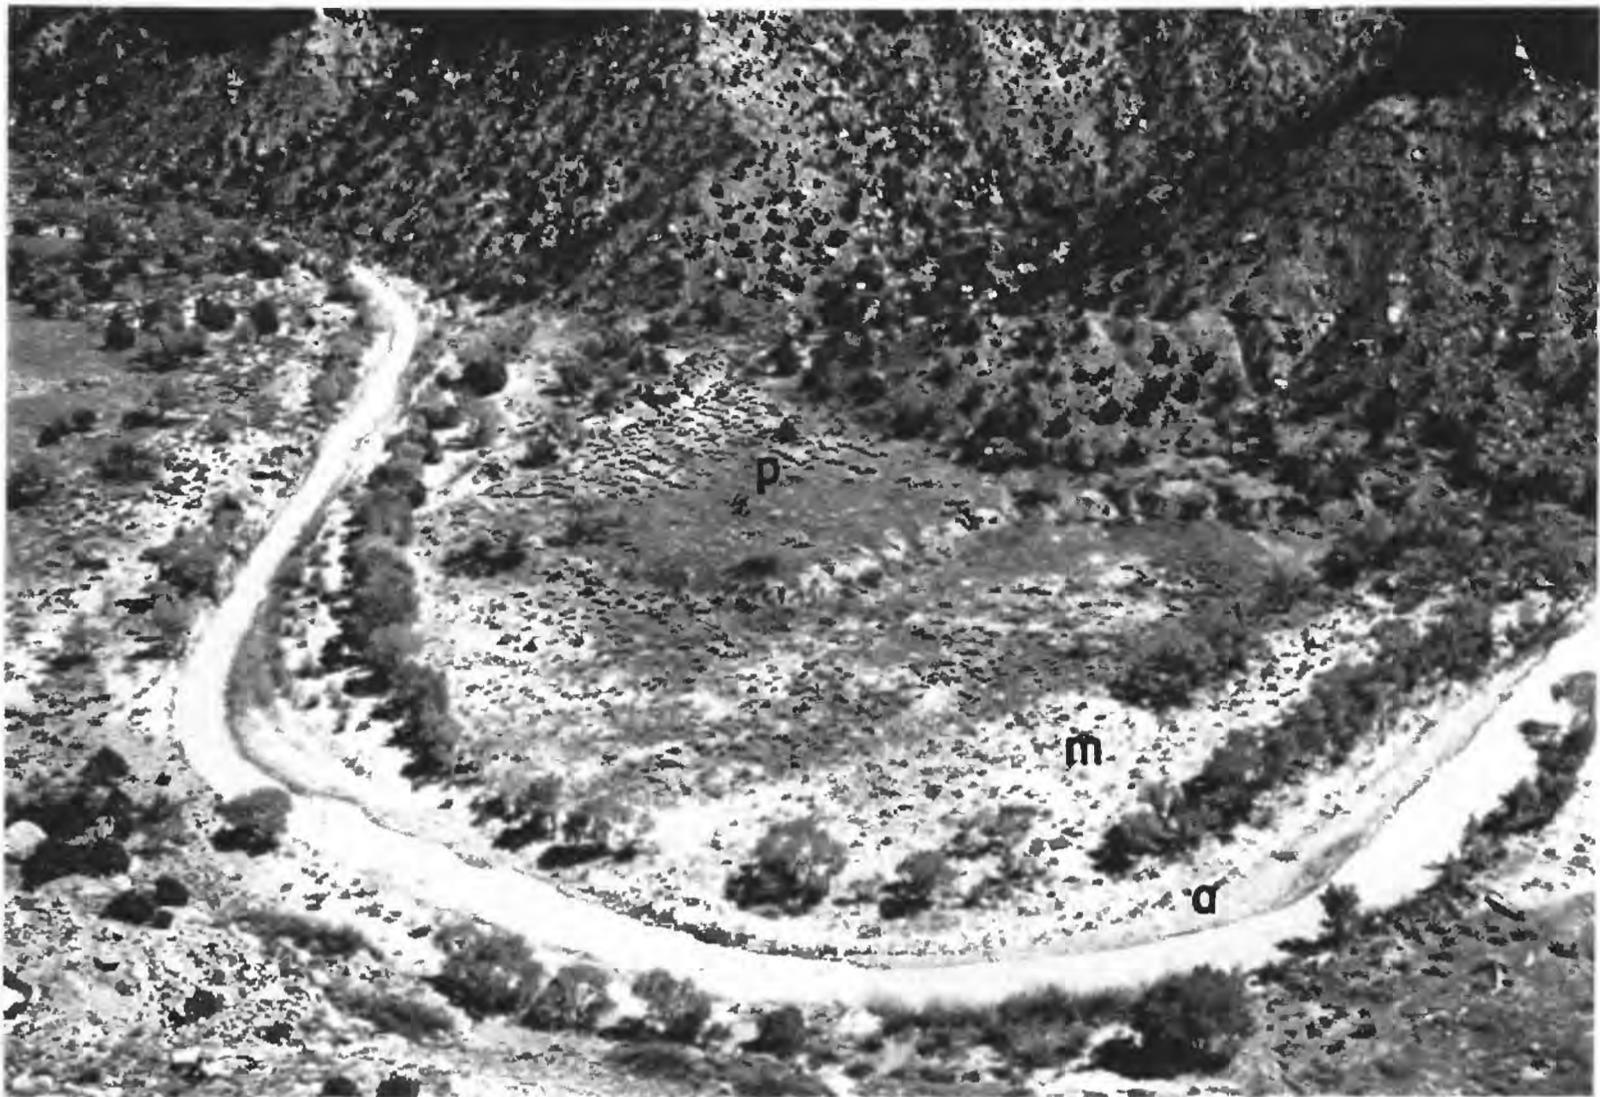
Figure 7. Photograph showing alluvial valley of East Fork and prominent point bar of modern terrace on south side of valley. a = active channel; m = modern terrace; p = prehistoric terrace.

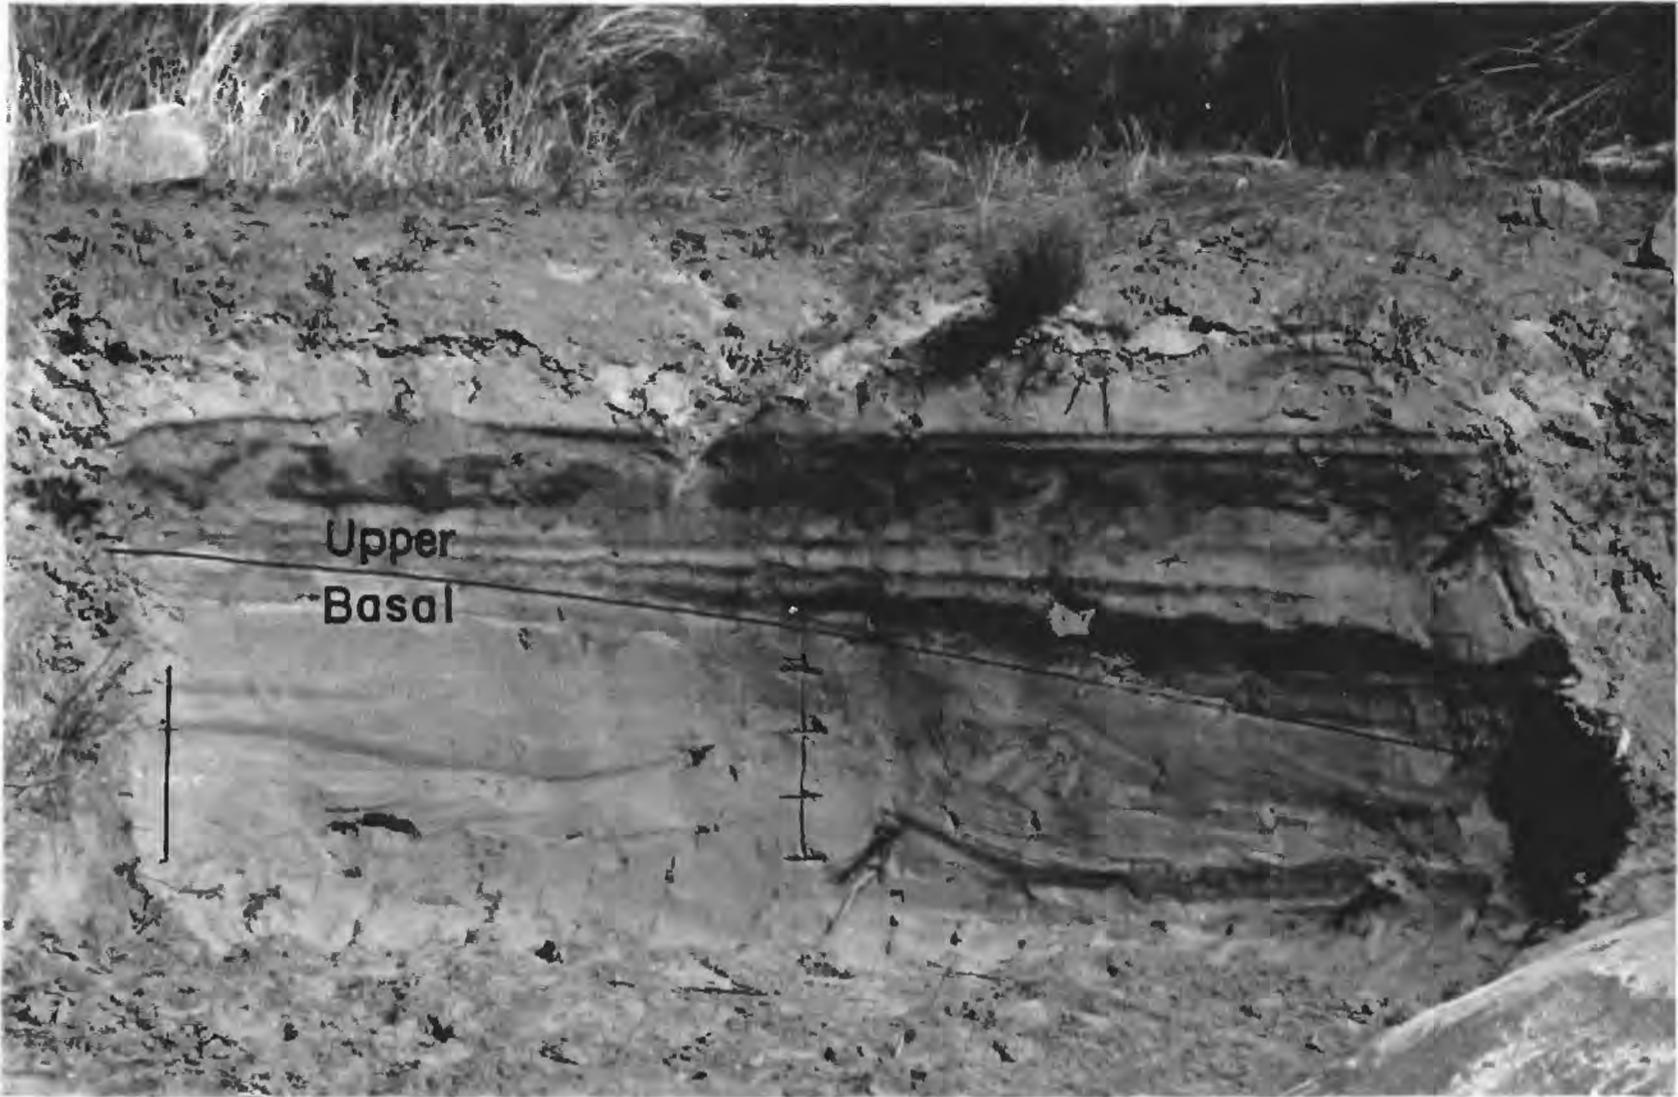
Figure 8. Photograph showing exposure of basal and upper unit of modern alluvium in East Fork. Vertical bar is 30 cm long. Light-colored beds are mainstem deposits; dark-colored beds are sheetwash deposits of clay, silt, and sand.

Alluvium of the modern terrace is well exposed in the cutbanks of the active channel and floodplain. Figure 8 shows the alluvium on the south side of the river just upstream of a large rockfall clast southeast of spot elevation 1202.0 m (fig. 5). The alluvium consists of two units, a basal sand about 50 cm (1.6 ft) thick and an upper stratified sand. The basal unit is massive without distinctive stratification, largely the result of fluvial reworking. A cottonwood tree resembling those on the modern terrace that date between 1940-1963 is rooted on the top of the basal unit, suggesting that the unit predates 1940-1963. The upper unit in the right side and upper portion of the exposure (fig. 8), consists of yellowish-gray beds of very fine to fine-grained sand of mainstem origin with interbedded dark-reddish brown silty and clayey sand derived from erosion of nearby hillslopes. The deposits are extensively bur-

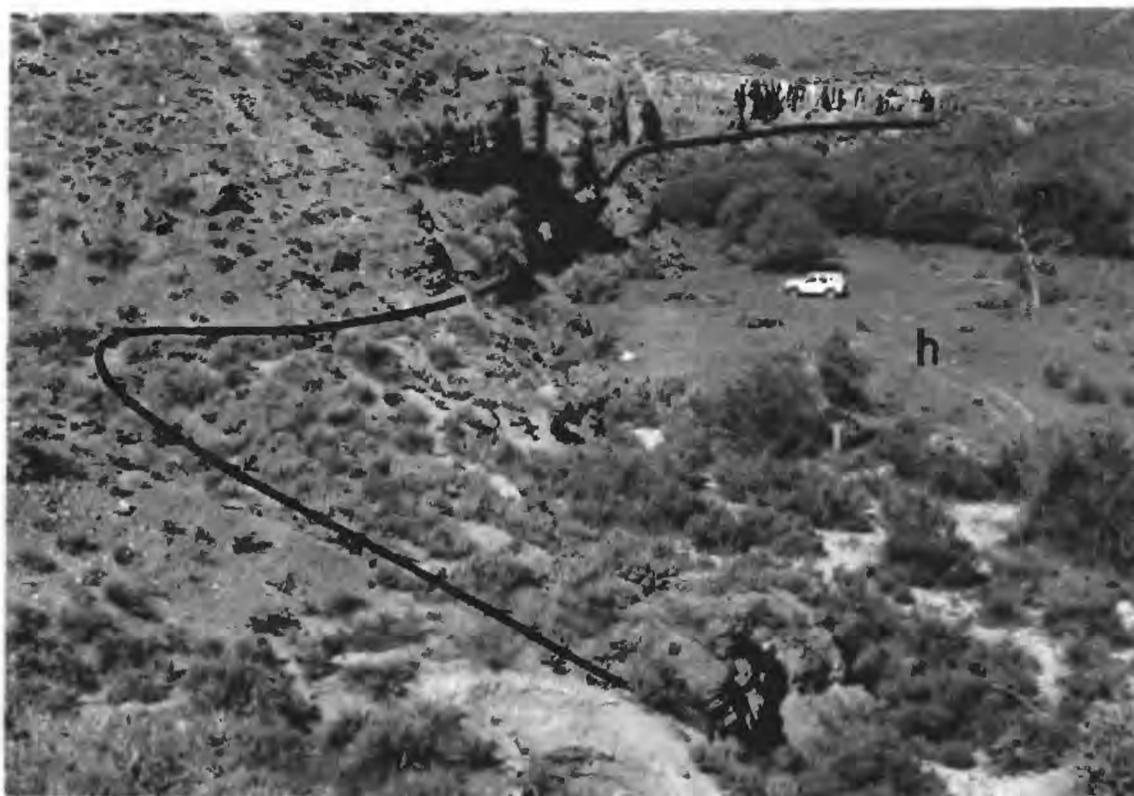
Figure 11. Photograph illustrating erosion of bedrock (Moenkopi Formation) associated with historic arroyo cutting west of Grafton. Line shows trace of irrigation ditch. Dashes show eroded ditch and bedrock. h = historic terrace; m = modern terrace.

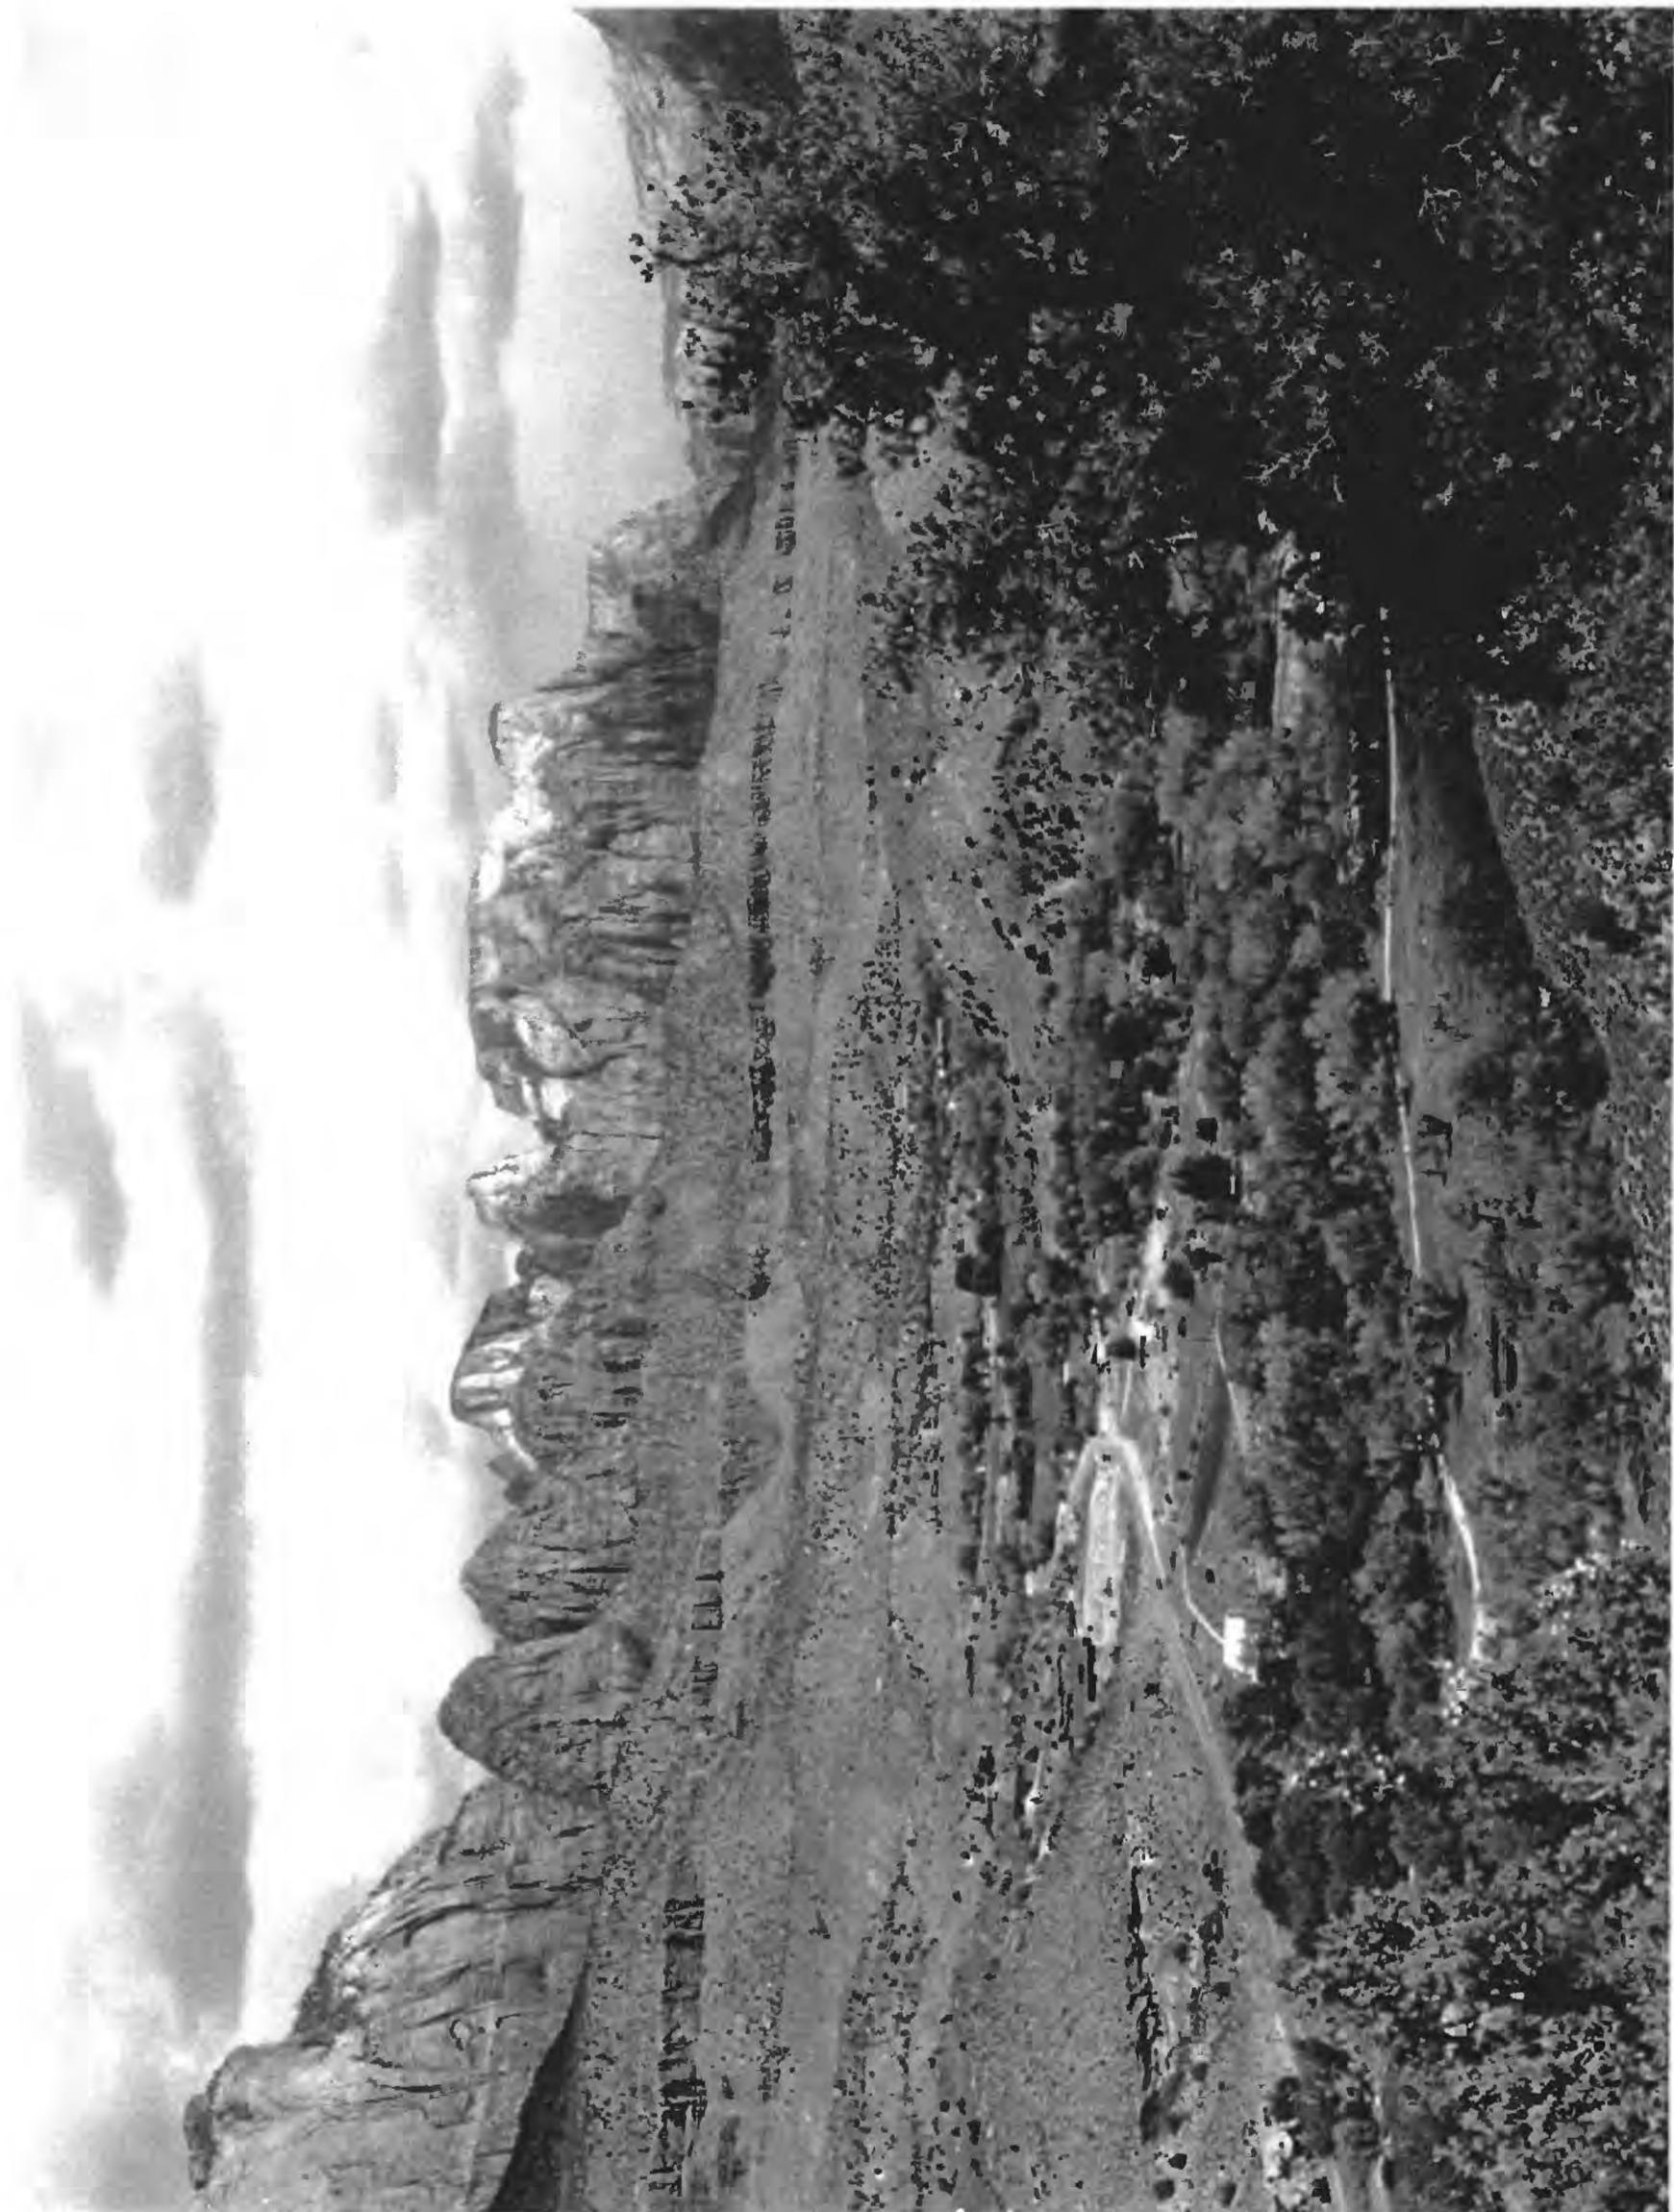
Figure 12. View to northeast up North Fork showing junction of North Fork and East Fork west of Springdale, Towers of the Virgin on skyline. A) 1873 and B) 1994.

The junction of Virgin River with East and North Fork is shown in figure 12 (Table 2). The early photograph (fig. 12a) was taken in 1873 by J.K. Hillers. In 1873, the river flowed at the level of the settlement terrace, and the river appeared to flood widely across the bottomland, as indicated by the streaks of high-albedo material parallel to the river (fig. 12a). The valley was relatively free of vegetation, probably the result of grazing and clearing for farming. The channel of East Fork in 1873 (fig. 12a) was located about where the dirt road crosses the settlement terrace in the contemporary photograph (fig. 12b). East Fork has shifted about 100 m (330 ft) south of its 1873 position, and the junction with North Fork shifted downstream. Although not visible in the contem-

porary photograph (fig. 12b), the river now flows 4 m (13 ft) below the adjacent settlement terrace. A woodland composed mainly of cottonwood is now well established along the river. At this locality, the width of the channel does not appear to have increased, but the channel has shifted position and deepened 4 m (13 ft).

Zion Canyon and North Fork downstream from Big Bend are shown in figure 15, an oblique aerial view from Observation Point (Table 2). The foreground of figure 12 is visible in the mid-ground of figure 15. In the 1903 photograph, the active channel of North Fork is indicated by the high-albedo material on the floor of the alluvial valley (fig. 15a); the channel appears to occupy most of the valley floor. At least five meander scars are eroded into the settlement terrace downstream of the mid-ground of the photograph. The meander scars resemble the plan-form of the historic terrace at East Fork (fig. 5). A plowed field or orchard is present on the settlement terrace on the right side of the valley. This field is not present in the 1929 photograph (fig. 15b); the terrace and field were removed by a shift in the channel between 1903-1929. Vegetation had begun to occupy channel bars by 1929, these bars probably correspond with the early modern terrace mapped upstream at the North Fork study site (fig. 9). The contemporary photograph (fig. 15c) shows a substantial decrease of channel width since 1929. In addition, a woodland of cottonwood is well developed. Extensive channelization and realignment of North Fork were done in this reach to maintain the present all-weather road. Much of this conservation work was done in the 1930s, and the present position of the channel in many places is partly a consequence of this stabilization work.

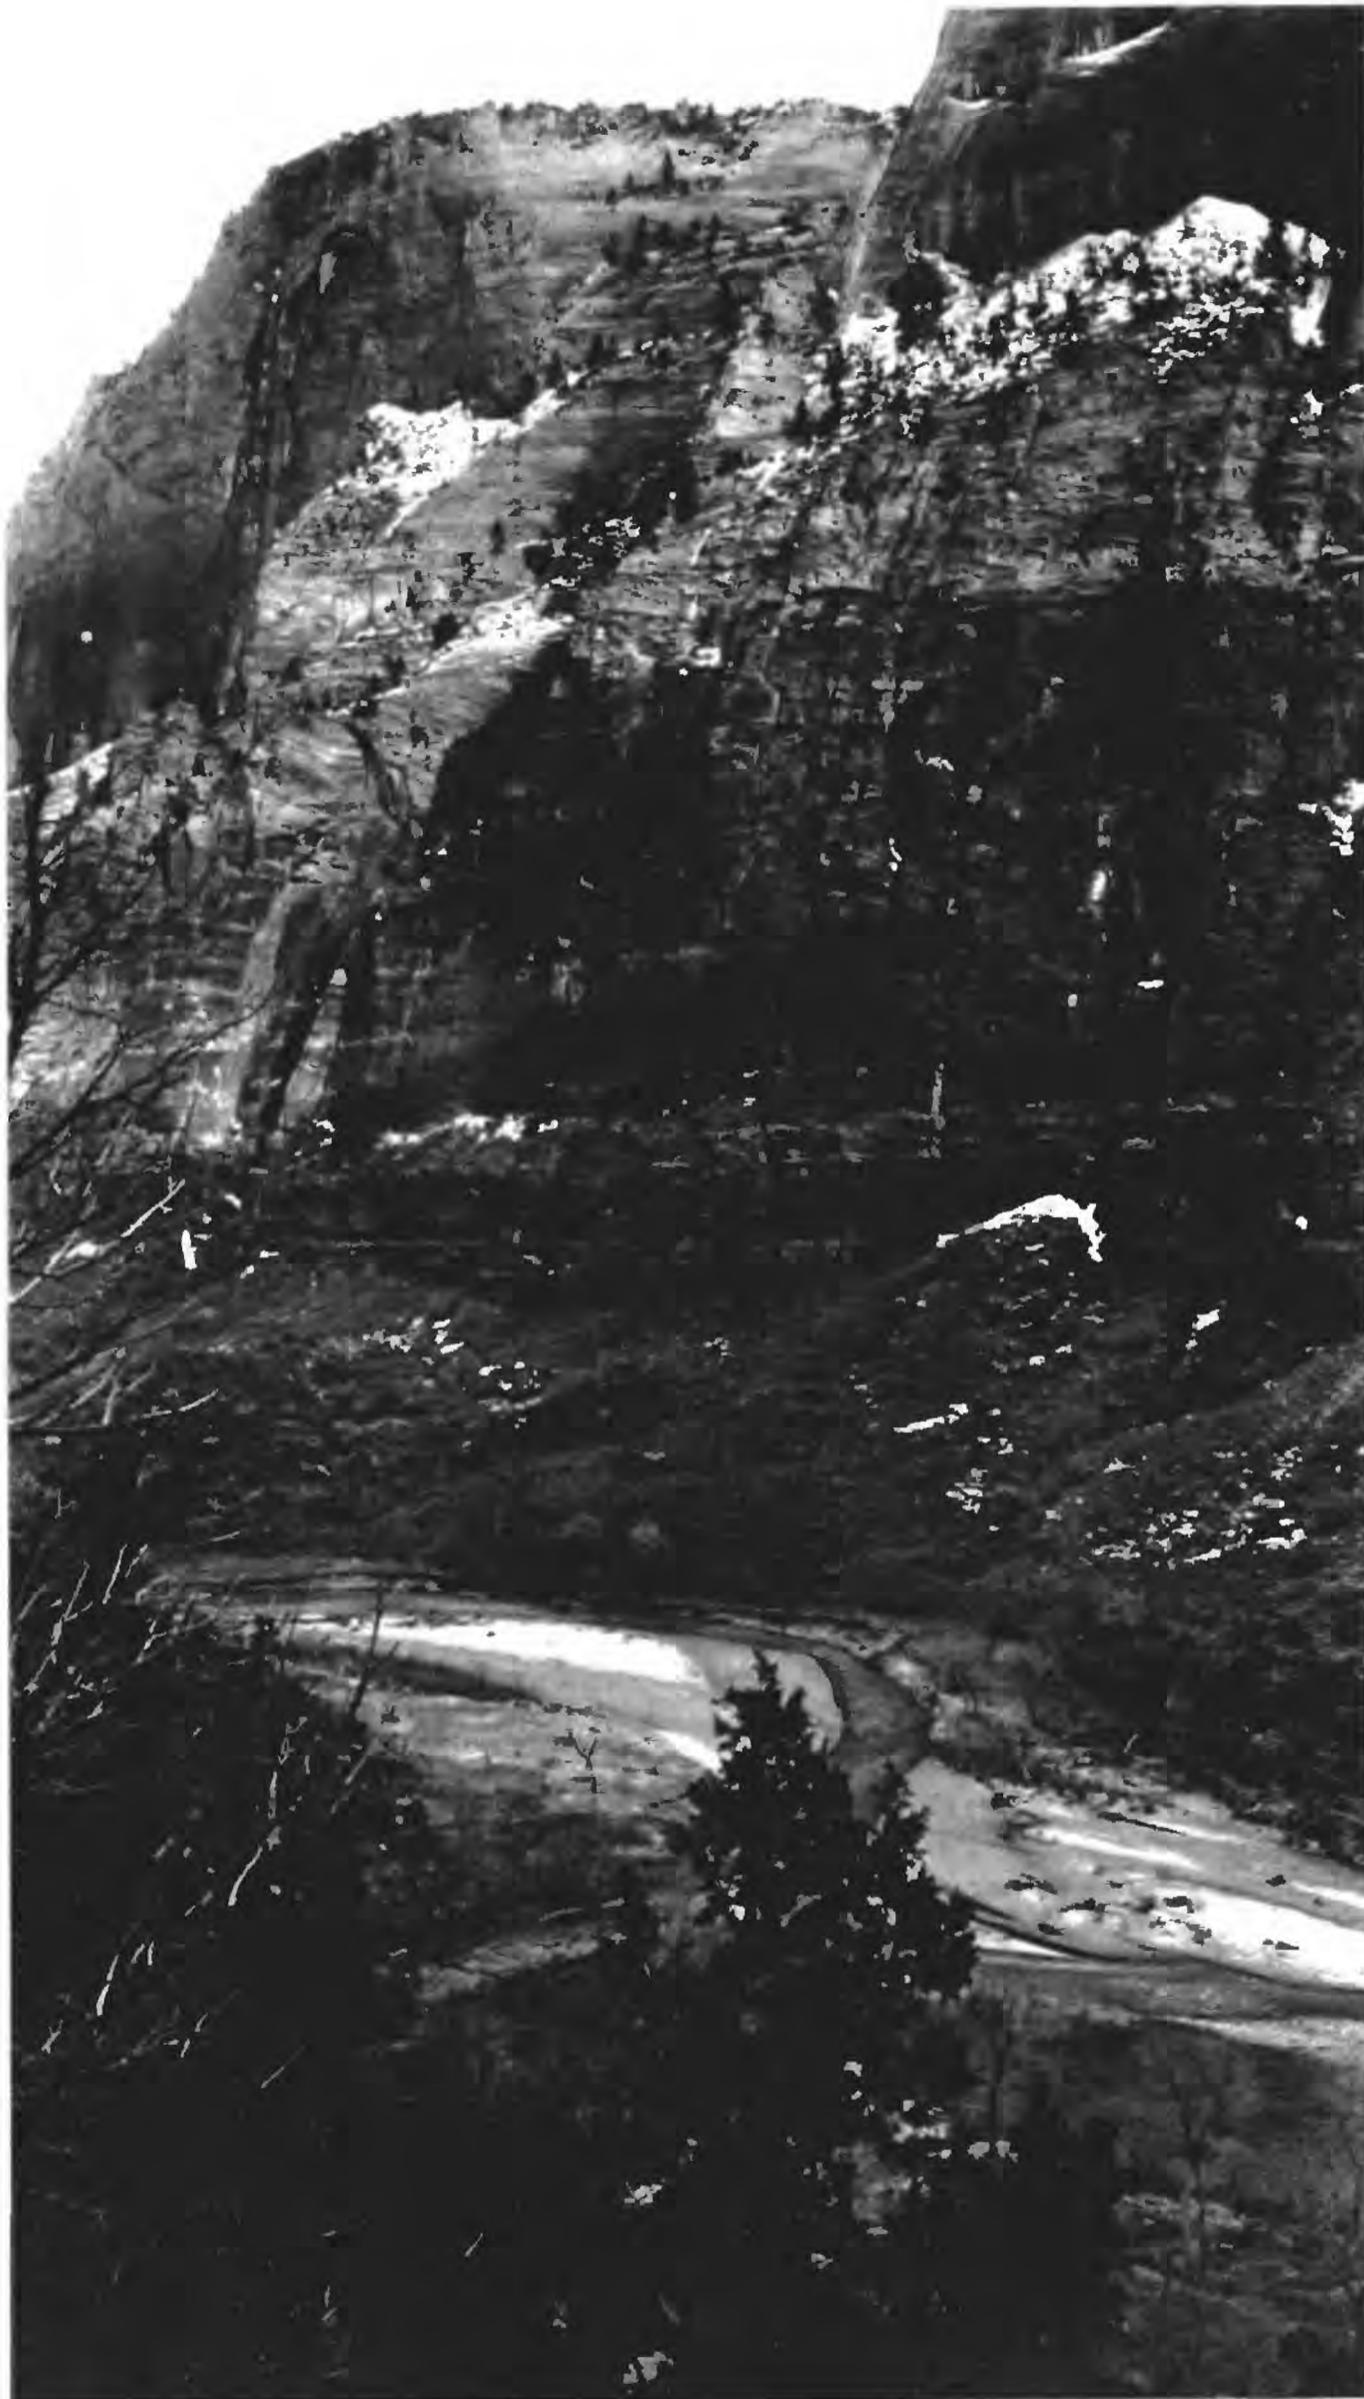
Figure 16. Upstream view of North Fork and Cable Mountain. A) 1909 and B) 1994.

shown in figure 16 (Table 2). The early photograph (fig. 16a) shows the historic channel extending across most of the valley in 1909. The cutbank and relatively high terrace on the right side of the river is probably the settlement terrace. However, a terrace cannot be identified at this spot in the Observation Point photograph (fig. 15a) taken only six years earlier. It is possible that the cutbank and terrace are related to the historic terrace. Gravel is present in the channel on the right side of the photograph in the upper foreground. The contemporary photograph (fig. 16b) shows that the channel shifted south, placing the active channel against bedrock. This shift occurred by 1929, as shown in the Observation Point photograph (fig. 15b). The height and diameter of cottonwood on the left side of the river identify this surface as the early modern terrace. This reach is largely unaffected by channel stabilization, which was unnecessary because the Zion Canyon Road is on bedrock above the alluvial valley. The left bank downstream from the bedrock cliff has been stabilized, as shown by the linear feature in the lower right of figure 16b.
