GEOMORPHIC HISTORY OF THE VIRGIN RIVER IN THE ZION NATIONAL PARK AREA, SOUTHWEST UTAH

U.S. GEOLOGICAL SURVEY OPEN-FILE REPORT 95-515

*Prepared in Cooperation with the
National Park Service*

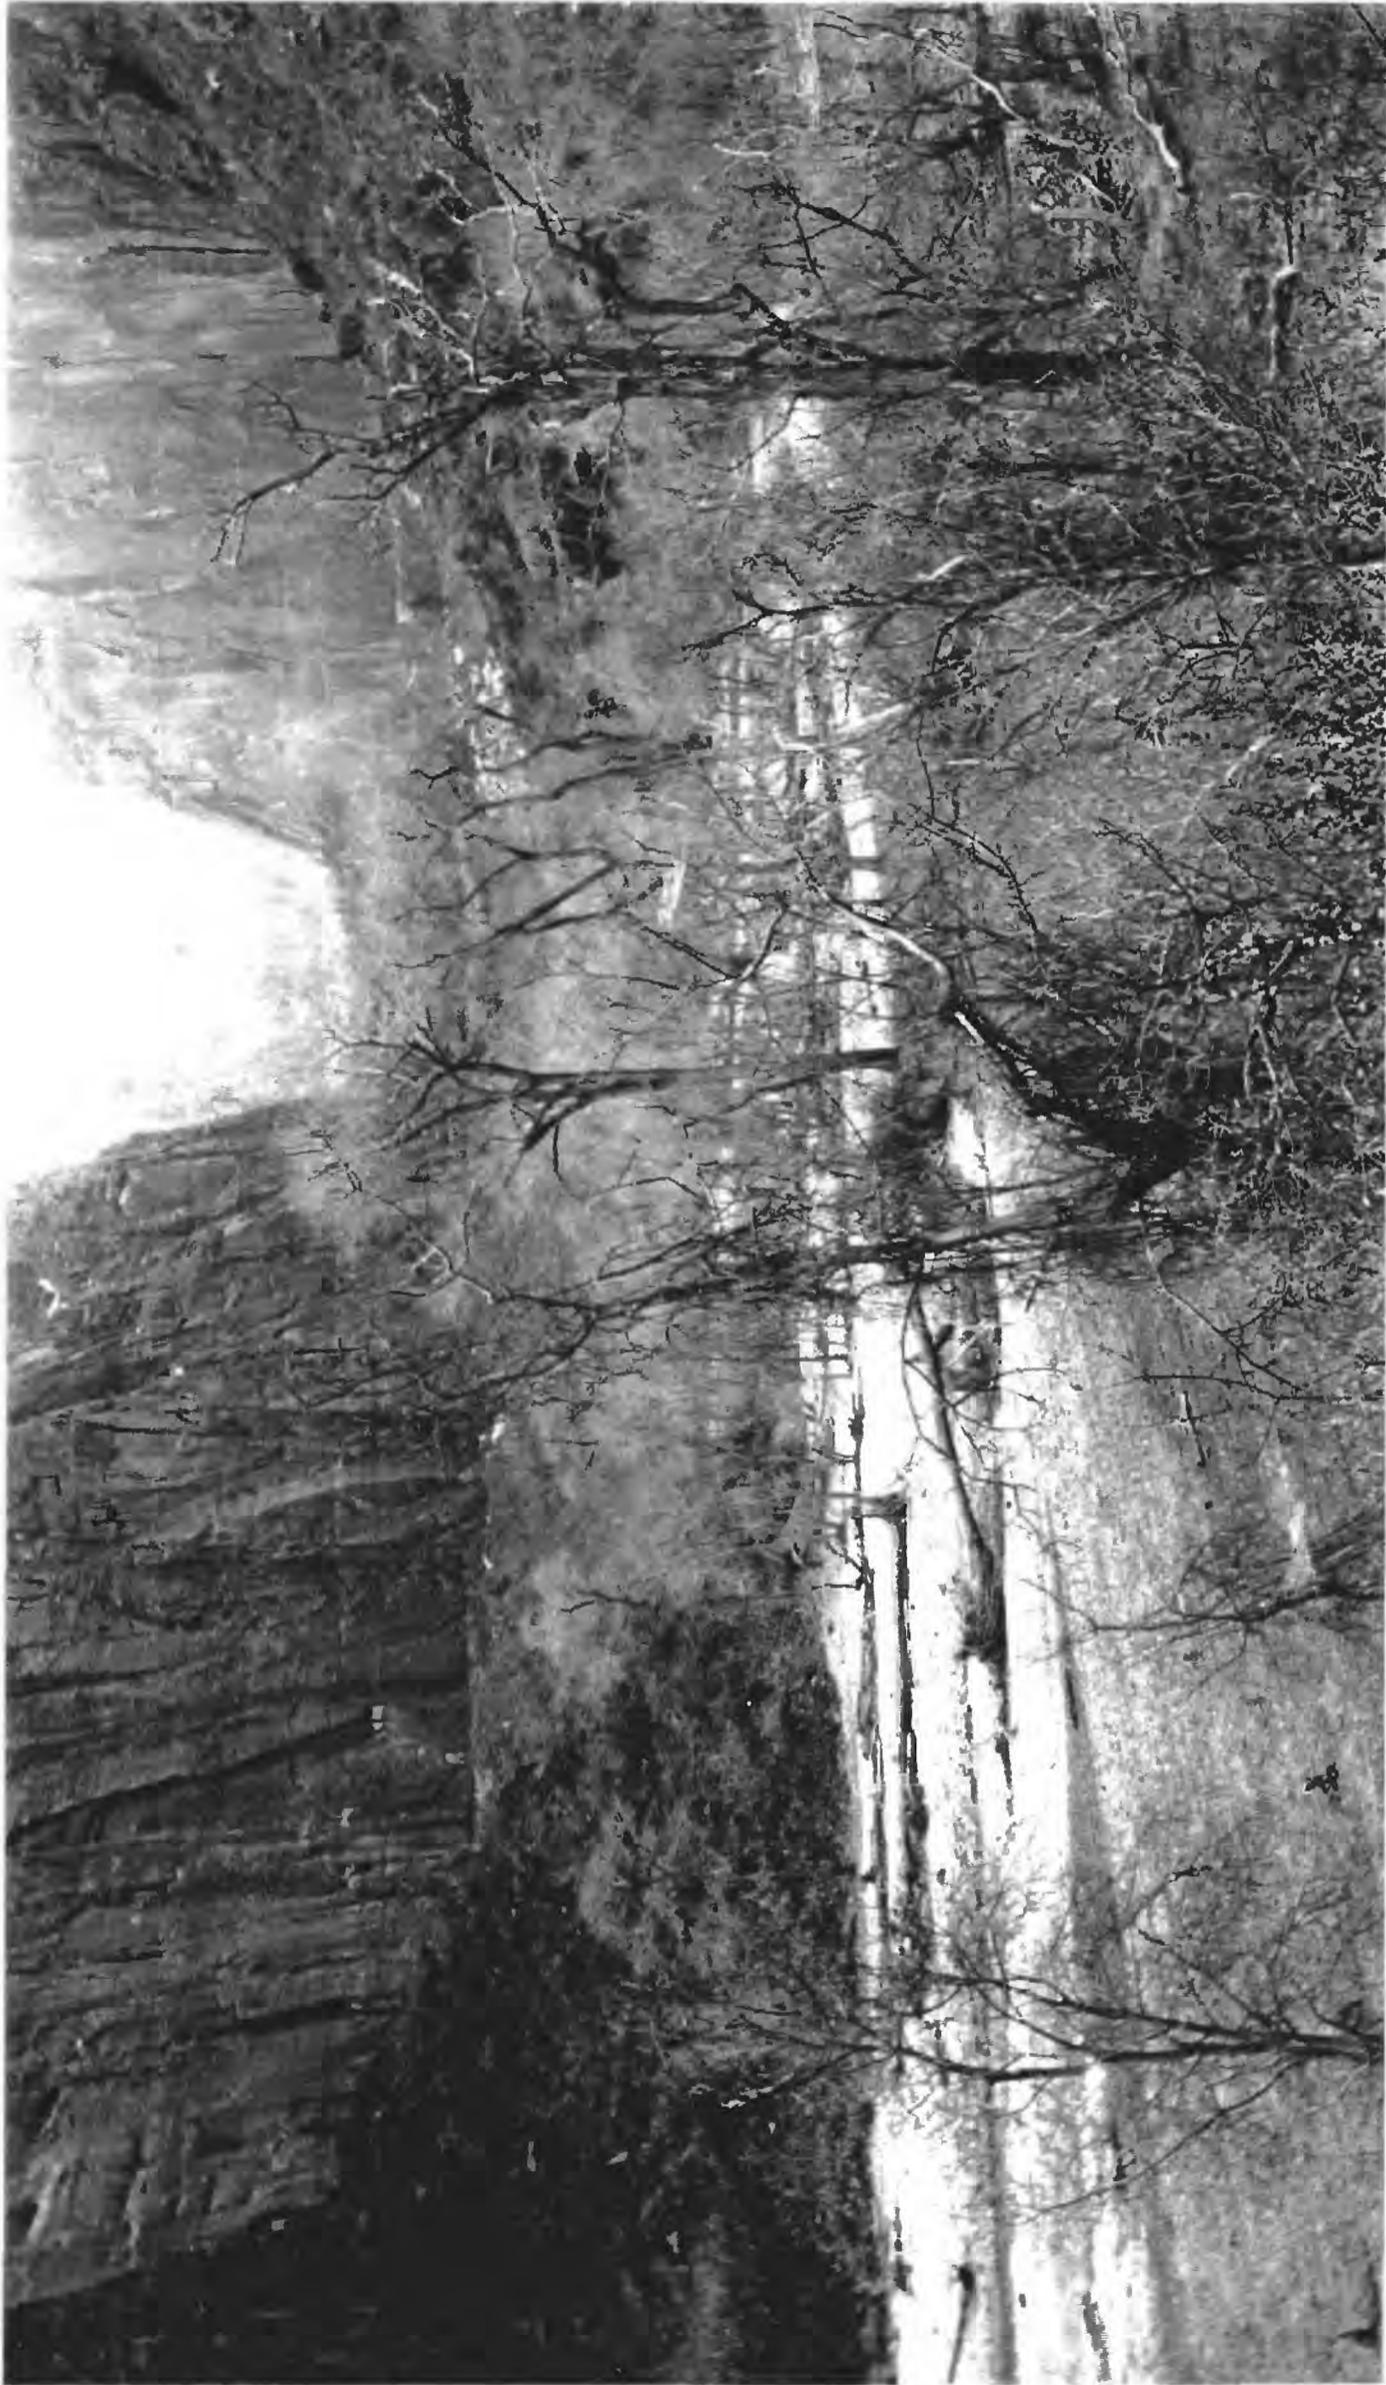
Figure 17. Downstream view of North Fork from The Pulpit, 1909.

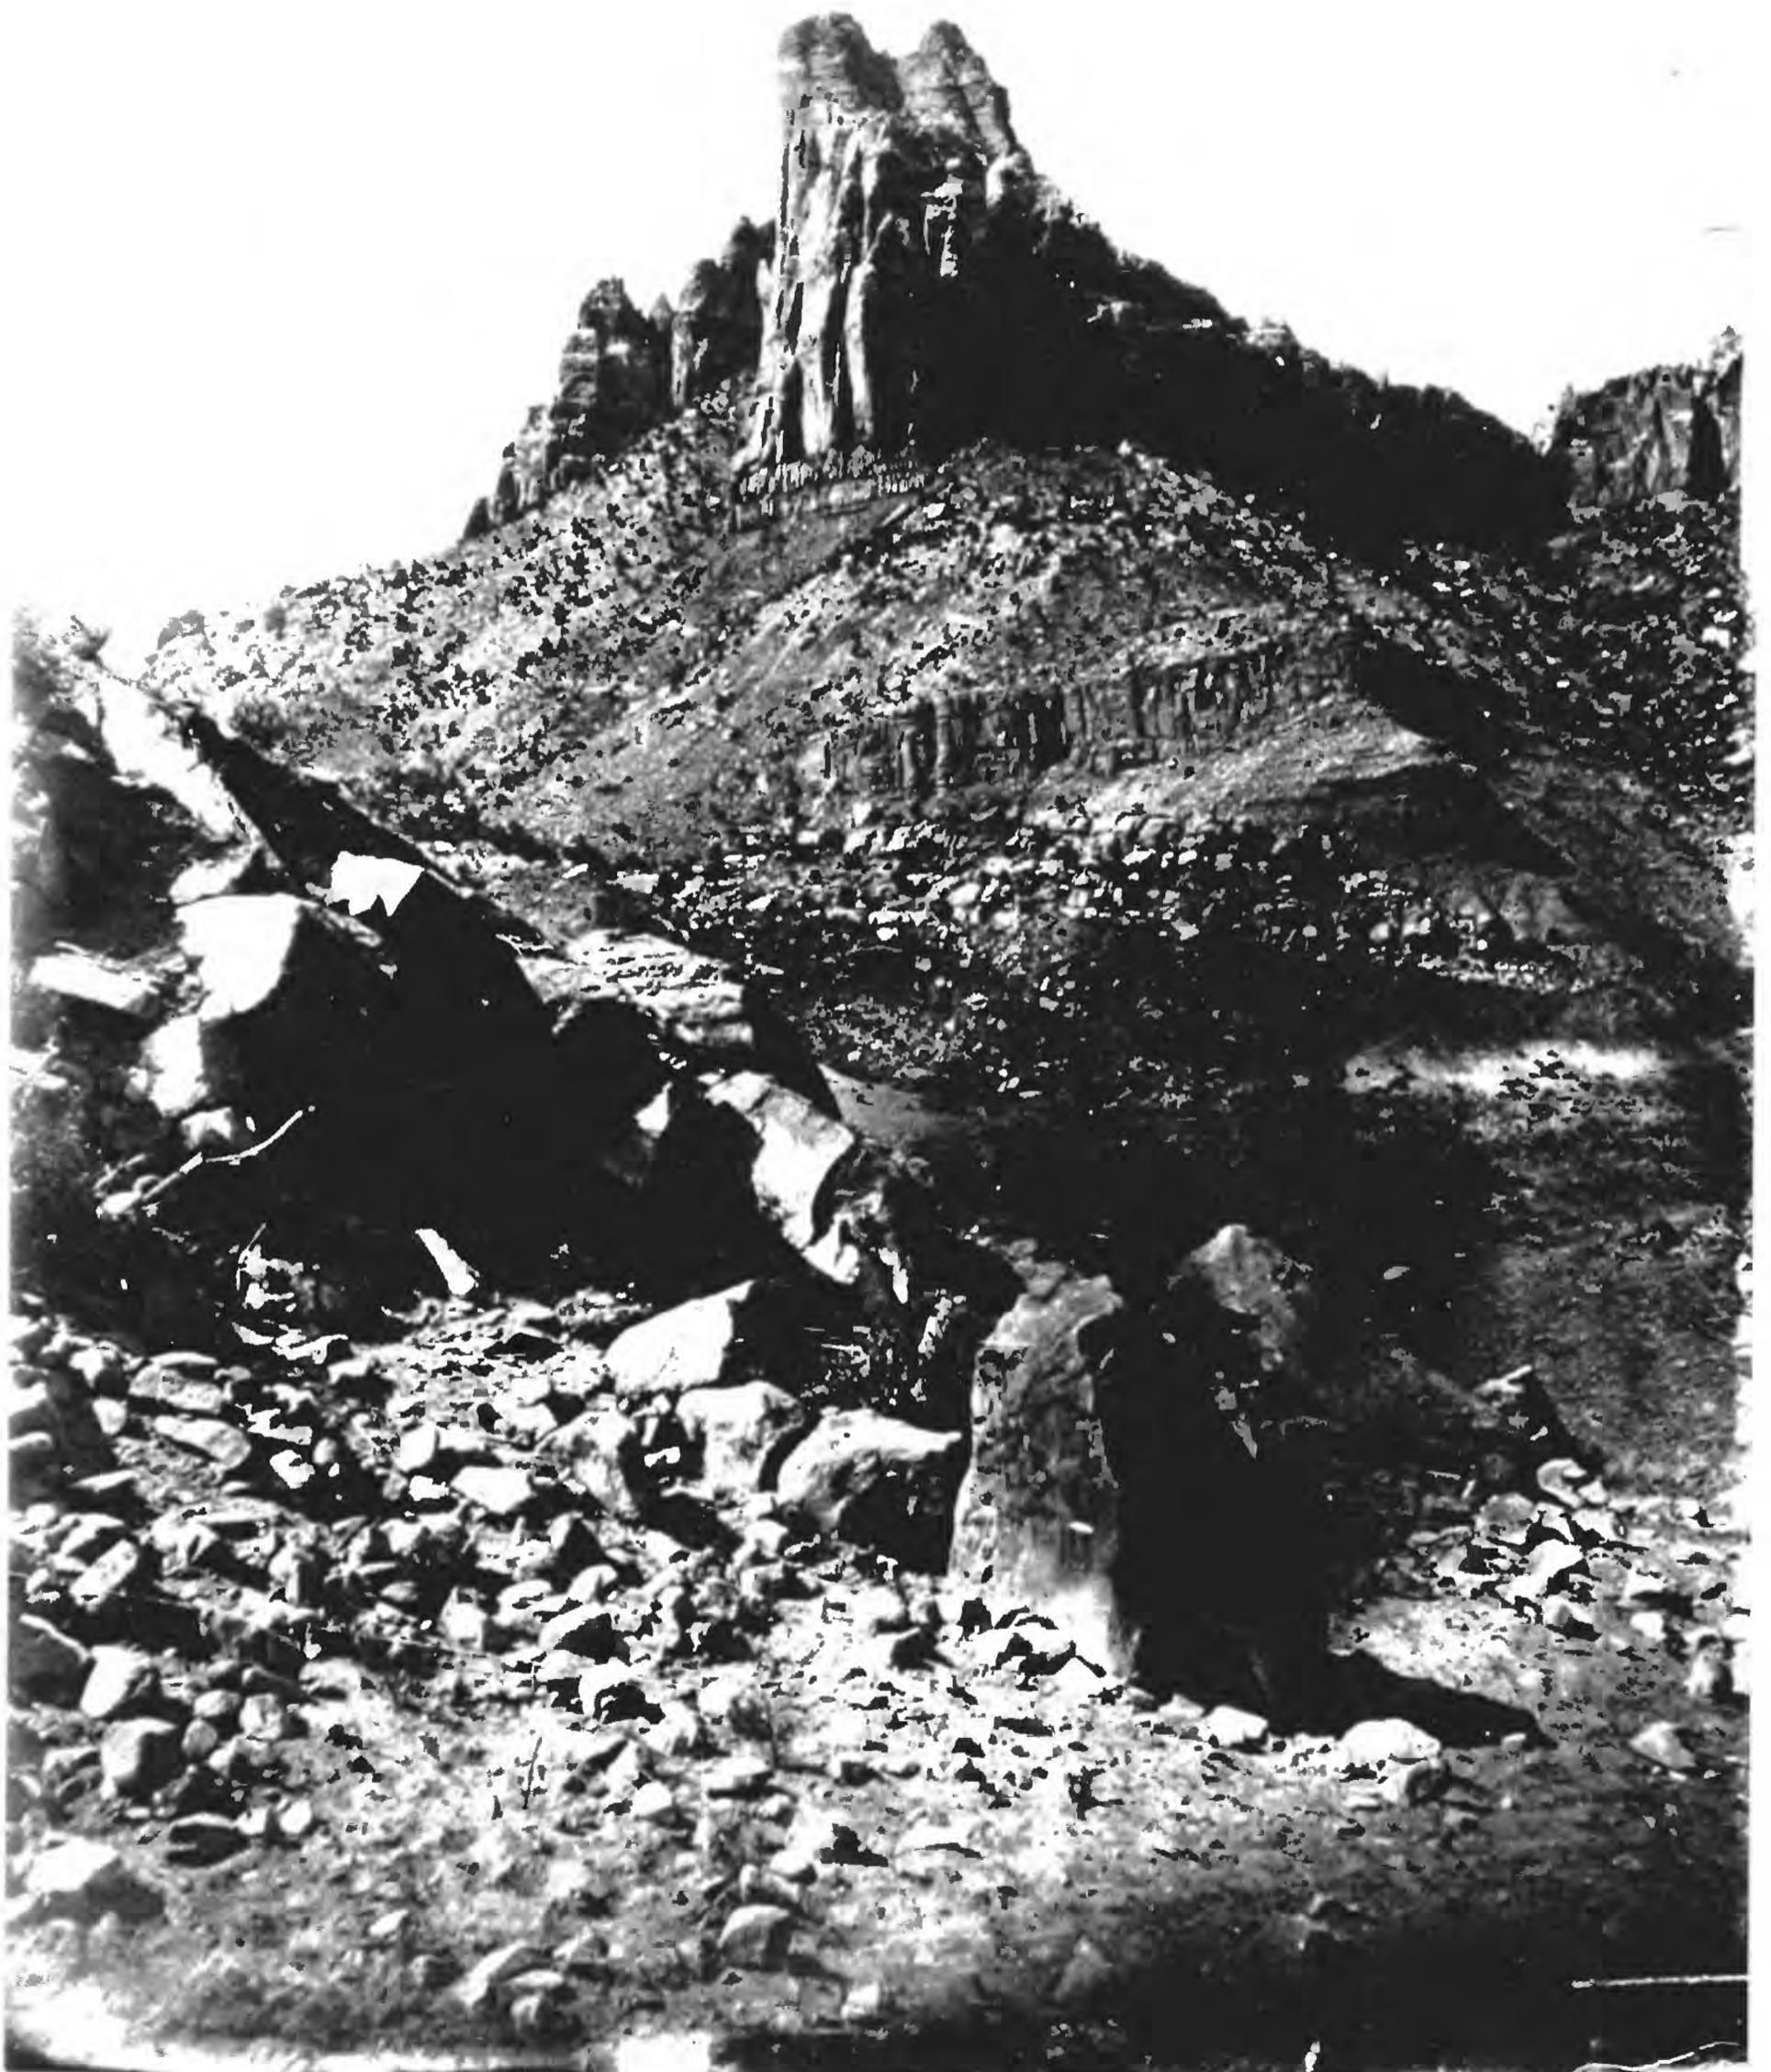
Figure 20. Johnson Mountain from site of Shunesburg. A) 1873 and B) 1994.
