Characteristics of Debris Flows of Noneruptive Origin on Mount Shasta, Northern California

By James C. Blodgett, Karen R. Poeschel, and Waite R. Osterkamp

U.S. GEOLOGICAL SURVEY

Open-File Report 96-144

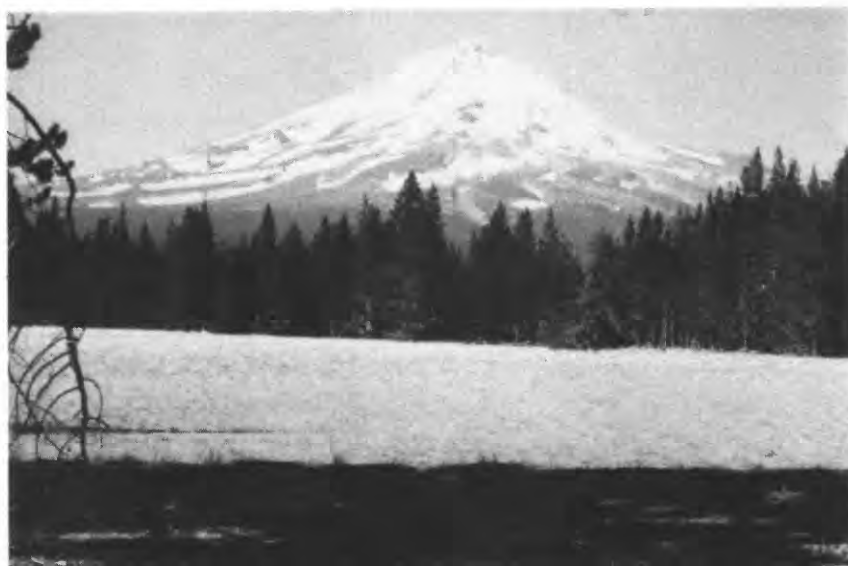
Figure 1. View of Mount Shasta, California. Gravel Creek alluvial fan in The Whaleback-Ash Creek Butte depression in foreground. Photograph taken July 1984.

Mount Shasta is a large stratovolcano in northern California about 61 km south of the Oregon-California border (figs. 1 and 2). Of the volcanoes in the Cascade Range, Mount Shasta is the second highest (altitude, 4,316.6 m) and one of the largest. The average basal diameter of Mount Shasta is about 27 km. Williams (1934) indicated that the Mount Shasta cone is perhaps larger in volume and height than Mount Rainier, Washington, because the cone of Mount Rainier rises above an elevated platform of older formations at an altitude of 2,440 m.

Mount Shasta (fig. 1) is a composite of at least four overlapping volcanic cones (Christiansen and others, 1977). Eruptive rocks are exposed on all sides of the mountain, but most areas are covered by varying thicknesses of till of Wisconsin or neoglacial age, pyroclastic flows, and debris-flow deposits. The widespread occurrences of interbedded pyroclastic and debris-flow deposits on Mount Shasta indicate that debris flows have been an important geomorphic process in the history of the mountain (Osterkamp and others, 1986).

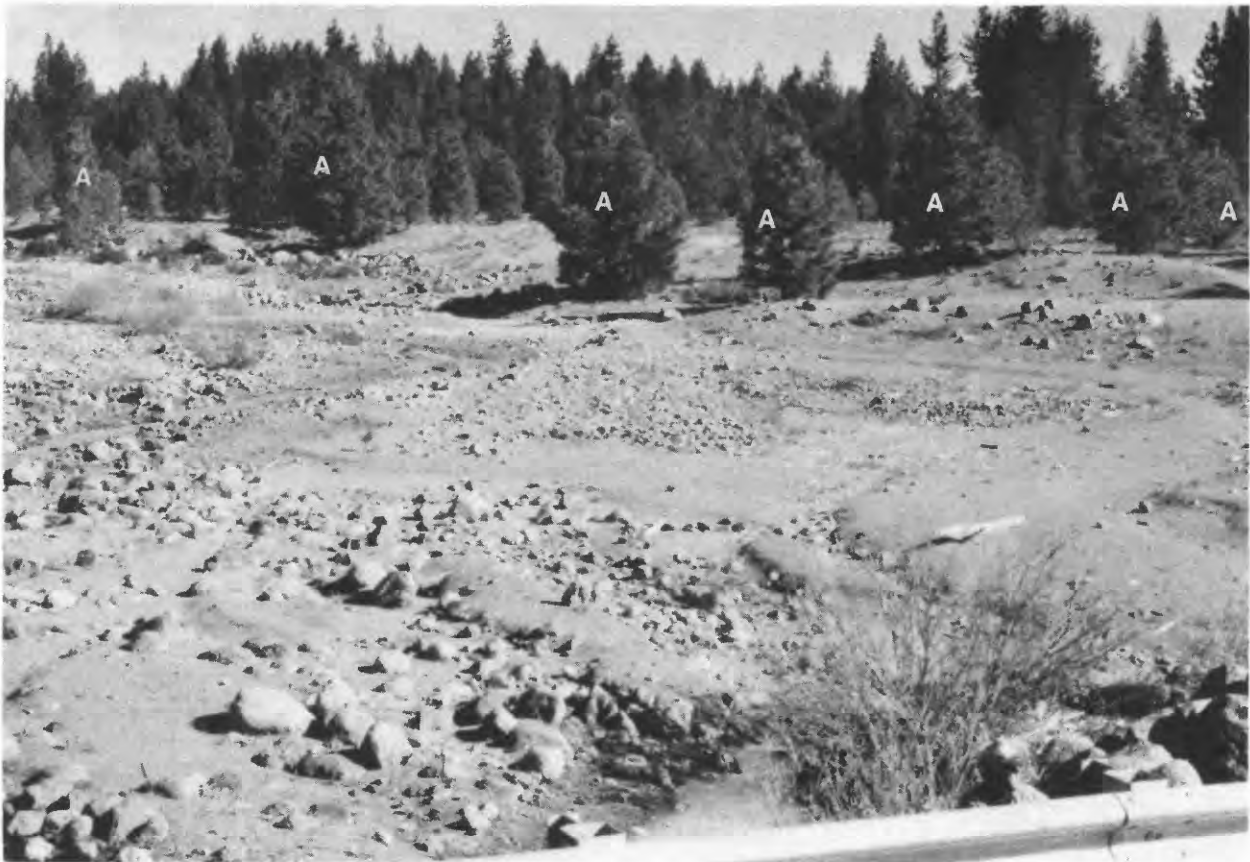
Figure 3. Typical deposits from a series of debris flows (1924-31) on Mud Creek debris fan just upstream from Road 13 crossing, sec. 27, T. 40 N., R. 2 W. Many trees in the background, marked (A) (about 9 m tall), began growing after this series of debris flows. Photograph taken May 1981.

repeatedly stacked and spread over an extensive area. These fans, such as those found on Mud Creek at Road 13 crossing (fig. 3), are typical of the alluvial fans on the flanks of Mount Shasta. Debris fans commonly are seen below 1,800-m altitude, which is about 10,000 m from the summit. These debris fans generally are incised between 1,200- and 1,800-m altitude; exceptions are Ash, Brewer, and Gravel Creeks, which have extensive debris-flow deposits with minor incision between 1,700- and 1,900-m altitude.

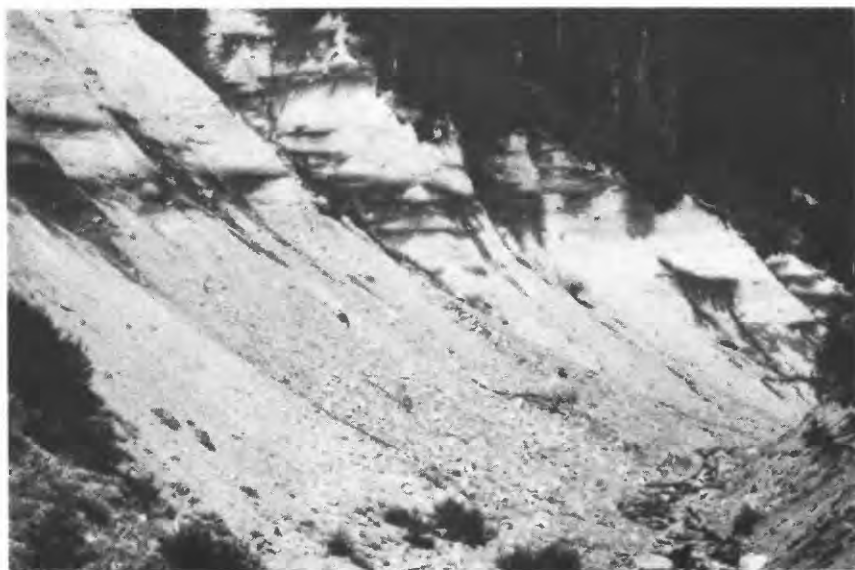
Figure 4. Slopes of loose eruptive debris that supply material for debris flows. Site in Mud Creek Canyon, sec. 31, T. 41 N., R. 2 W., near McCloud. Flow from right to left. Photograph taken September 1984.

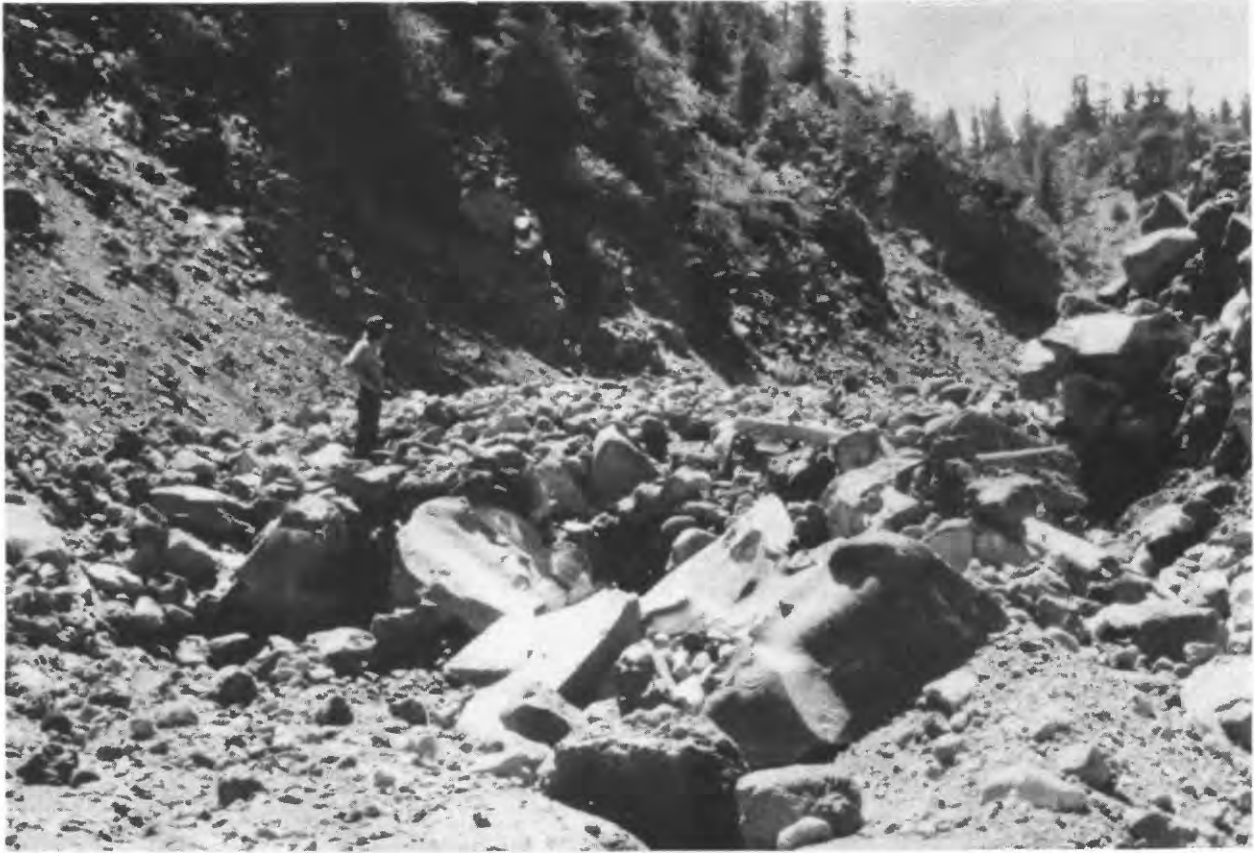
Figure 7. View upstream of small debris-flow deposit (1.5 m thick) on Whitney Creek. Altitude is 2,440 m. Channel slope is 0.18. Accumulation of large boulders and cobbles at the downstream front (terminal lobe) is shown. Photograph taken August 1981.

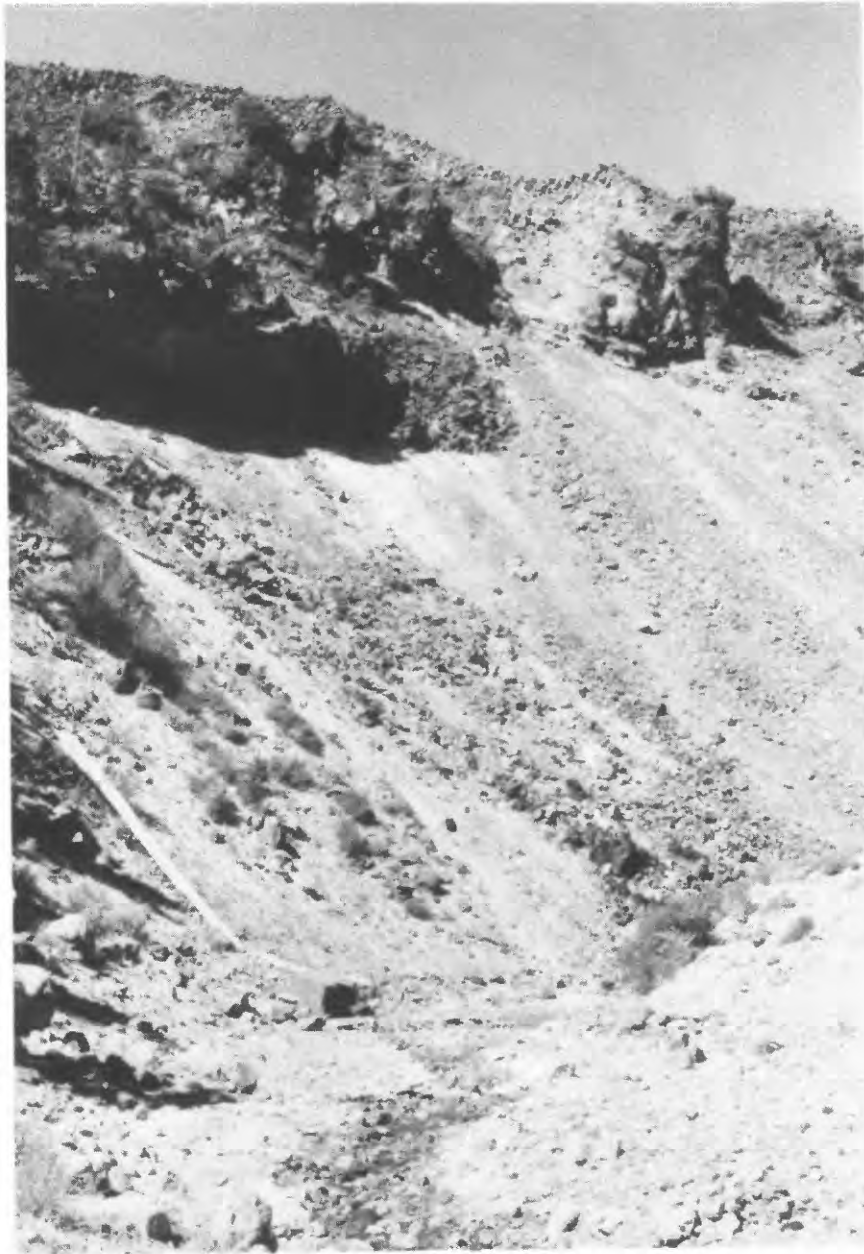
Figure 8. Bank erosion of Whitney Creek (fig. 2) channel beneath the Lava Park lava flow in sec. 19, T. 42 N., R. 3 W. Flow is from left to right. Scale is indicated by fallen trees on left bank of channel near left foreground. Photograph taken in 1983.

Lava flows that lie unconformably on the land surface or debris deposits that are highly fractured periodically break off, falling into a channel and causing the potential for temporary blockage of the channel (fig. 8). This debris then becomes a source of material for transport by future debris flows. The

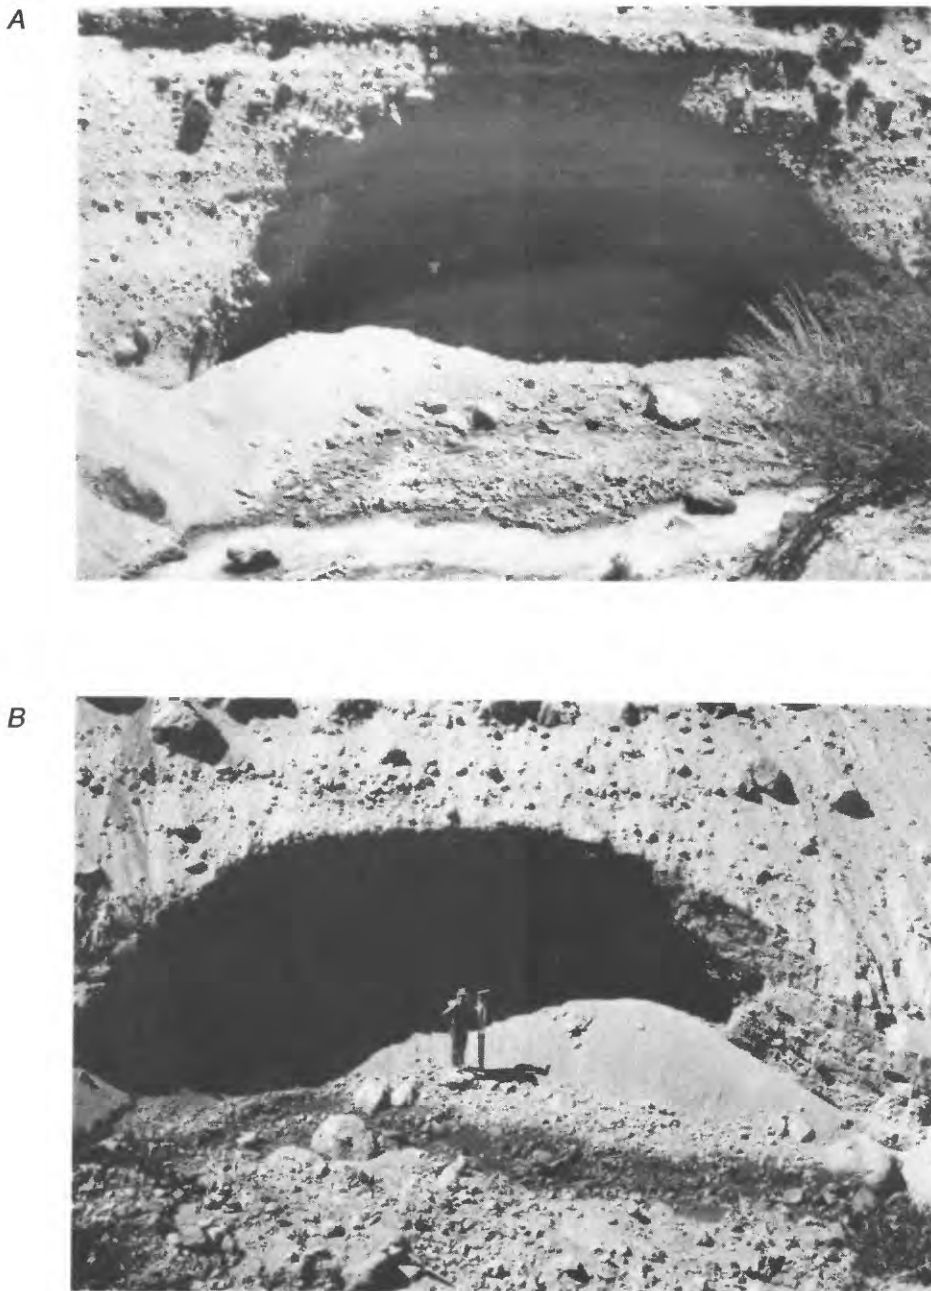
Figure 9. Bank erosion as a source of material for debris-flow formation. Photographs taken August 1984. A, Undercut bank on Mud Creek (sec. 8, T. 40 N., R. 2 W.). Note man in center of picture. Flow is from left to right. B, Undercut bank on Whitney Creek (sec. 19, T. 42 N., R. 3 W.). Flow is from left to right.

potential for channel blockage is also illustrated at sites on Mud and Whitney Creeks (fig. 9), where local scour and bank failure formed caverns in the loose, uncompacted material that subsequently collapsed and

created temporary dams. These dams cause lateral channel migration and create the potential for flow impoundment. The sudden release of water from the impoundment, sediment transported from upstream

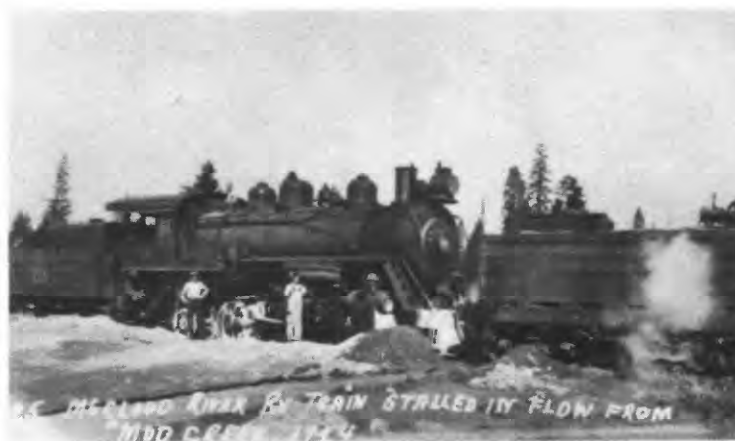
Figure 10. McCloud River Railroad train stalled at crossing of debris flow on Mud Creek, 1924 (sec. 35, T. 40 N., R. 2 W.). Photograph courtesy of Kite Photo-News, McCloud, California.

wall of the Mud Creek canyon collapse into the gorge, forming temporary dams behind which the water is impounded until able to overflow and carry away the obstacle." The onrushing flood (debris flow) then continued down the canyon for about 10 km, spilled over its banks, and left behind in the flat country (debris fan) thick sheets of bouldery detritus (fig. 3) in a matrix of sand and mud that crossed the McCloud River Railroad and inundated the road bed (fig. 10).

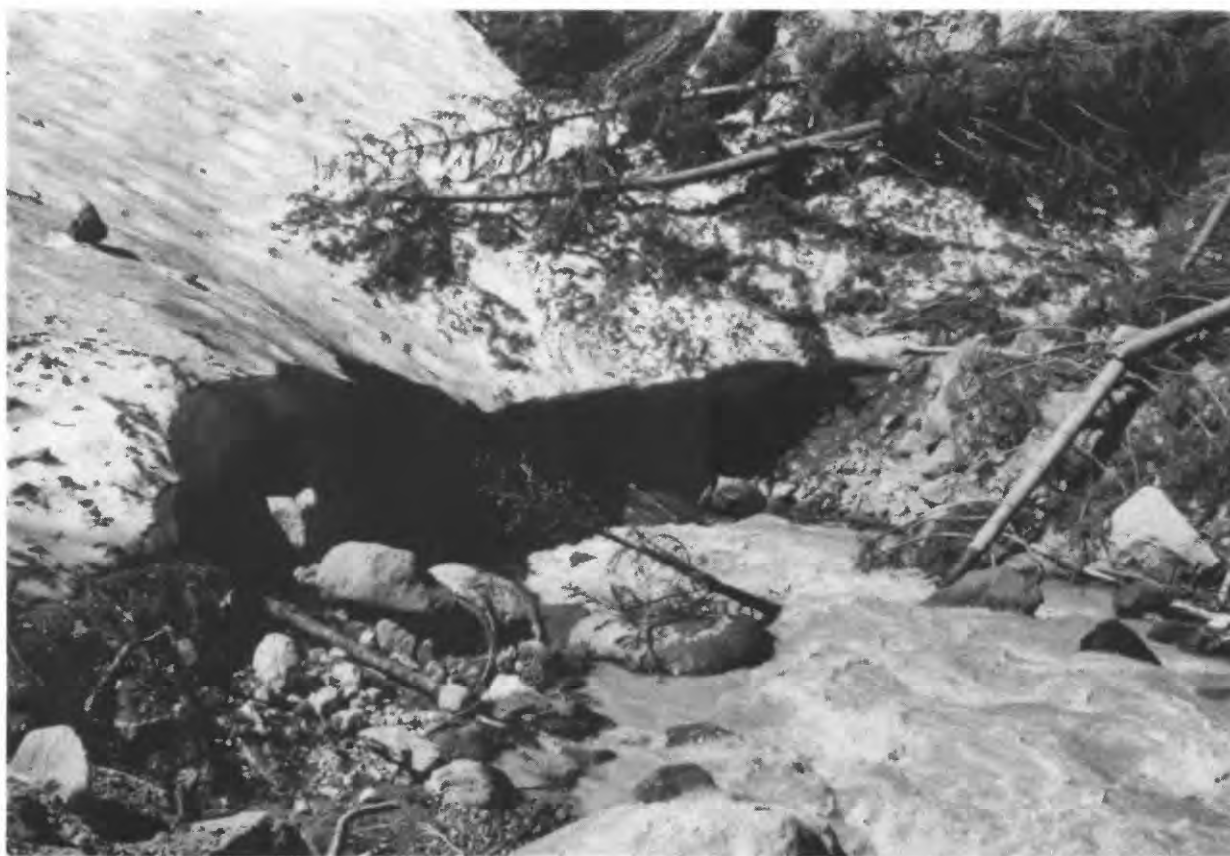
Figure 11. Entrance of snow tunnel in incised channel formed by melting or scouring action of streamflow. Location is about 3 km upstream from Mud Creek Dam. Slope is 0.073. Flow is from right to left. Photograph taken July 1984.

Most snow bridges are formed in deep-shaded parts of incised channels on the mountain. When these bridges catch earth and silt (debris) as described by the Mount Shasta Herald (July 21, 1977), or the snow tunnels collapse, a temporary reservoir may be formed. These dams then may be dislocated or breached, thereby creating surges of water and debris that may cause debris flows downstream.

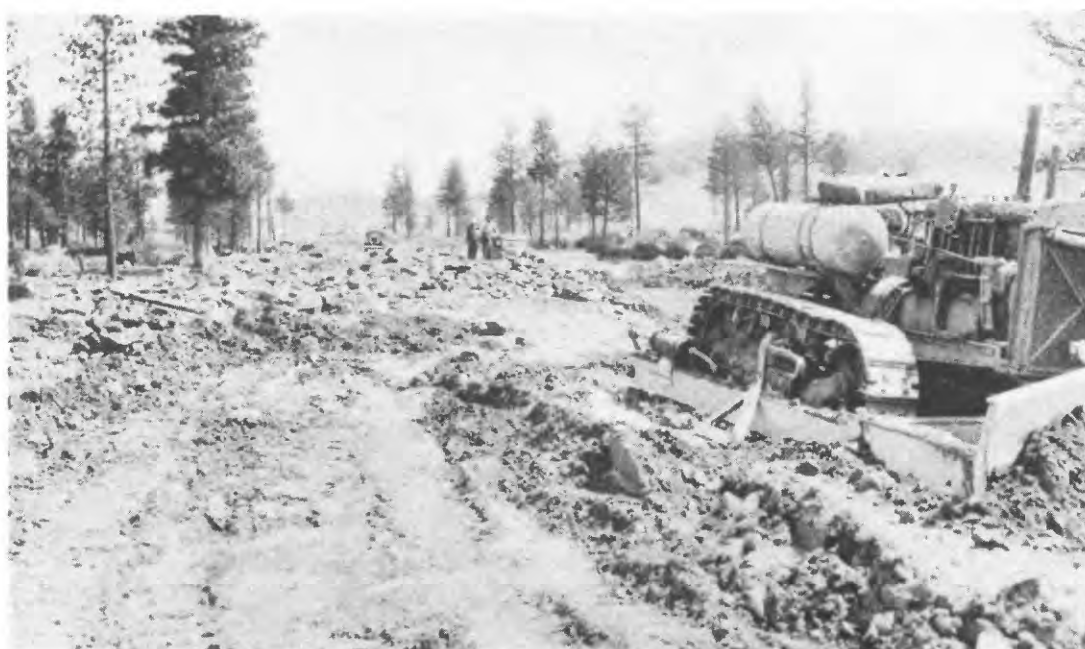
Figure 12. Debris flow from Whitney Creek covering U.S. Highway 97 following rainstorm on August 28, 1935. The highway was buried to a depth of 1.2 m by mud and boulders for a distance of 370 m. Flow from right to left. Photograph courtesy of California Department of Transportation.

The August 1935 debris flow on Whitney Creek continued downstream 6 km, blocking U.S. Highway 97 (fig. 2) and partly burying several automobiles (fig. 12). In a report of this flood by the California Department of Highways and Public Works, Nutting (1935) reported that the debris flow was attributed to a "warm thunderstorm on the [Whitney and Bolam] glaciers that started the snow and ice to melt and the resulting flow soon assumed the proportions of an avalanche." The assumption that the August 1935 debris flow on Whitney Creek was caused by precipitation is confirmed by a review of climatological data reports for 1935 (Bowie, 1935). Although climatic data for the storm on August 28, 1935, are not available for the Whitney Creek area, data from the U.S. Department of Agriculture Weather Bureau climatic stations at

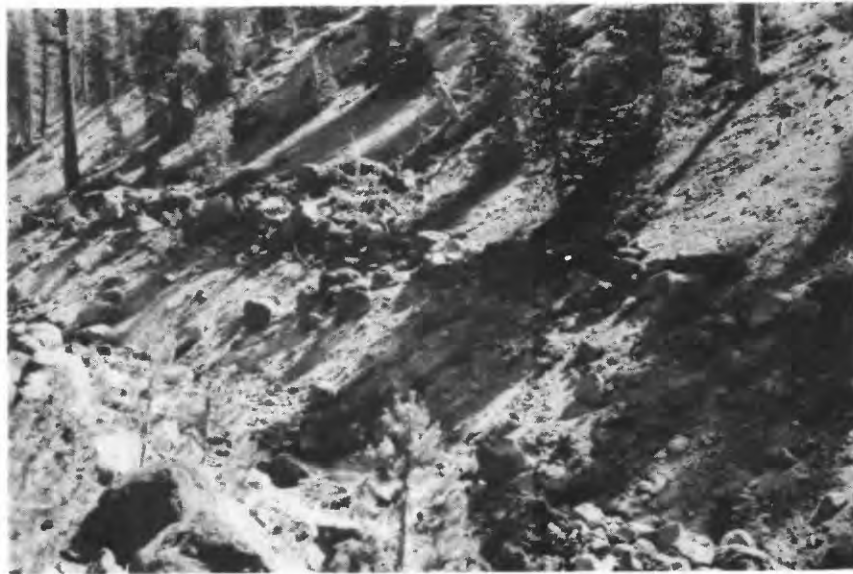
Figure 20. View downstream of boulder levees along margins of 1918 and 1939 debris flows, Inconstance Creek, California, in sec. 26, T. 42 N., R. 3 W. Photograph taken July 1984.
