LEVEL II SCOUR ANALYSIS FOR
BRIDGE 22 (WODSTH00180022) on
TOWN HIGHWAY 18, crossing
NORTH BRIDGEWATER BROOK,
WOODSTOCK, VERMONT

U.S. Geological Survey
Open-File Report 96-159

Prepared in cooperation with
VERMONT AGENCY OF TRANSPORTATION
and
FEDERAL HIGHWAY ADMINISTRATION

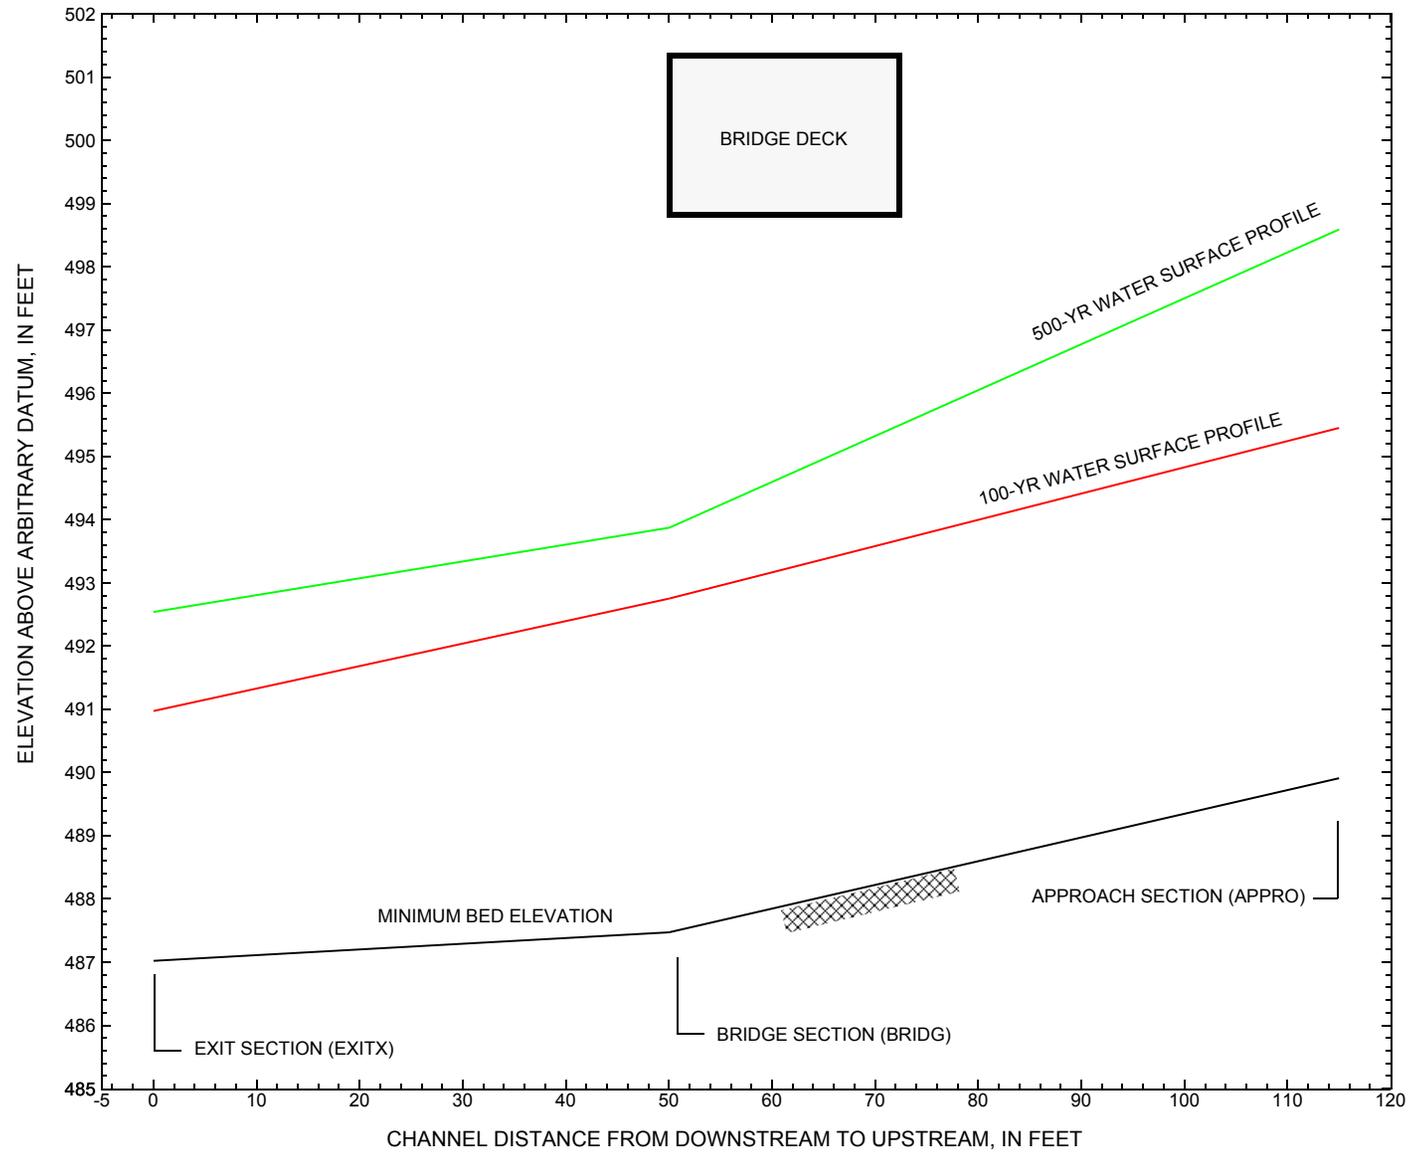
Figure 7. Water-surface profiles for the 100- and 500-yr discharges at structure [WODSTH00180022](#) on town highway 18, crossing [North Bridgewater Brook, Woodstock, Vermont](#).

Hydraulic analyses of the reach were done by use of the Federal Highway Administration's WSPRO step-backwater computer program (Shearman and others, 1986, and Shearman, 1990). Results of the hydraulic model are presented in the Bridge Hydraulic Summary, Appendix B, and figure 7.

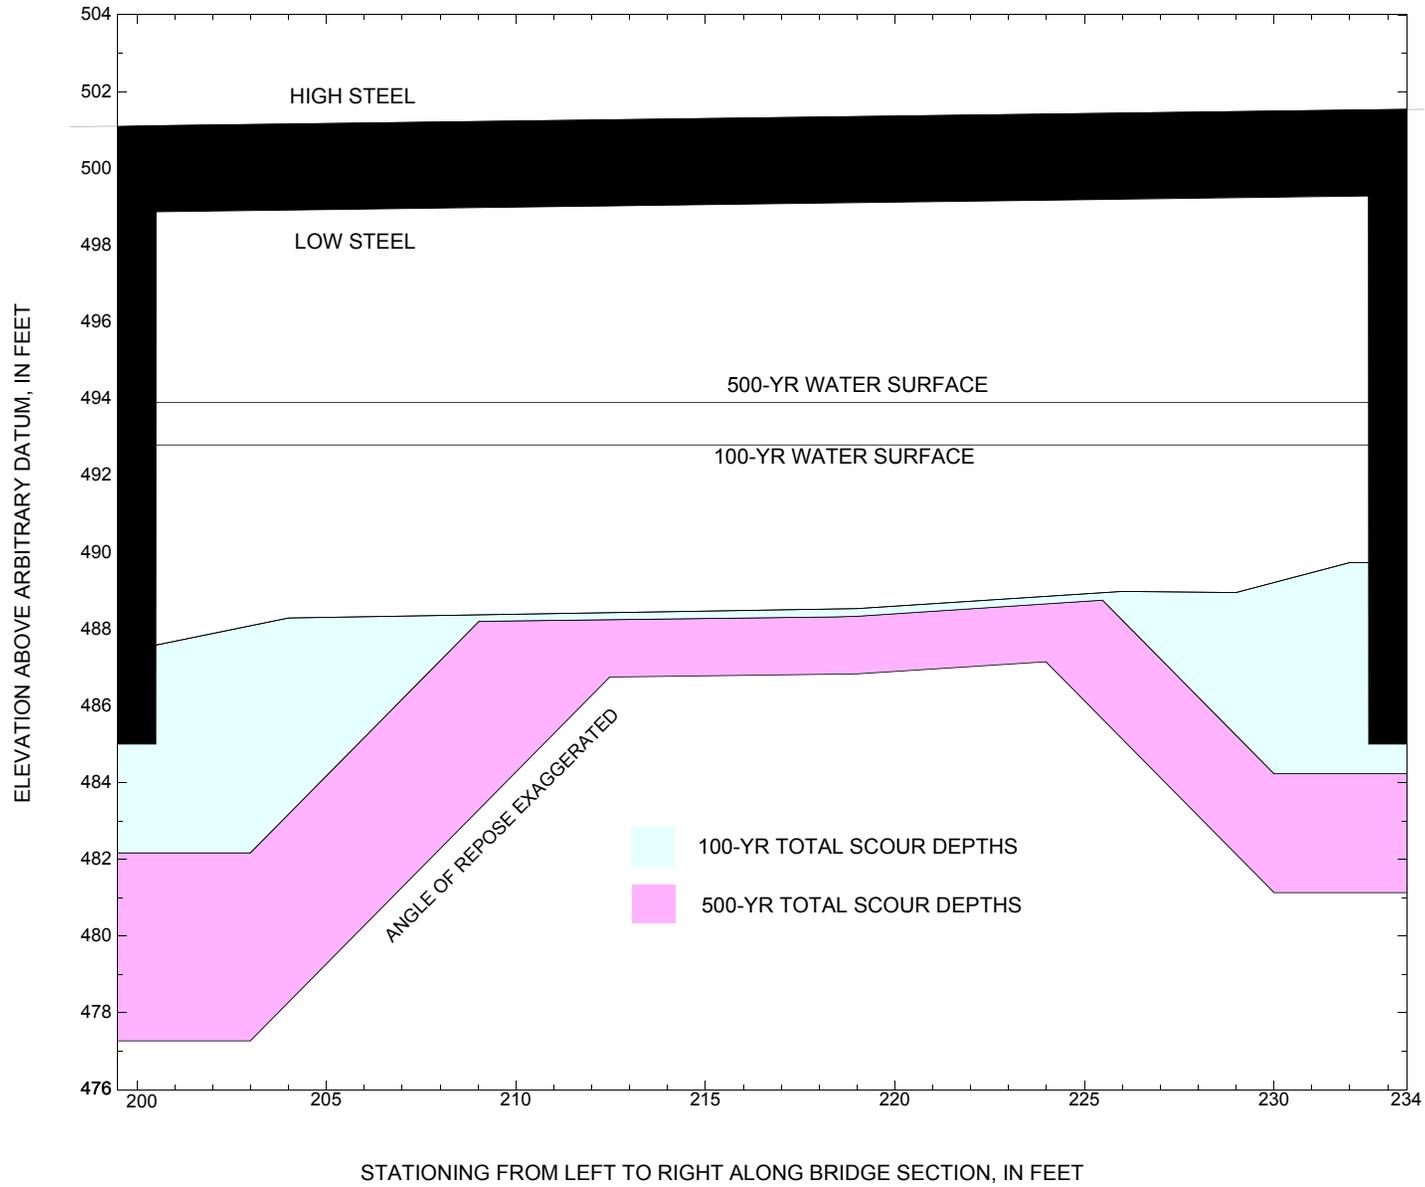
Figure 8. Scour elevations for the 100-yr and 500-yr discharges at structure [WODSTH00180022](#) on town highway 18, crossing [North Bridgewater Brook, Woodstock, Vermont](#).

Scour depths and rock rip-rap sizes were computed using the general guidelines described in Hydraulic Engineering Circular 18 (Richardson and others, 1993). Scour depths were calculated assuming an infinite depth of erosive material and a homogeneous particle-size distribution. The scour analysis results are presented in tables 1 and 2 and a graph of the scour depths is presented in figure 8.

Scour depths were computed using the general guidelines described in Hydraulic Engineering Circular 18 (Richardson and others, 1993). Scour depths were calculated assuming an infinite depth of erosive material and a homogeneous particle-size distribution. The results of the scour analysis are presented in tables 1 and 2 and a graph of the scour depths is presented in figure 8.

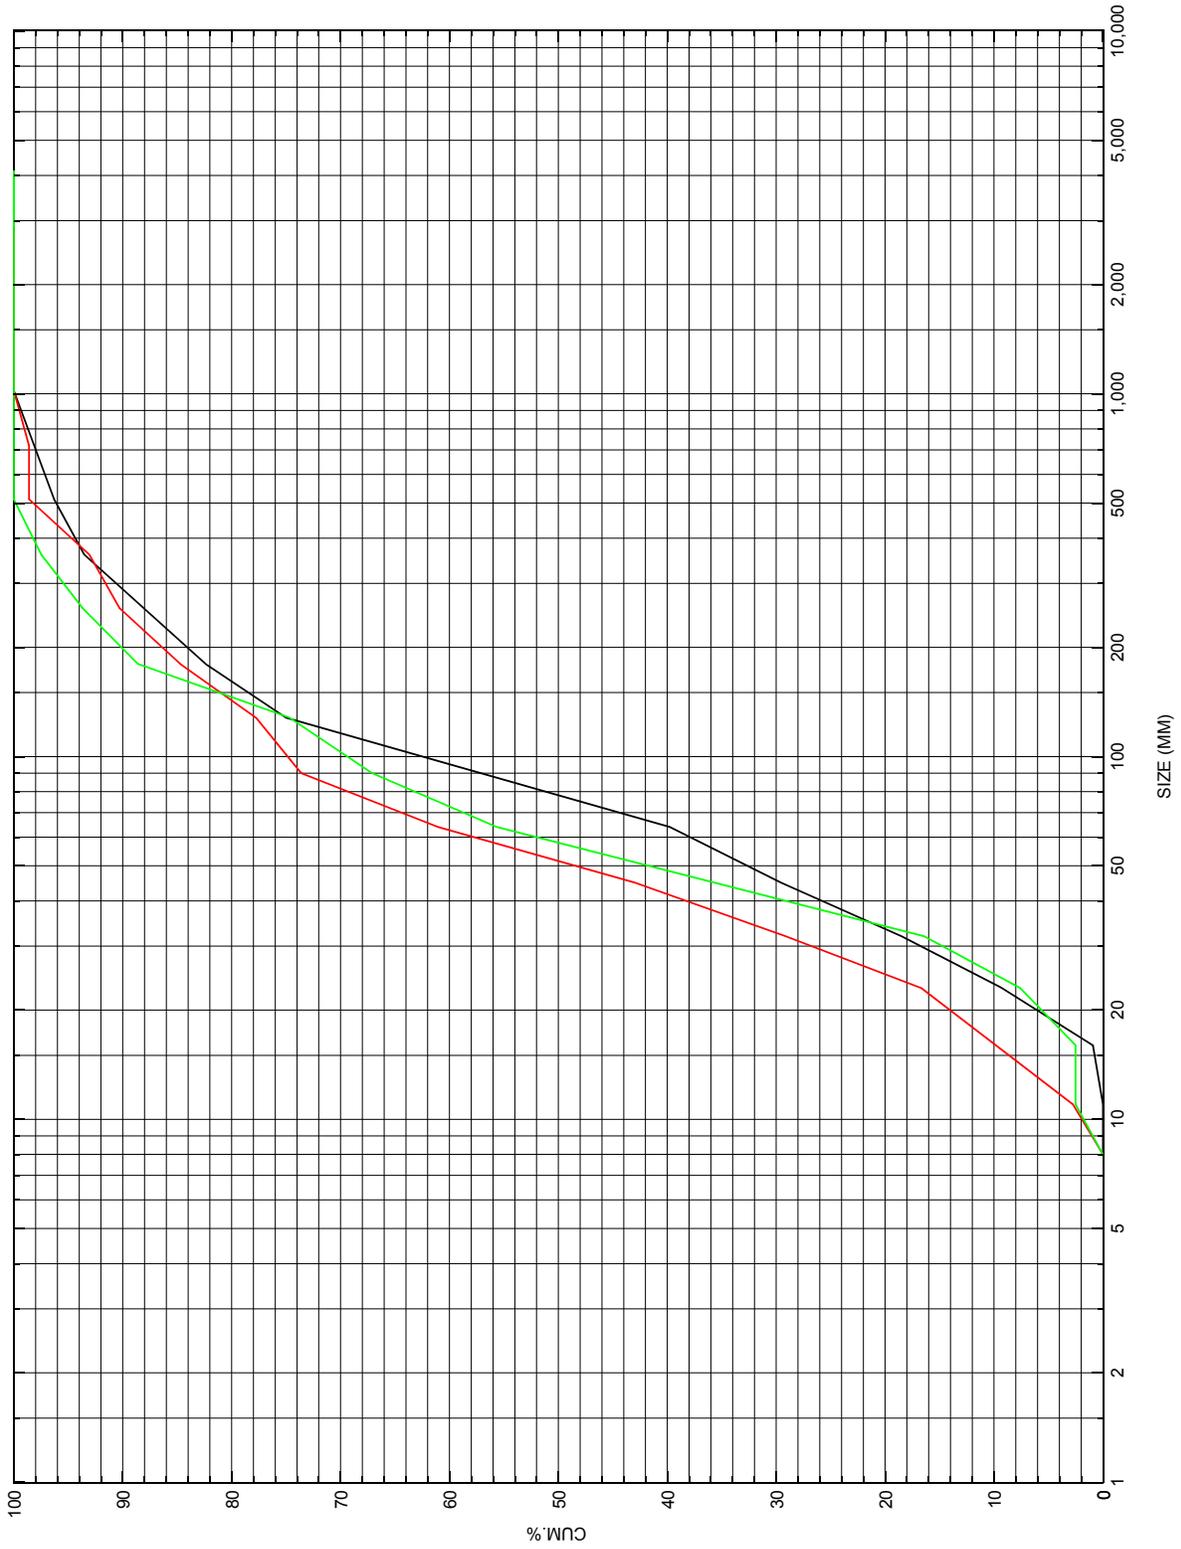
Appendix C. Bed material particle-size distribution at the approach cross-section for structure [WODSTH00180022](#), in [Woodstock](#), Vermont.
