LEVEL II SCOUR ANALYSIS FOR  
BRIDGE 42 (BETHTH00860042) on  
TOWN HIGHWAY 86, crossing  
GILEAD BROOK,  
BETHEL, VERMONT

U.S. Geological Survey  
Open-File Report 96-310

Prepared in cooperation with  
VERMONT AGENCY OF TRANSPORTATION  
and  
FEDERAL HIGHWAY ADMINISTRATION

By JOSEPH D. AYOTTE and DONALD L. SONG

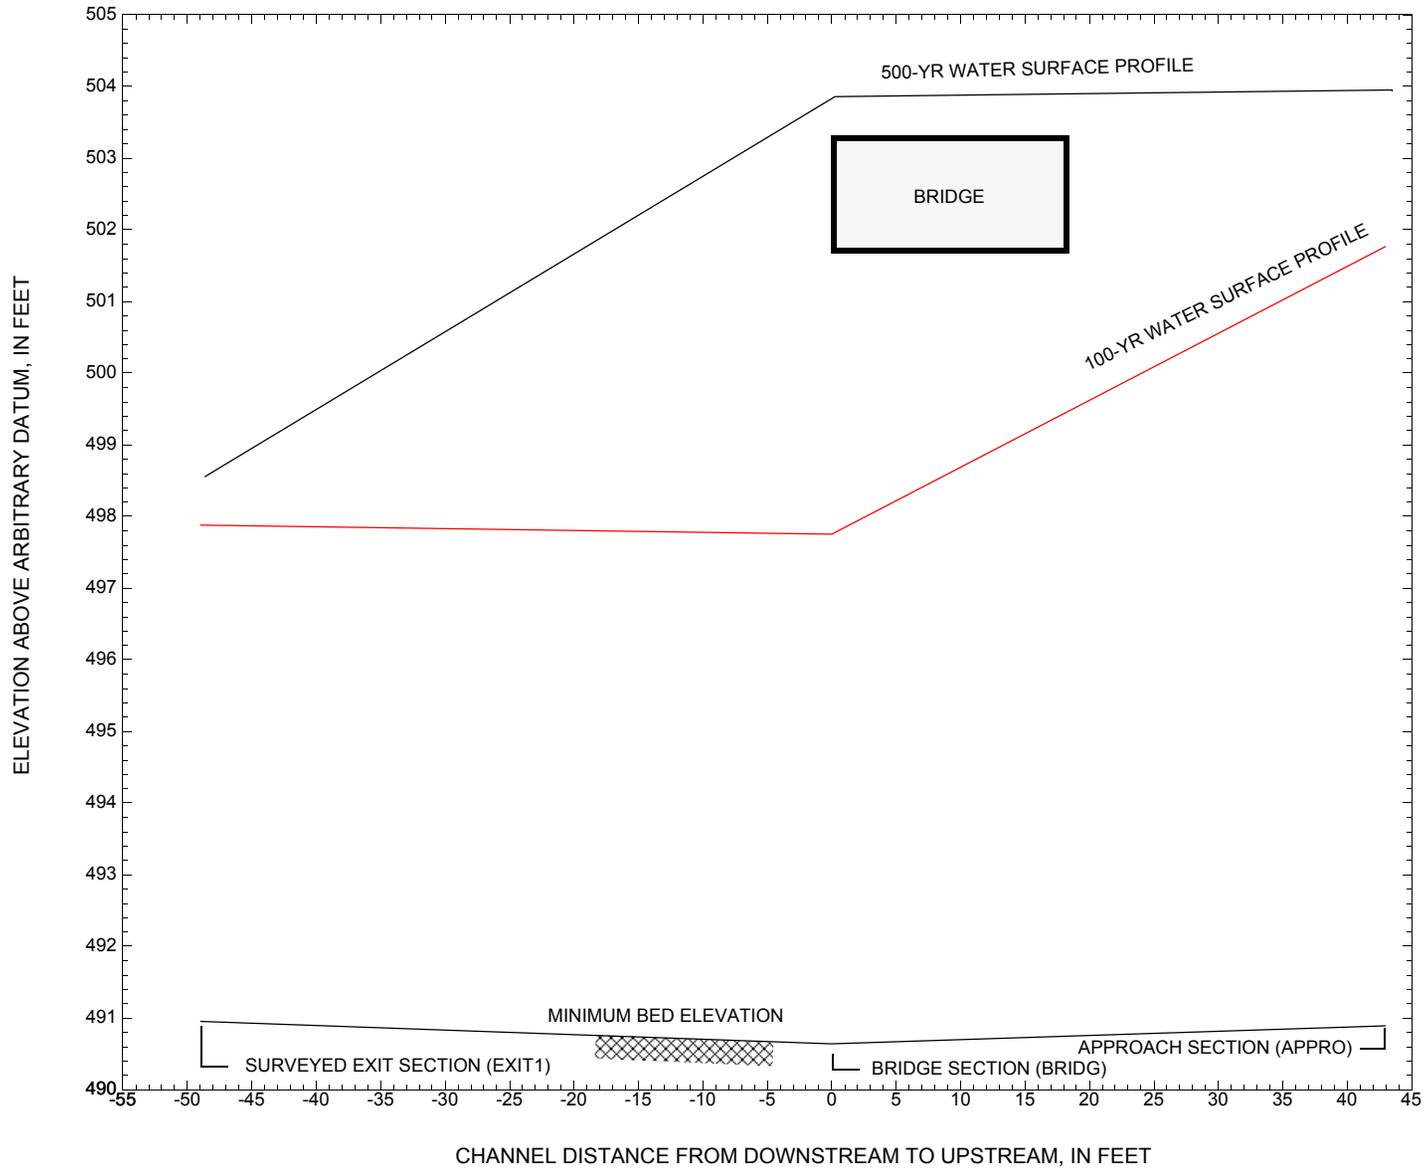
Figure 7. Water-surface profiles for the 100- and 500-yr discharges at structure [BRIDTH00340026](#) on town highway 34, crossing [Ottauquechee River, Bridgewater, Vermont](#).

Hydraulic analyses of the reach were done by use of the Federal Highway Administration's WSPRO step-backwater computer program (Shearman and others, 1986, and Shearman, 1990). Results of the hydraulic model are presented in the Bridge Hydraulic Summary, Appendix B, and figure 7.

100-year discharge 2,200 ft<sup>3</sup>/s  
 Water-surface elevation in bridge opening 497.8 ft  
 Road overtopping? N Discharge over road 0 ft/s  
 Area of flow in bridge opening 155 ft<sup>2</sup>  
 Average velocity in bridge opening 14.2 ft/s  
 Maximum WSPRO tube velocity at bridge 17.8 ft/s

500-year discharge 2,800 ft<sup>3</sup>/s  
 Water-surface elevation in bridge opening 501.8 ft  
 Road overtopping? Y Discharge over road 310 ft/s  
 Area of flow in bridge opening 249 ft<sup>2</sup>  
 Average velocity in bridge opening 9.8 ft/s  
 Maximum WSPRO tube velocity at bridge 11.9 ft/s

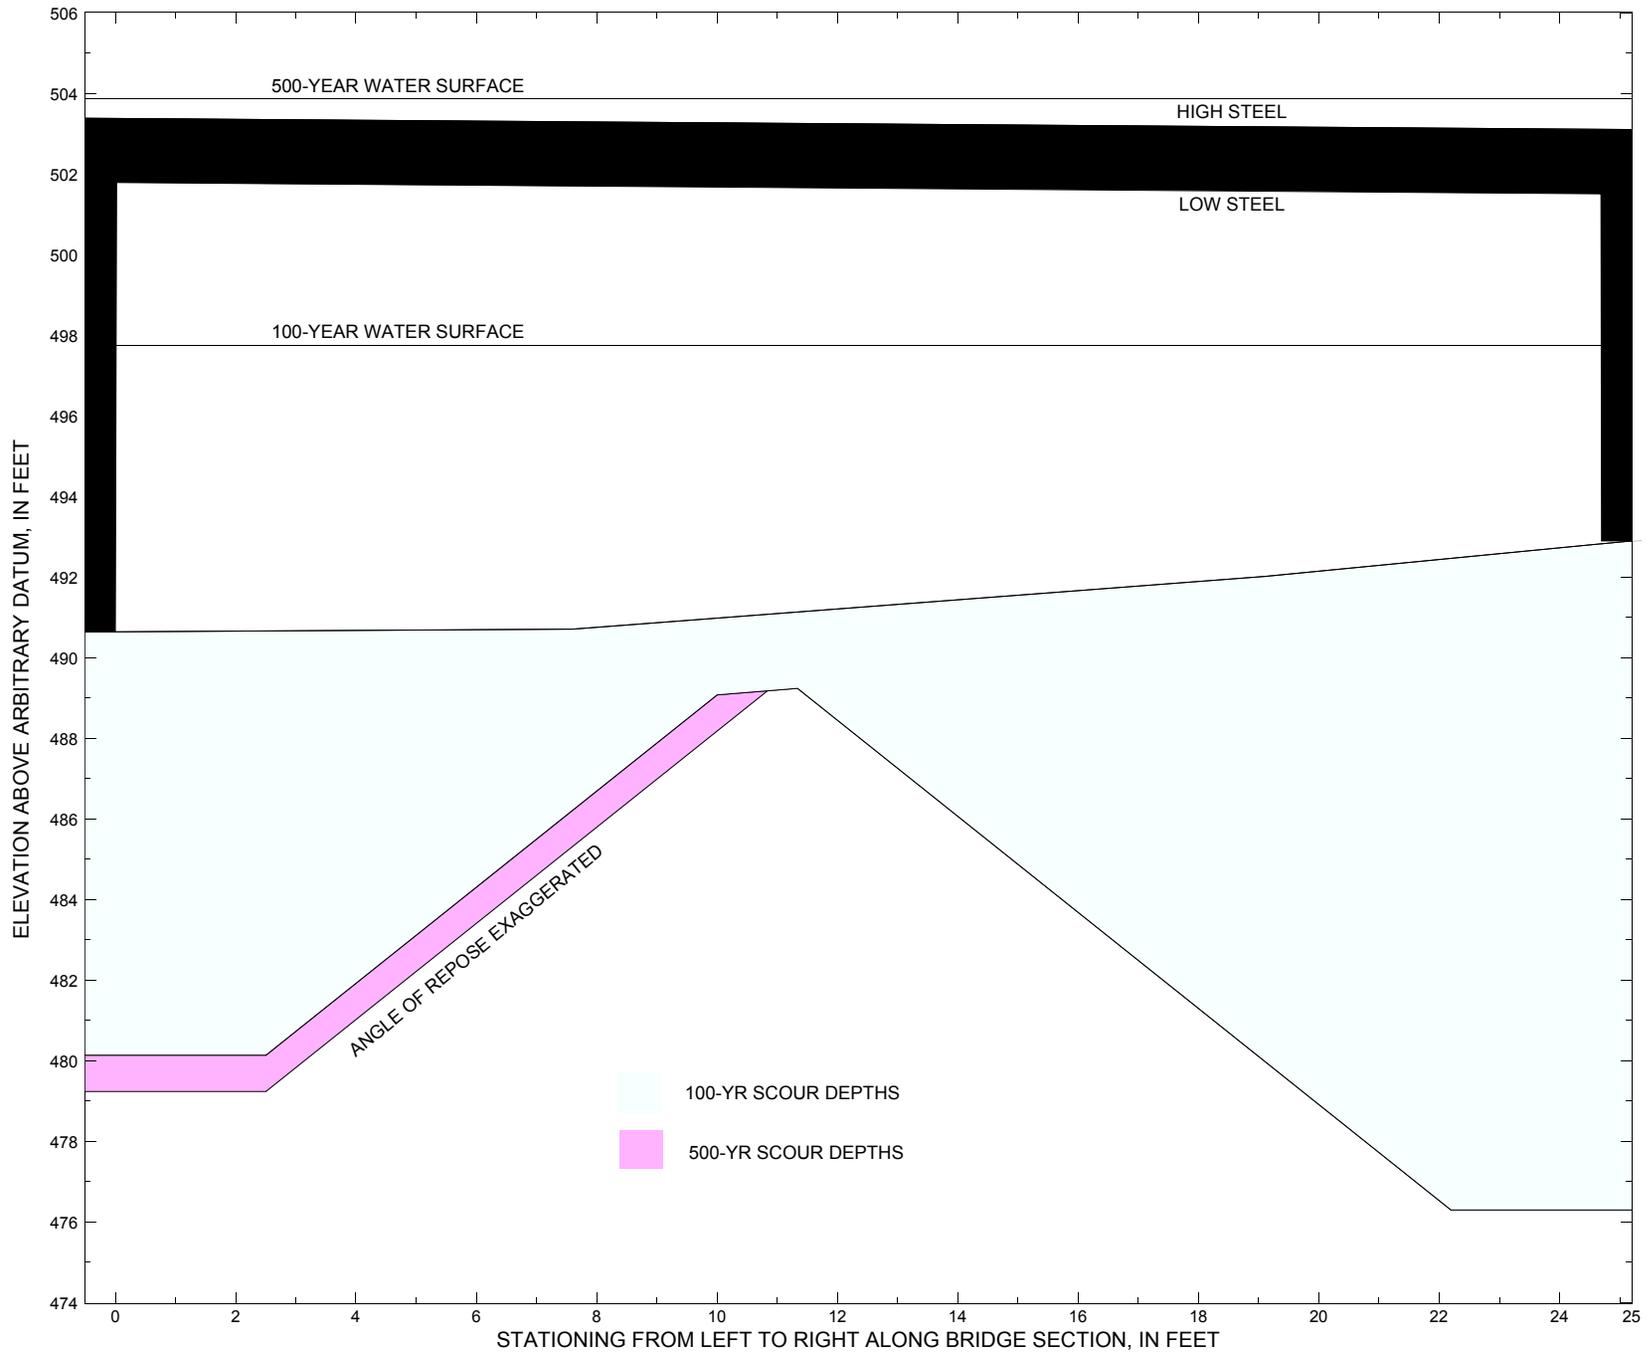
Figure 8. Scour elevations for the 100-yr and 500-yr discharges at structure BRIDTH00340026 on town highway 34, crossing Ottauquechee River, Bridgewater, Vermont.

Scour depths were computed using the general guidelines described in Hydraulic Engineering Circular 18 (Richardson and others, 1993). Scour depths were calculated assuming an infinite depth of erosive material and a homogeneous particle-size distribution. The results of the scour analysis are presented in tables 1 and 2 and a graph of the scour depths is presented in figure 8.

Contraction scour was computed by use of the clear-water contraction scour equation (Richardson and others, 1993, p. 35, equation 18) for the 100-year and incipient road-overflow discharges. Contraction scour for the 500-year discharge was computed by use of the Chang pressure-flow scour equation (Richardson and others, 1995, p. 145-146). For the 500-year modelled discharge, there was orifice flow at the bridge. Contraction scour at bridges with orifice flow is best estimated by use of the Chang pressure-flow scour equation (oral communication, J. Sterling Jones, October 4, 1996). The results of Laursen's clear-water contraction scour (Richardson and others, 1993, p. 35, equation 18) were also computed for the 500-year discharge and can be found in appendix F. For contraction scour computations, the average depth in the contracted section (AREA/TOPWIDTH) is subtracted from the depth of flow computed by the scour equation (Y2) to determine the actual amount of scour. In this case, the incipient road-overflow model resulted in the worst-case contraction scour with a scour depth of 2.8 ft.

Worst-case abutment scour occurred at the 500-year discharge for both abutments with scour at left abutment of 11.4 ft and scour at the right abutment of 15.7 ft.

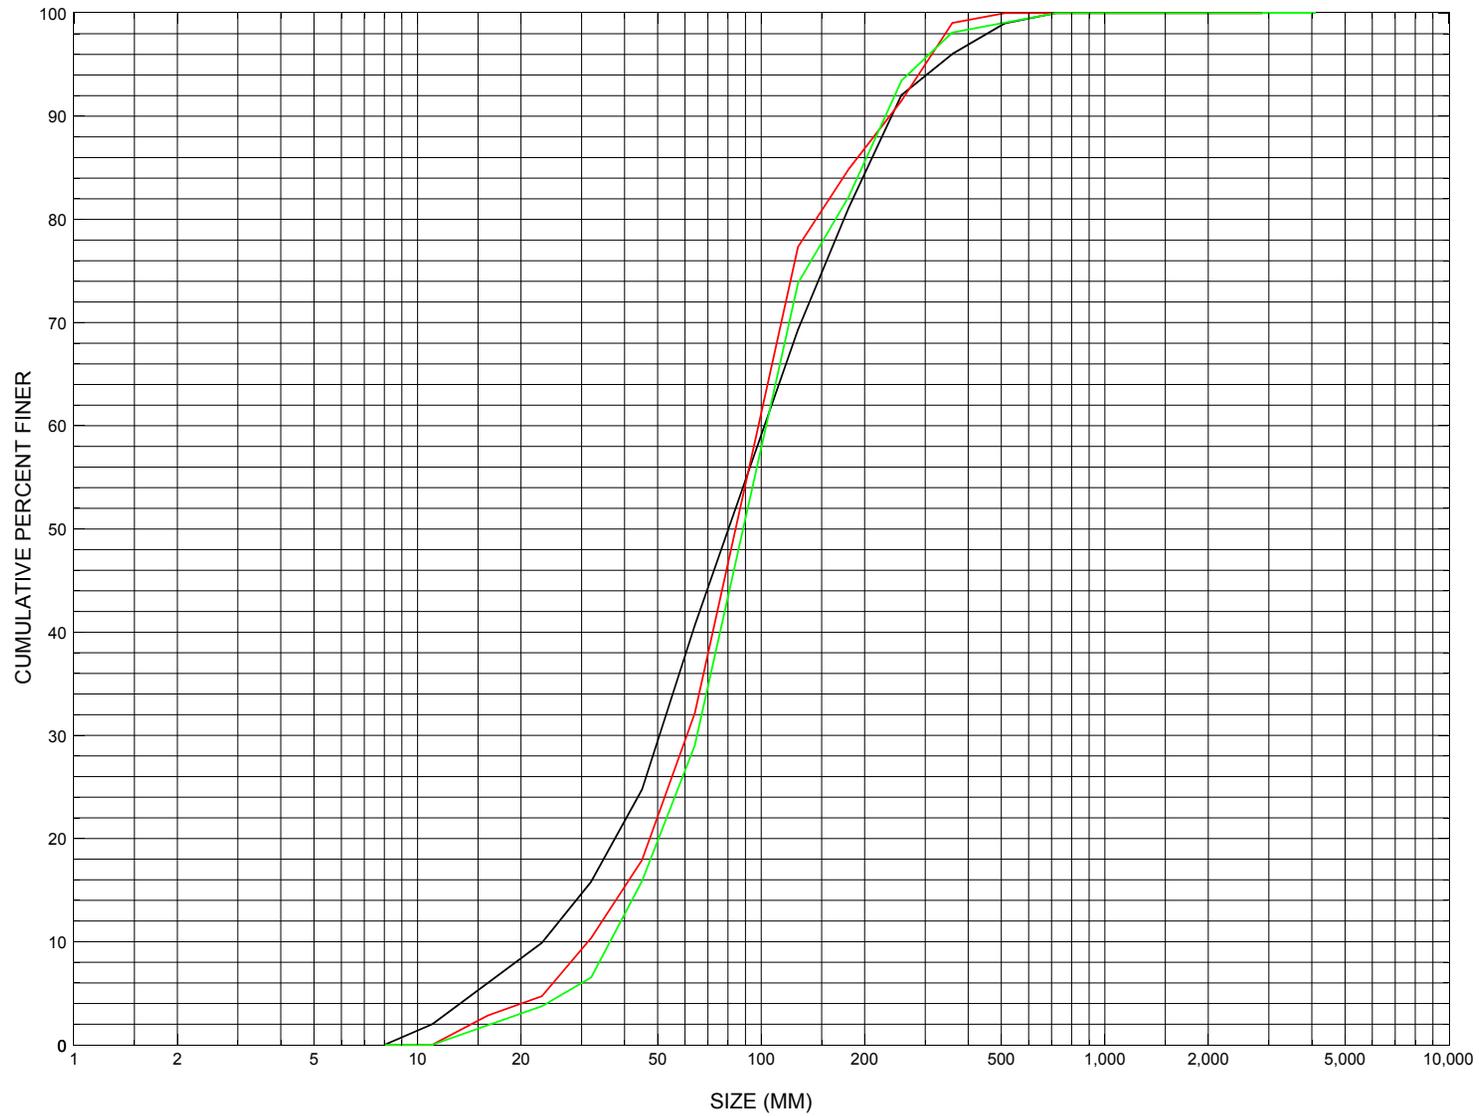
Appendix C. Bed material particle-size distributions for three pebble count transects at the approach cross-section for structure BRIDTH00340026, in Bridgewater, Vermont.
