# LEVEL II SCOUR ANALYSIS FOR BRIDGE 4 (CRAFTH00040004) on TOWN HIGHWAY 4, crossing WHITNEY BROOK, CRAFTSBURY, VERMONT

U.S. Geological Survey  
Open-File Report 96-402

By Erick M. Boehmler and Robert E. Hammond

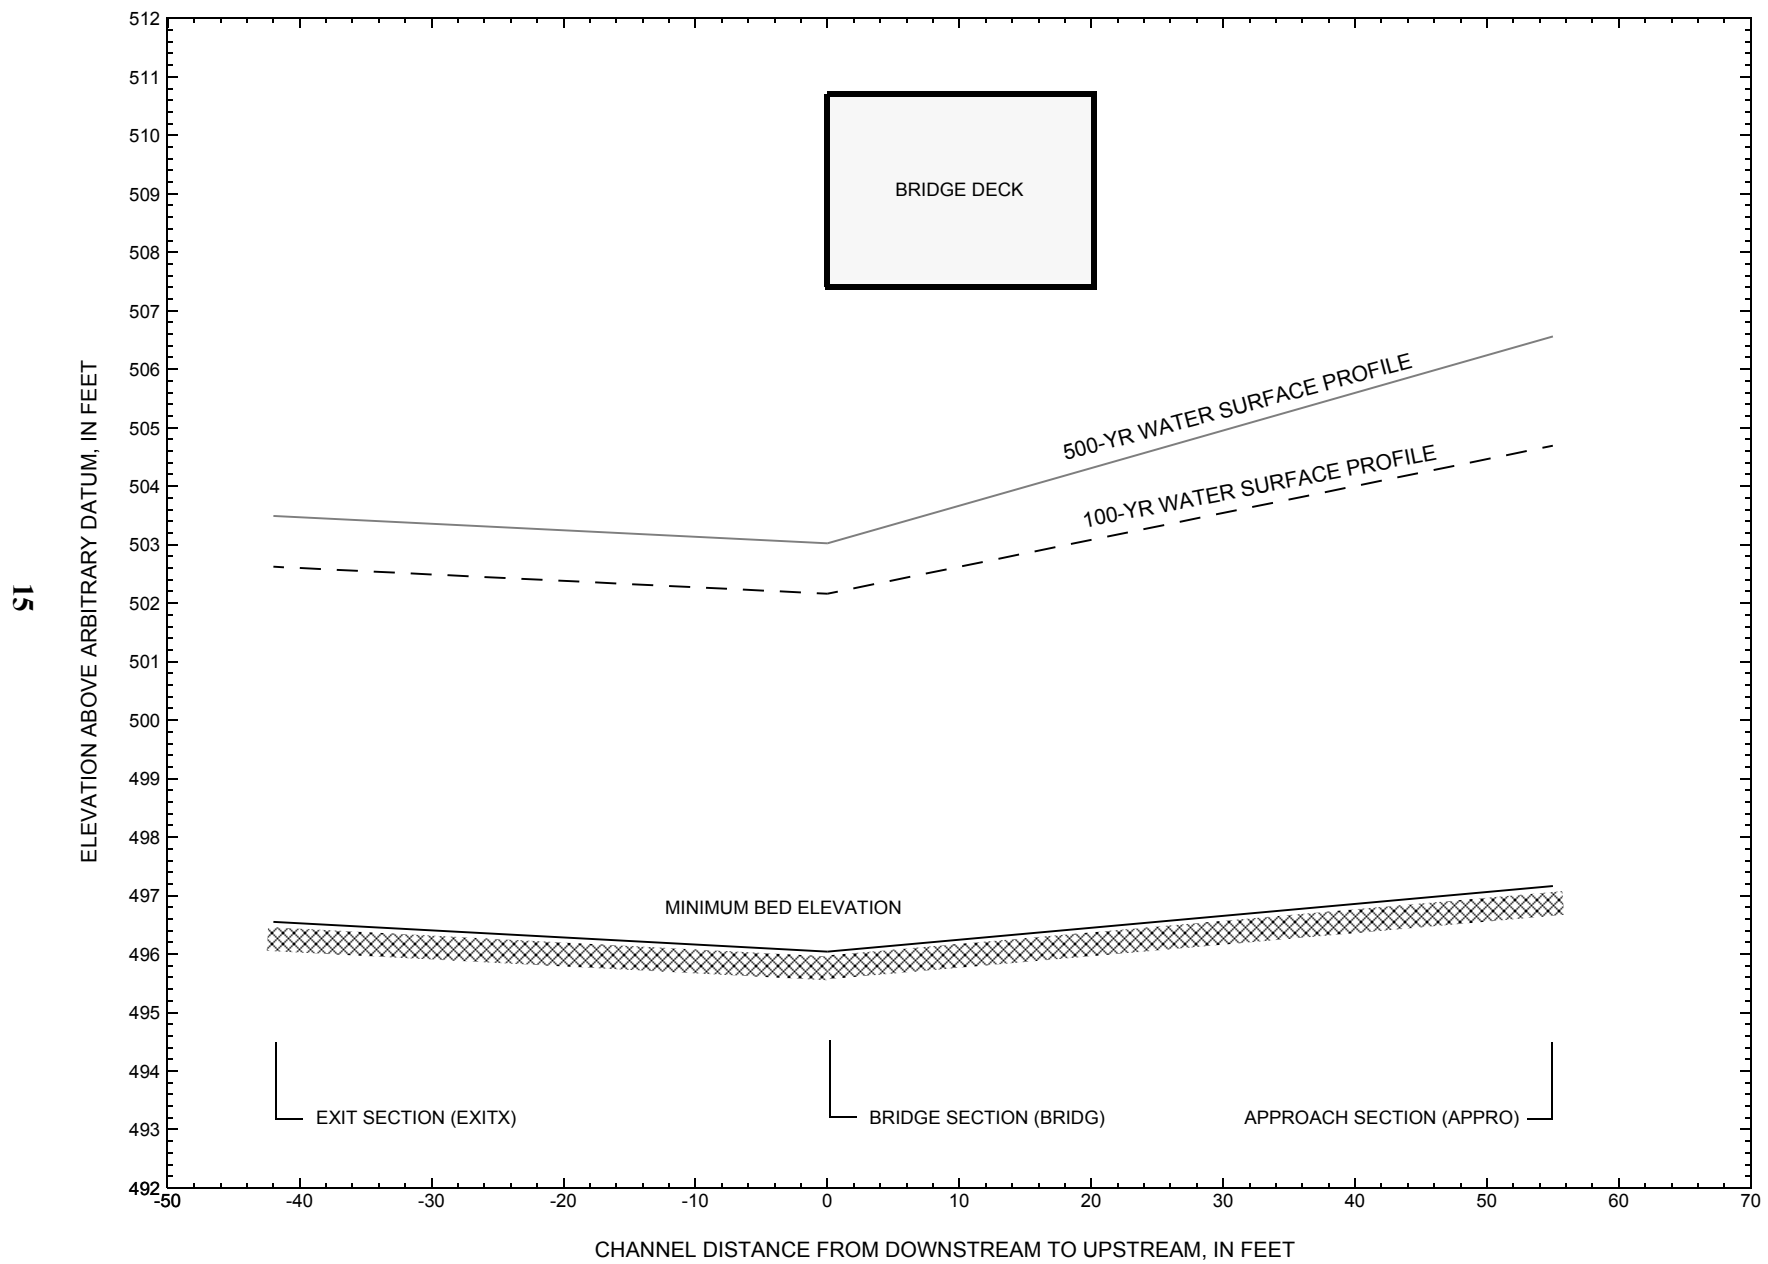
Figure 7. Water-surface profiles for the 100- and 500-yr discharges at structure [CRAFTH00040004](#) on town highway 4, crossing [Whitney Brook, Craftsbury, Vermont](#).

Hydraulic analyses of the reach were done by use of the Federal Highway Administration's WSPRO step-backwater computer program (Shearman and others, 1986, and Shearman, 1990). The analysis reported herein reflect conditions existing at the site at the time of the study. Furthermore, in the development of the model it was necessary to assume no accumulation of debris or ice at the site. Results of the hydraulic model are presented in the Bridge Hydraulic Summary, Appendix B, and figure 7.

100-year discharge 2,150 ft<sup>3</sup>/s  
 Water-surface elevation in bridge opening 502.2 ft  
 Road overtopping? N Discharge over road - ft<sup>3</sup>/s  
 Area of flow in bridge opening 180 ft<sup>2</sup>  
 Average velocity in bridge opening 12.0 ft/s  
 Maximum WSPRO tube velocity at bridge 14.0 ft/s

Water-surface elevation at Approach section with bridge 504.7  
 Water-surface elevation at Approach section without bridge 504.0  
 Amount of backwater caused by bridge 0.7 ft

500-year discharge 2,950 ft<sup>3</sup>/s  
 Water-surface elevation in bridge opening 503.0 ft  
 Road overtopping? N Discharge over road - ft<sup>3</sup>/s  
 Area of flow in bridge opening 208 ft<sup>2</sup>  
 Average velocity in bridge opening 14.2 ft/s  
 Maximum WSPRO tube velocity at bridge 16.6 ft/s

Water-surface elevation at Approach section with bridge 506.6  
 Water-surface elevation at Approach section without bridge 504.8  
 Amount of backwater caused by bridge 1.8 ft

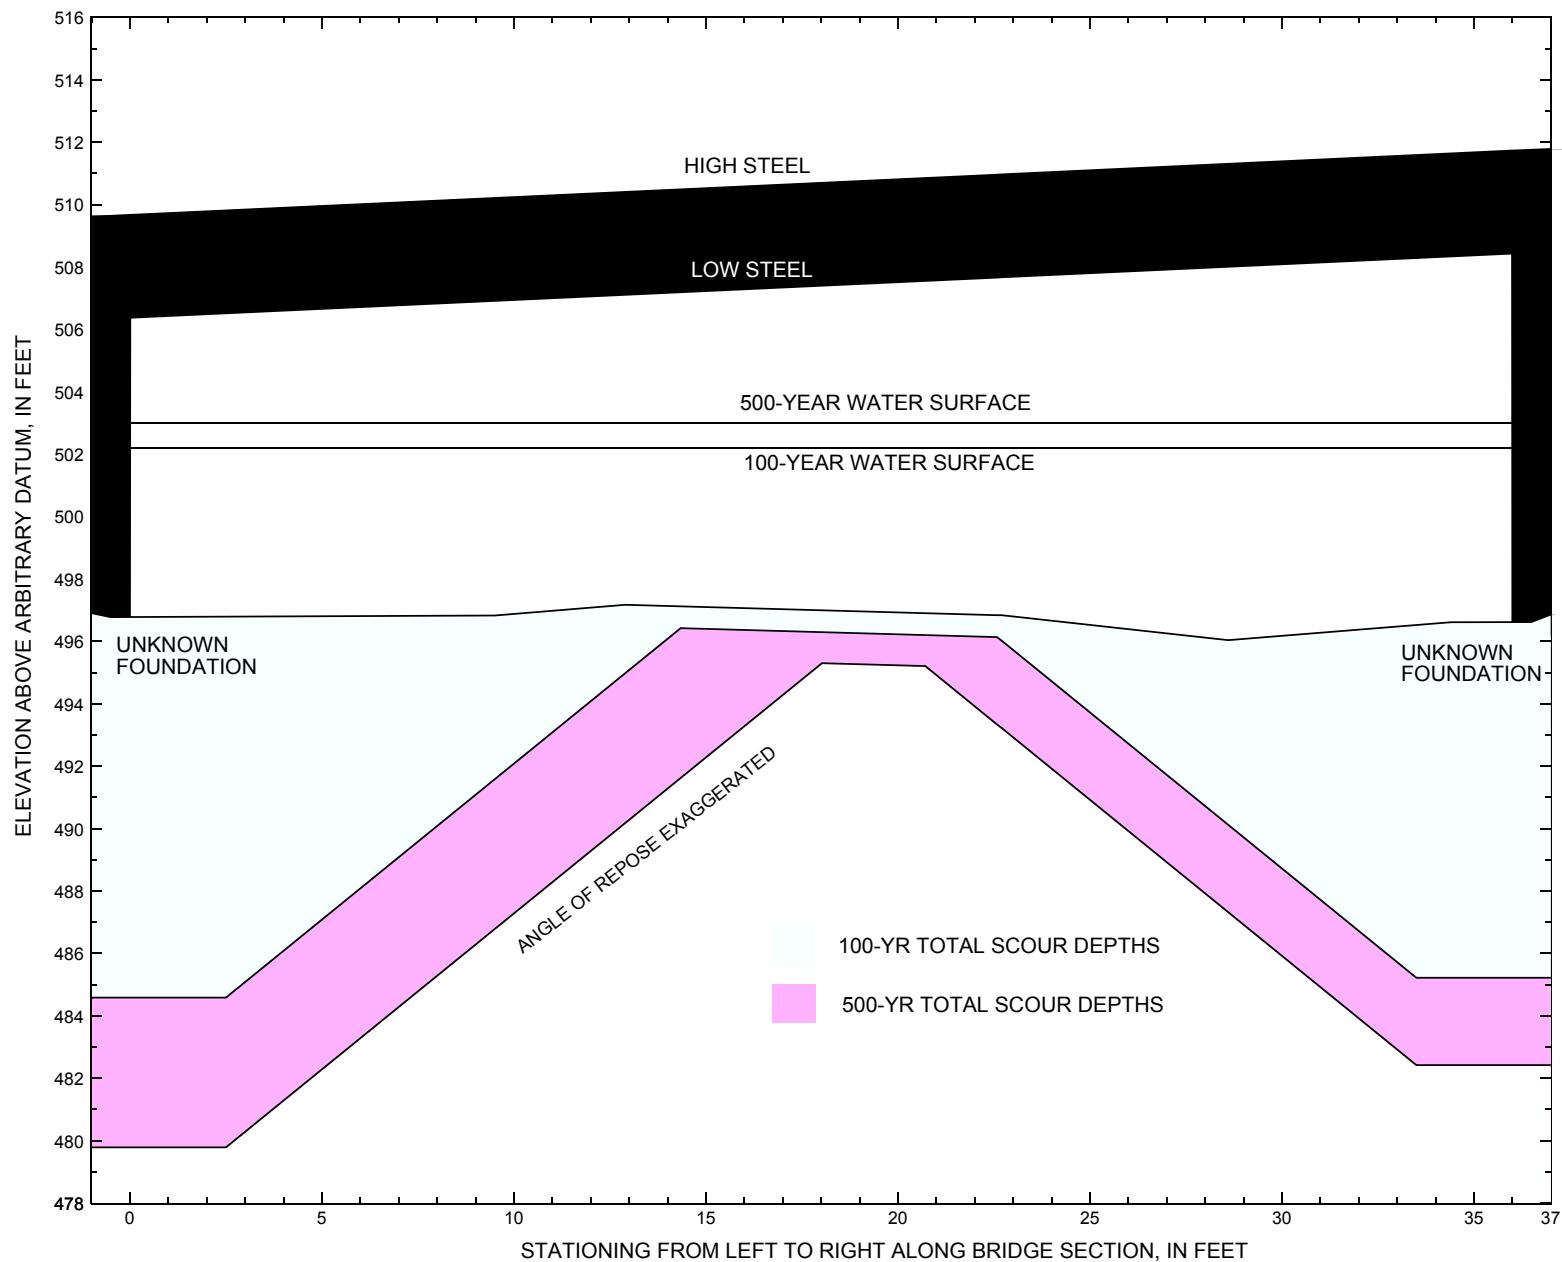
Figure 8. Scour elevations for the 100-yr and 500-yr discharges at structure [CRAFTH00040004](#) on town highway 4, crossing [Whitney Brook, Craftsbury, Vermont](#).

Scour depths were computed using the general guidelines described in Hydraulic Engineering Circular 18 (Richardson and others, 1995). Scour depths were calculated assuming an infinite depth of erosive material and a homogeneous particle-size distribution. The results of the scour analysis are presented in tables 1 and 2 and a graph of the scour depths is presented in figure 8.

<i>Live-bed scour</i>	--	--	--
<i>Clear-water scour</i>	0.7	1.7	--
<i>Depth to armoring</i>	16.5	49.2	--
<i>Left overbank</i>	--	--	--
<i>Right overbank</i>	--	--	--

<i>Abutment scour</i>	11.5	15.3	--
<i>Left abutment</i>	10.7	12.5	--
<i>Right abutment</i>			
<i>Pier scour</i>	--	--	--
<i>Pier 1</i>	--	--	--
<i>Pier 2</i>	--	--	--
<i>Pier 3</i>

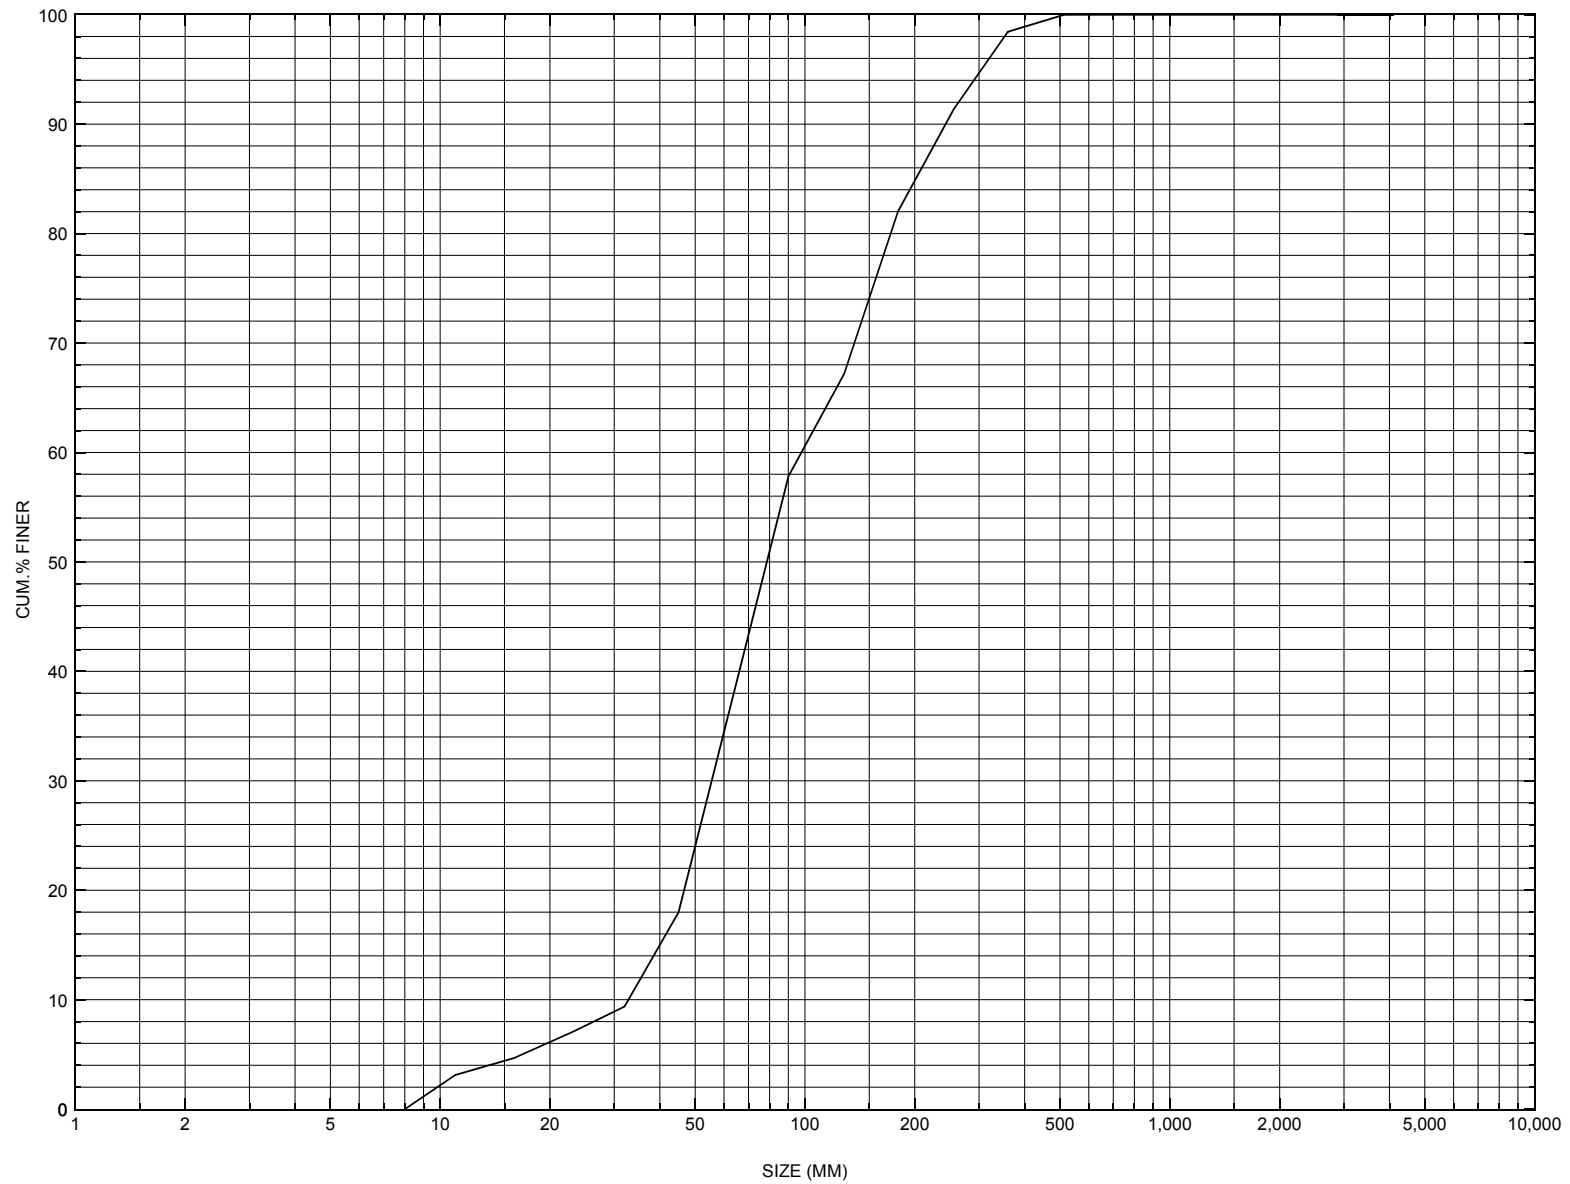
Appendix C. Bed material particle-size distribution [for one pebble count transect](#) at the approach cross-section for structure [CRAFTH00040004](#), in [Craftsbury](#), Vermont.
