LEVEL II SCOUR ANALYSIS FOR
BRIDGE 37 (BARTTH00080037) on
TOWN HIGHWAY 8, crossing the
WILLOUGHBY RIVER,
BARTON, VERMONT

U.S. Geological Survey
Open-File Report 96-405

Prepared in cooperation with
VERMONT AGENCY OF TRANSPORTATION
and
FEDERAL HIGHWAY ADMINISTRATION

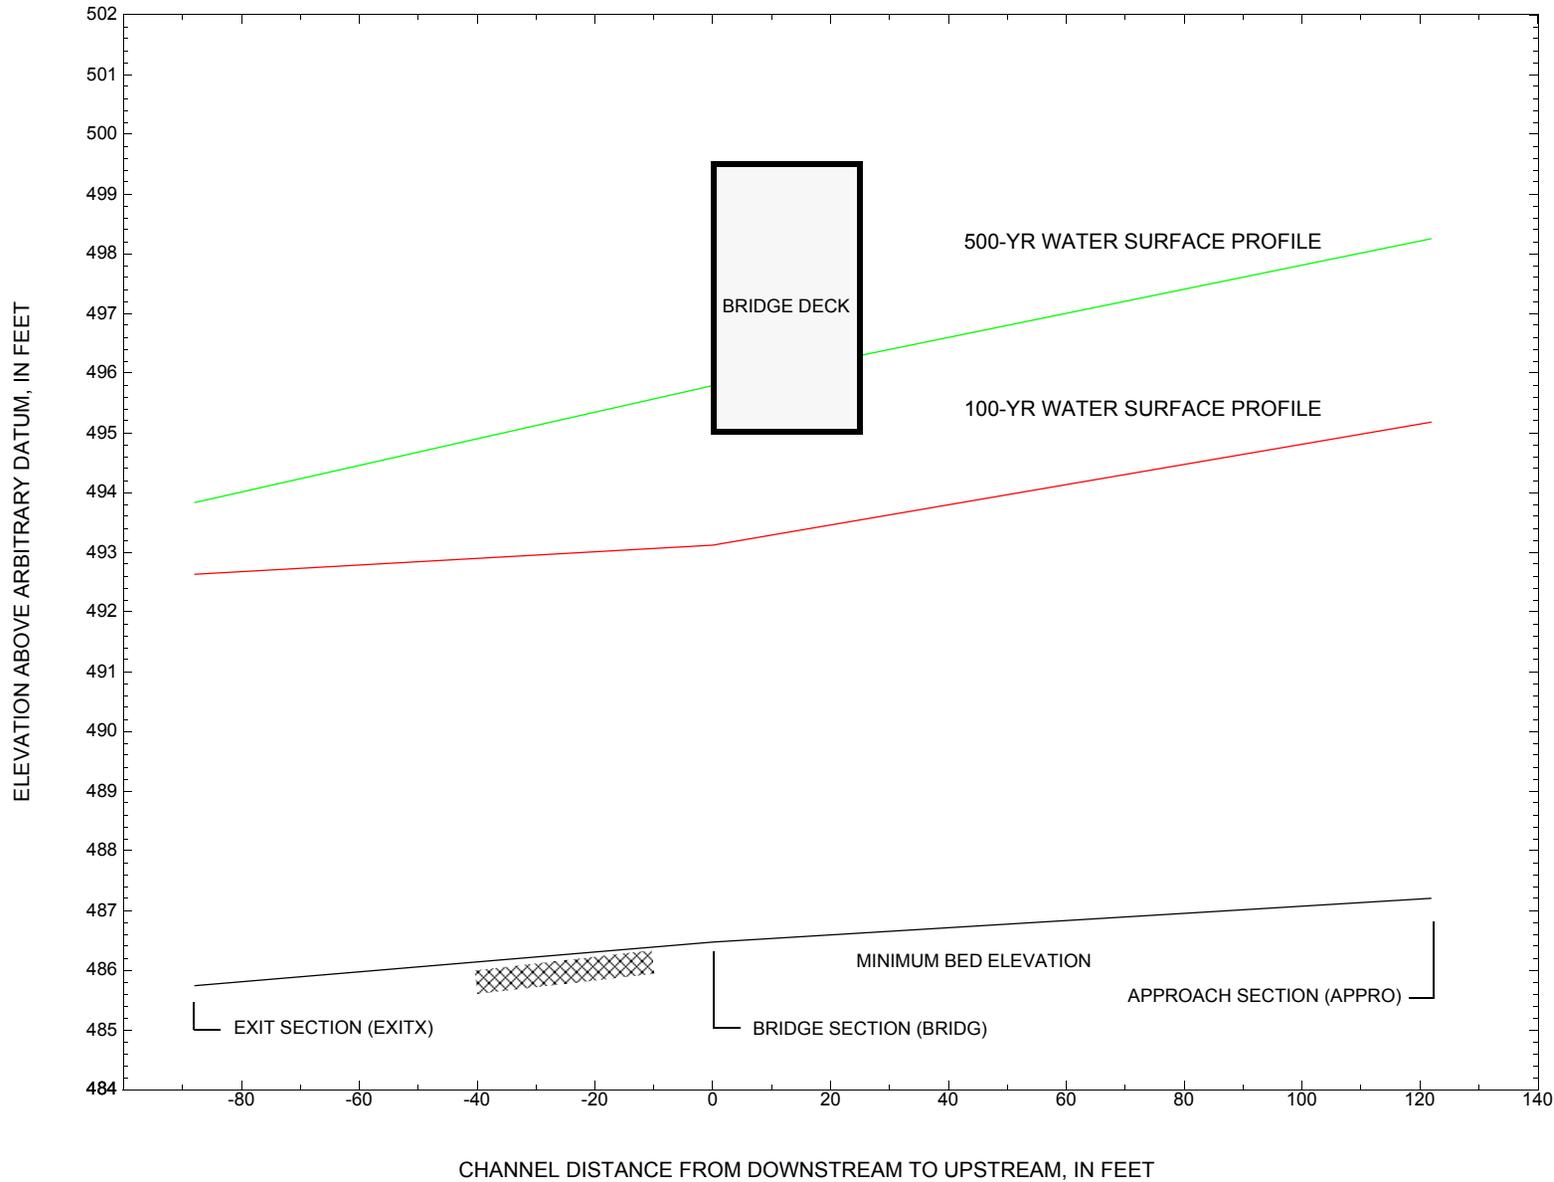
Figure 7. Water-surface profiles for the 100- and 500-yr discharges at structure [BARTTH00080037](#) on town highway 8, crossing [Willoughby River, Barton, Vermont](#).

Hydraulic analyses of the reach were done by use of the Federal Highway Administration's WSPRO step-backwater computer program (Shearman and others, 1986, and Shearman, 1990). The analysis reported herein reflects conditions existing at the site at the time of the study. Furthermore, in the development of the model it was necessary to assume no accumulation of debris or ice at the site. Results of the hydraulic model are presented in the Bridge Hydraulic Summary, Appendix B, and figure 7.

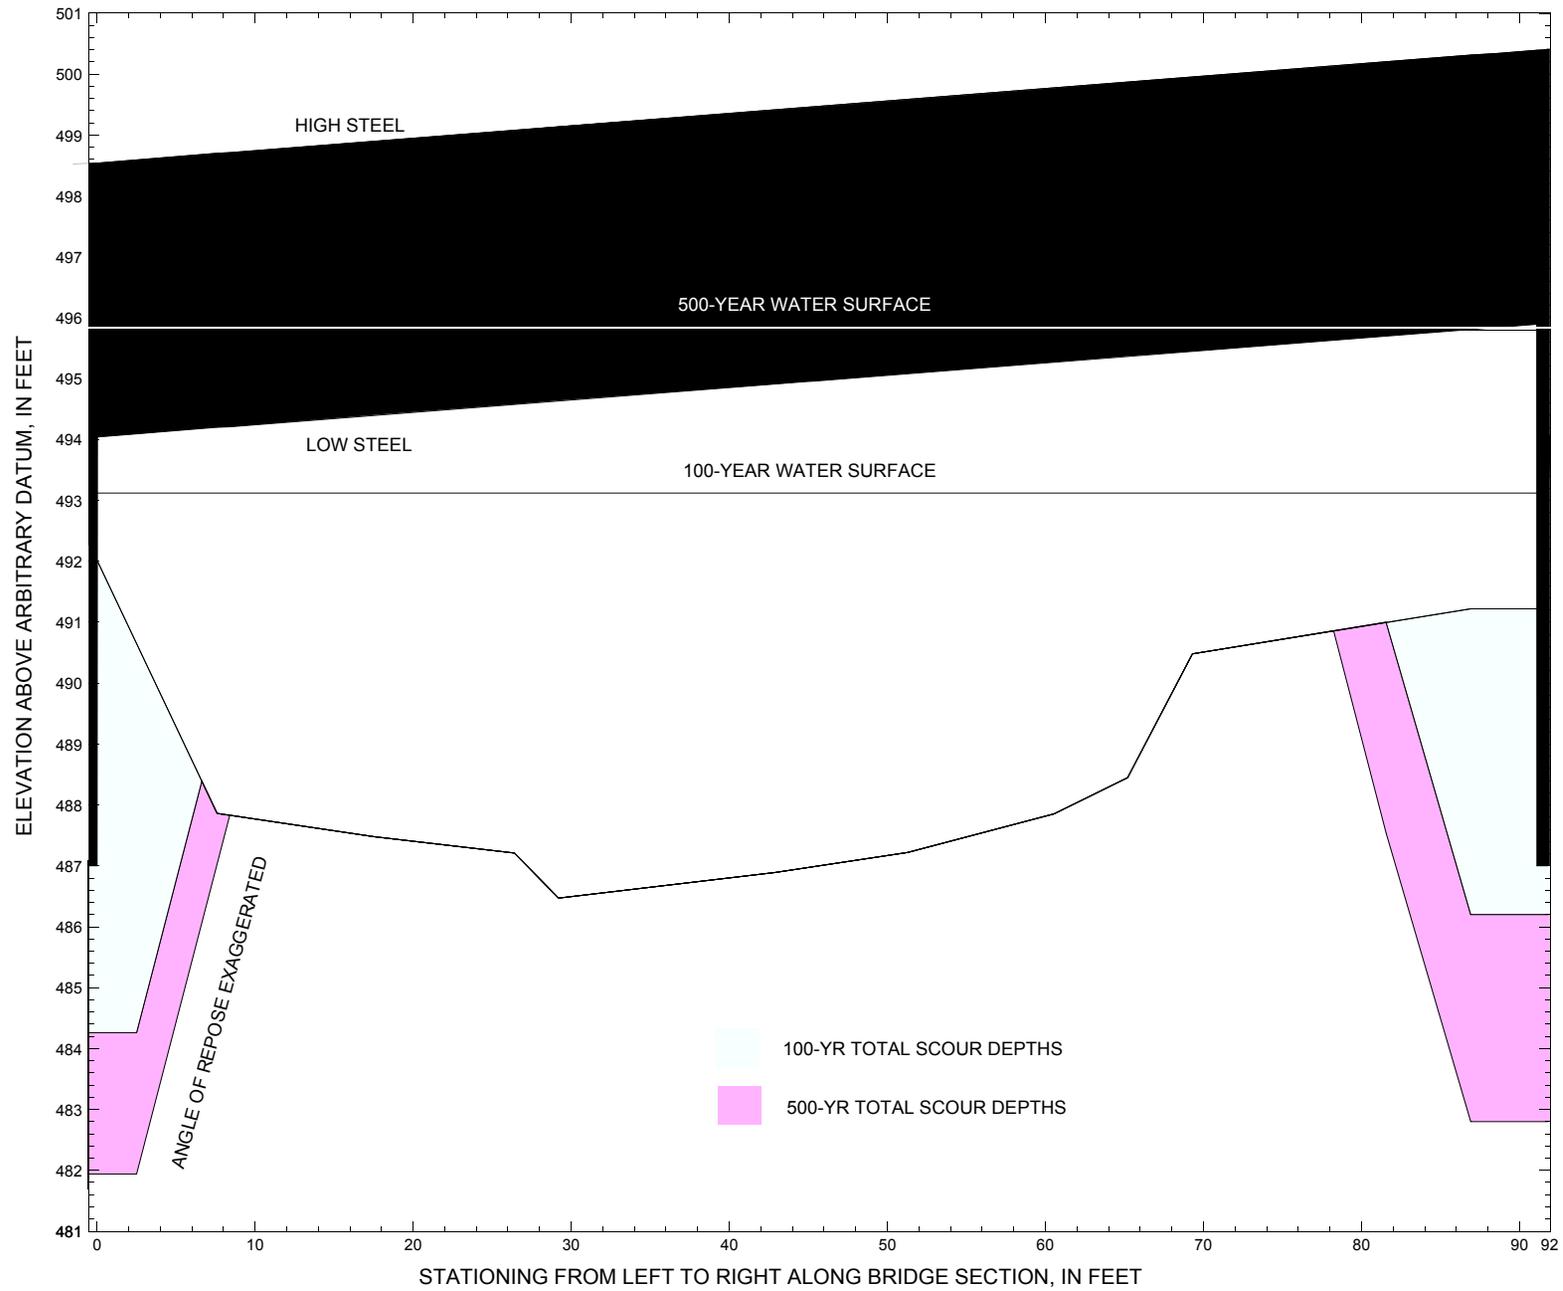
Figure 8. Scour elevations for the 100-yr and 500-yr discharges at structure [BARTTH00080037](#) on town highway 8, crossing [Willoughby River, Barton, Vermont](#).

Scour depths and rock rip-rap sizes were computed using the general guidelines described in Hydraulic Engineering Circular 18 (Richardson and others, 1993). Scour depths were calculated assuming an infinite depth of erosive material and a homogeneous particle-size distribution. [Data in appendix D \(Vermont Agency of Transportation, written communication, August 4, 1994\)](#) indicate that the right abutment may be founded on or near marble bedrock which may limit scour depths. Bedrock was not detected by borings in the vicinity of the left abutment. The scour analysis results are presented in tables 1 and 2 and a graph of the scour depths is presented in figure 8.

Scour depths were computed using the general guidelines described in Hydraulic Engineering Circular 18 (Richardson and others, 1993). Scour depths were calculated assuming an infinite depth of erosive material and a homogeneous particle-size distribution. The results of the scour analysis are presented in tables 1 and 2 and a graph of the scour depths is presented in figure 8.

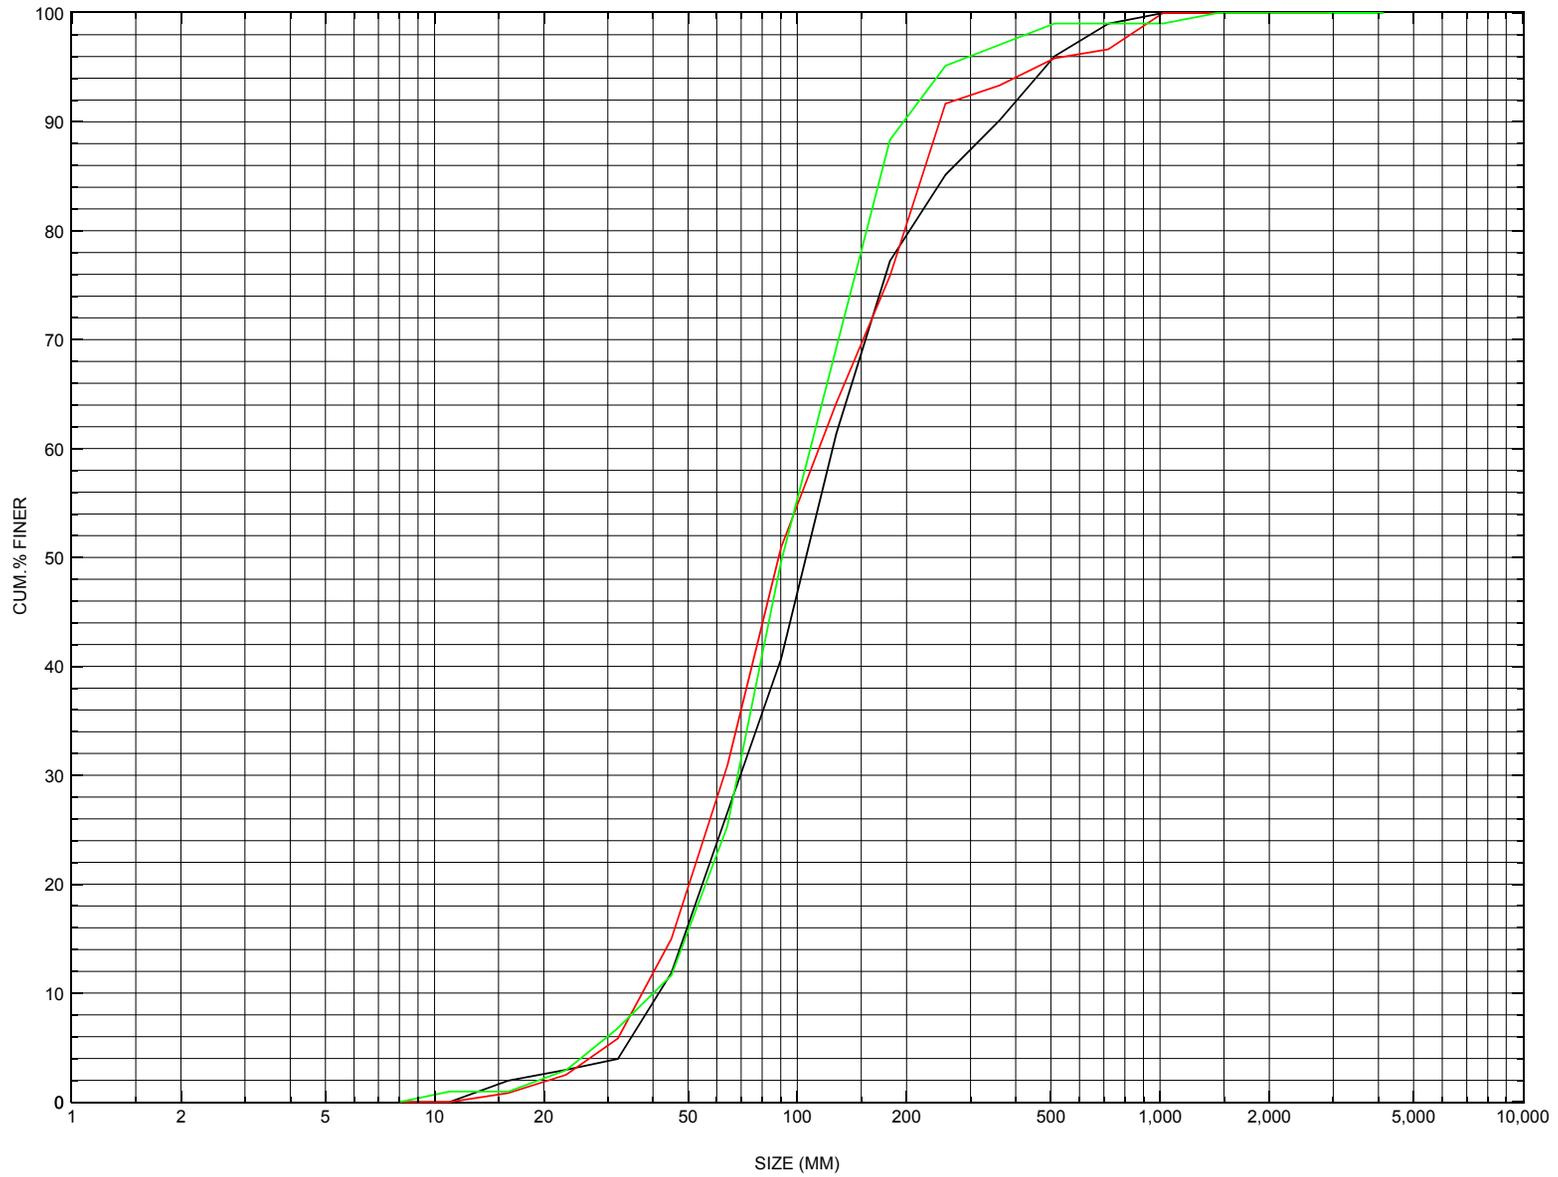
Appendix C. Bed material particle-size distributions for three pebble count transects at the approach cross-section for structure BARTTH00080037, in Barton, Vermont.

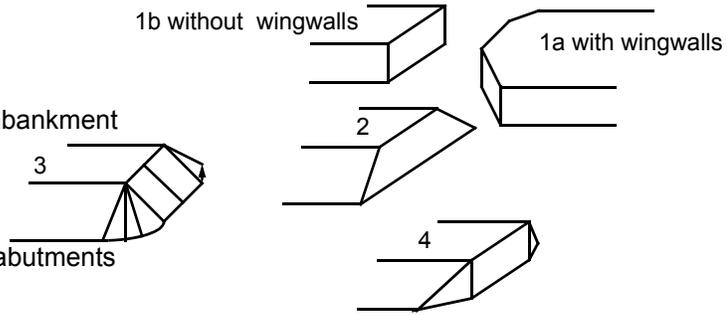
18. Level II Bridge Type: 1A/4

- 1a- Vertical abutments with wingwalls
- 1b- Vertical abutments without wingwalls
- 2- Vertical abutments and wingwalls, sloping embankment
Wingwalls perpendicular to abut. face
- 3- Spill through abutments
- 4- Sloping embankment, vertical wingwalls and abutments
Wingwall angle less than 90°.
