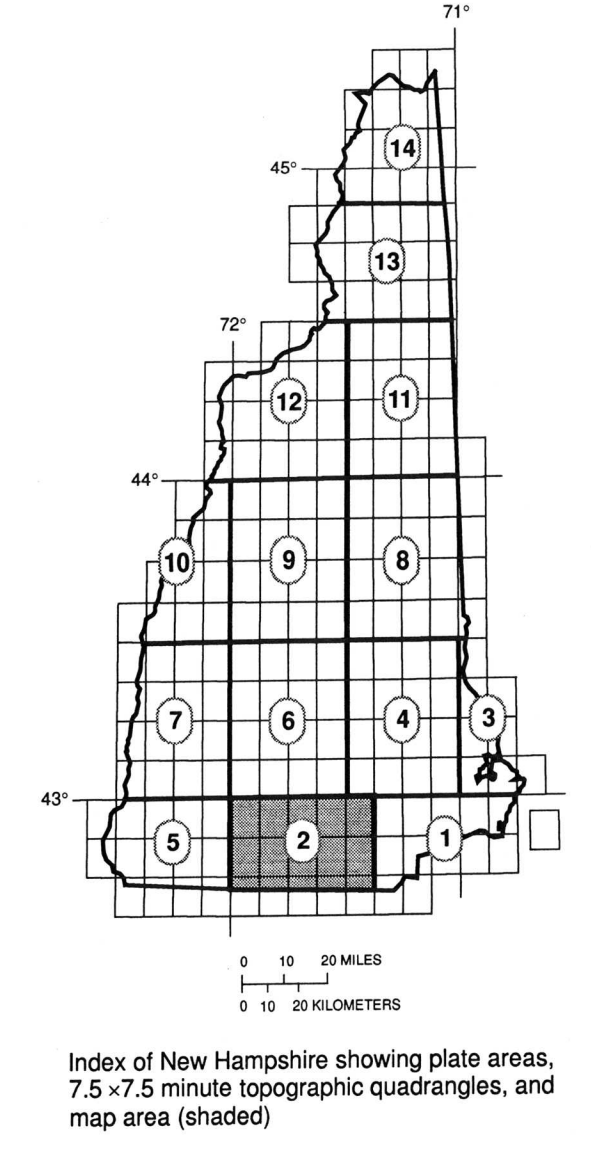
Lineaments shown here represent straight photolinear features that are likely to be the result of underlying zones of vertical or high-angle bedrock fractures and are not obviously caused by other geologic or cultural features. U.S. Geological Survey Open-File Report 96-479 (Clark and others, 1996) describes the criteria and methods used to identify the lineaments shown in this map.

— Lineament observed by the use of low-altitude aerial photography having an approximate scale of 1:20,000

..... Lineament observed by the use of high-altitude aerial photography having an approximate scale of 1:80,000

~~~~~ Lineament observed by the use of 1:250,000-scale side-looking airborne radar imagery

----- Lineament observed by the use of 1:1,000,000-scale Landsat imagery
