Geomorphology of the Lower Copper River, Alaska

U.S. GEOLOGICAL SURVEY

Open-File Report 96-500

By Timothy P. Brabets

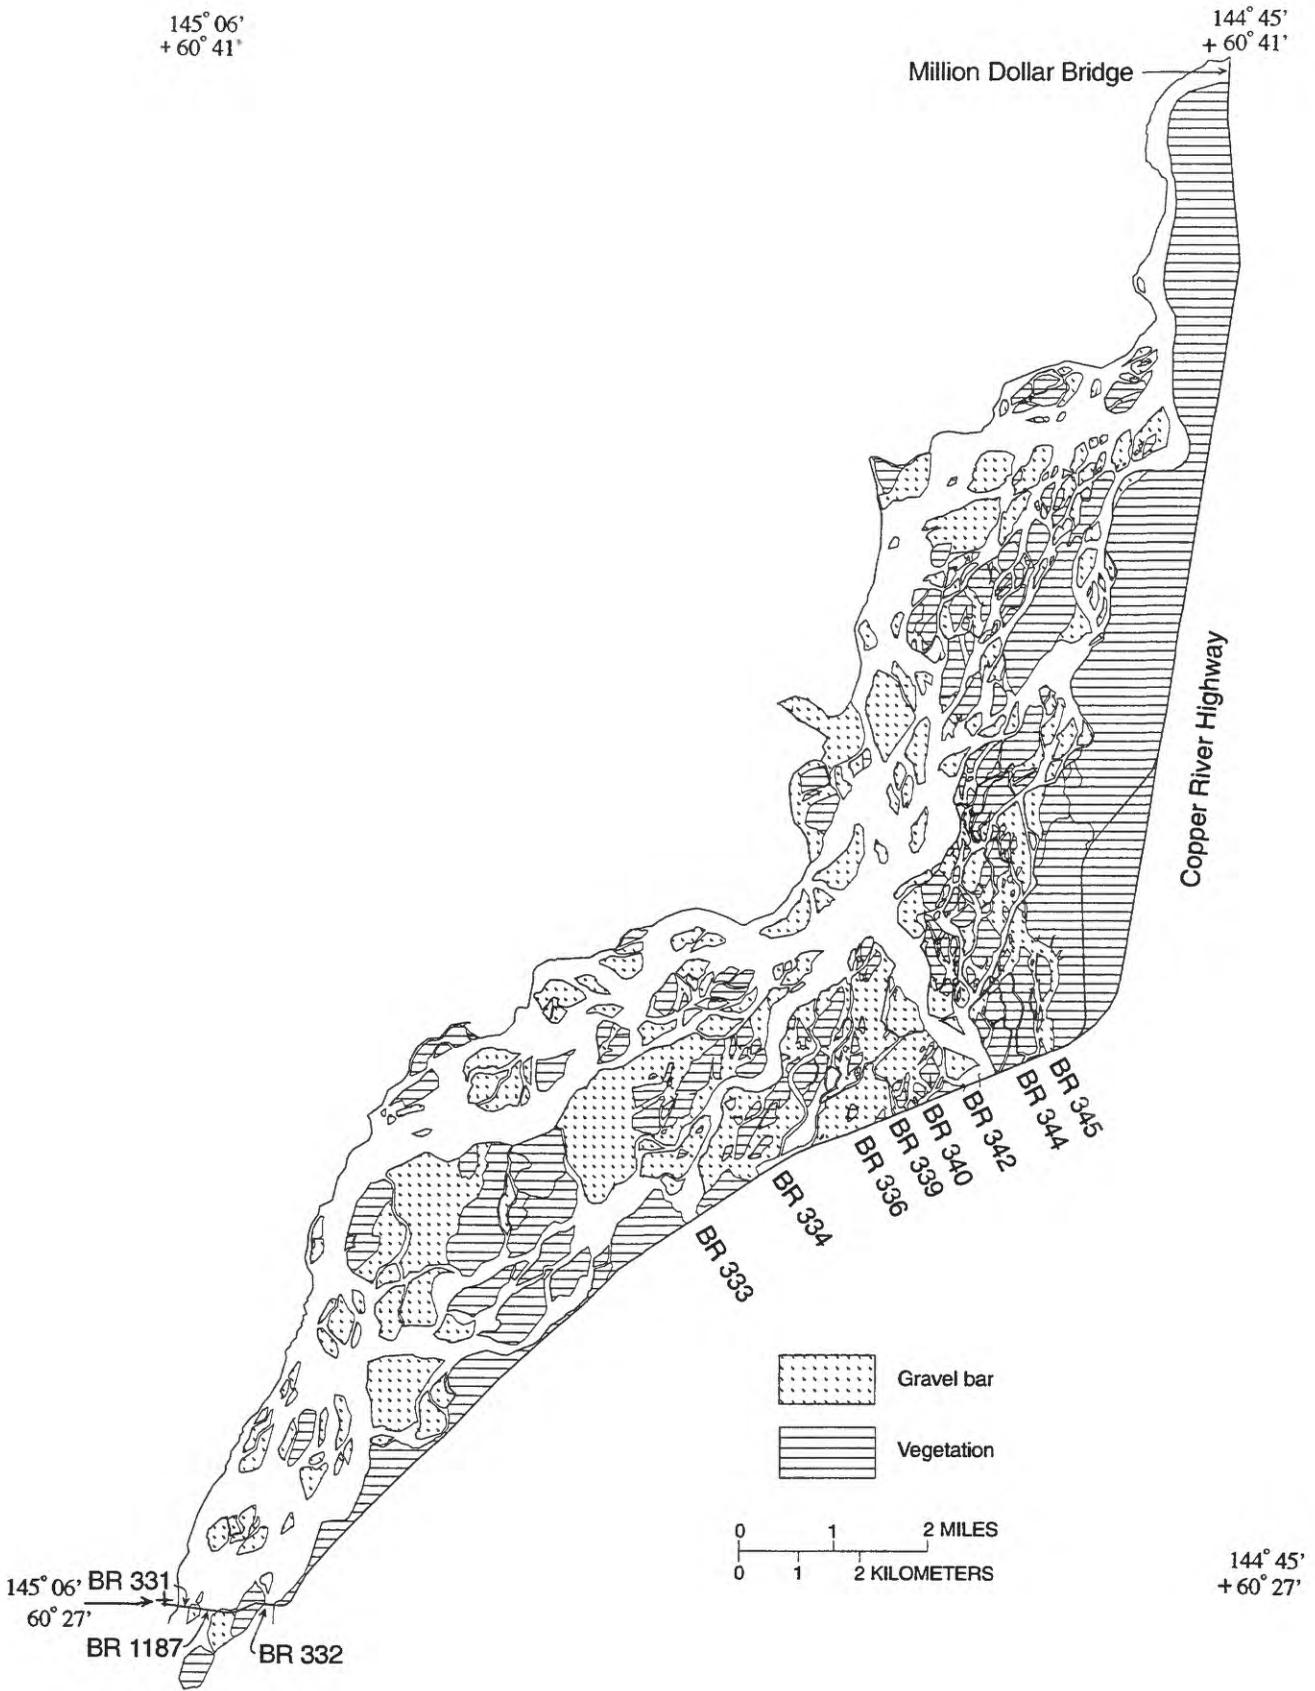
Figure 2. Locations of bridges (BR) along the Copper River Highway, 1991.

Significant bridge scour and damage to the Copper River Highway that can be directly attributed to the changes in the alluvial system of the lower Copper River have occurred. At Bridge 342 (fig. 2), the Alaska Department of Transportation and Public Facilities (ADOT&PF) has made major repairs to both the bridge and the spur dikes. These repairs have cost millions of dollars. The nature of the alluvial system can also cause additional problems, such as encroachment of the river to the highway or scour at other bridges. If a better understanding of the alluvial system could be gained, future problems could be anticipated and thus more cost-effective mitigation measures could be taken.

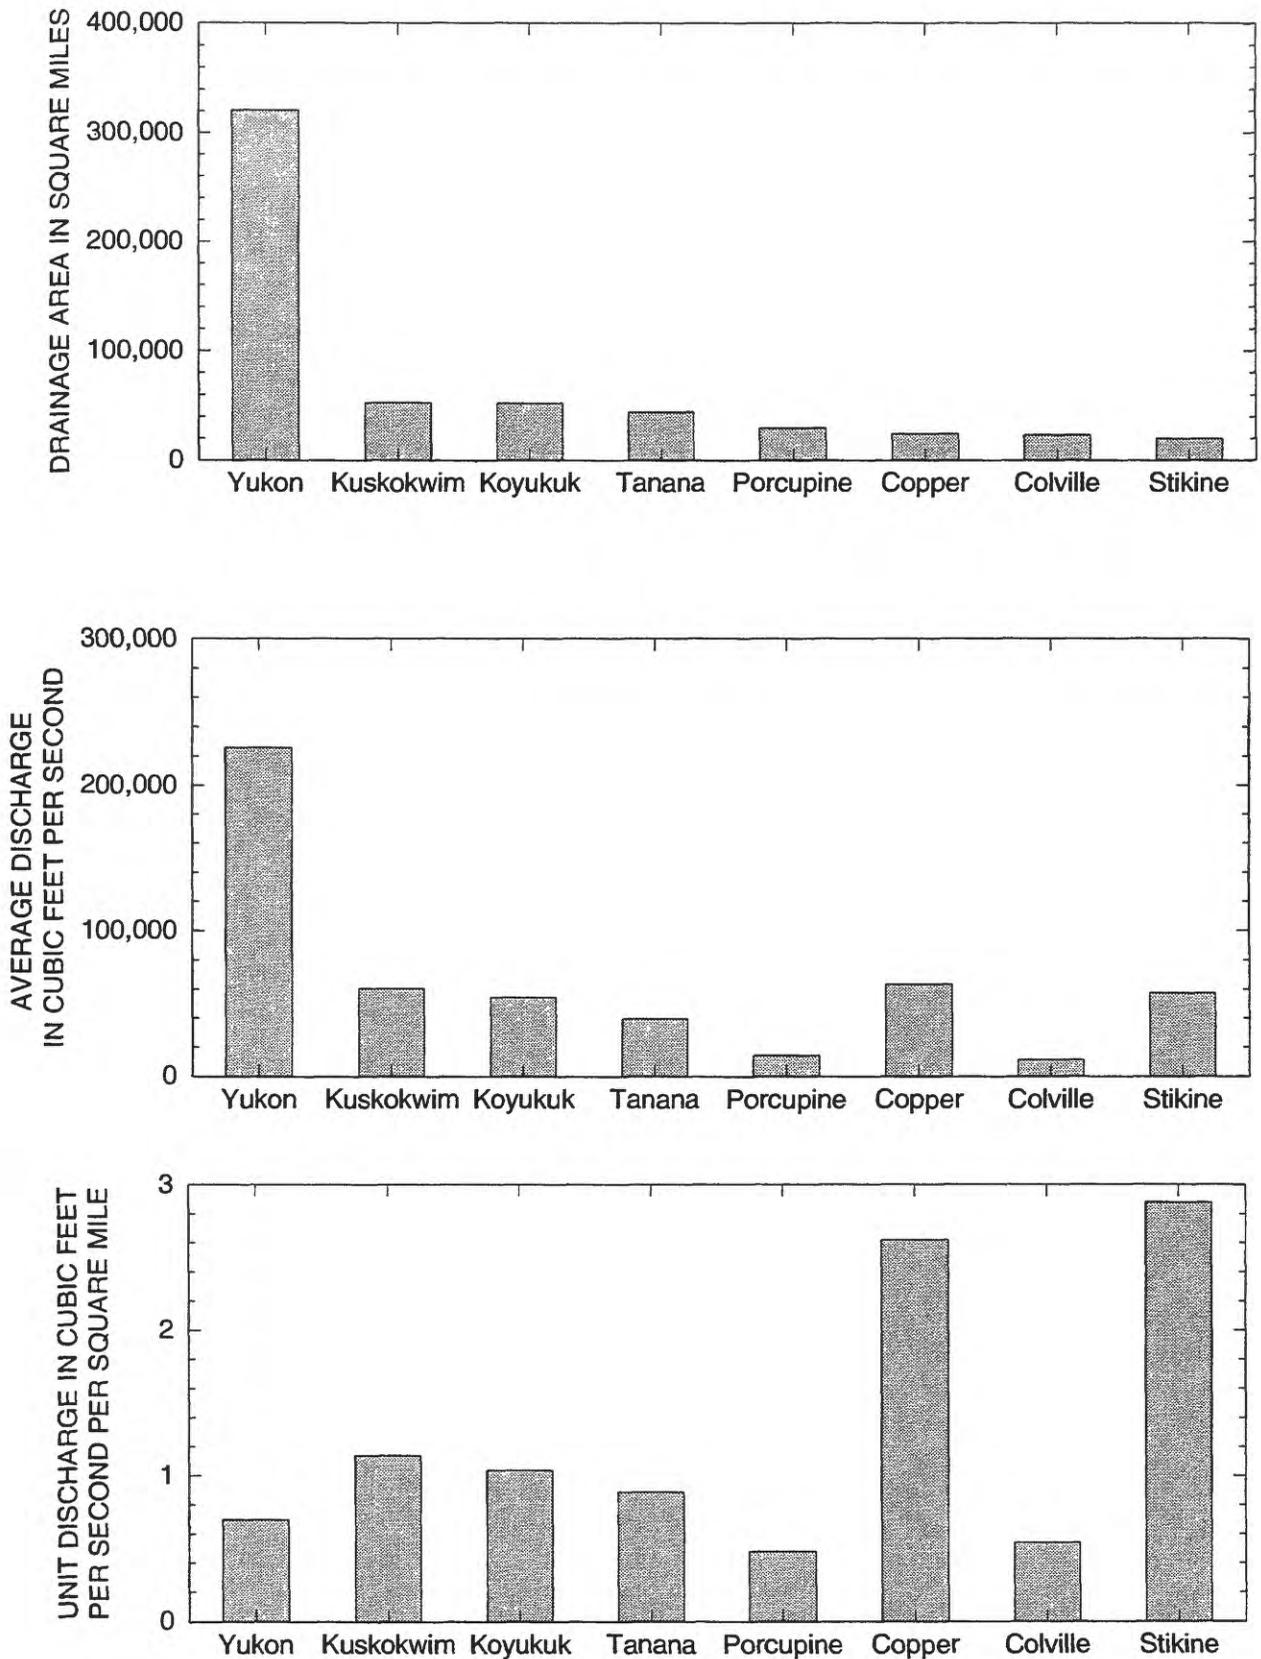
Figure 4. Comparison of drainage area, average discharge, and unit discharge of large river basins in Alaska.

The Copper River basin is the sixth largest basin in Alaska with an area of 24,200 mi² (fig. 4). However, the average discharge of the Copper River, 57,400 ft³/s, ranks second behind that of the Yukon River. The average discharge per square mile of the Copper River ranks second to that of the Stikine River, which also has a relatively large percentage of its area—10 percent—covered by glaciers.

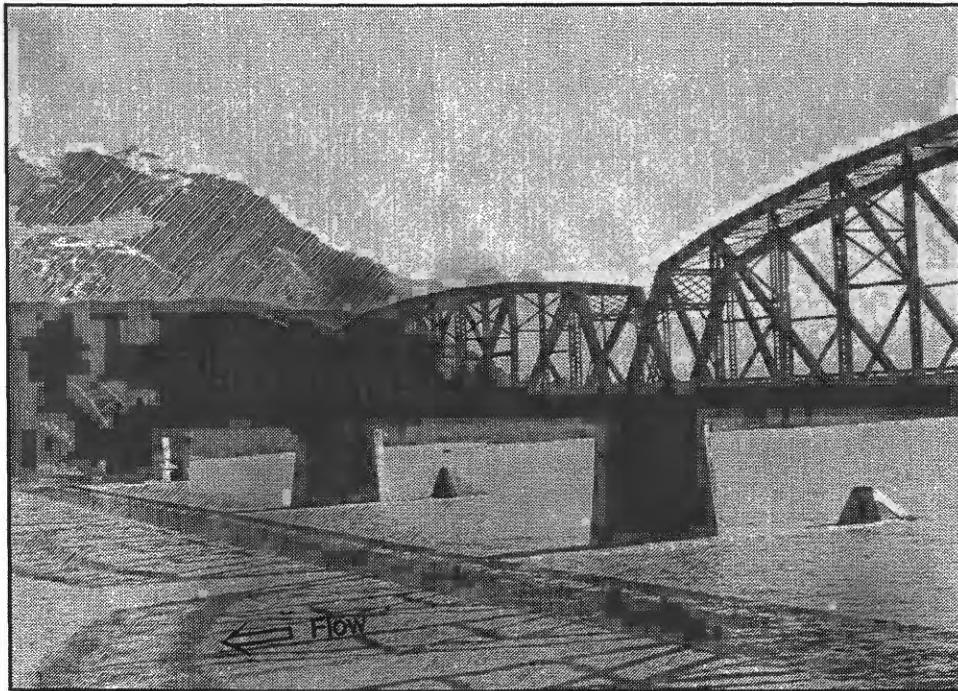
Figure 6. Million Dollar Bridge on the Copper River Highway, 1991.

Seismic shaking caused compaction and subsidence at most of the bridge approaches on the Copper River Highway. During the earthquake, all the bridges supported by piles made of old rails were severely damaged or destroyed because the brittle rail piles were unable to withstand the severe seismic shaking generated by the earthquake (Kachadoorian, 1968). Because of the severe seismic shaking, the 405-foot north span on the north side of the Million Dollar Bridge fell from its pier support to the river bottom where it rests today (fig. 6).

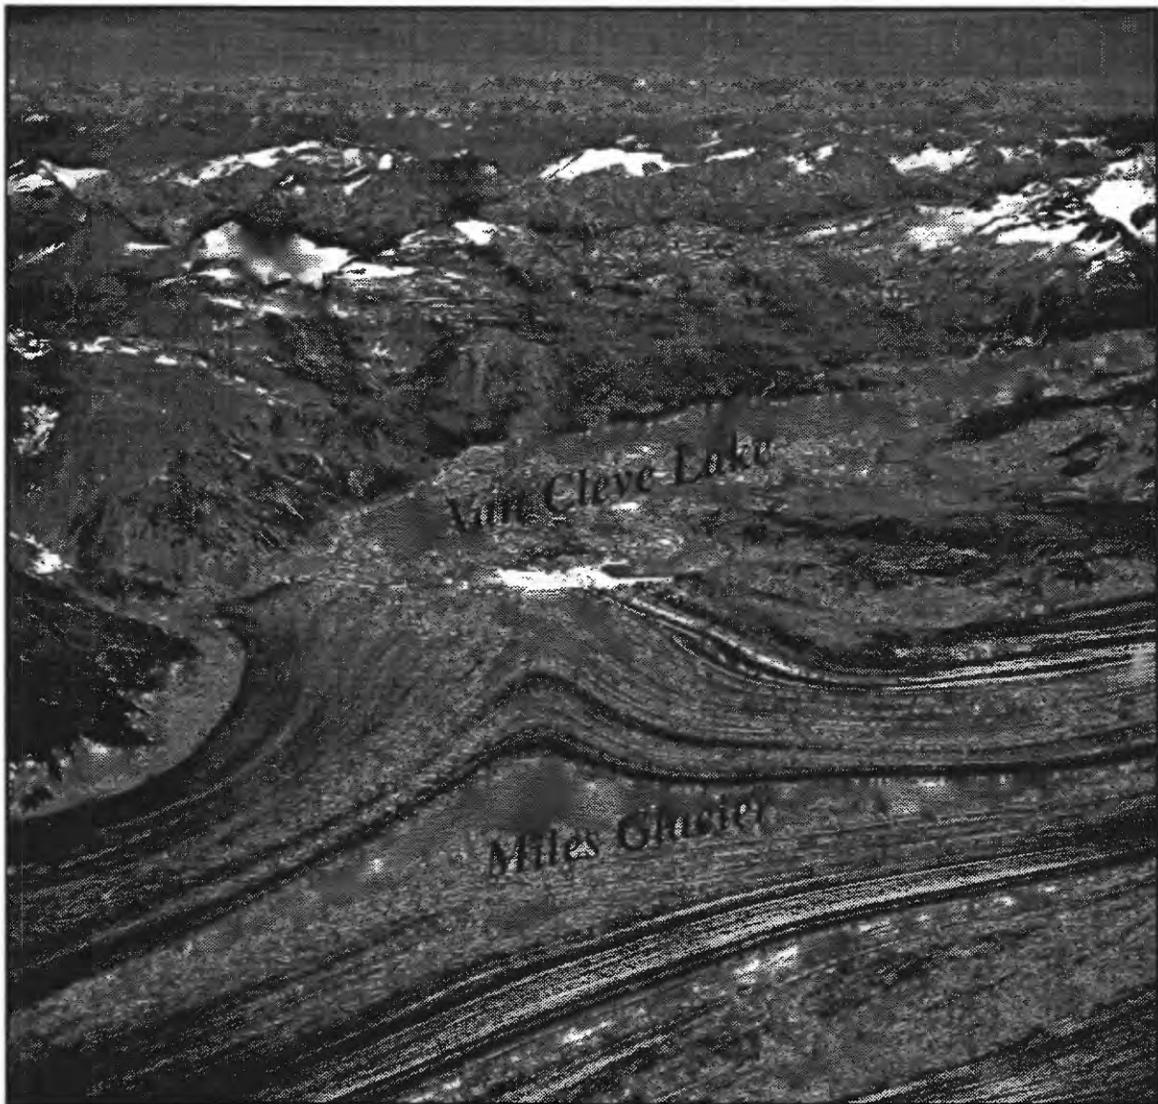
Figure 7. Van Cleve Lake, August 1969. View is to the northeast. Miles Glacier (in foreground) flows from right to left.

As Miles Glacier flows downstream towards the Copper River, it blocks the outlet of the valley where Van Cleve Glacier is located. The meltwater from Van Cleve Glacier, rainfall runoff, and snowmelt runoff are impounded by the ice of Miles Glacier, forming Van Cleve Lake (figs. 1 and 7). Van Cleve Lake fills until it reaches a depth that exceeds about 0.9 times the thickness of the ice dam. When this limit is exceeded, the ice at the dam begins to float, causing the dam to become unstable (Post and Mayo, 1971).

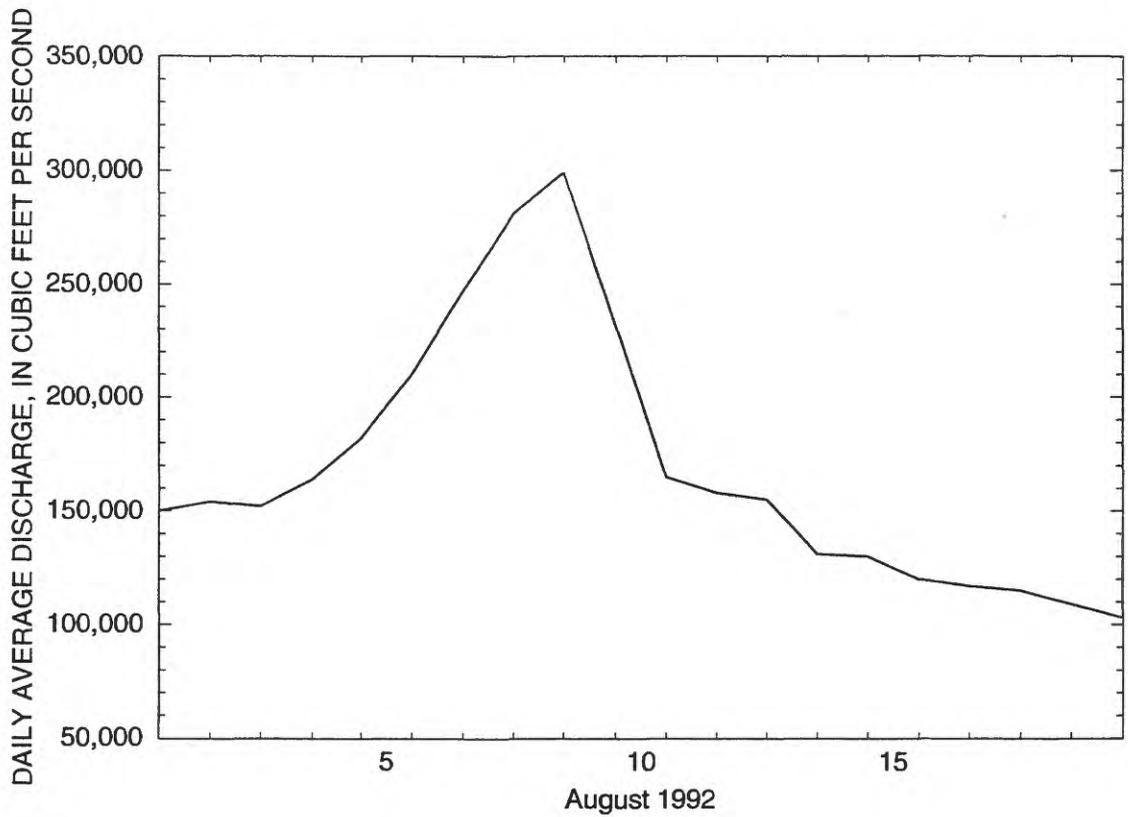
Figure 9. Discharge hydrograph of the Copper River at the Million Dollar Bridge during the breakout of Van Cleve Lake, August 4-12, 1992.

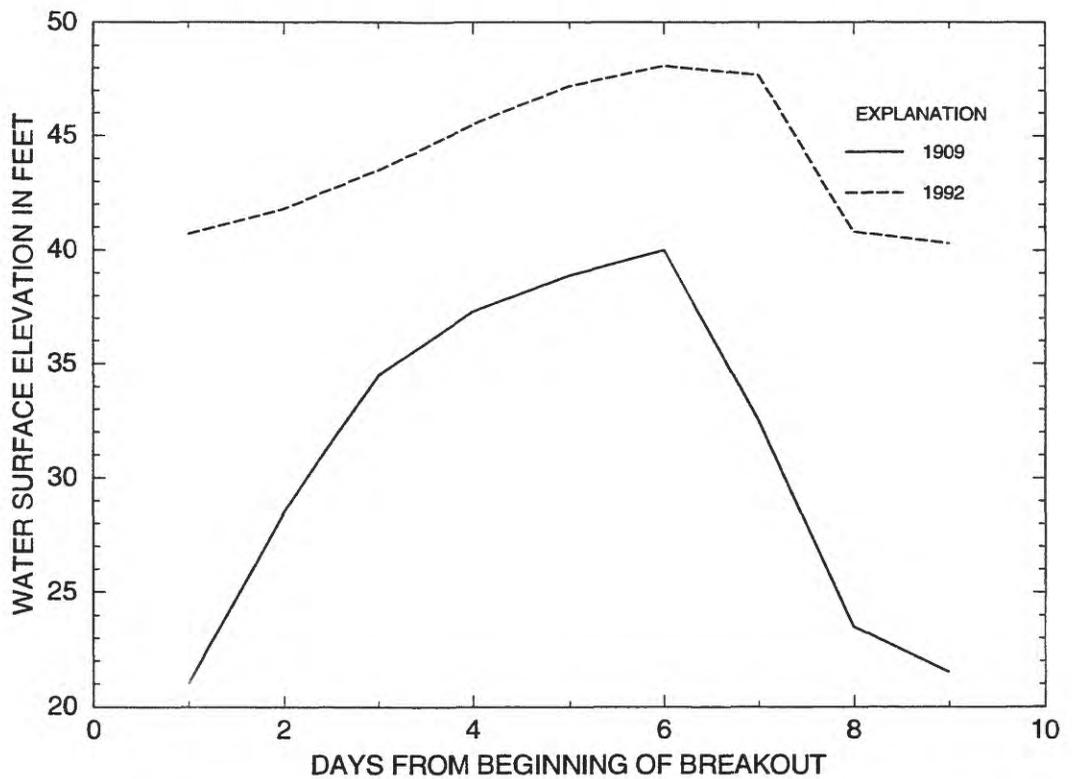
Figure 10. Water surface elevation of the Copper River at the Million Dollar Bridge during Van Cleve Lake breakout of 1909 and 1992.

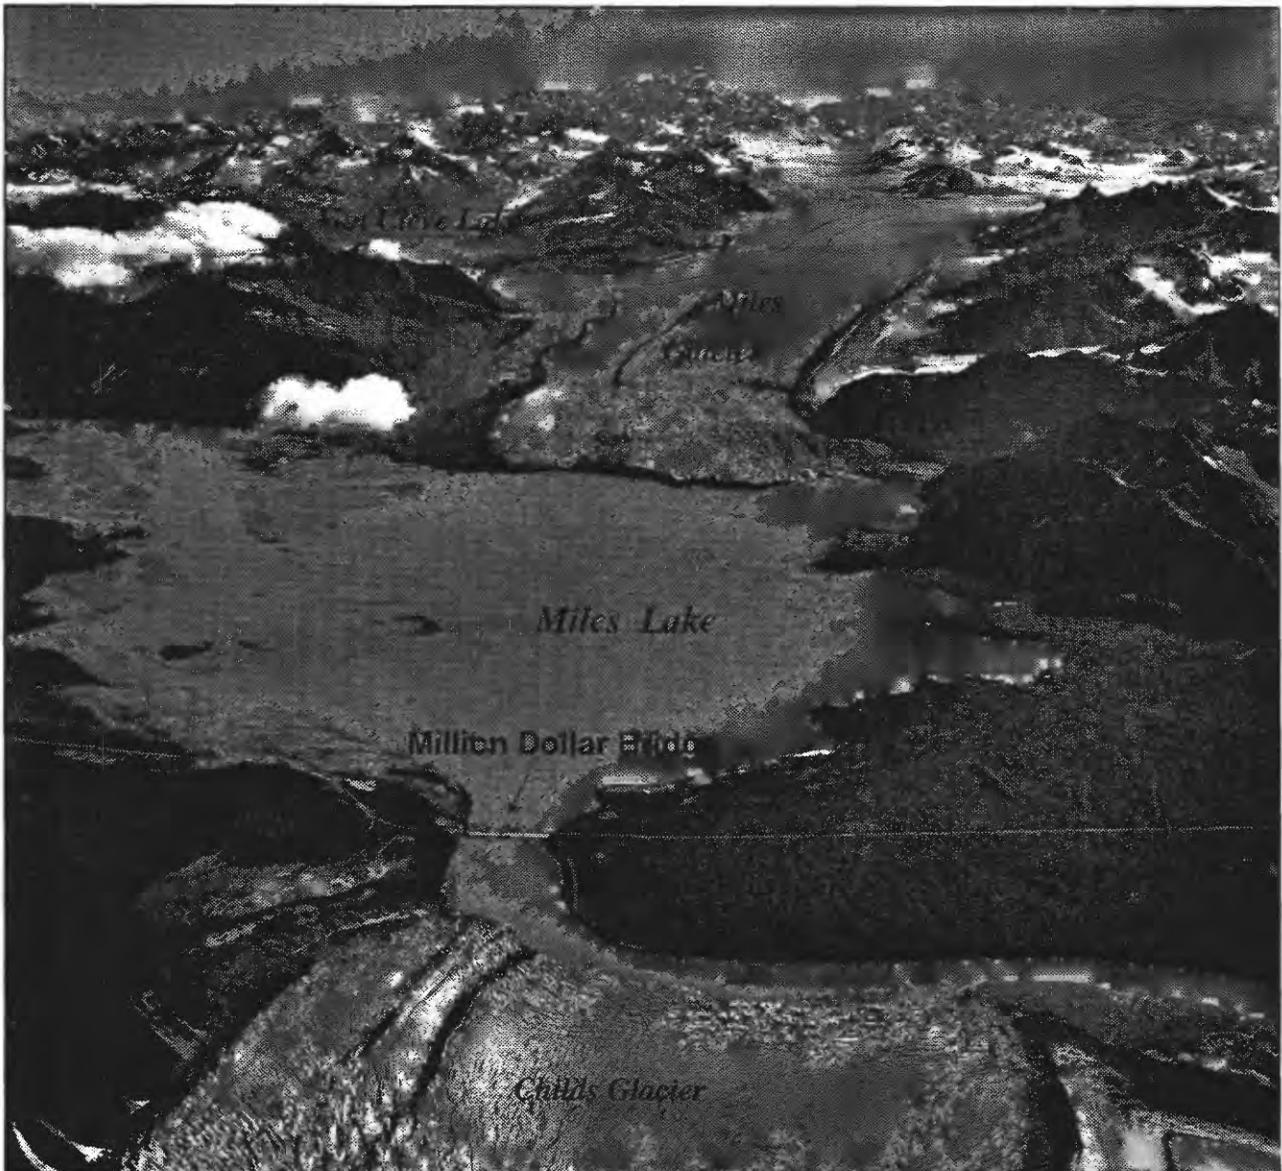
Figure 11. Miles Lake, 1966. View is to the east.

Miles Lake (fig. 11) formed after the southern lobe of Miles Glacier retreated between 1884 and 1898 (Abercrombie, 1900). At the time of Tarr and Martin's expedition during 1910, the Copper River flowed along the morainal front of Miles Glacier through Abercrombie Rapids and into Miles Lake (fig. 12). Around 1950, the Copper River cut a new channel through the northern stagnant lobe of Miles Glacier, abandoning Abercrombie Rapids (fig. 13). Between 1910 and 1950, the terminus of Miles Glacier retreated approximately 1.7 mi with a loss in area of about 9.3 mi². From 1950 to 1991, the terminus of Miles Glacier (fig. 14) retreated approximately 1,400 ft near the center of the glacier; however, the southern lobe of the glacier retreated approximately 1.2 mi. The total loss in area between 1950 and 1991 was about 2.0 mi². Currently (1996), the Copper River flows southward along the face of Miles Glacier, and then turns westward towards the Million Dollar Bridge.

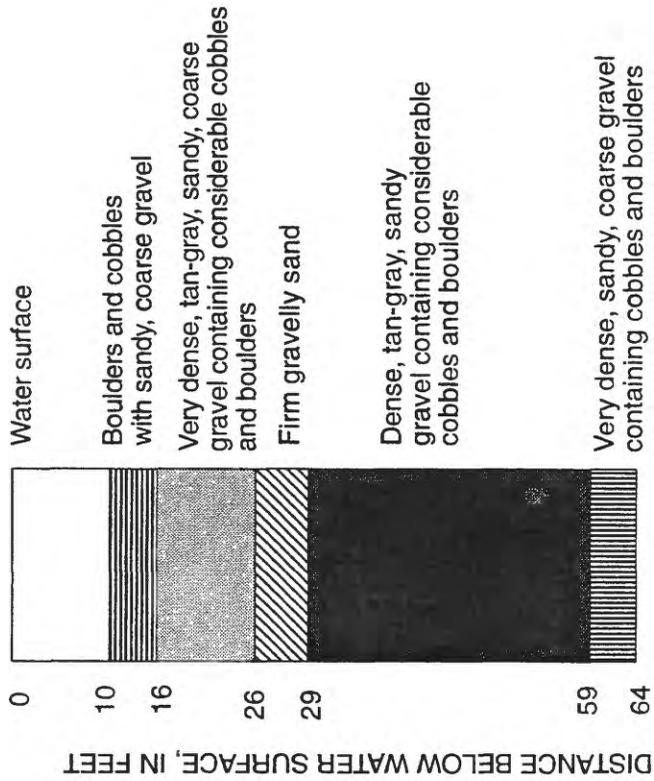
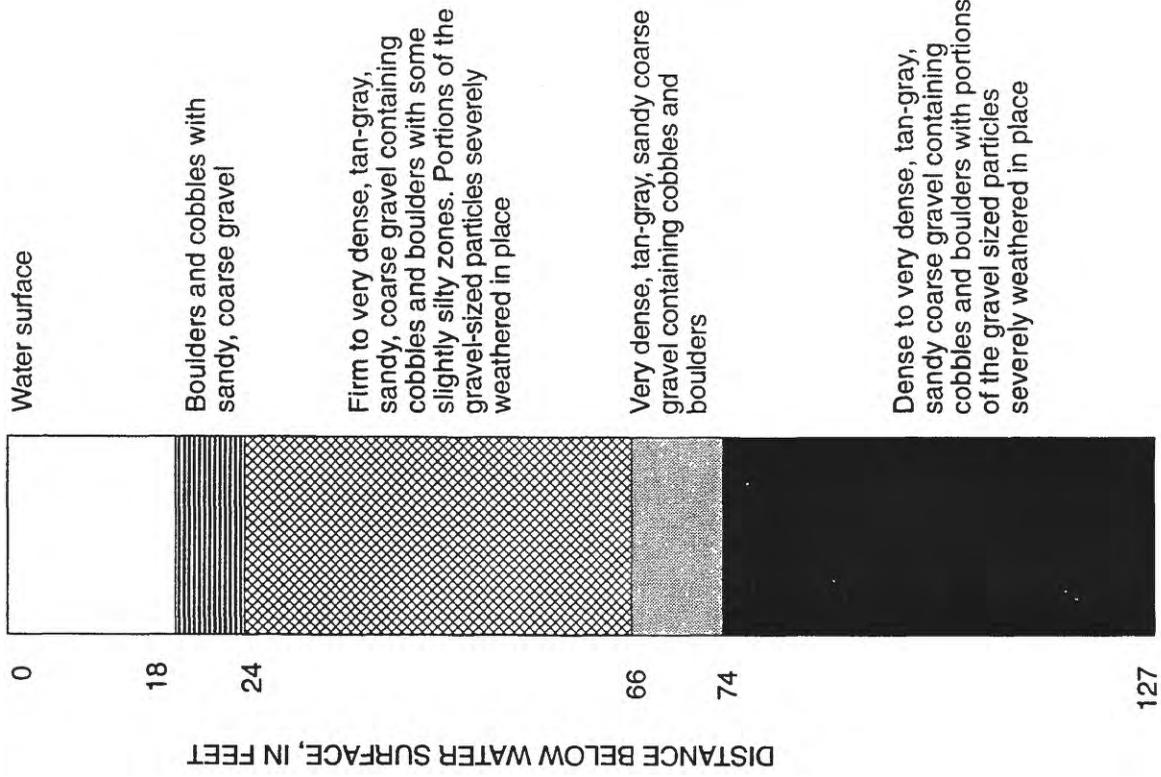
Figure 15. Borings from area near the Million Dollar Bridge on the Copper River Highway.

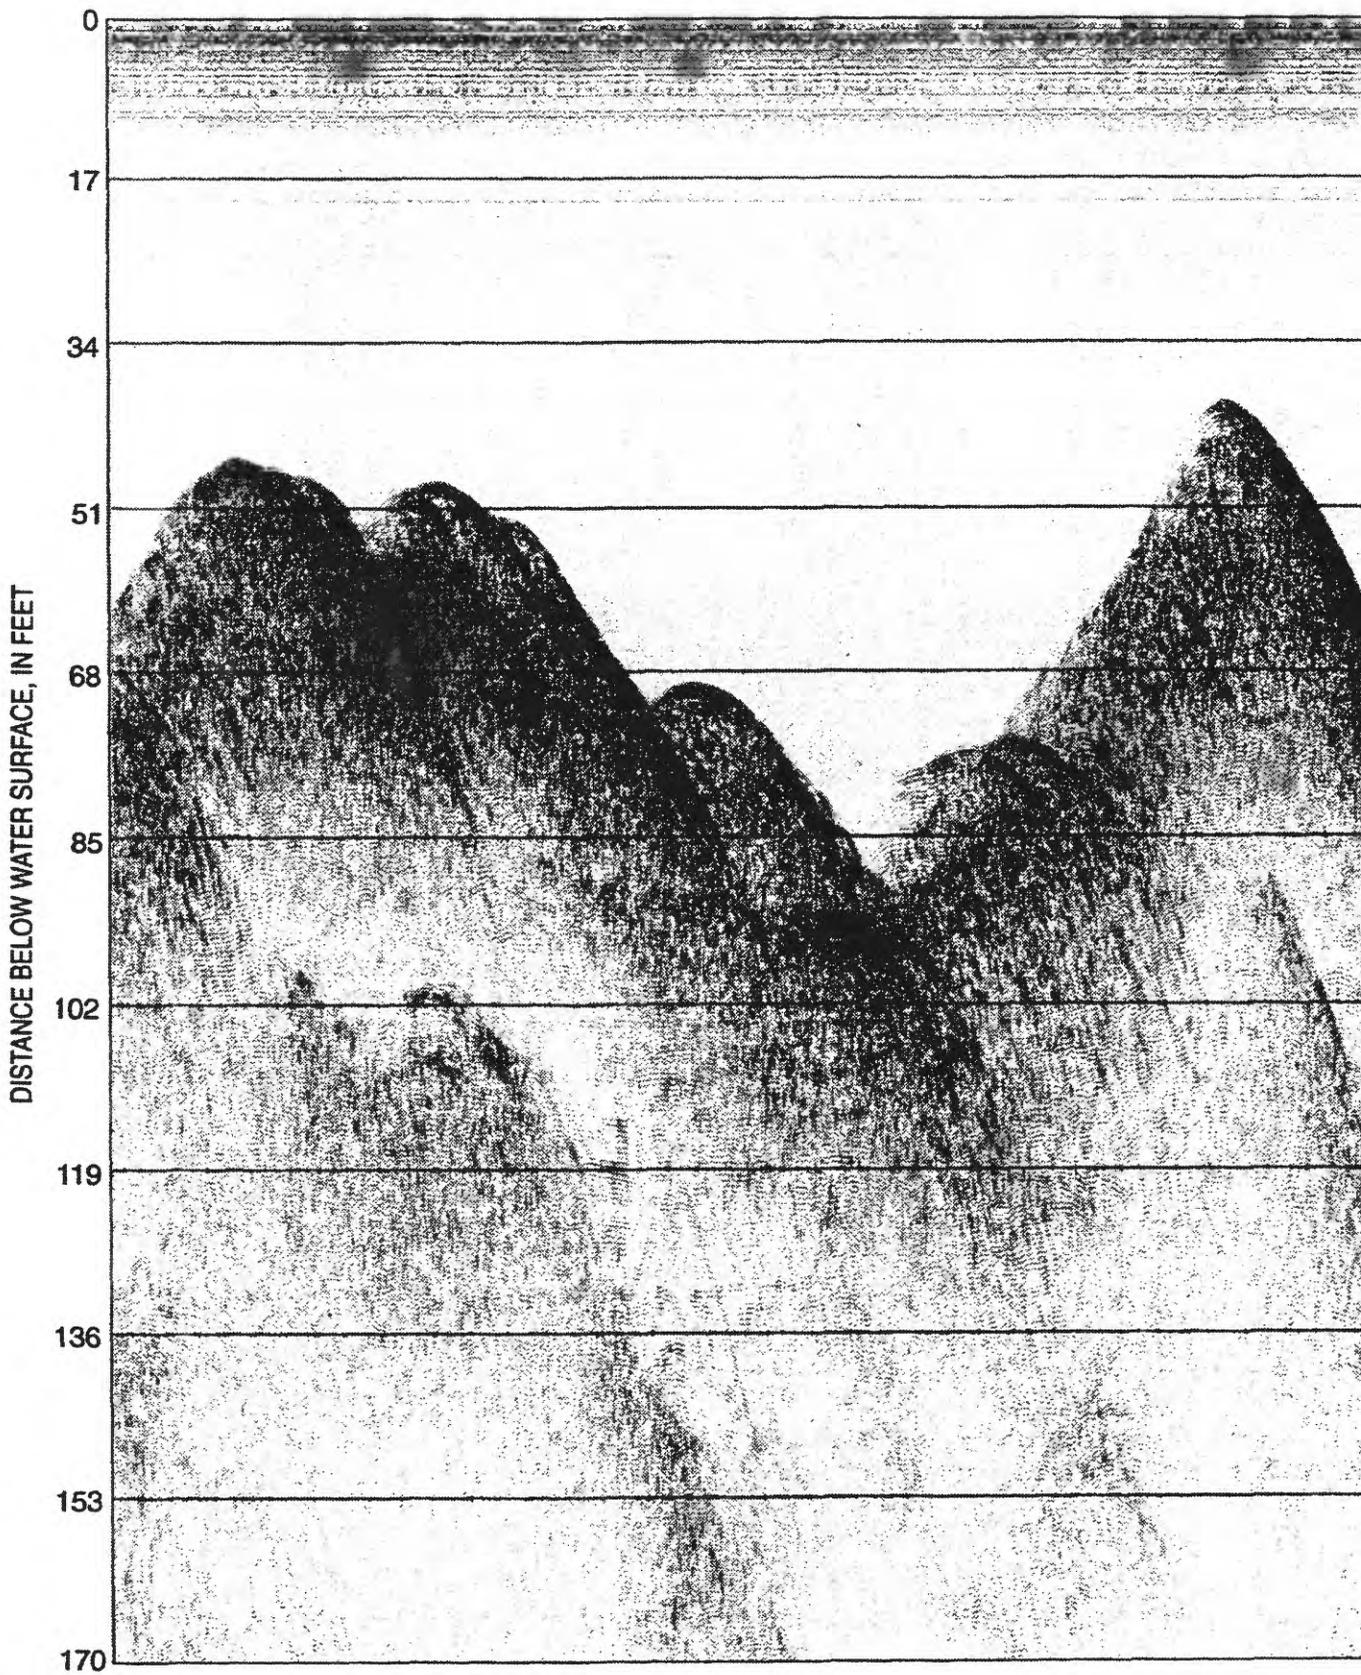
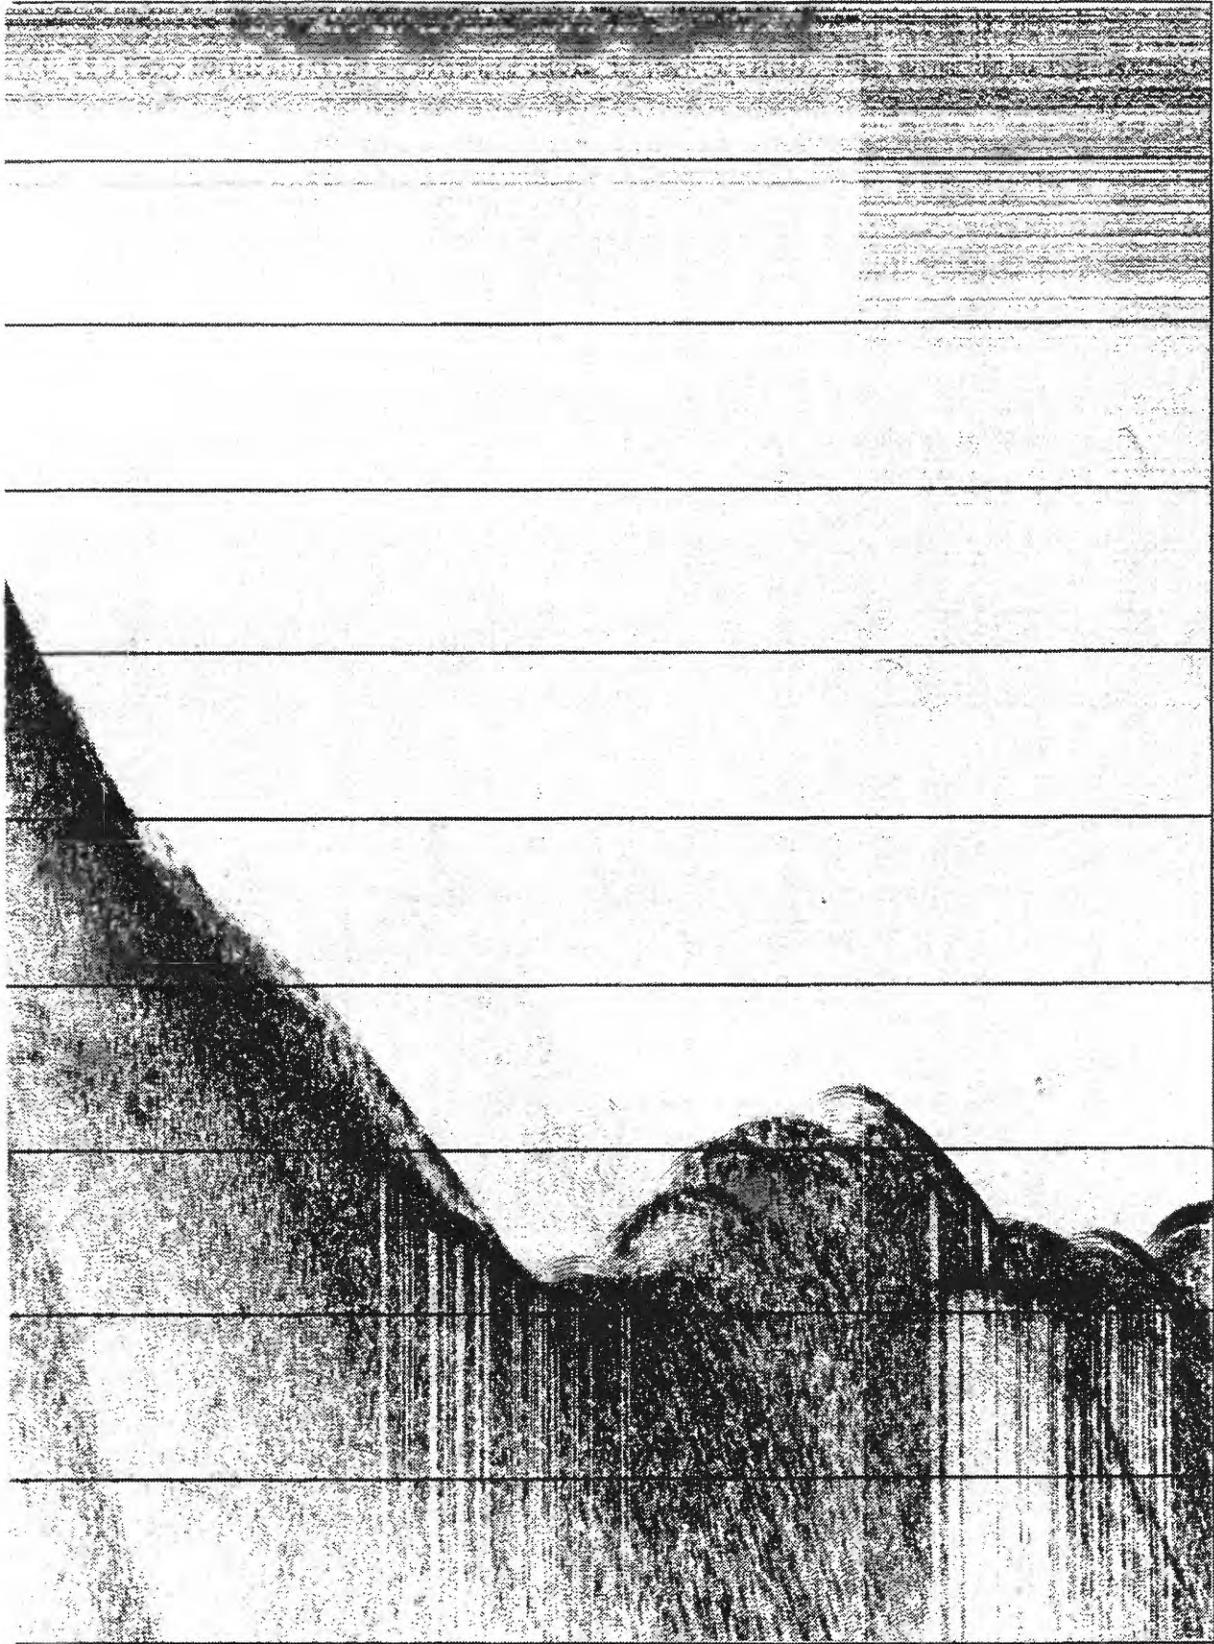
Figure 16. Record of 7.0-kHz continuous seismic reflection cross section from Profile 1 at Miles Lake.
(Approximate length of profile is one-half mile, see fig.14 for location.)

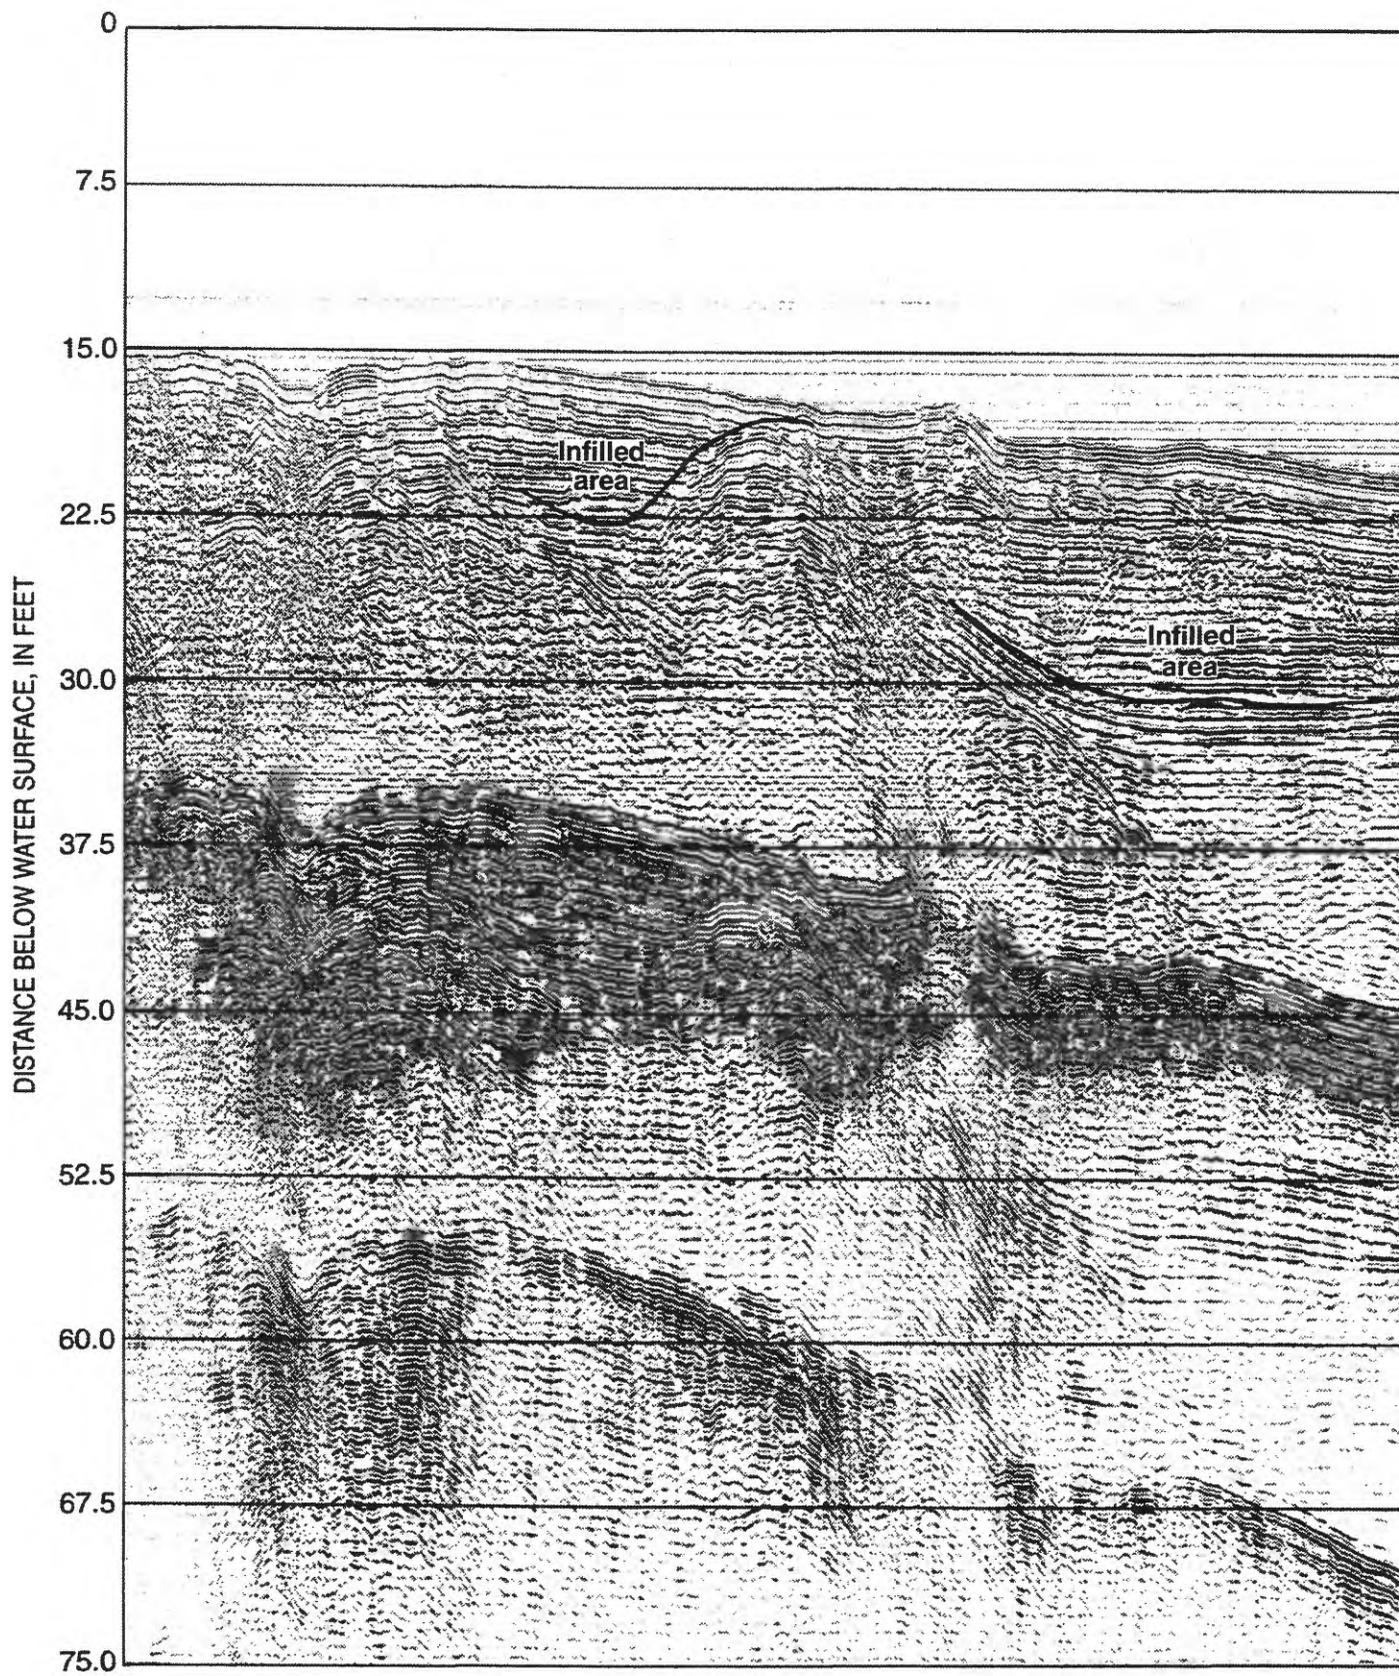
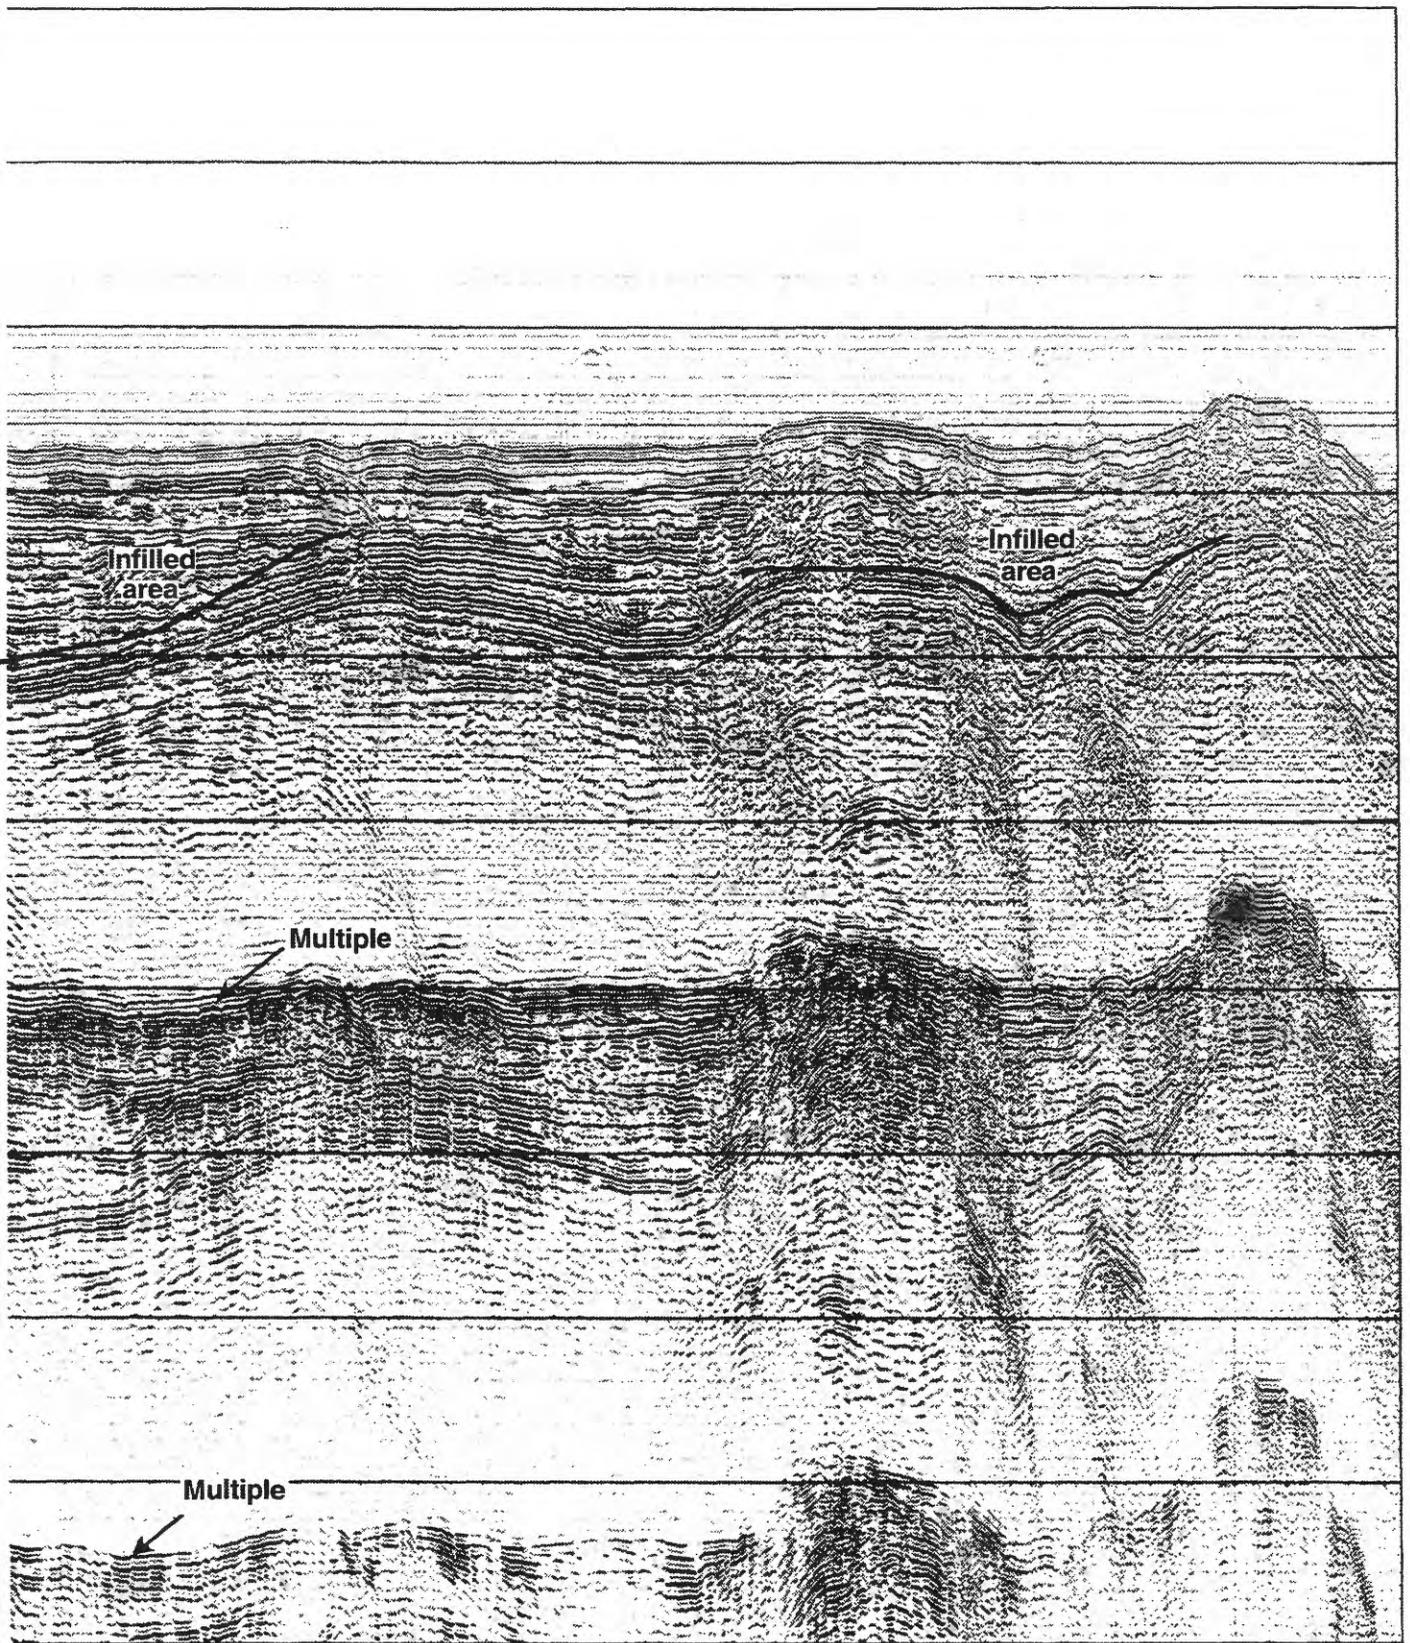
Figure 17. Record of 7.0-kHz continuous seismic reflection cross section from Profile 2 at Miles Lake. (See figure 14 for location.)

Profile 2 (fig. 17) was also a north/south profile taken approximately 1 mi downstream from Miles Glacier. In this section, the depth of water was fairly uniform and a distinct layer of fine-grained sediments was present. This layer ranged in thickness from about 2 ft to about 8 ft and overlies a coarser grained deposit which is most likely the glacier-deposited material.

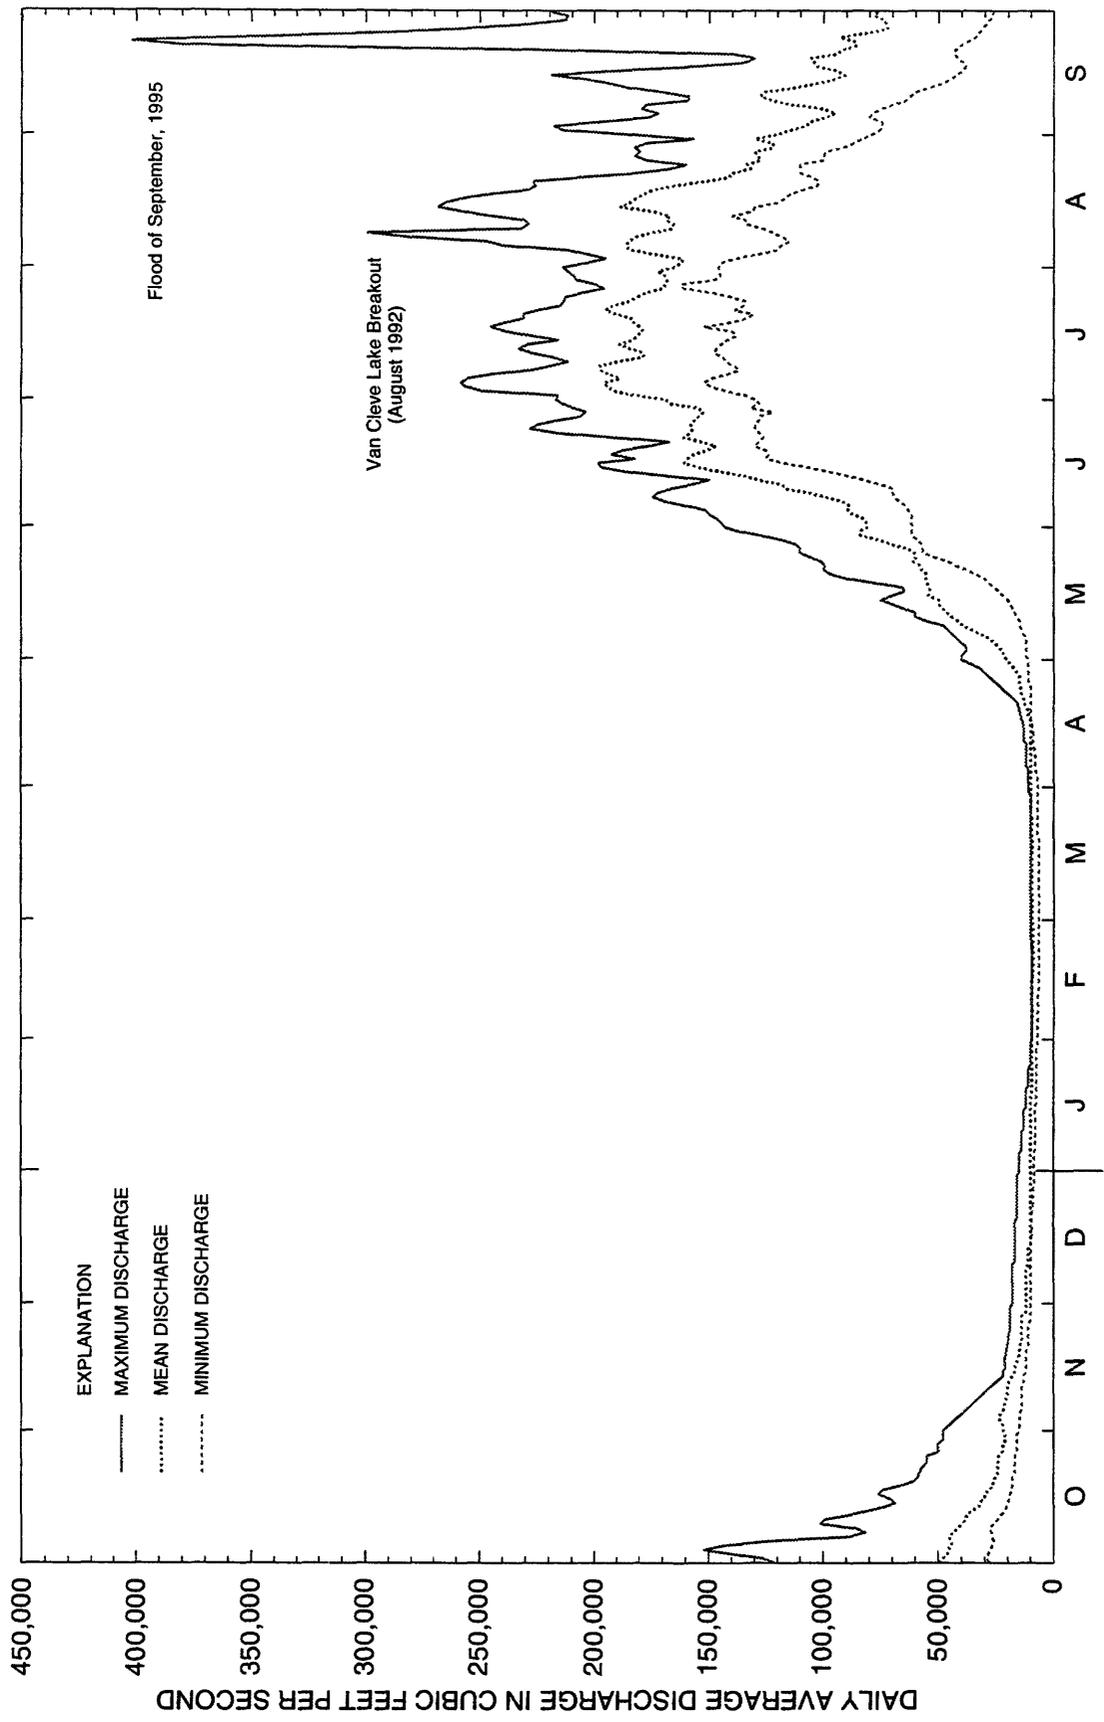
Figure 18. Flow statistics of the Copper River at Million Dollar Bridge, 1988-1995.

The average discharge of the Copper River at the Million Dollar Bridge is about 57,400 ft³/s; minimum flows occur during winter months and maximum flows occur during summer months (fig. 18). During late May or early June, a high-flow period begins, reflecting snow-melt runoff. Rainfall and glacial melt cause this high-flow period to continue from mid-July through August. Two distinct features are noted for the period of record: the breakout of Van Cleve Lake in August 1992 and the large flood of September 1995.
