Geomorphology of the Lower Copper River, Alaska

U.S. GEOLOGICAL SURVEY

Open-File Report 96-500

By Timothy P. Brabets

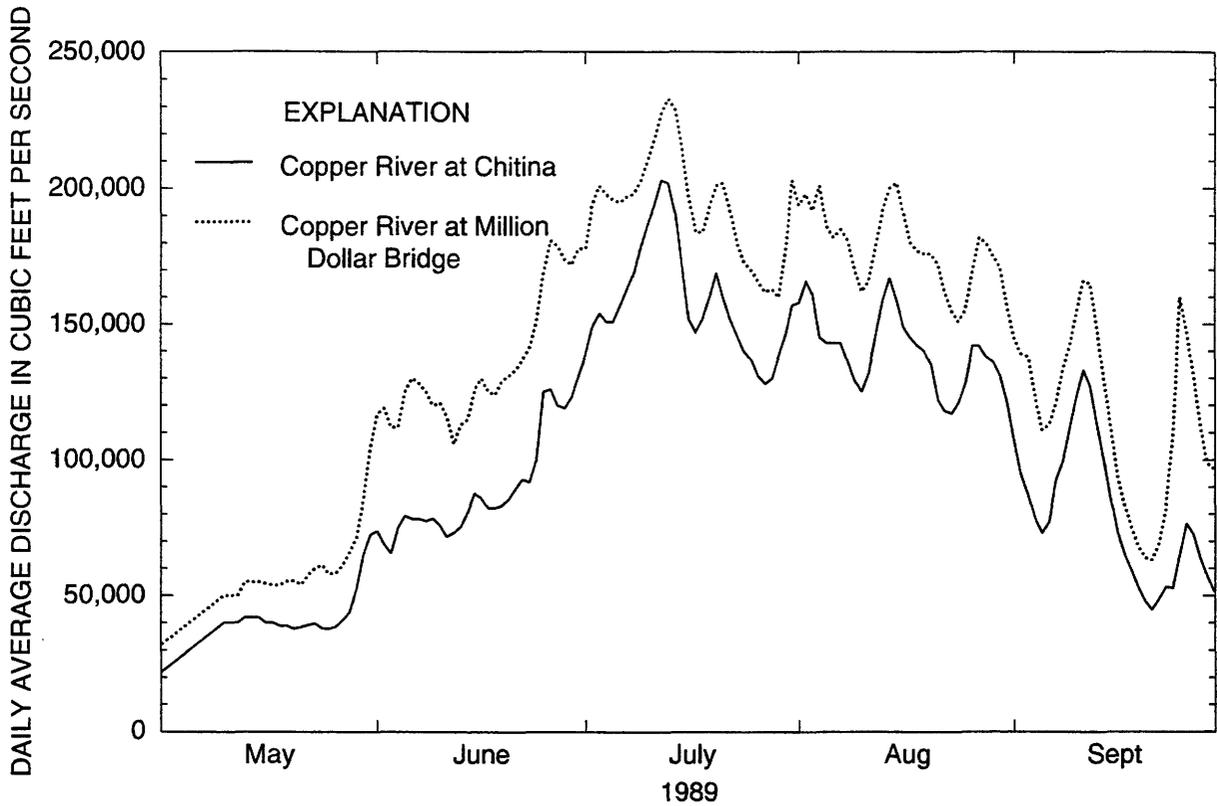
Figure 19. Daily discharge hydrographs of the Copper River at Chitina and Copper River at Million Dollar Bridge - 1989 water year.

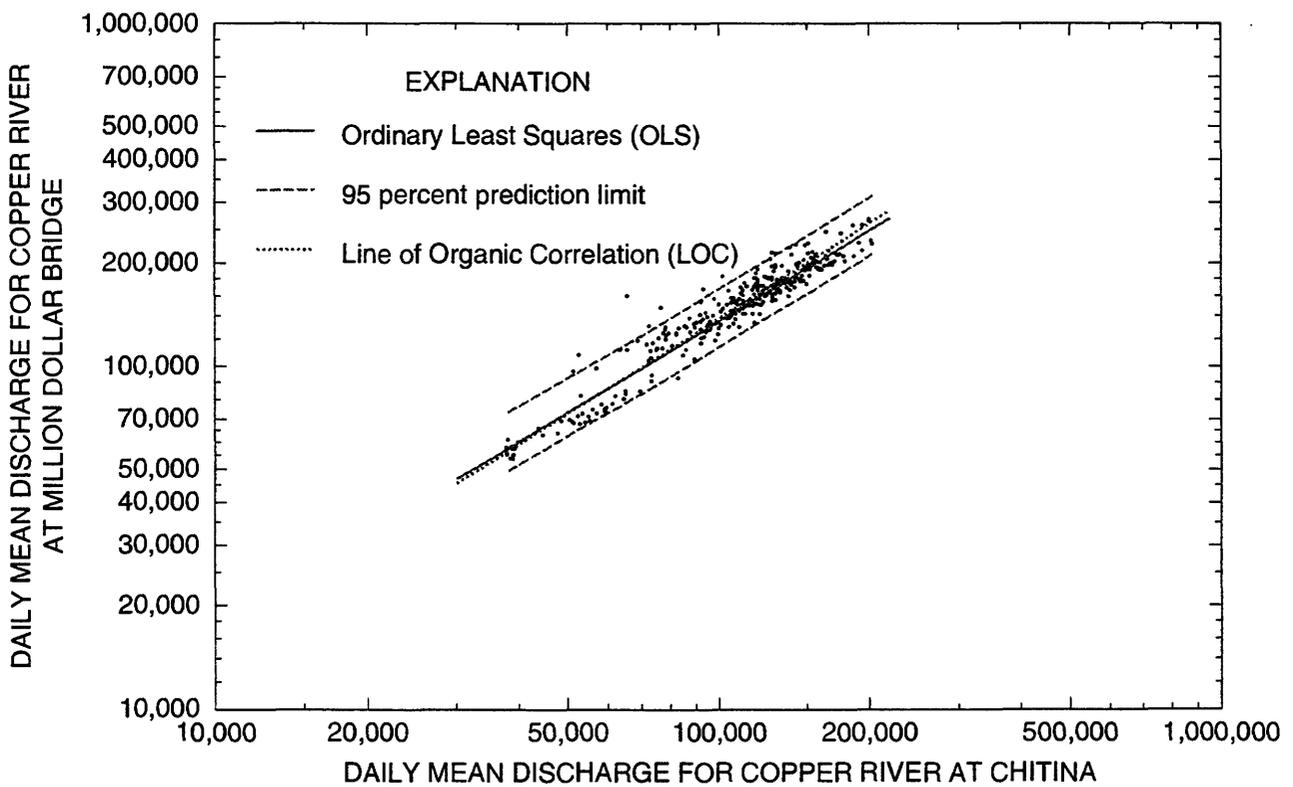
Figure 20. Comparison of concurrent discharges at Copper River at Chitina and at the Million Dollar Bridge.

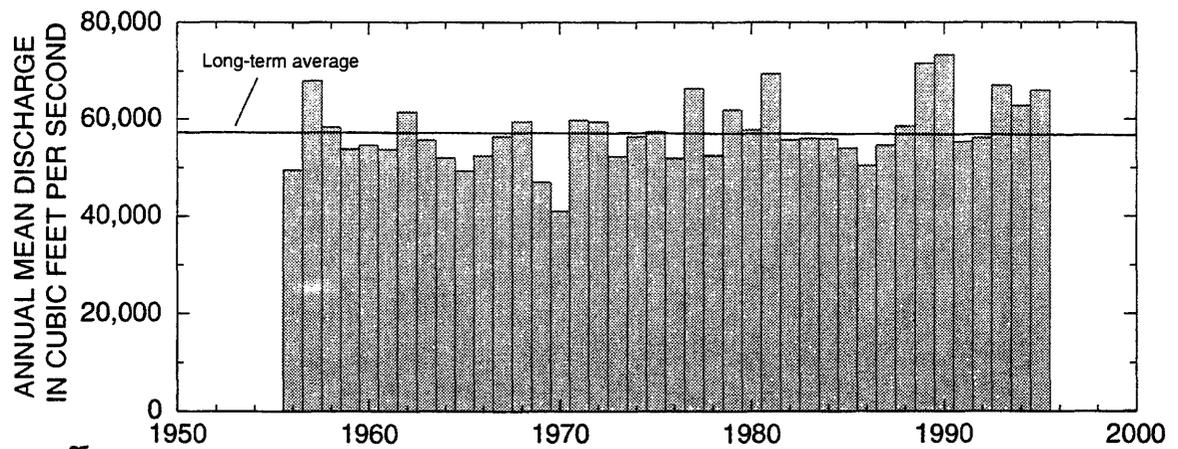
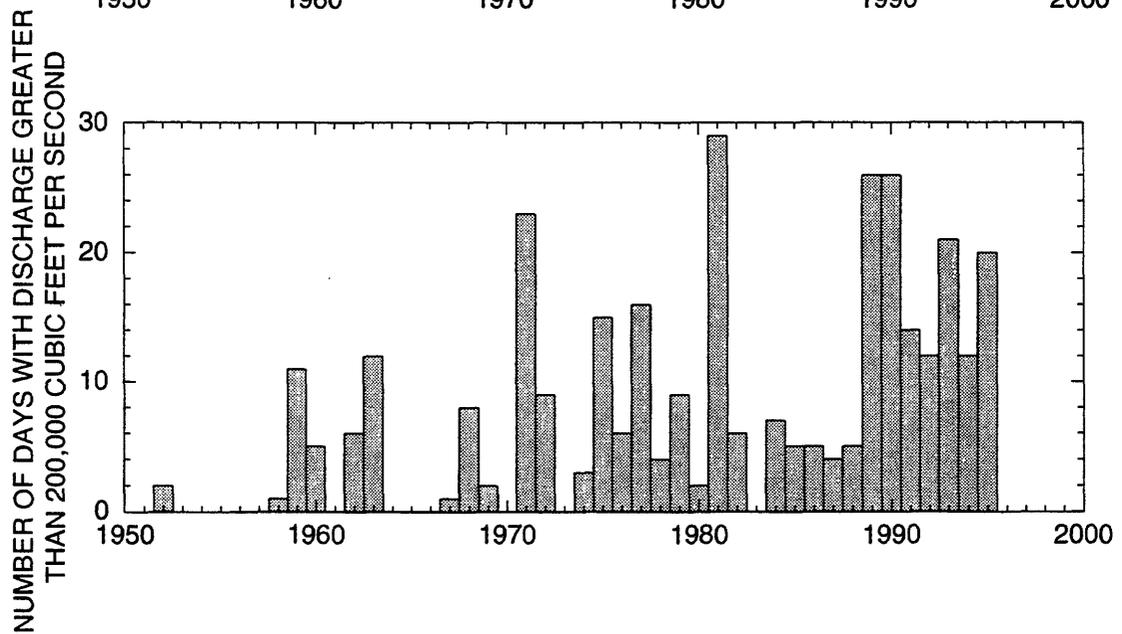
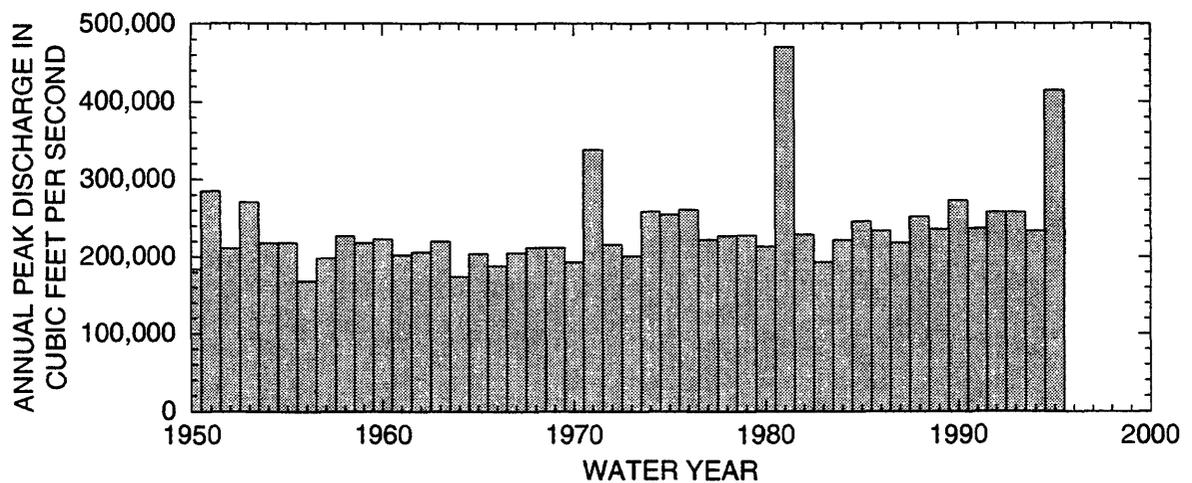
Figure 21. Synthesized flow statistics for Copper River at Million Dollar Bridge, 1950-1988.

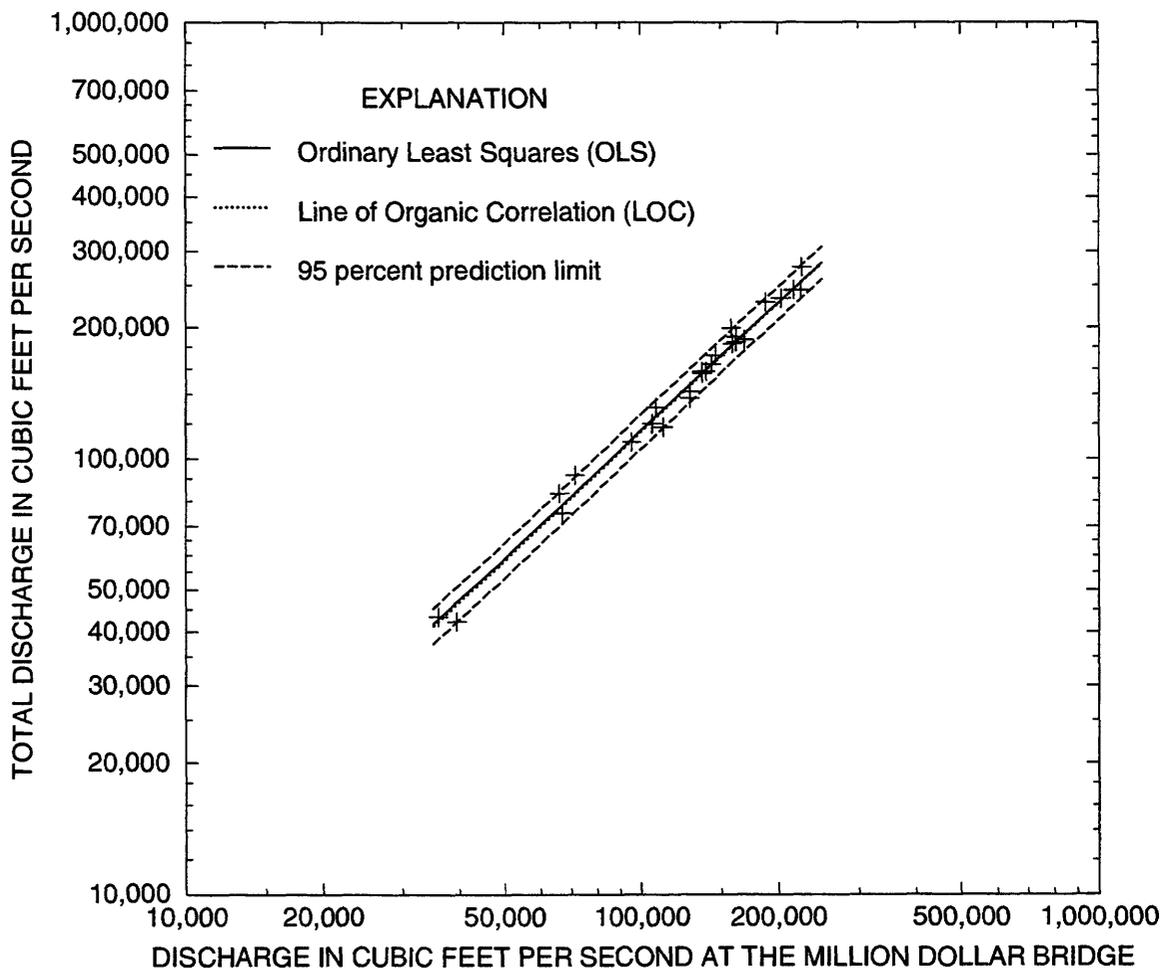
Figure 22. Comparison of discharge of the Copper River at the Million Dollar Bridge with the total measured discharge from Bridges 331 to 345.

The sum of the discharges measured at each of the bridges along the Copper River Highway equals the flow past the Million Dollar Bridge plus any inflow downstream from the Million Dollar Bridge. The primary inflow between the Million Dollar Bridge and the Copper River Highway is the runoff from Childs Glacier and from Goodwin Glacier. Comparing the discharge at the Million Dollar Bridge with the total measured discharge indicated a good correlation (fig. 22).

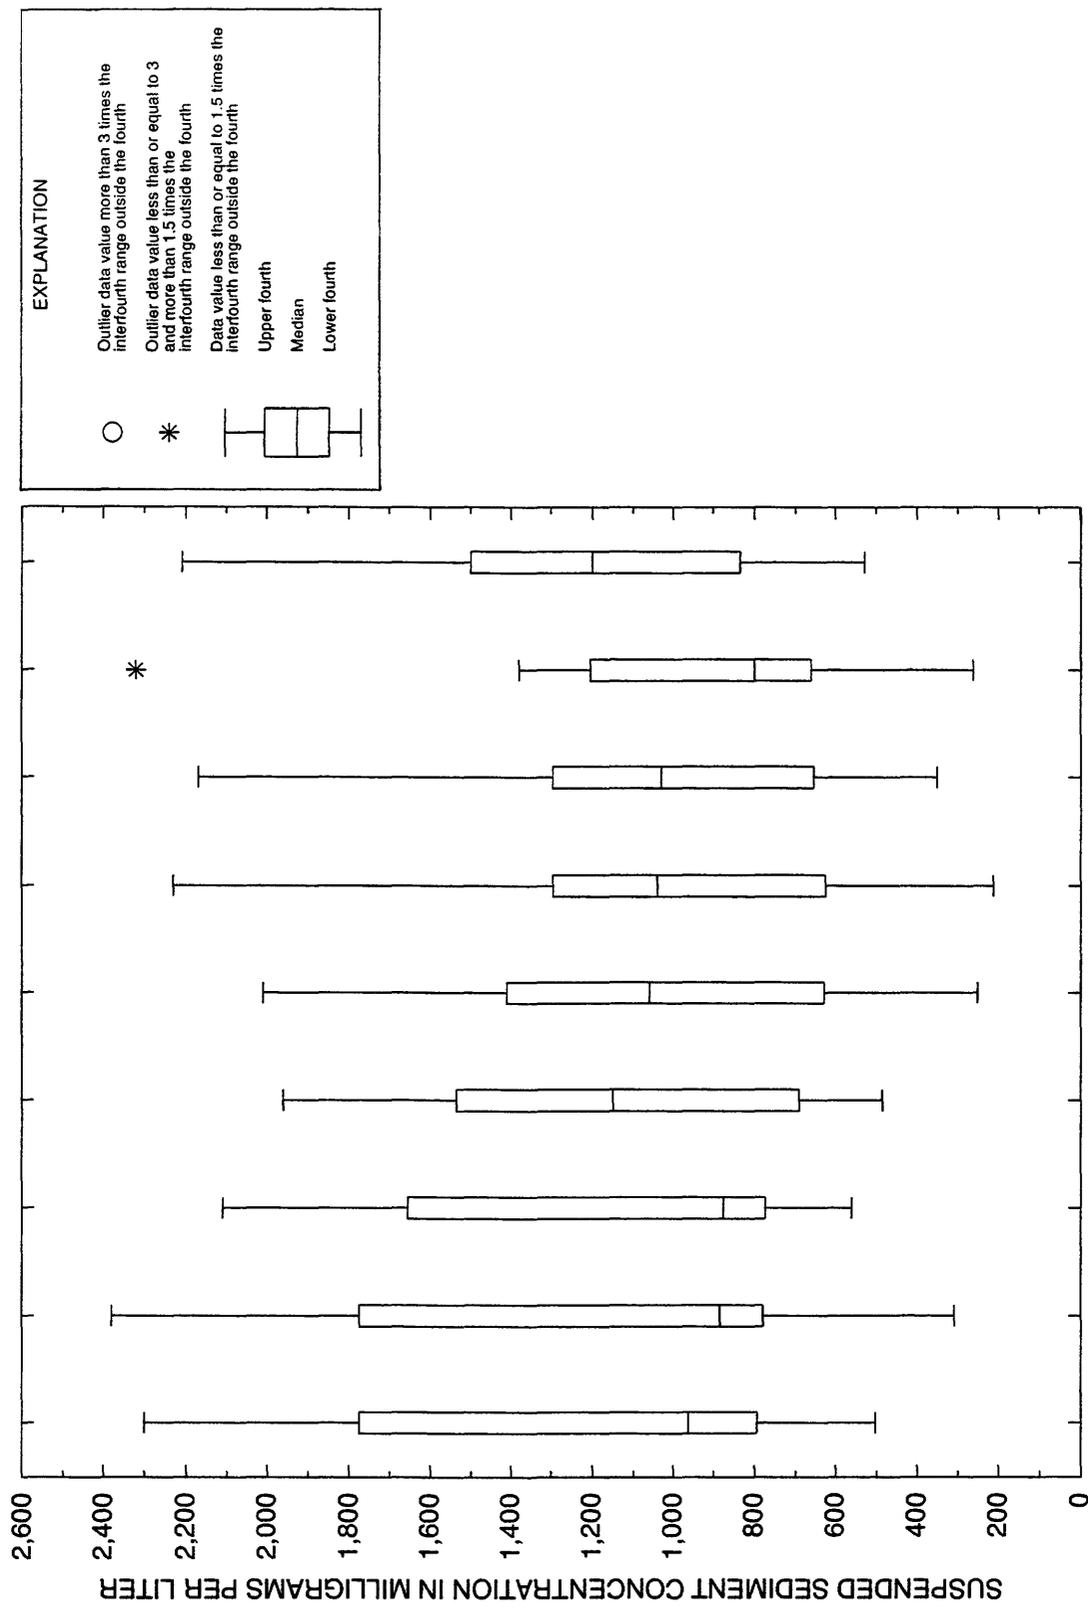
Figure 23. Boxplots of suspended sediment concentrations at bridges along the Copper River Highway.

Results of the Kruskal-Wallis test (table 8) indicated no significant difference among the mean suspended-sediment concentrations. Thus, the suspended-sediment concentrations at the Million Dollar Bridge and at Bridges 331-342 are considered to be similar.

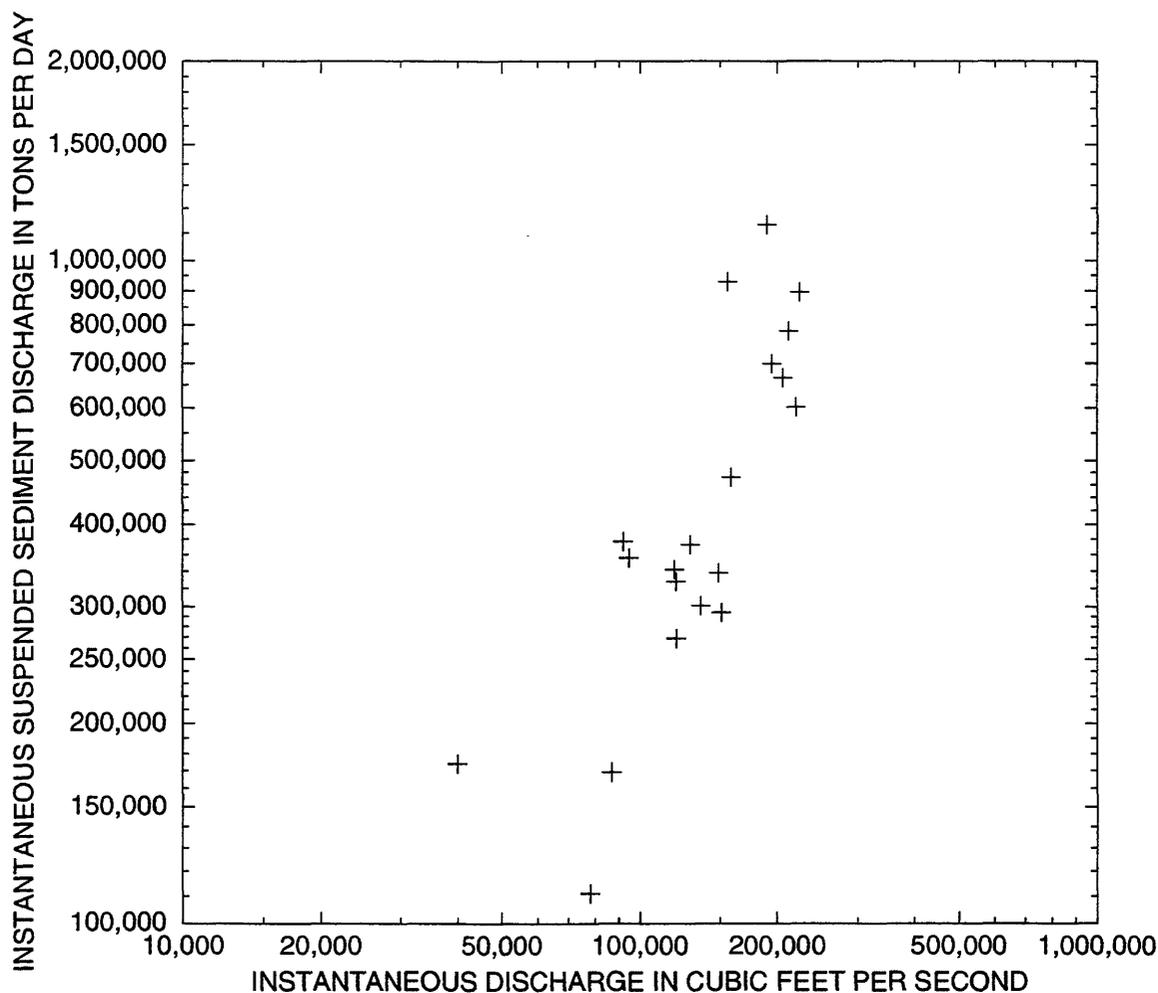
Figure 24. Suspended sediment discharge and instantaneous water discharge for Copper River at Million Dollar Bridge.

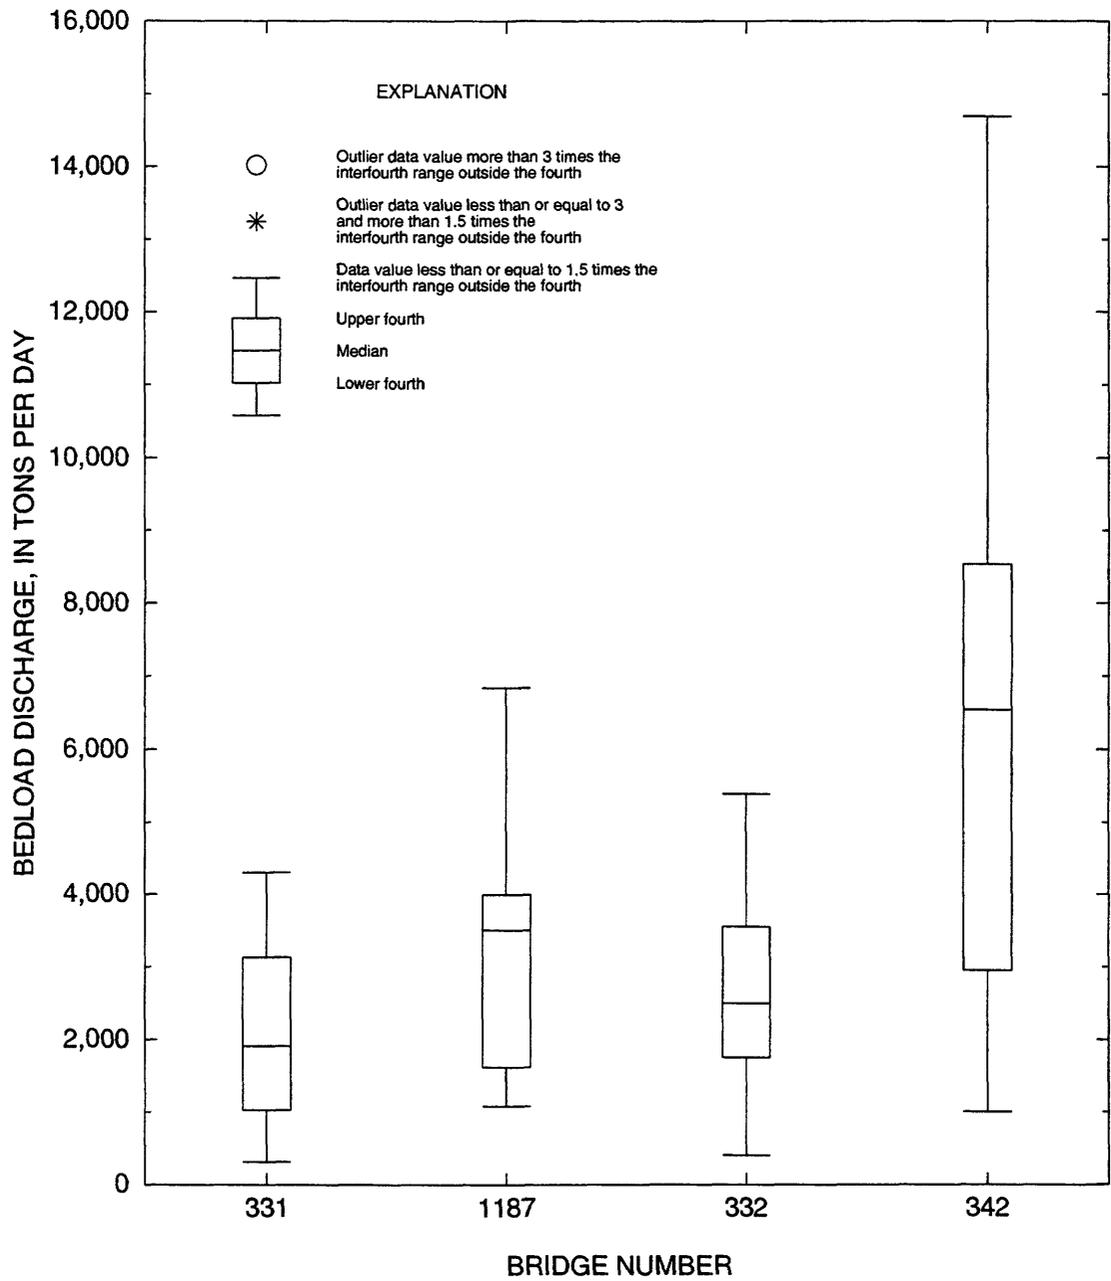
Figure 26. Boxplots of bedload discharge for Bridges 331, 1187, 332, and 342.

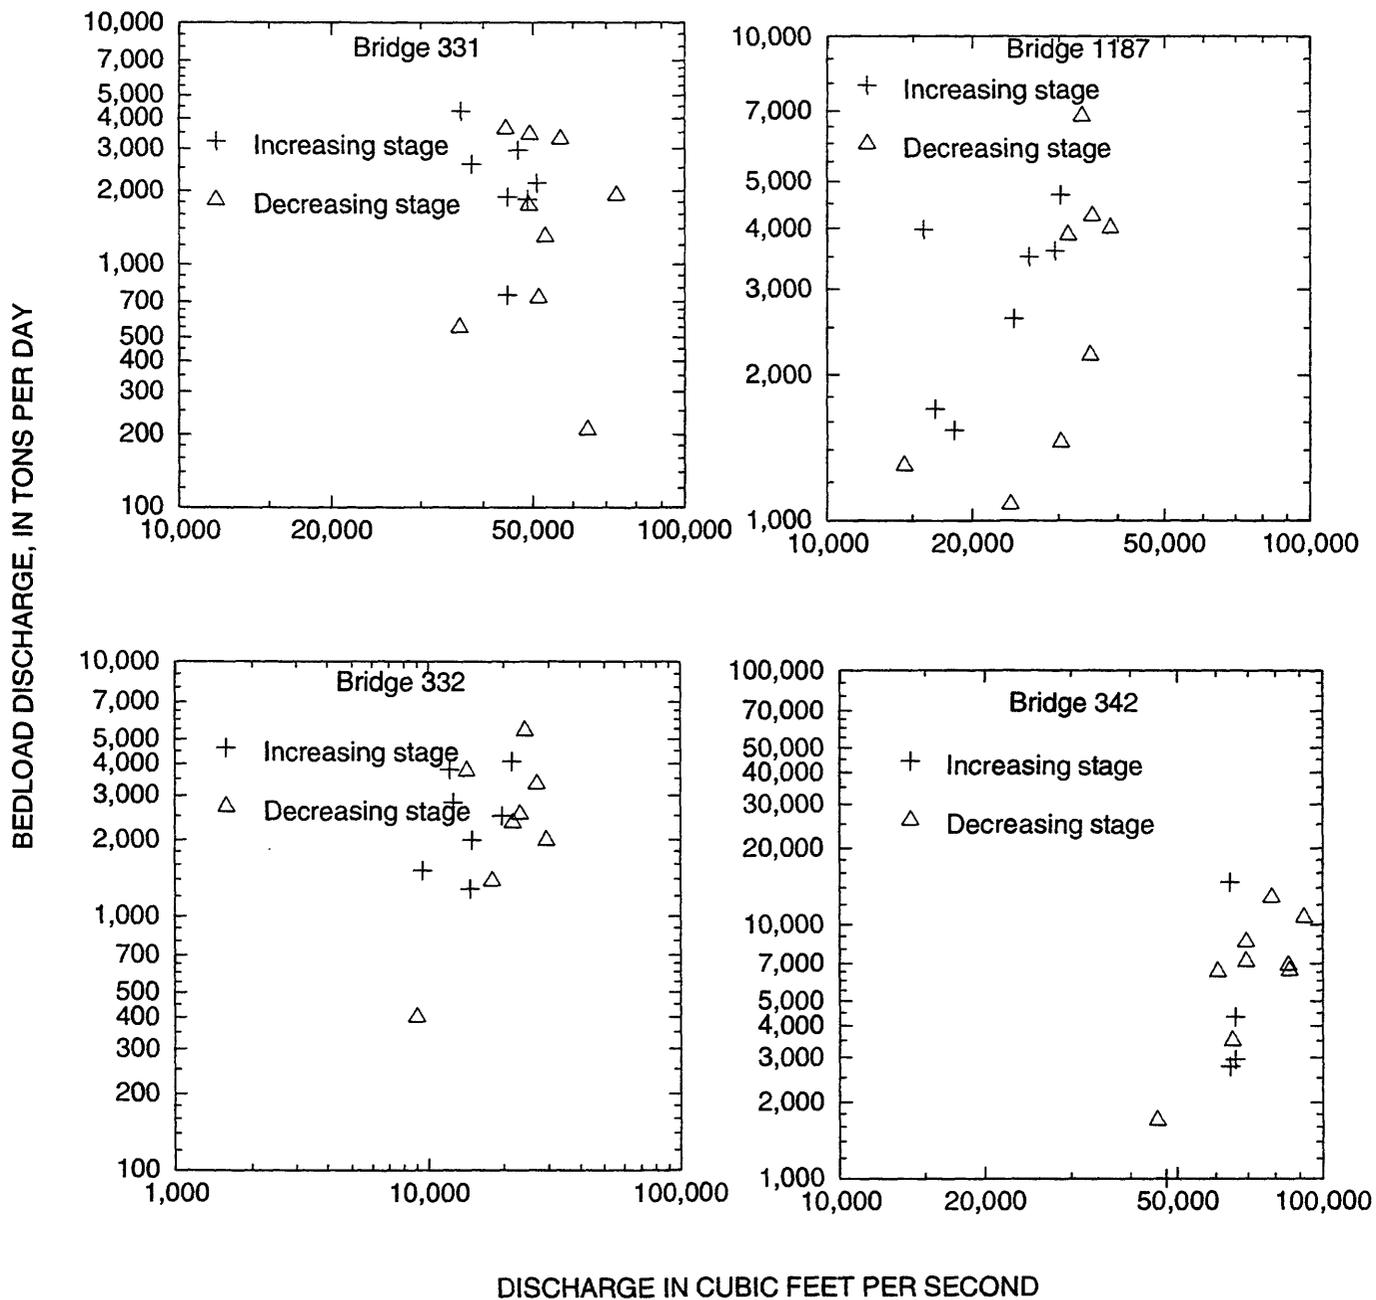
Figure 27. Bedload discharge and water discharge for the Copper River at Bridges 331, 1187, 332, and 342.

The bedload data were further analyzed to determine if some type of relation exists between bedload discharge and water discharge. In reaches where the supply of transportable sediment is not uniformly distributed, a pattern of bedload transport has been described by Klingeman and Emmett (1982). During a runoff period, the sediment supply at a sampling site downstream from an area in which large quantities of transportable sediment are stored is depleted during the rising stage of storm runoff. This depletion in supply results in reduced bedload discharges for a given water discharge. During the recession stage of storm runoff, the supply of transportable sediment at the sampling site is replaced by sediment scoured from the upstream storage area and bedload discharges increases. In comparing the bedload collected during a rising stage or a falling stage (fig. 27), this type of pattern appears to be evident at Bridge 342. More bedload was being transported during a falling stage or when discharge was decreasing. However, at Bridges 1187 and 332, the pattern appears to be reversed; more bedload was being transported during a rising stage when discharge was increasing.

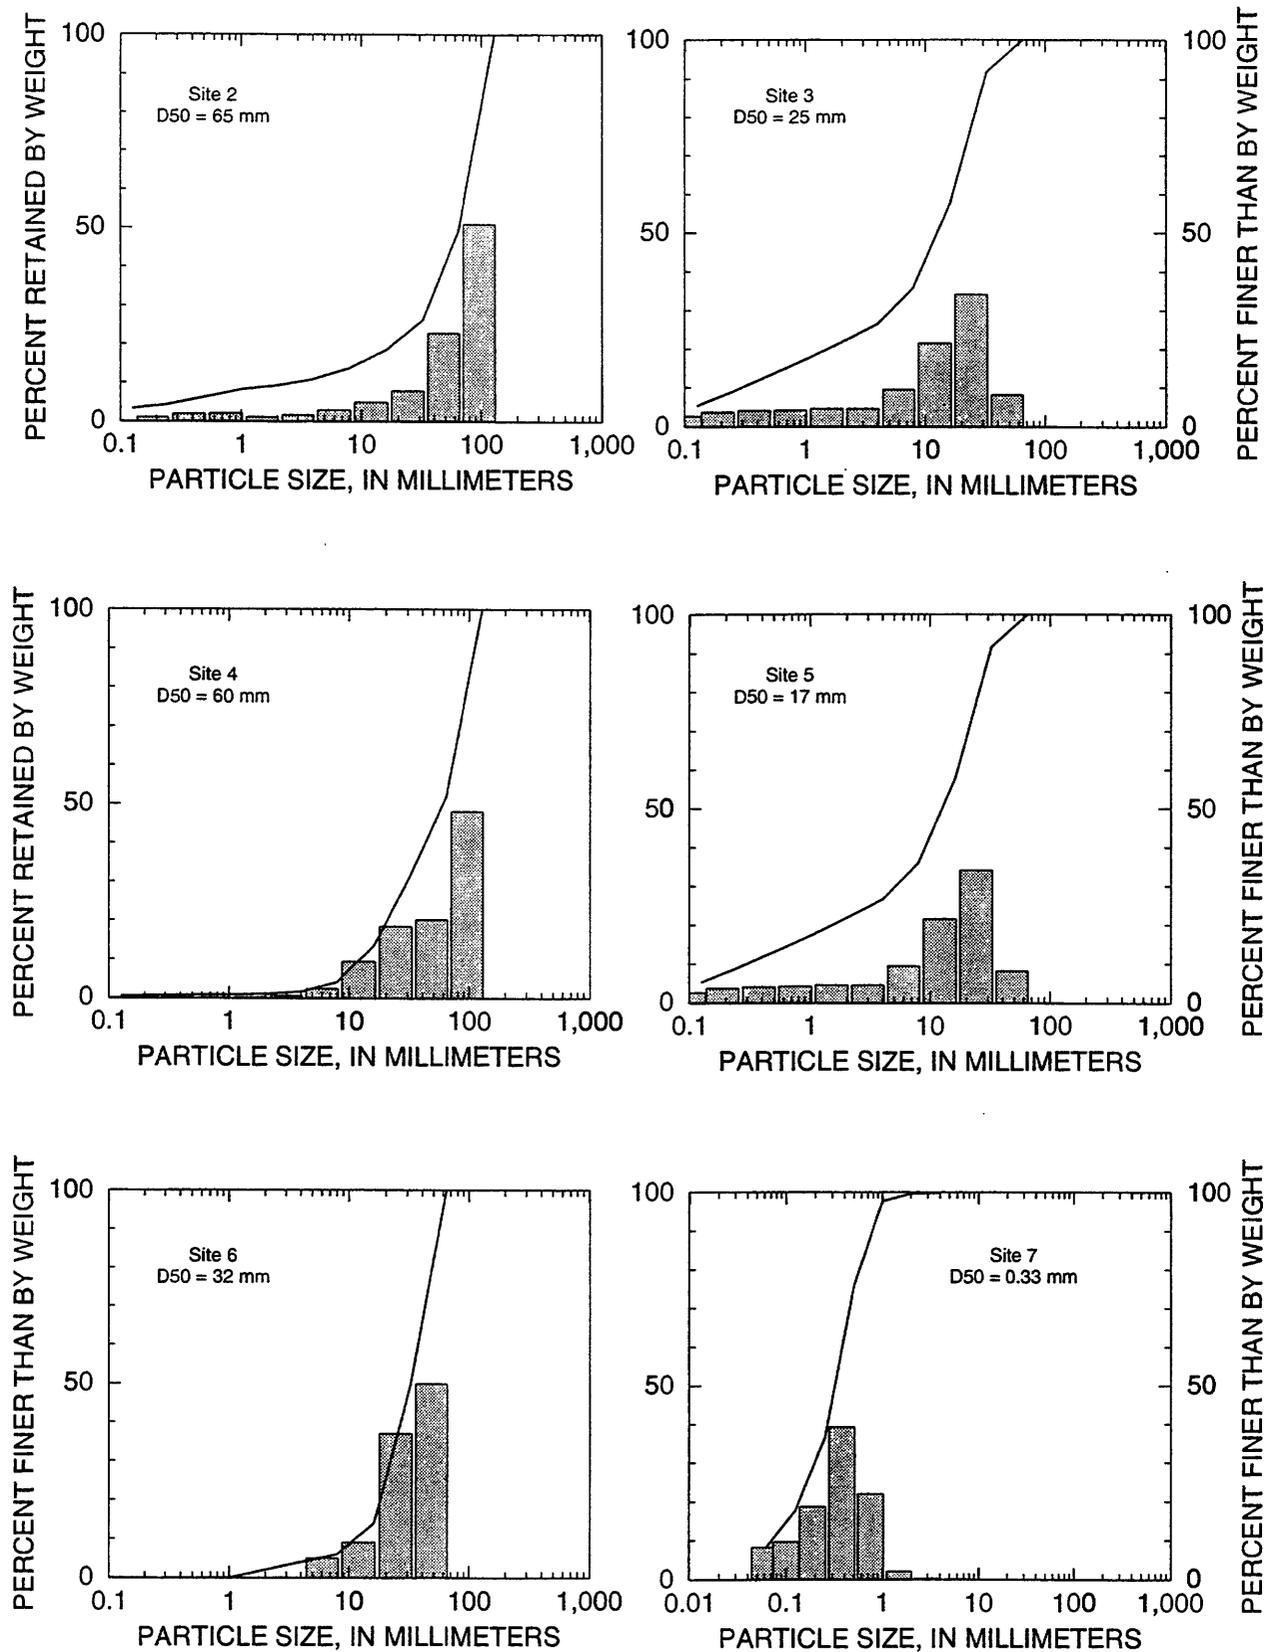
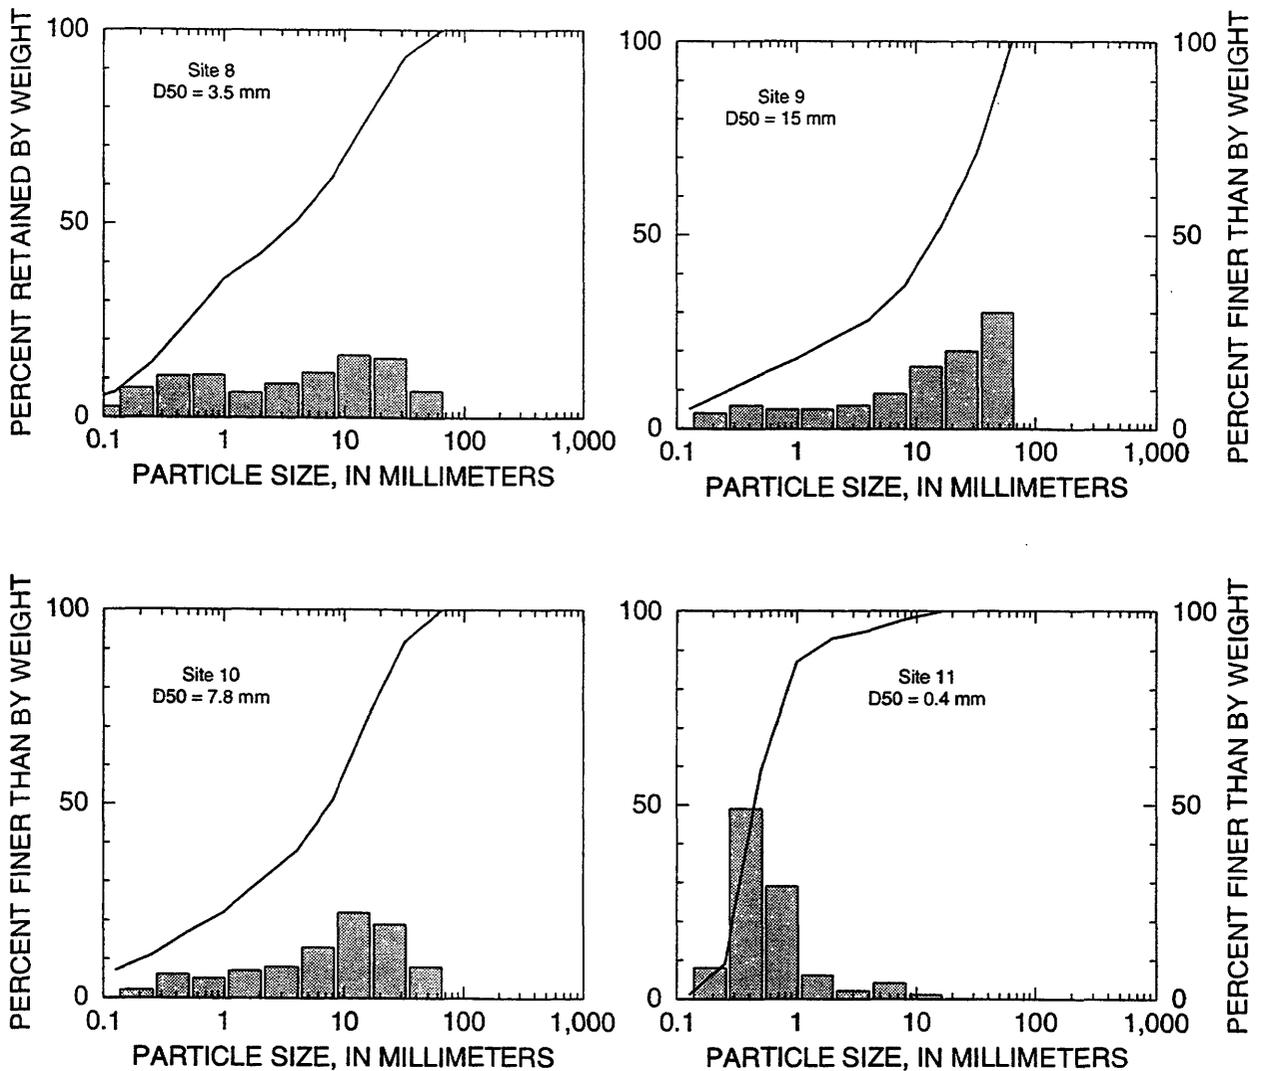
Figure 29. Particle-size distribution and median diameter of bed material samples of the Copper River.

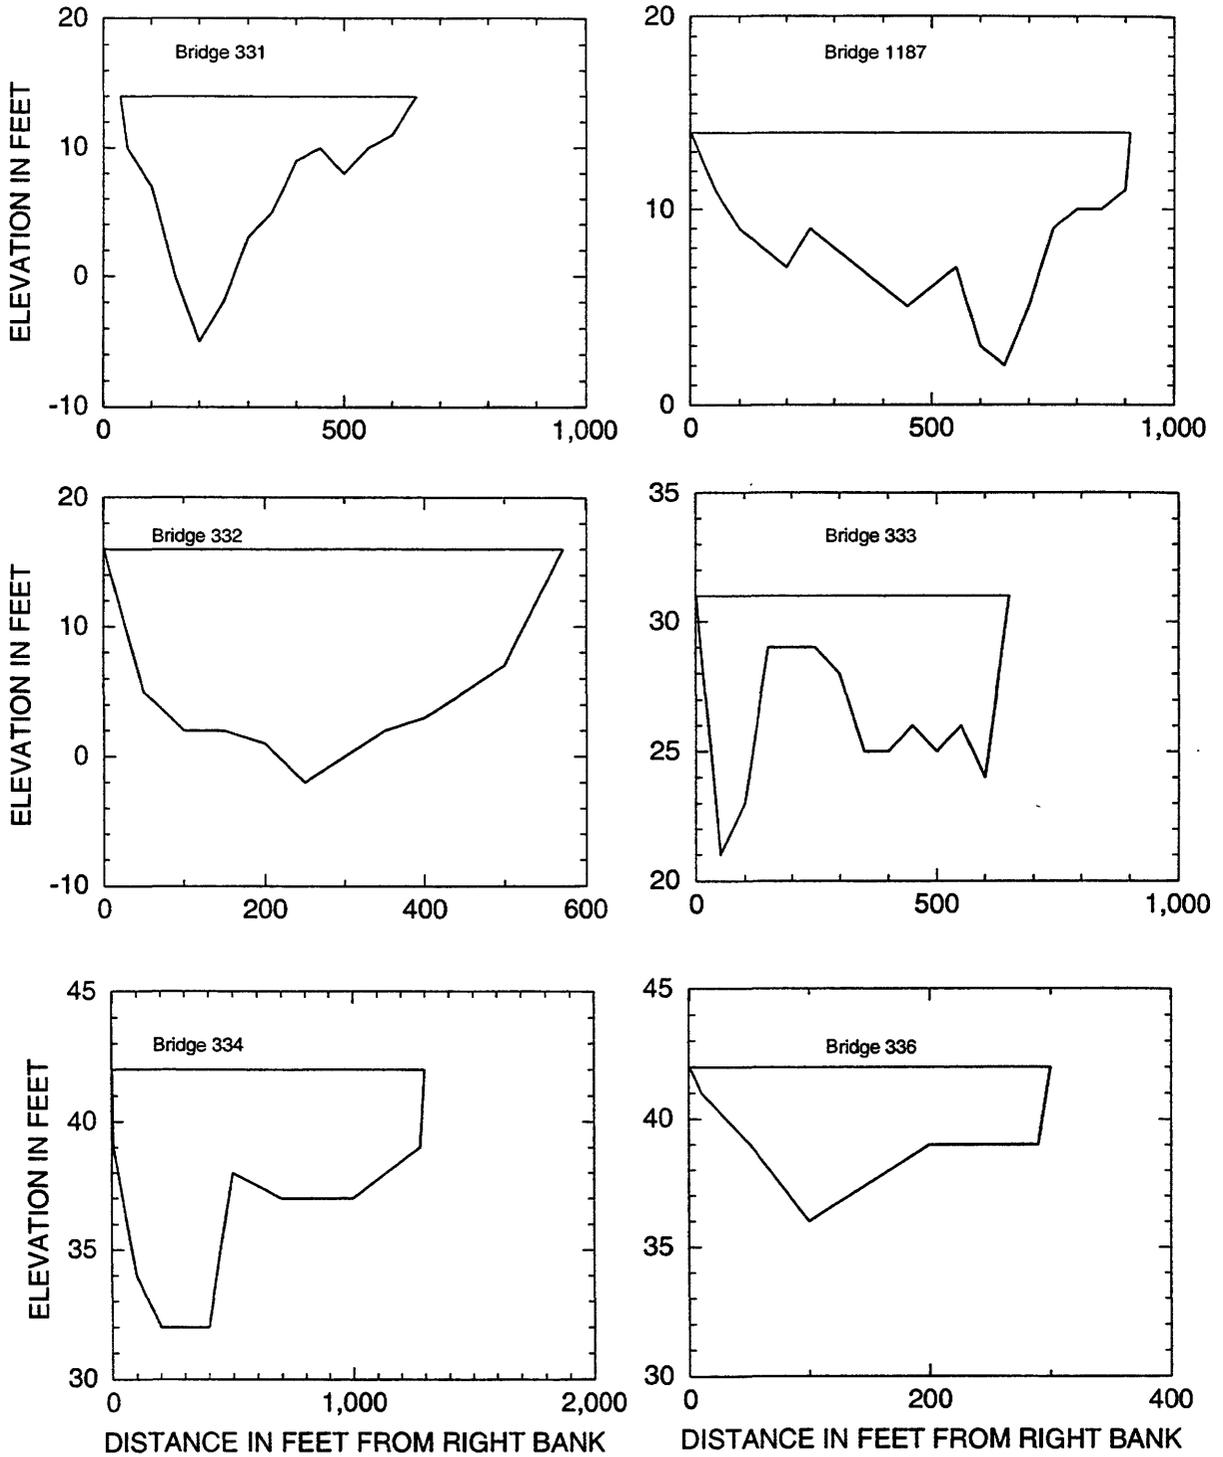
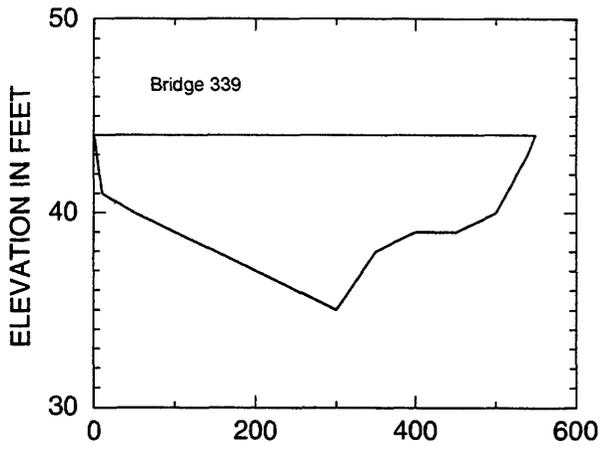
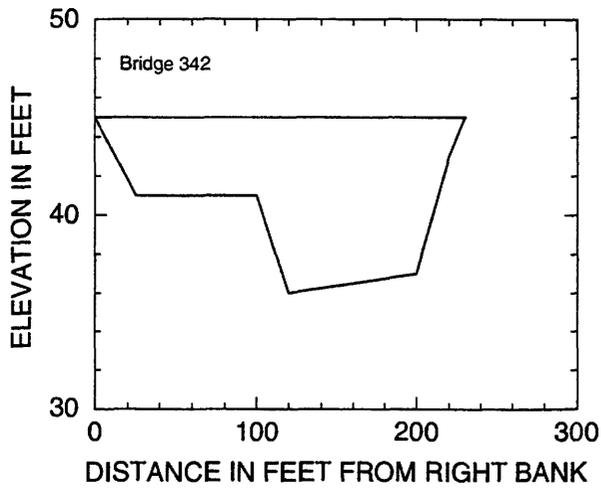
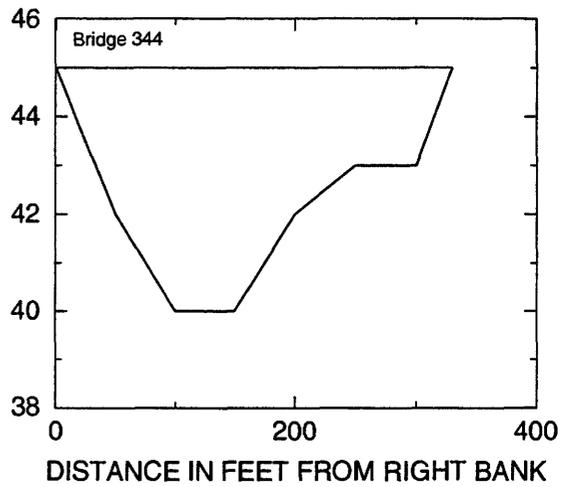
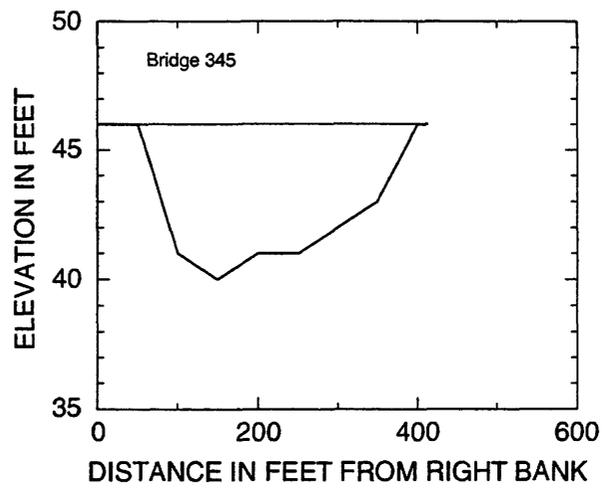
Figure 30. Cross sections of the Copper River at bridges along the Copper River and Northwestern Railway, 1908.

From 1908 to 1968, no significant channel changes appear to have taken place at Bridge 342 (fig. 30 and fig. 32). The channel at the bridge in 1968 was 280 ft wide and when the replacement bridge was constructed in 1976-78, the channel was cleaned out to a width of 400 ft. Three years later, during the 1981 flood, the Copper River cut a channel through the road at the approach to the bridge (Cordova Times, 1983).

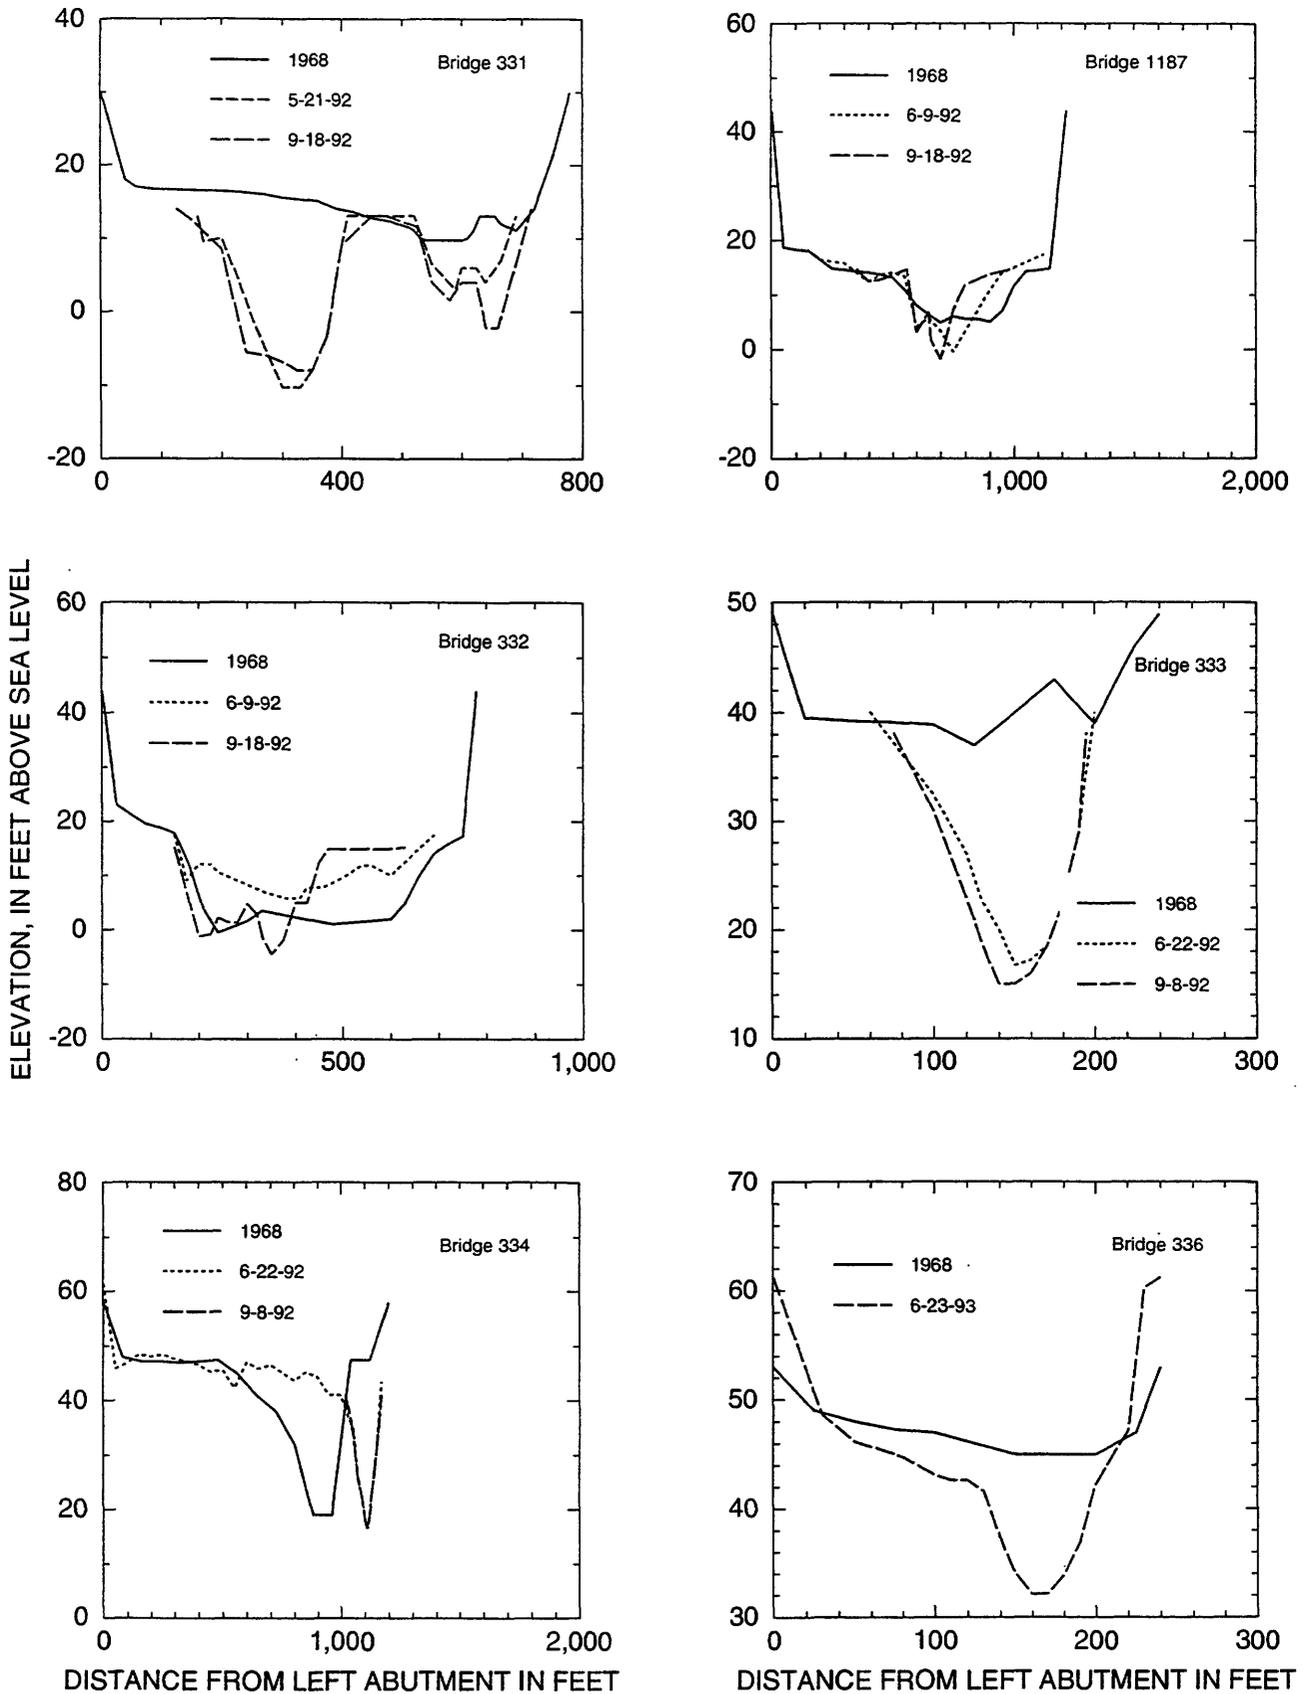
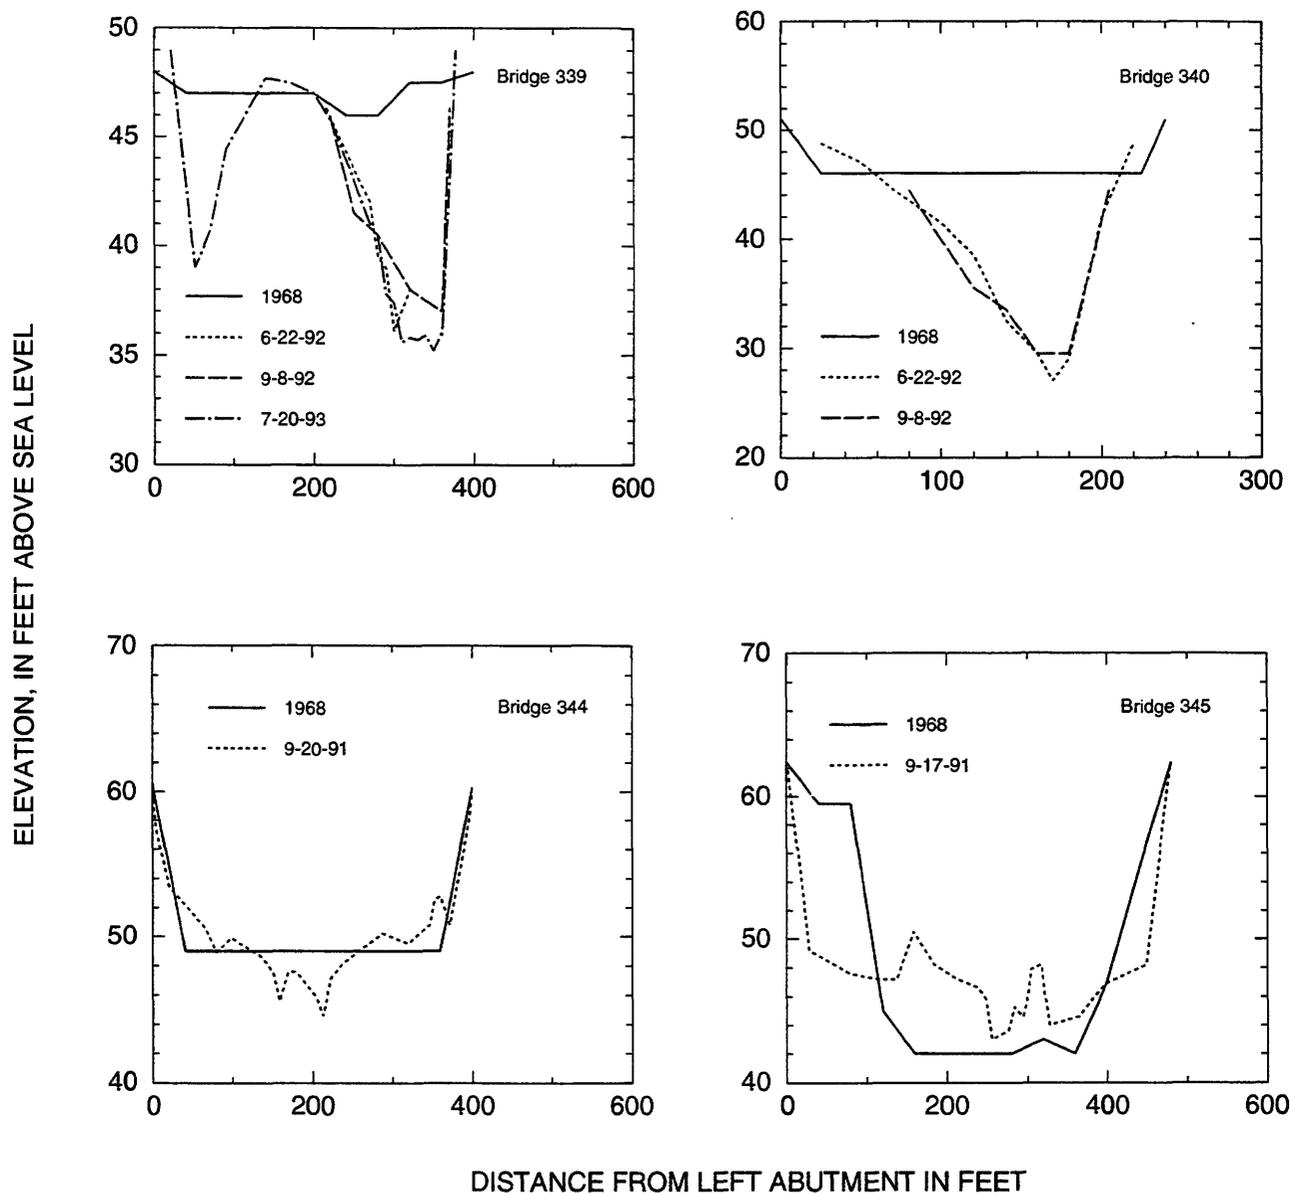
Figure 31. Cross sections of the Copper River at bridges along the Copper River Highway, 1968-1993.
