Geomorphology of the Lower Copper River, Alaska

U.S. GEOLOGICAL SURVEY

Open-File Report 96-500

By Timothy P. Brabets

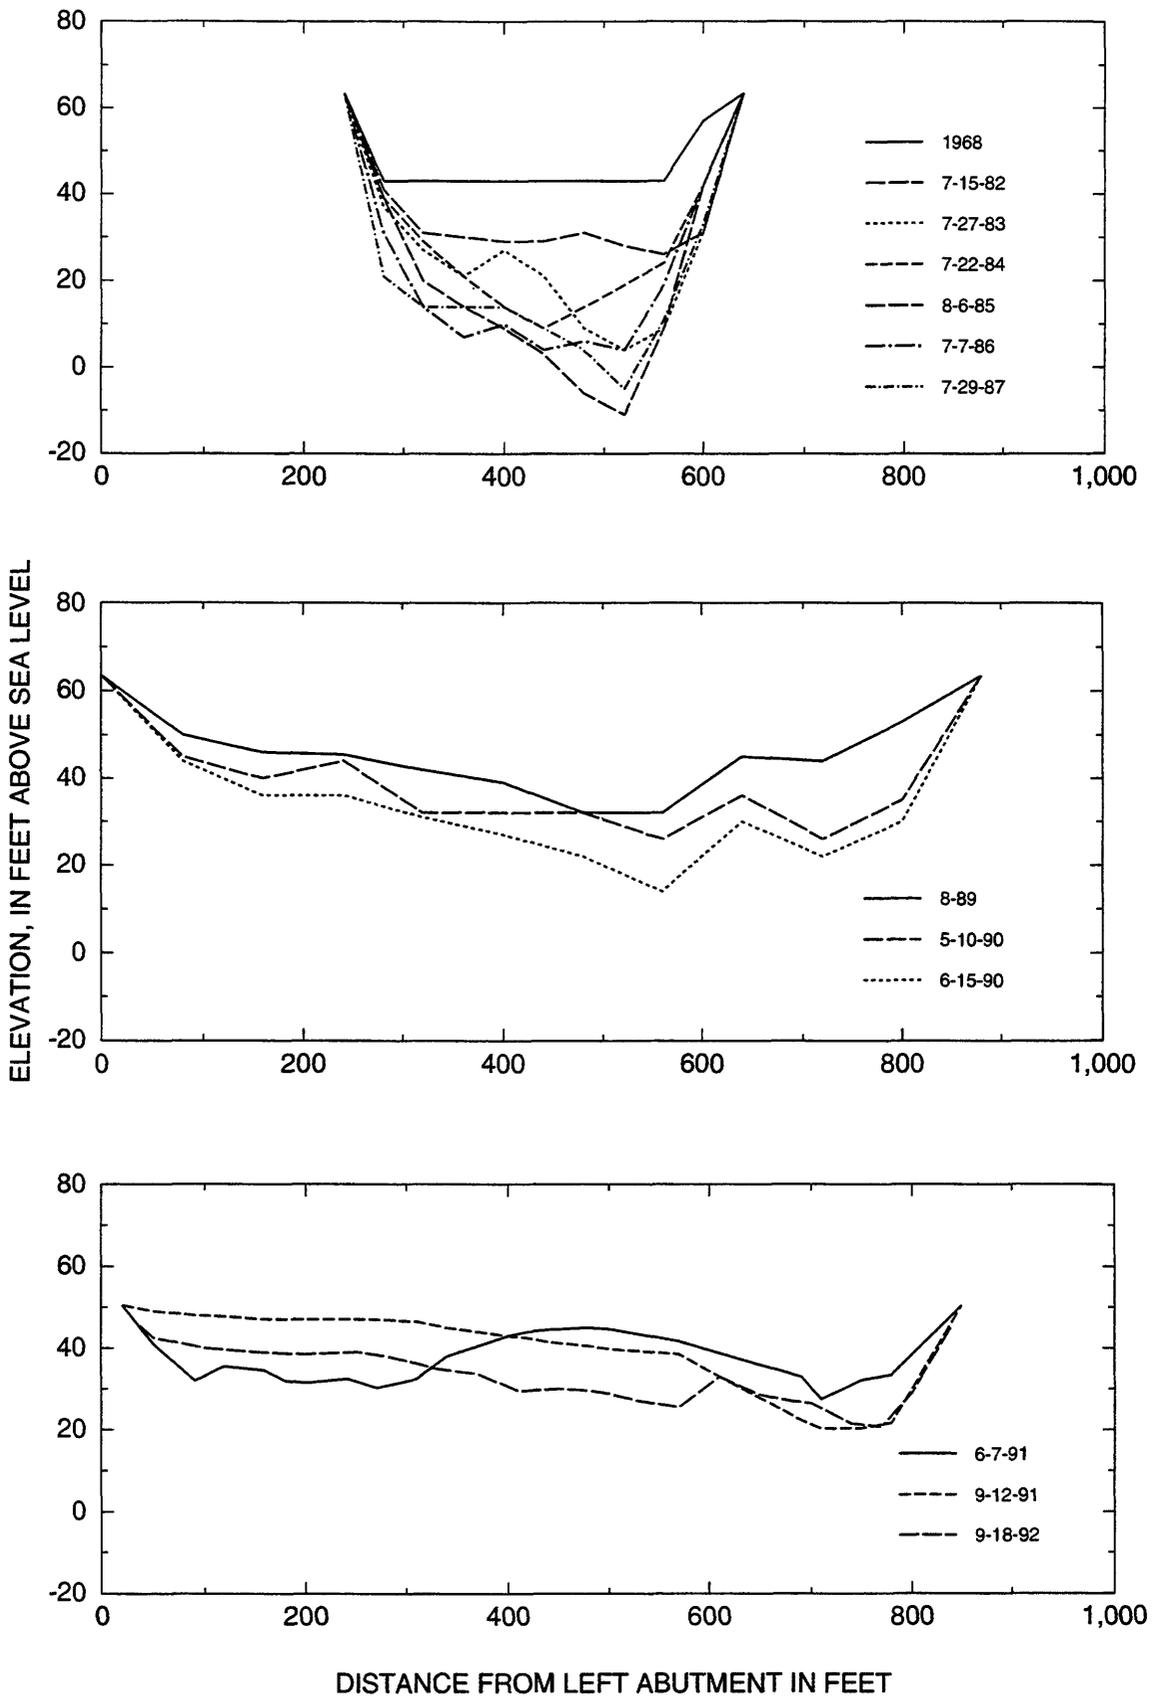
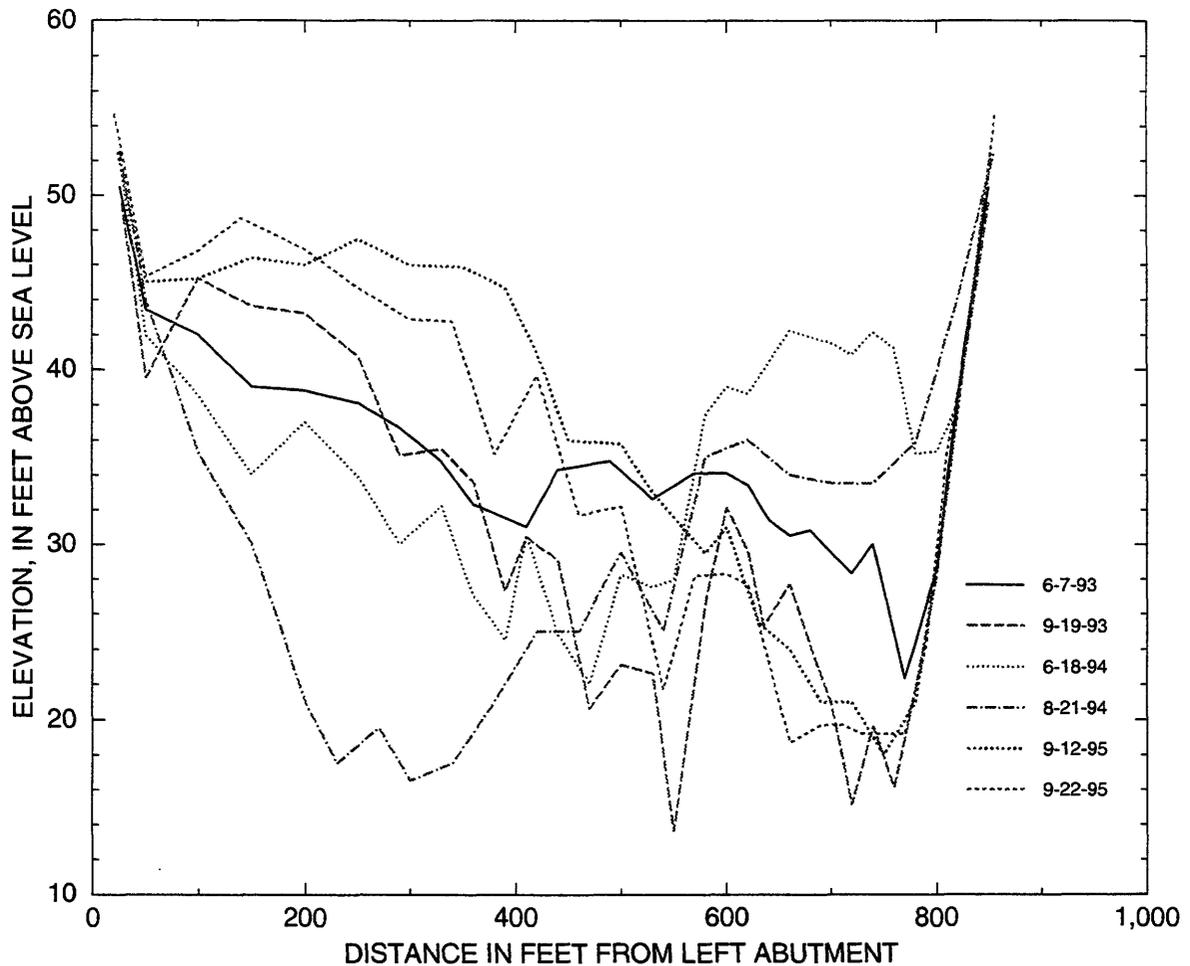
Figure 32. Cross sections of the Copper River at Bridge 342, 1968-1995.

From 1908 to 1968, no significant channel changes appear to have taken place at Bridge 342 (fig. 30 and fig. 32). The channel at the bridge in 1968 was 280 ft wide and when the replacement bridge was constructed in 1976-78, the channel was cleaned out to a width of 400 ft. Three years later, during the 1981 flood, the Copper River cut a channel through the road at the approach to the bridge (Cordova Times, 1983).

Beginning in 1982, the ADOT&PF began to monitor the streambed at Bridge 342 on a regular basis. Because of the increased flow through the bridge, contraction scour occurred. The channel continually scoured and filled, and as much as 54 ft of scour occurred from 1968 to 1985 at one point in the channel (fig. 32). From 1982 to 1987, the mean bed elevation of the channel decreased from 36.6 ft to 22.0 ft (table 12). Concern for the safety and integrity of the bridge led ADOT&PF to make major repairs to the structure in 1987. These repairs consisted of lengthening the bridge at each end by 240 ft (480 ft total) and constructing spur dikes at the left and right upstream abutments. Construction was completed in November 1988.

upstream spur dike. The flow of the Copper River was directed at the highway embankment and then flowed westward under the bridge. This resulting change in flow direction caused considerable scour on the right side of the channel (fig. 32) and lowered the mean bed elevation to 34.9 ft. In 1990-91, the spur dikes were rebuilt to a higher elevation. Since that time, the channel has continued to shift. In 1991, the tip of a gravel bar upstream from the bridge was about 300 ft from the tip of the rebuilt spur dike (fig. 33-34). From 1991 to 1993, surveys showed the gradual erosion of the gravel bar and the gradual realignment of the channel. In 1991, the angle of flow to Bridge 342 was approximately 70 degrees. By 1994, visual observations indicated that most of the gravel bar had eroded and that the angle of flow to the bridge was nearly 90 degrees. This realignment most

likely caused the scour on the left side of the channel (fig. 32). In 1995, visual observation indicated that the gravel bar had reappeared and the angle of flow had returned to about 70 degrees. This change in flow direction most likely caused fill to occur in the left side of the channel.

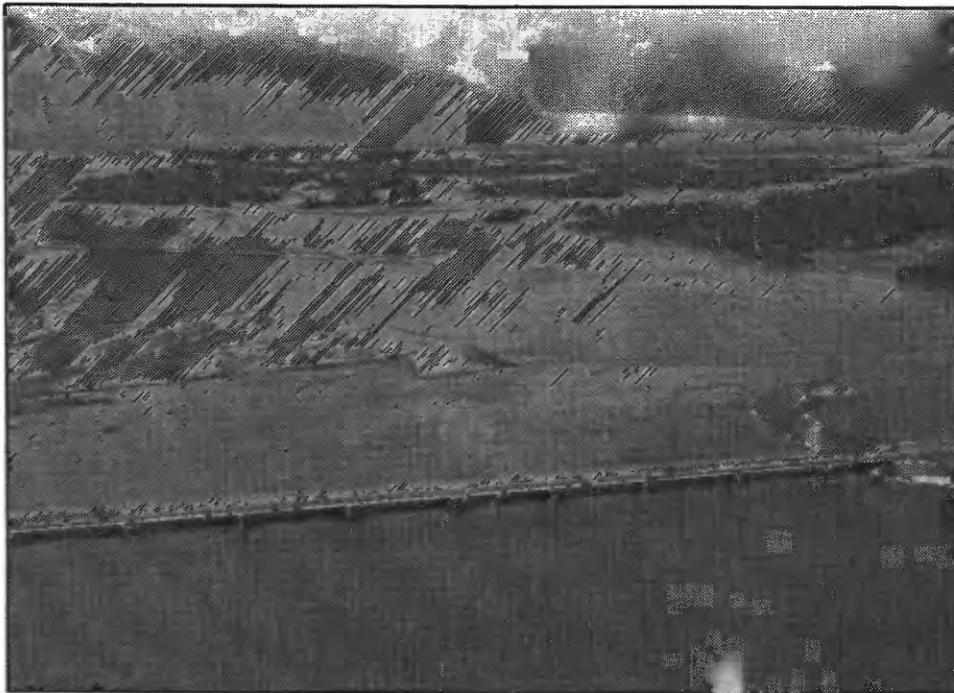
Figure 33. Bridge 342, spur dike, and gravel bar: top, September 1991; bottom, September 1992. View is looking upstream from the bridge.

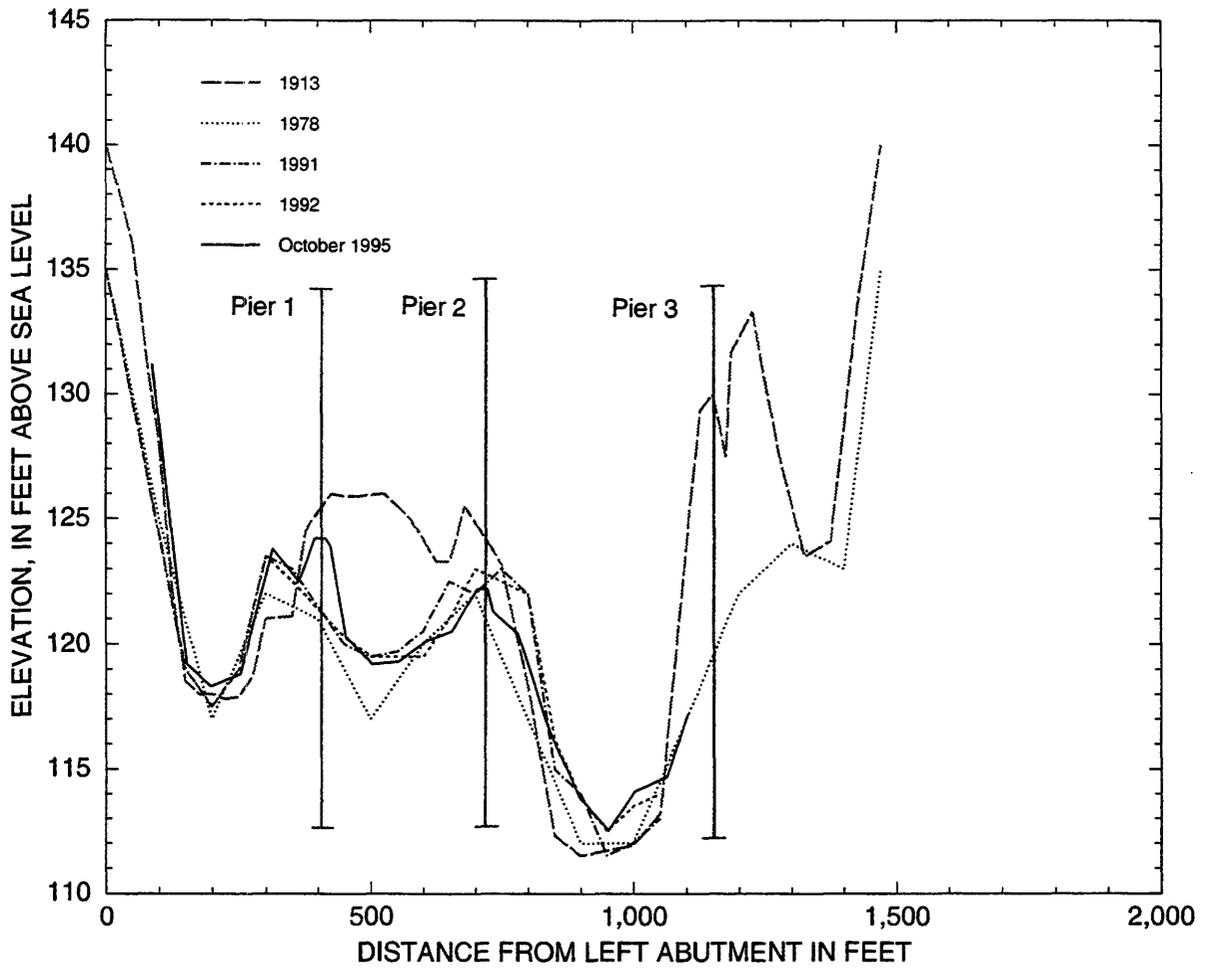
Figure 35. Cross sections of the Copper River at the Million Dollar Bridge, 1913-1995.

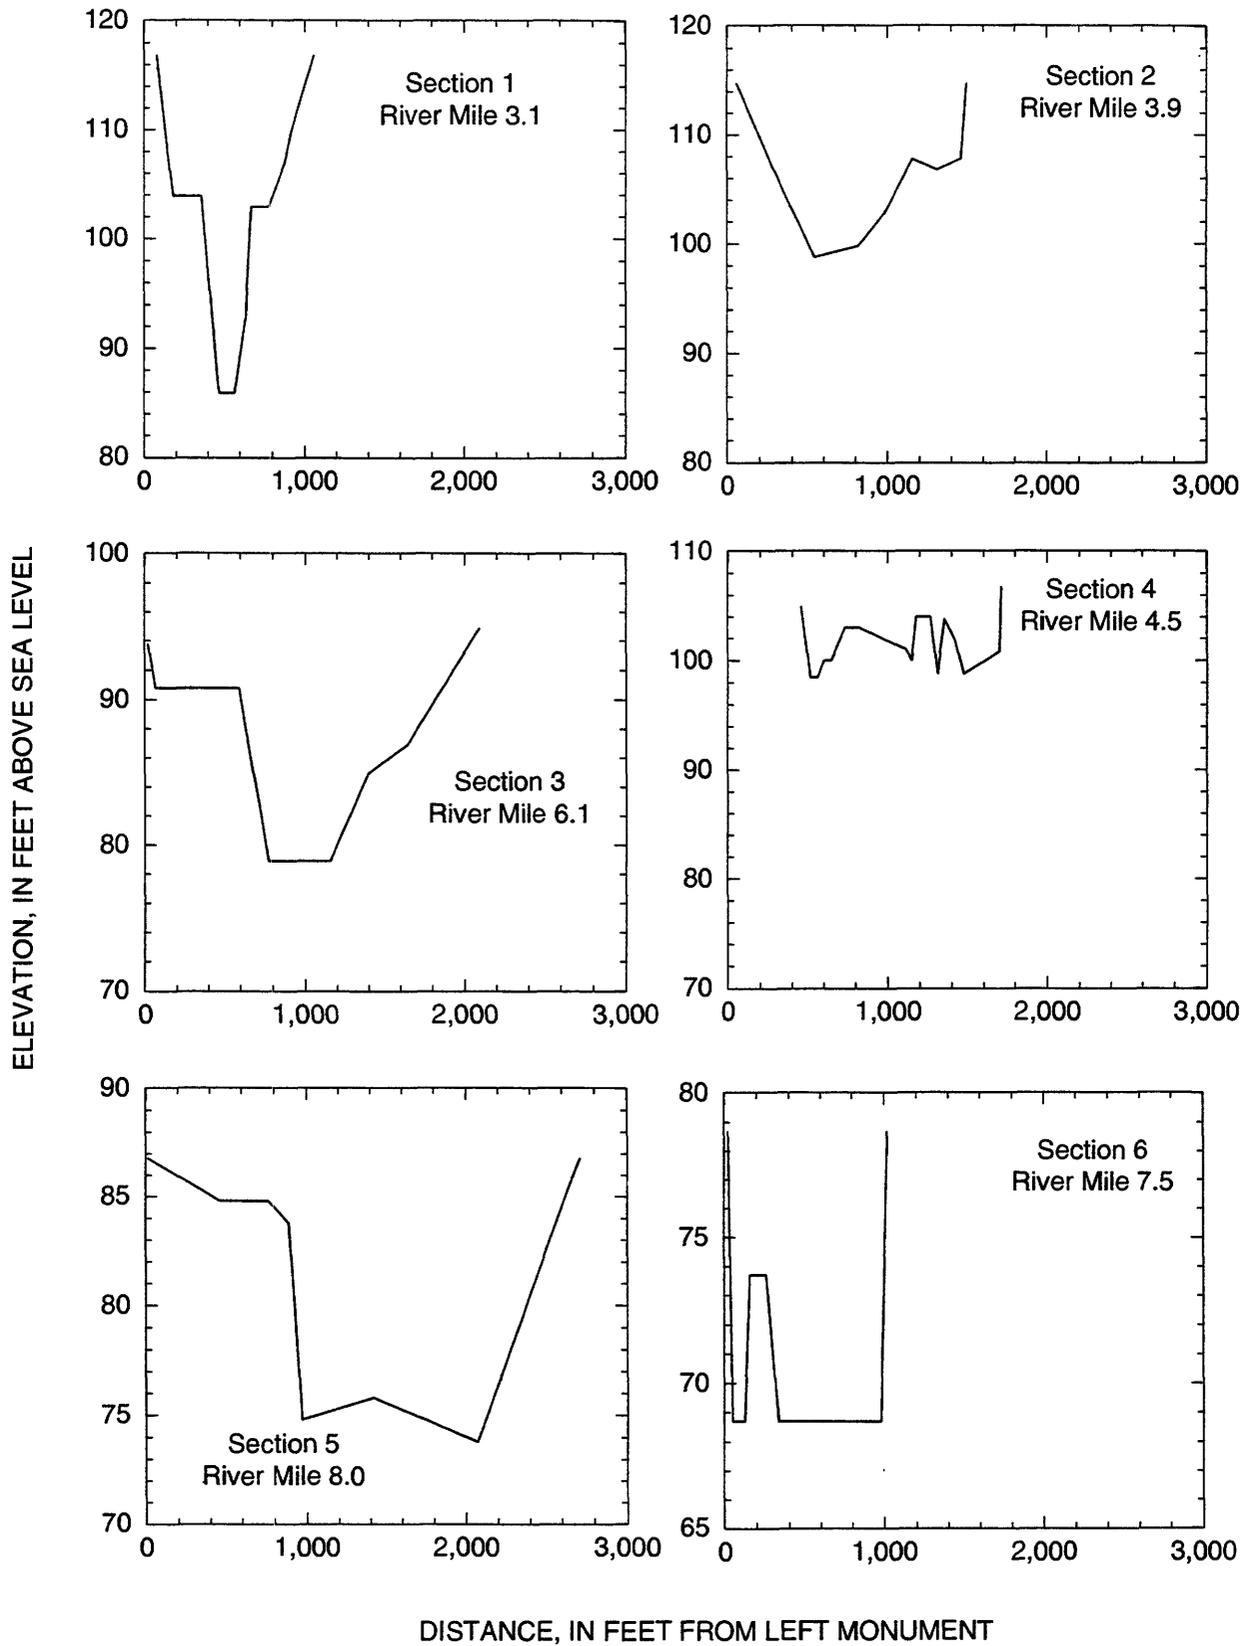
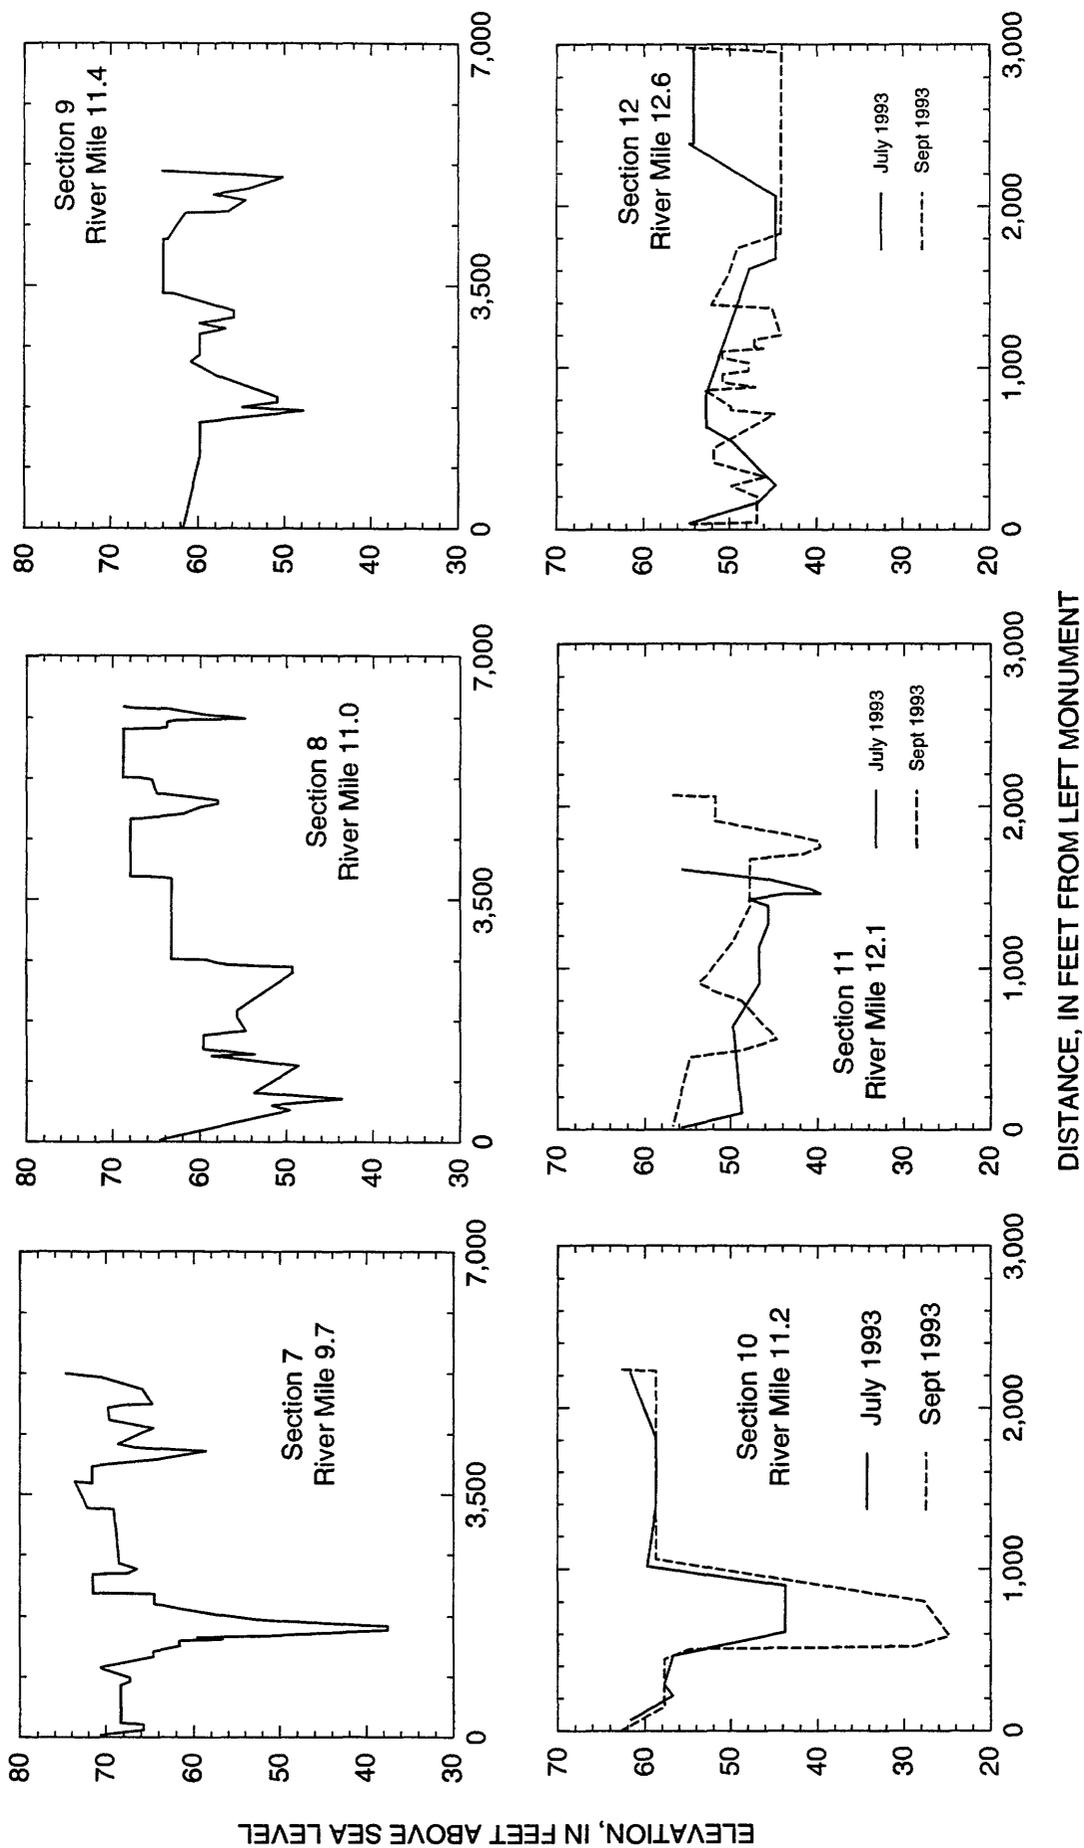
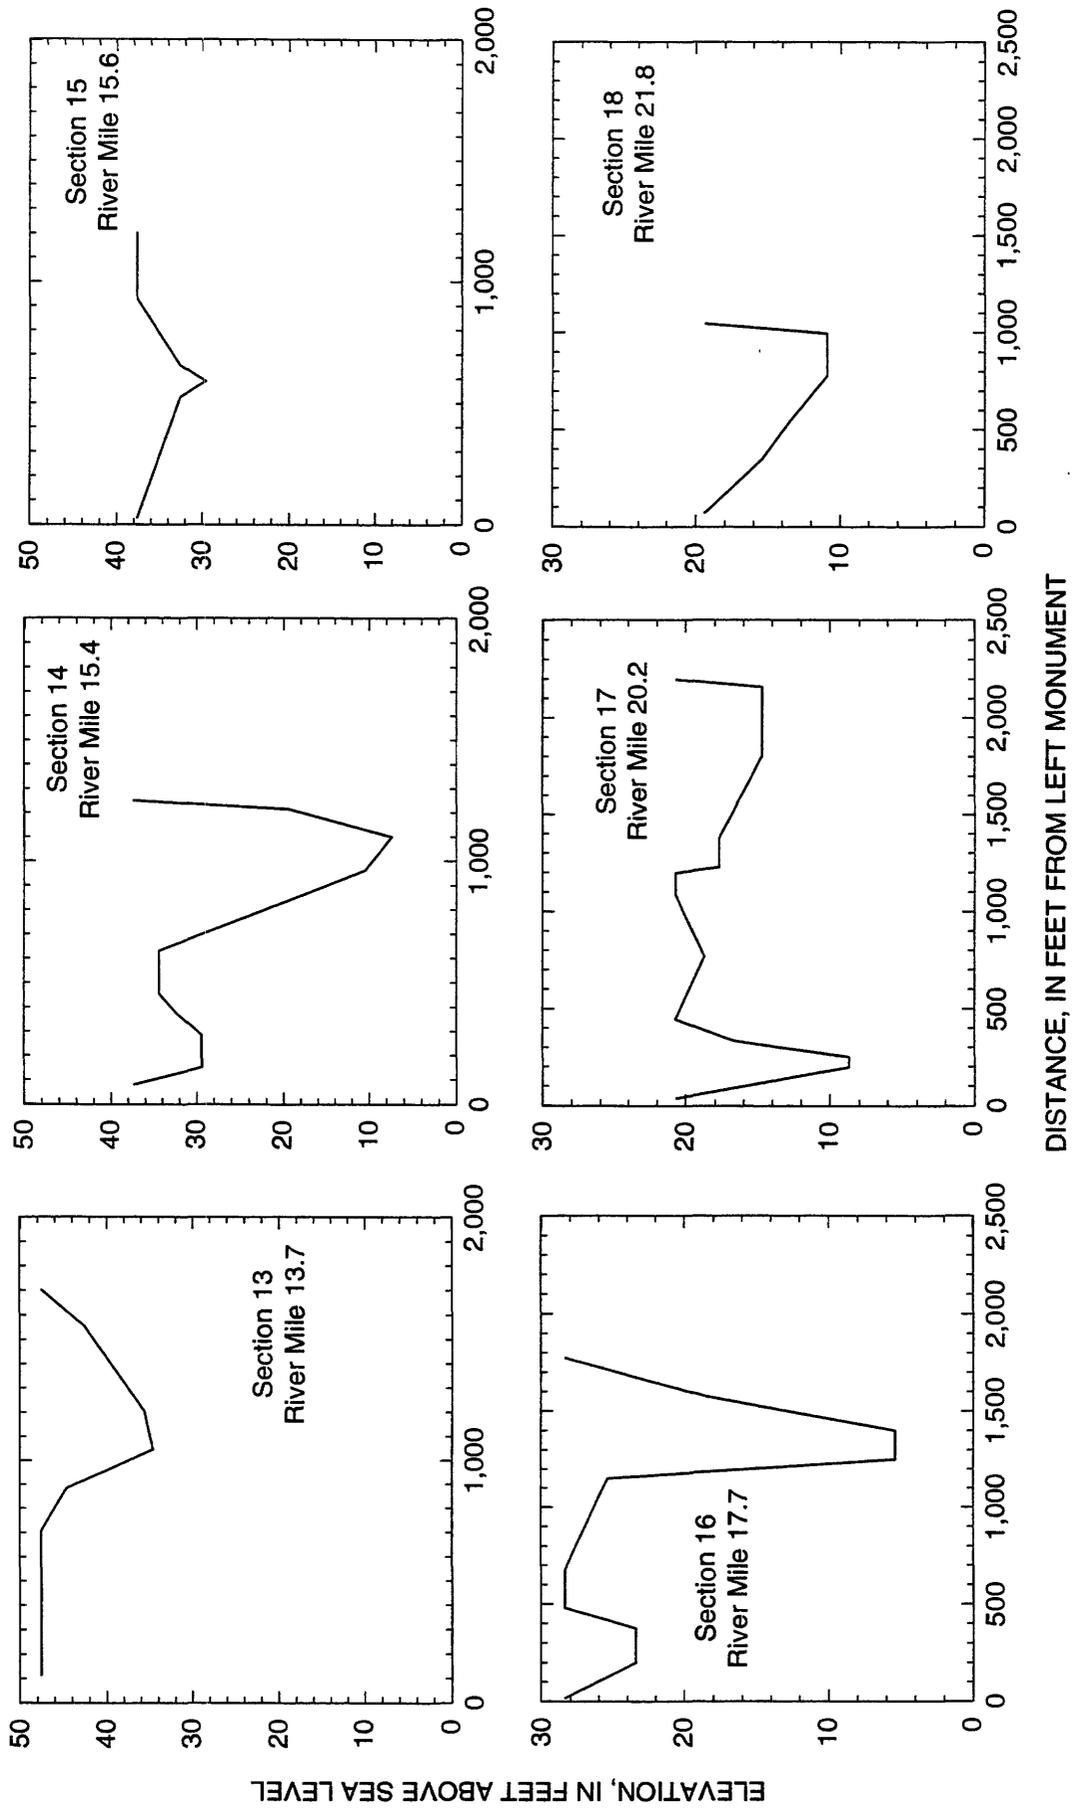
Figure 37. Cross sections of the Copper River, 1993 (see figure 36 for cross-section locations).

Cross section 1 (fig. 37) is located just downstream from Childs Glacier. The bed material at this site is composed of large cobbles and boulders, similar to the characteristics found at the Million Dollar Bridge. The section is uniform and deep and not likely to change because of the type of material. The remaining cross sections are located within the alluvial plain and are expected to change.

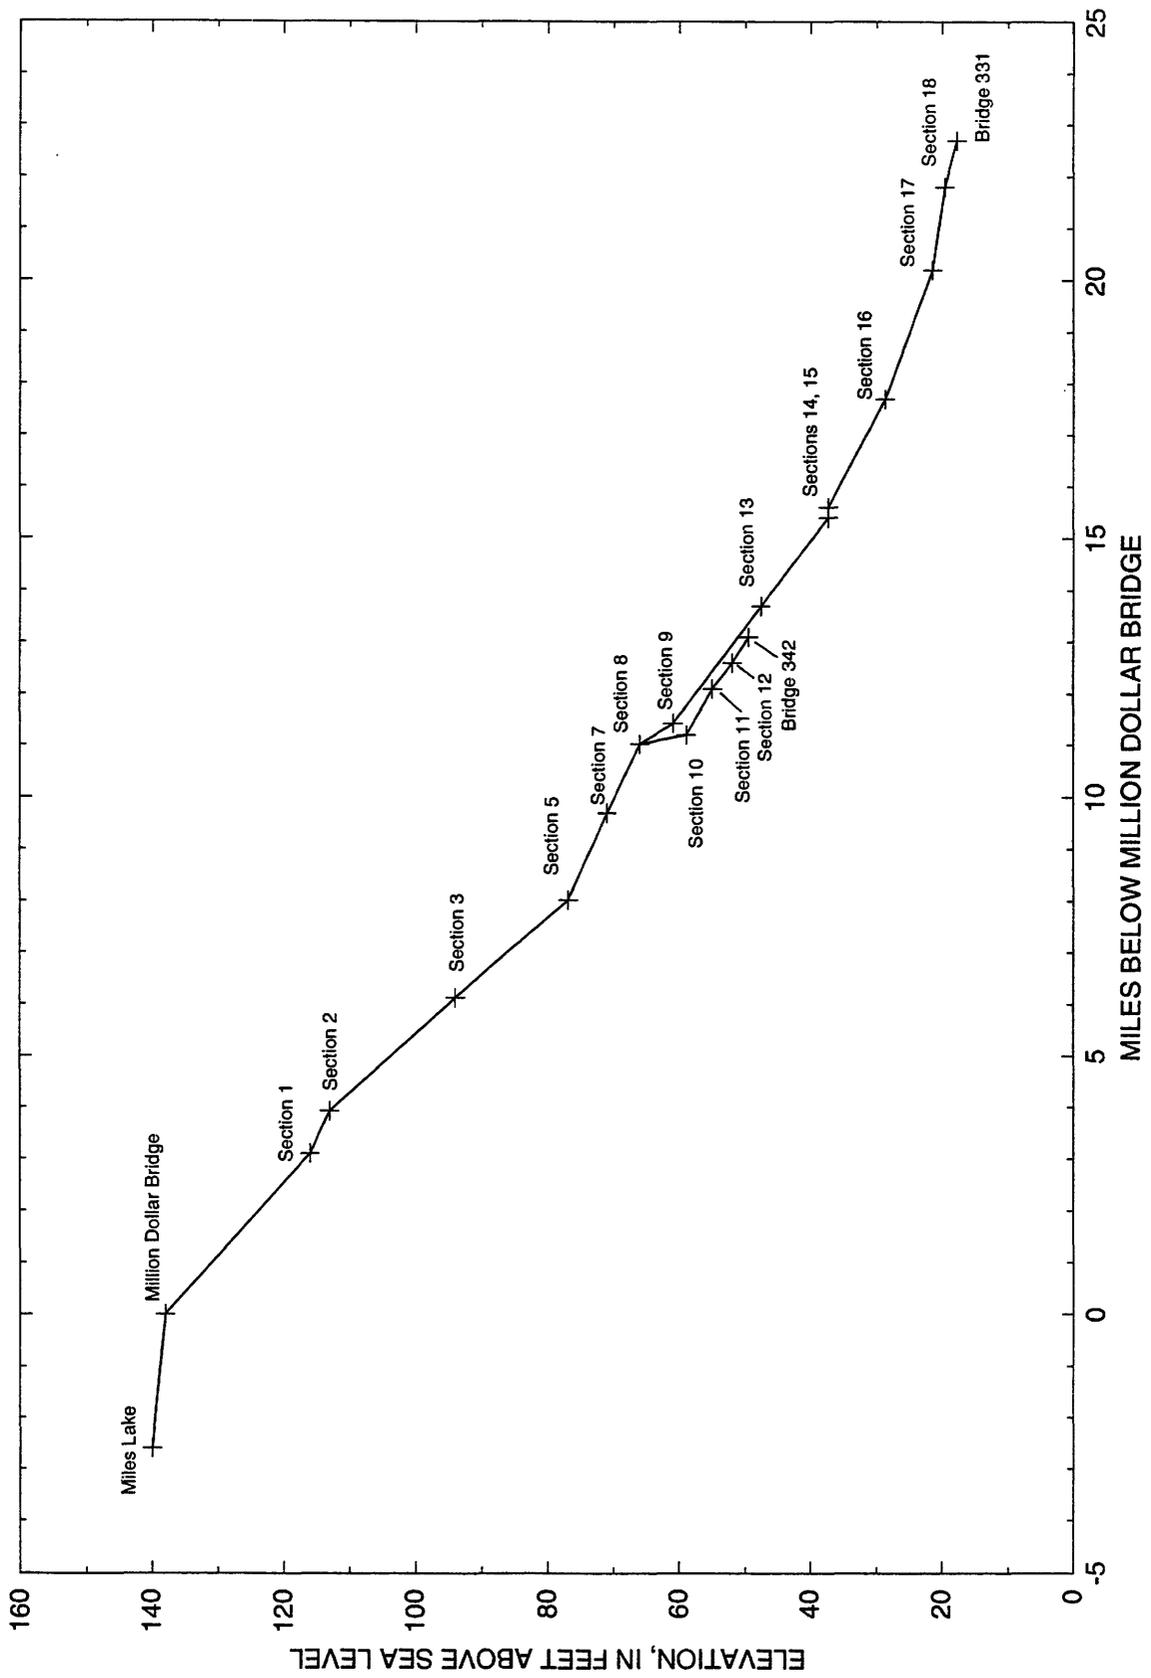
Figure 38. Water surface elevations at locations along the Copper River.

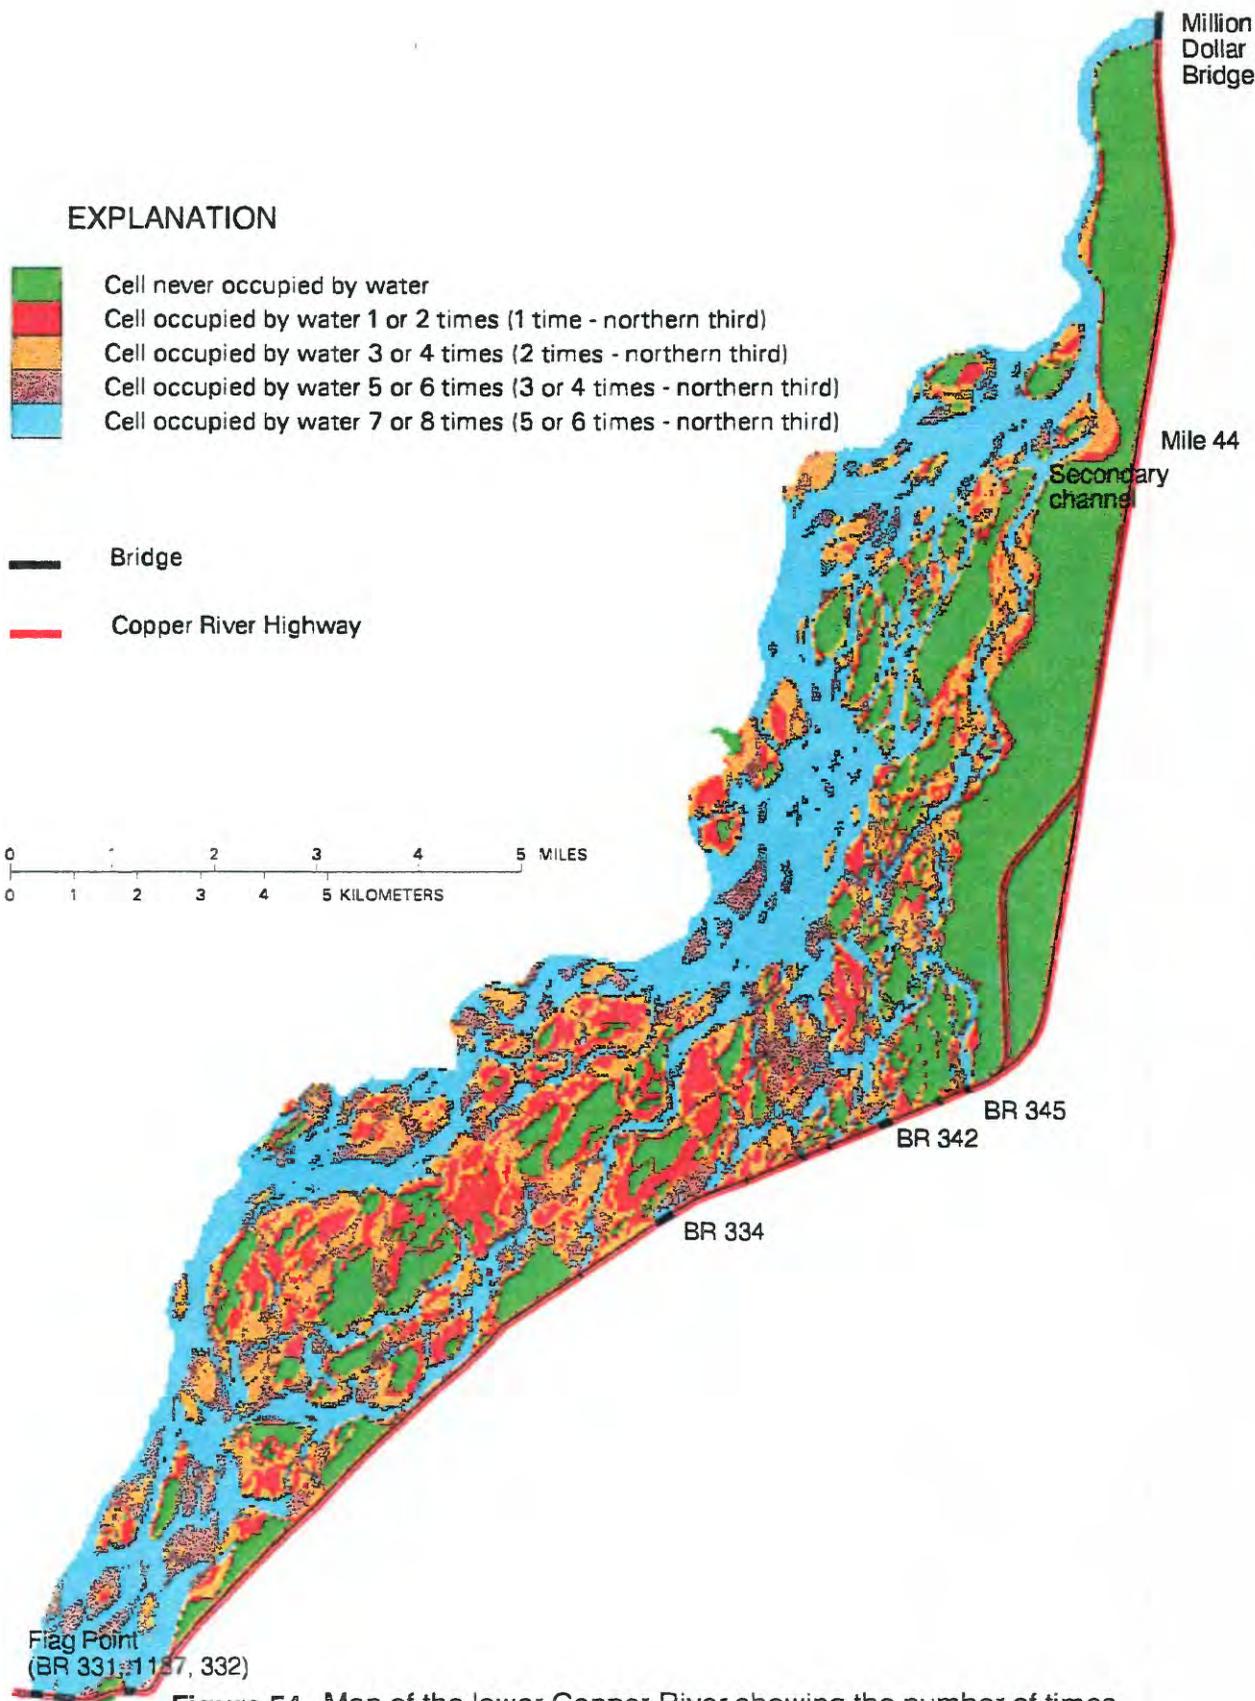
Figure 54. Map of the lower Copper River showing the number of times a cell has been occupied by water.

A probability analysis of the lower Copper River indicated stable areas and the long-term locations of channels. By knowing the number of times a particular area has been occupied by water and the last year an area was occupied by water, areas of instability can be located. A Markov analysis of the lower Copper River indicated that the tendency of the flood plain is to remain in its current state. Large floods of the magnitude of the 1981 event are believed to be the cause of major changes in the lower Copper River.

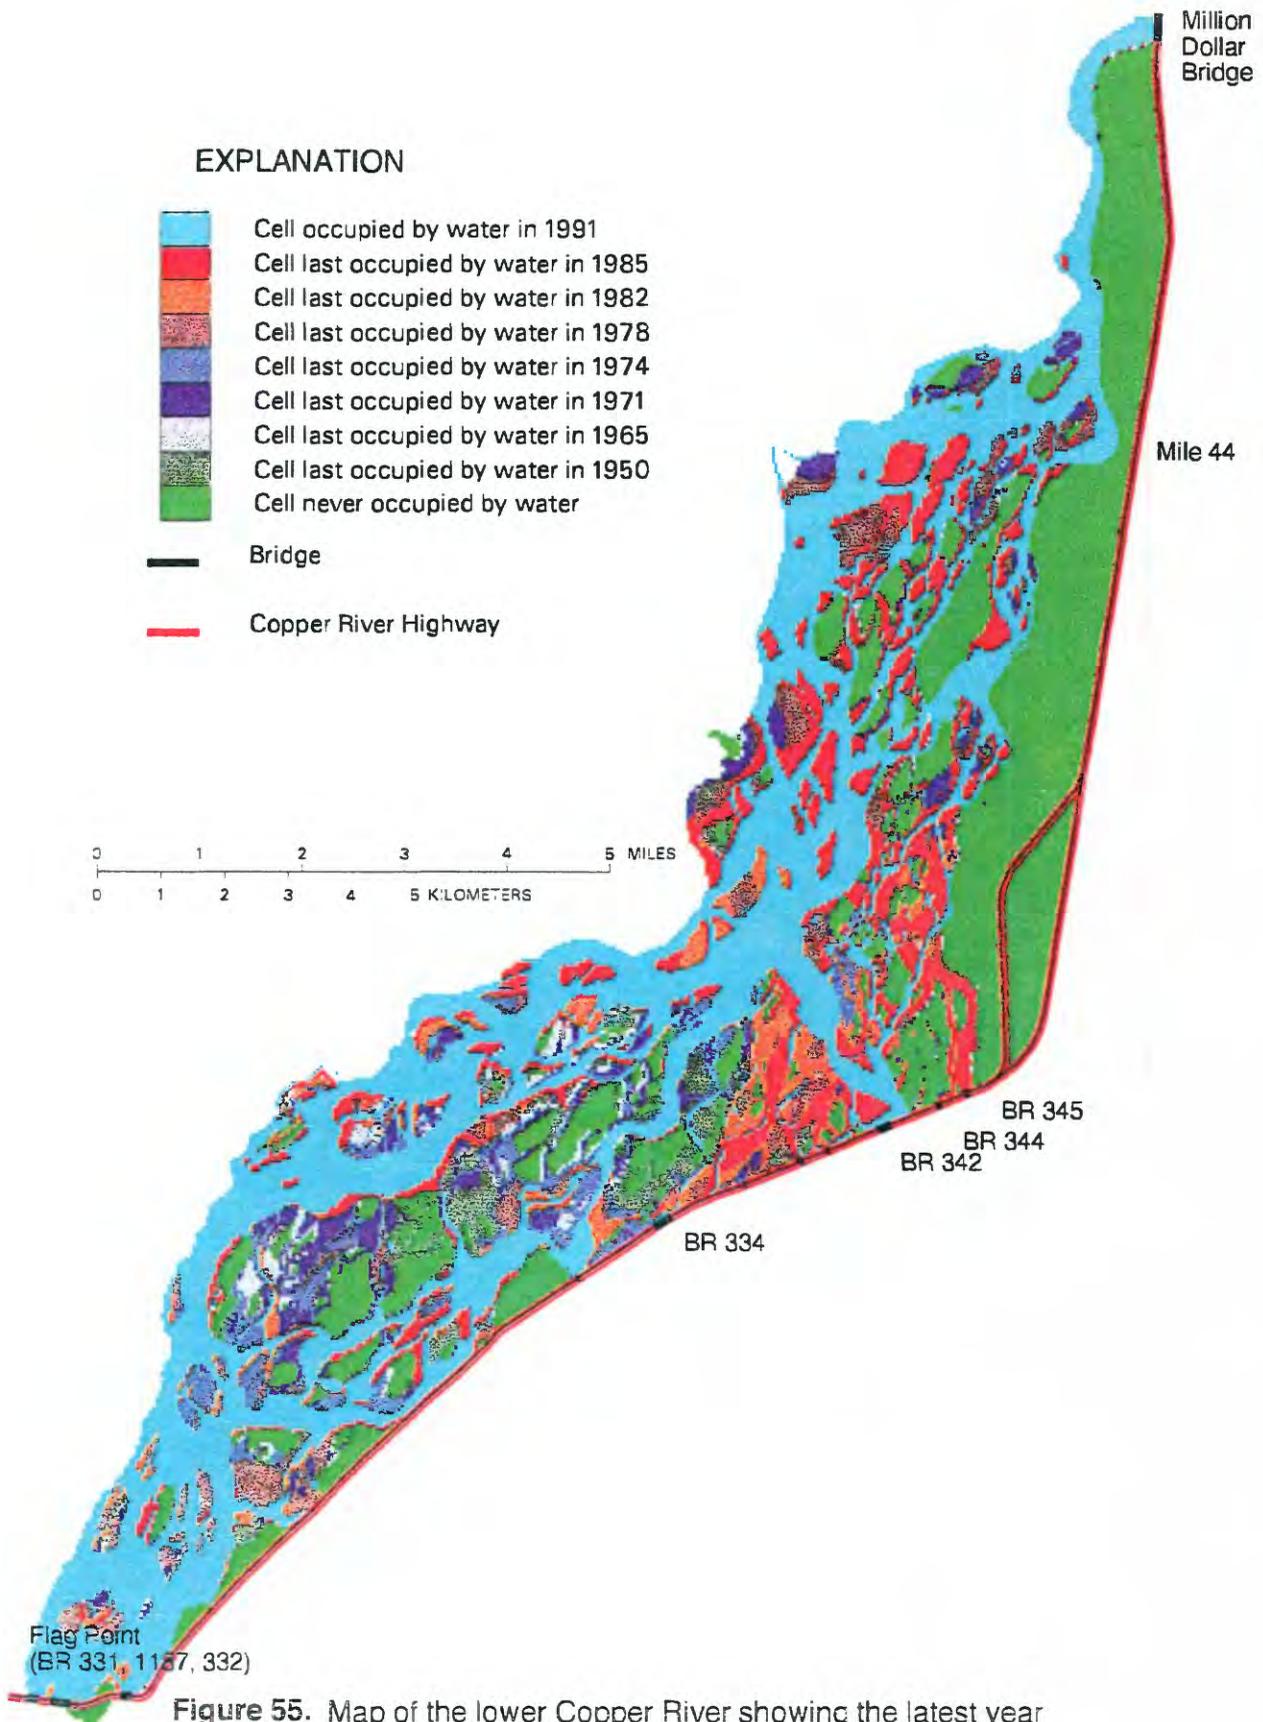
Figure 55. Map of the lower Copper River showing the latest year a cell has been occupied by water.
