Philadelphia Merchants' Exchange Conservation Strategy:
Marble Characteristics and Deterioration

Open-File Report 96- *519*

Chapter 2: MARBLE CHARACTERISTICS AND DETERIORATION

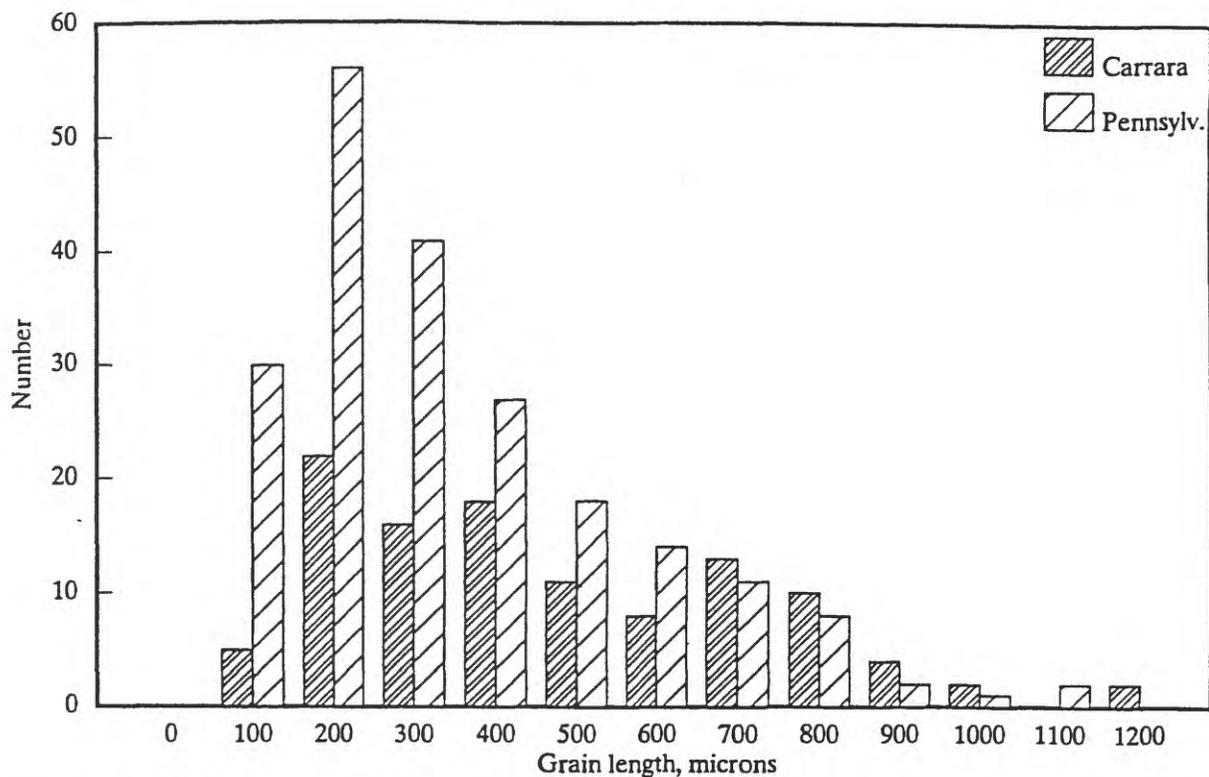
Figure 14. Calcite grain size for Pennsylvania and Carrara marble samples; longest dimension of grains measured in microns vs. number of grains in each size range.

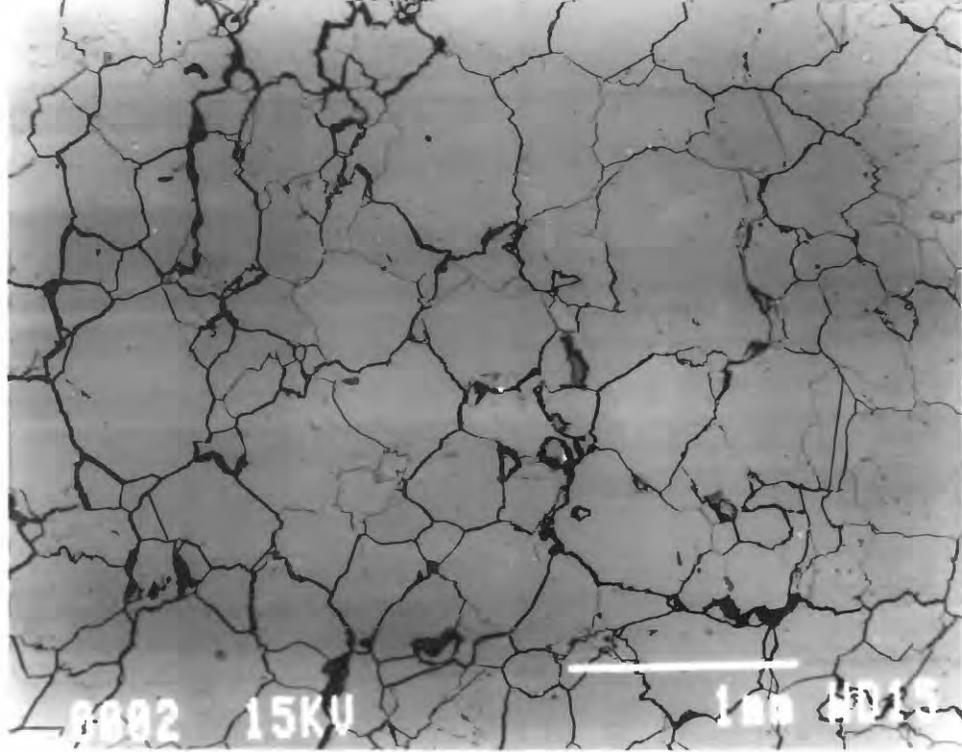
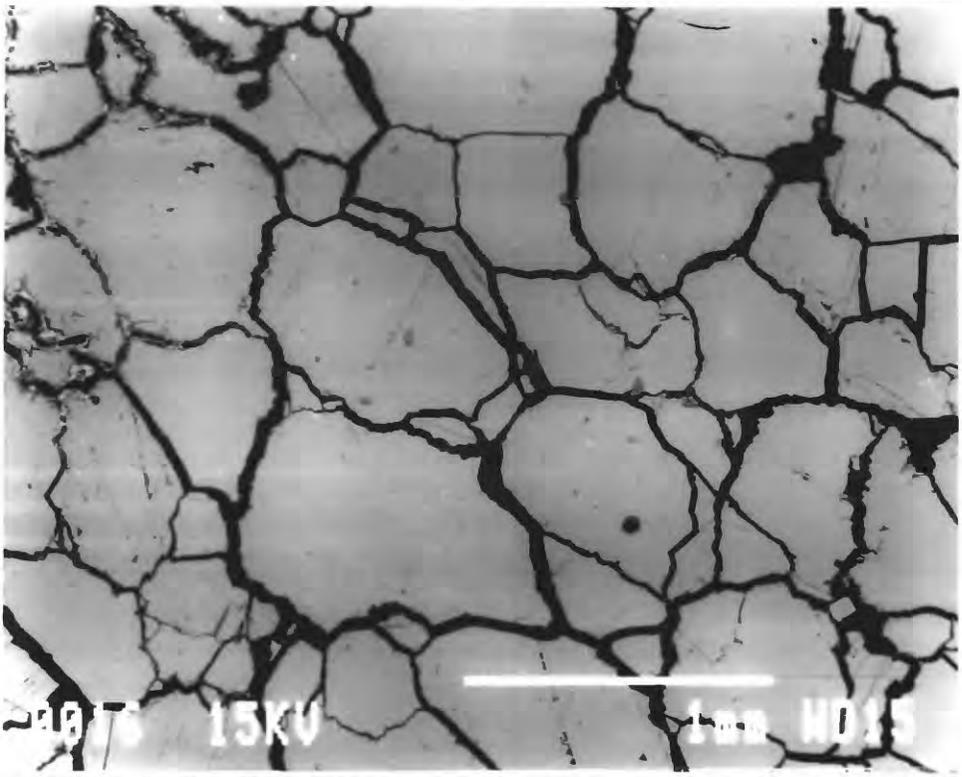
Figure 15. Typical grain shapes and boundaries in a) Pennsylvania marble and b) Carrara marble. The Pennsylvania marble sample is from a small spalled piece on the wall of the east facade portico with no visible alteration crust; the Carrara marble sample is a cross section of an alteration-covered carved piece that fell from an east facade column capital. Photos are scanning electron micrographs from polished sections; scale at lower right.

Texture differences are reflected on a visible and a microscopic scale. In contrast to the Carrara marble, the pronounced foliation of the Pennsylvania marble is a major weakness that has been visibly accentuated by exposure. But on a microscopic scale, within the planes of foliation, intergranular gaps are narrower in the Pennsylvania marble than in the Carrara marble. Polished thin sections of poorly consolidated samples of Carrara and Pennsylvania marble allow a comparison to be made of the grain boundary and pore structure characteristics of these two marbles (Figure 15).

The grain boundaries of the Pennsylvania marble sample are fairly thin, typically 5mm wide, with some boundaries at about 10 mm. In contrast, the Carrara marble grain boundaries are fairly wide; typically 20 to 30 mm, ranging from 5 mm to 60 mm. Further, the area occupied by stone versus pore space differs and may be significant in choosing treatment actions. On average, for a 1.8 x 1.7 mm area in a SEM photograph, 2.9% of the Pennsylvania marble sample is pore space (92.9% is calcite grains) compared to 12.2% pore space in the Carrara marble (83% calcite grains).

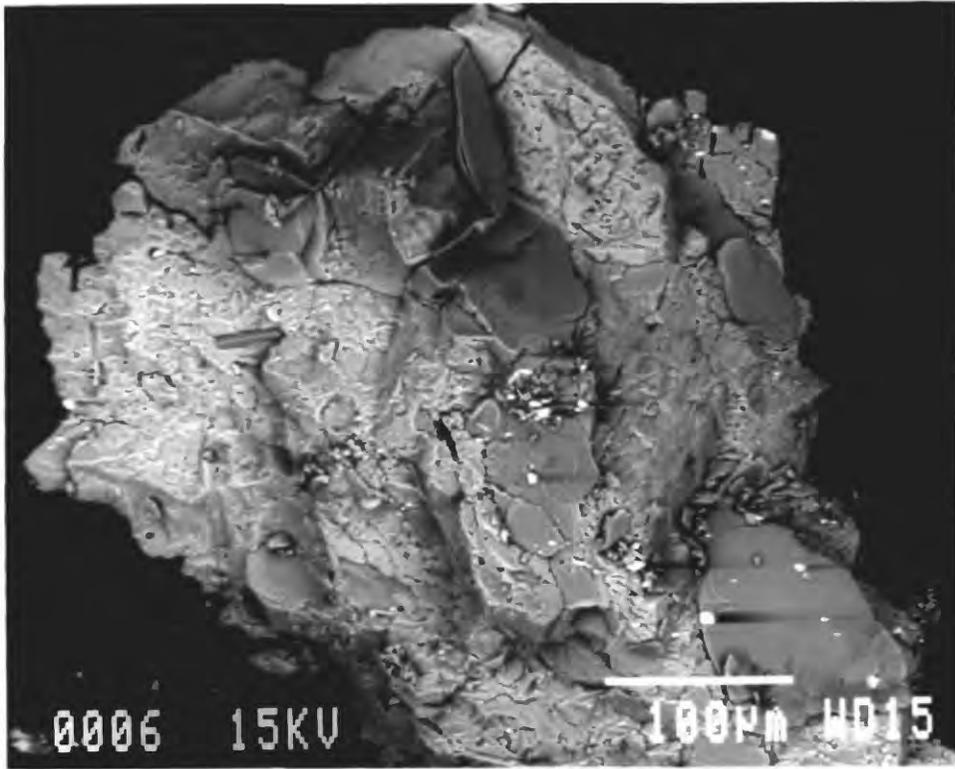
Figure 16. Backscattered electron image of a Pennsylvania marble calcite grain with attached (platy, darker gray) muscovite grains. Small bright white dots are apatite grains. The sample is from an antefix.

Variations in inclusions, texture, and grain characteristics are the most striking difference between the Pennsylvania and Carrara marbles. The disaggregated grains of the two marbles are visibly different in color; Carrara marble grains are yellow to beige, while Pennsylvania marble grains are blue to gray in color. The composition of the calcite from both marbles, however, is very similar (Table 1). Although the grains in the Pennsylvania marble sample appear smaller than those in the Carrara marble sample, grain measurements indicate that their size ranges overlap (Figure 14). Calcite grains from the Carrara marble are mostly rounded to slightly angular (Figure 15b); in rare cases a minor inclusion phase may be attached to the calcite grain. Calcite grains from the Pennsylvania marble are also rounded to slightly angular, but many individual grains have abundant inclusions of muscovite and apatite (Figure 16).

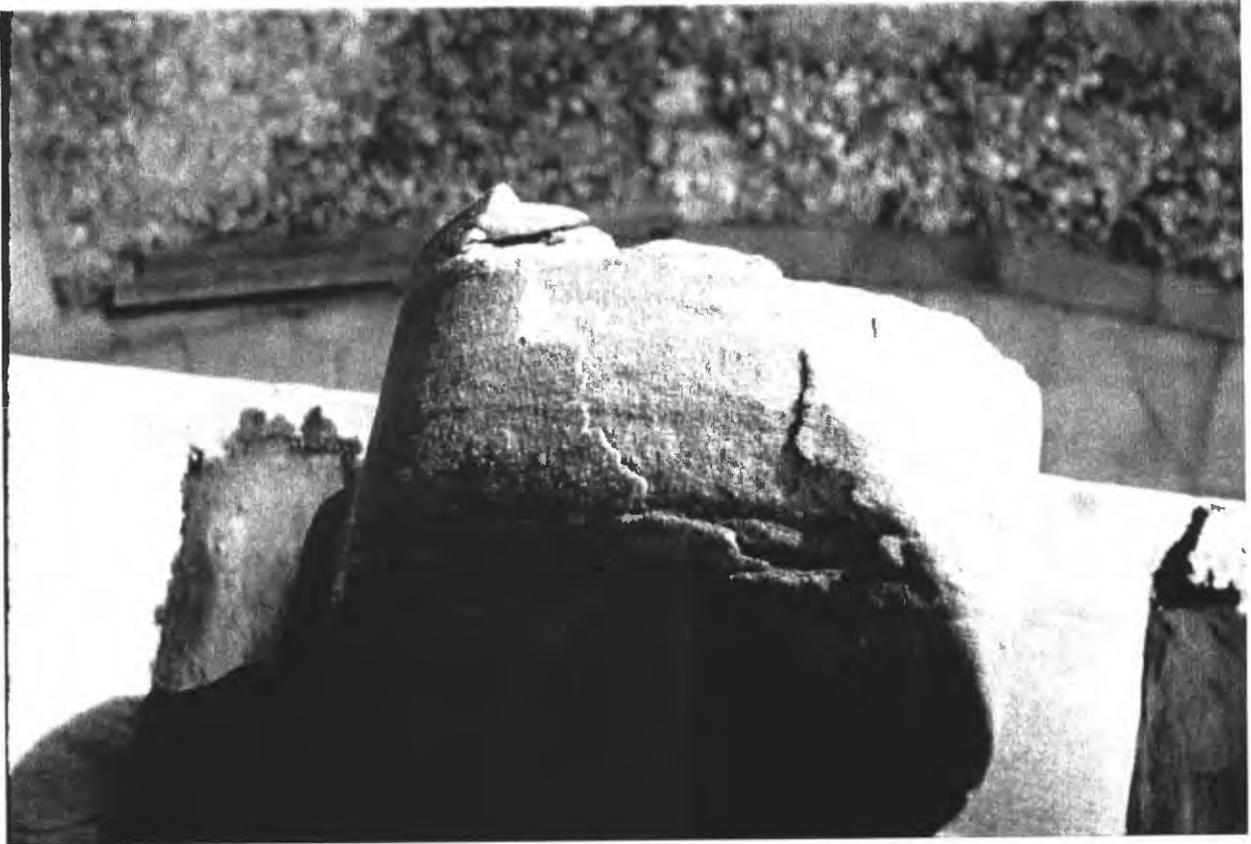
Figure 17. Weathering has accentuated the natural foliation (planar texture) of the Pennsylvania marble and resulted in spalling and loss of layers of stone material on this antefix.

Various architectural details at the Exchange have suffered from dissolution deterioration that varies with the exposure to rain. The antefixes are the architectural detail most fully exposed to rain. Roughened surfaces and loss of much of the carved detail on the antefix faces (see Plate 9) are typical features of dissolution deterioration that result from the full exposure as well as from characteristics of the stone. Although some antefixes show preferential weathering around inclusions (see Plate 9), most have suffered from a more general loss of stone material. The natural foliation of the marble has led to a common form of antefix deterioration; thin layers of stone spalled along weakened foliation planes on the backs of the antefixes (Figure 17).

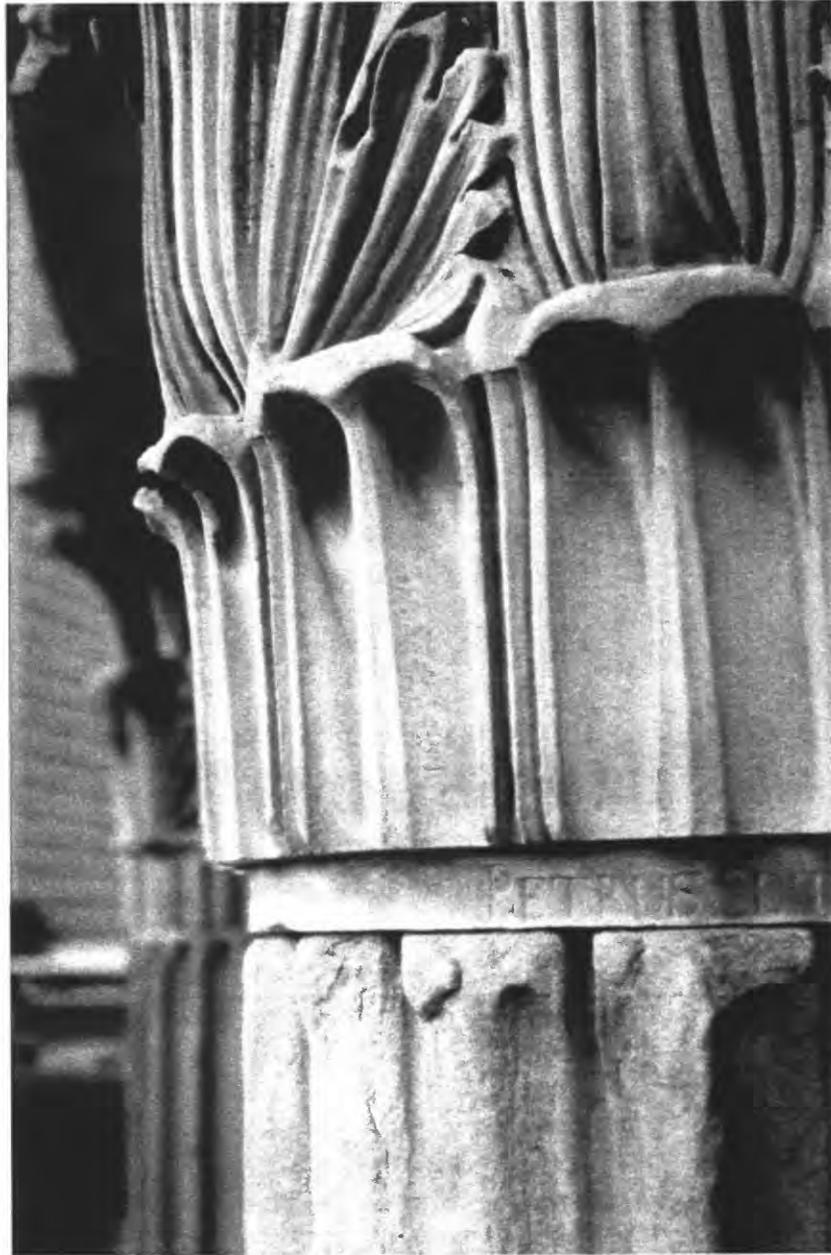
Figure 18. The Pennsylvania marble in the column shafts is grainier and has lost more of the original carved details compared to the similarly-exposed Carrara marble.

The columns and capitals show the most dramatic deterioration (Figure 18). Many of the exterior volutes on the east facade column capitals are missing, as are much of the carved details between the volutes. Where the volutes are fully exposed to washing from rain, the surface is whitened and covered with loosened grains of calcite. The Carrara marble in the capitals has weathered homogeneously with no indication of preferential loss of inclusions. The

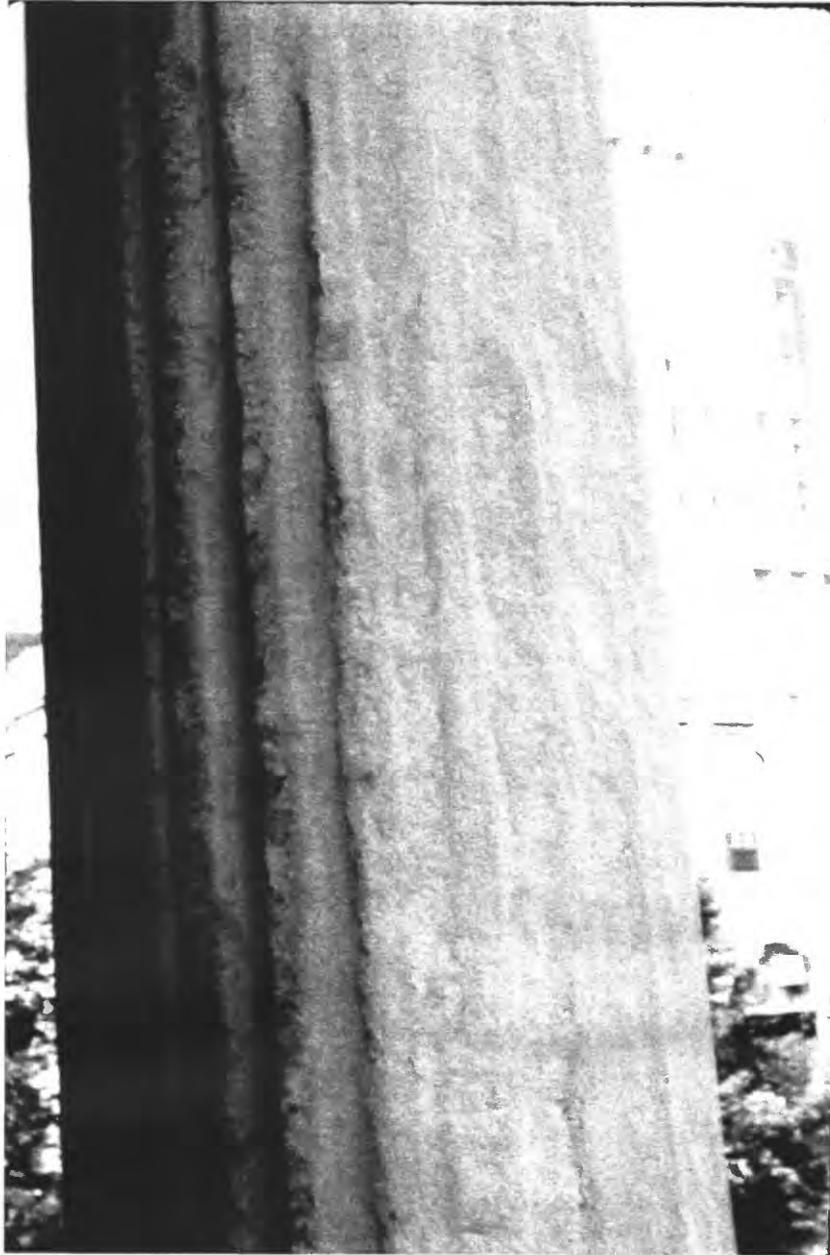
Figure 19. Column shafts of Pennsylvania marble on the east facade have developed rounded, wavy edges. Where the foliation of the original stone lies parallel to the exposed stone surface, the arrises are almost completely gone.

Pennsylvania marble columns have nearly all lost the upper edge of the flutes in exposed areas. On the outward facing sides of the column shaft, the arrises no longer have smooth surfaces or sharp edges; the surface is sugared and rough, and the arrises are rounded or wavy where the stone has split along the foliation that runs vertically in the column (Figure 19). Around a given column, the impact from dissolution on the stone integrity is quite notable; zones of rain-exposed and rain-sheltered flutes can be readily identified (Figure 20) and mapped (see Chapter 5). Dissolution effects on the column bases are far less pronounced than on the shafts, possibly because on the bases the foliation in the stone is horizontal or because there may be less variation in the stone selected for bases.

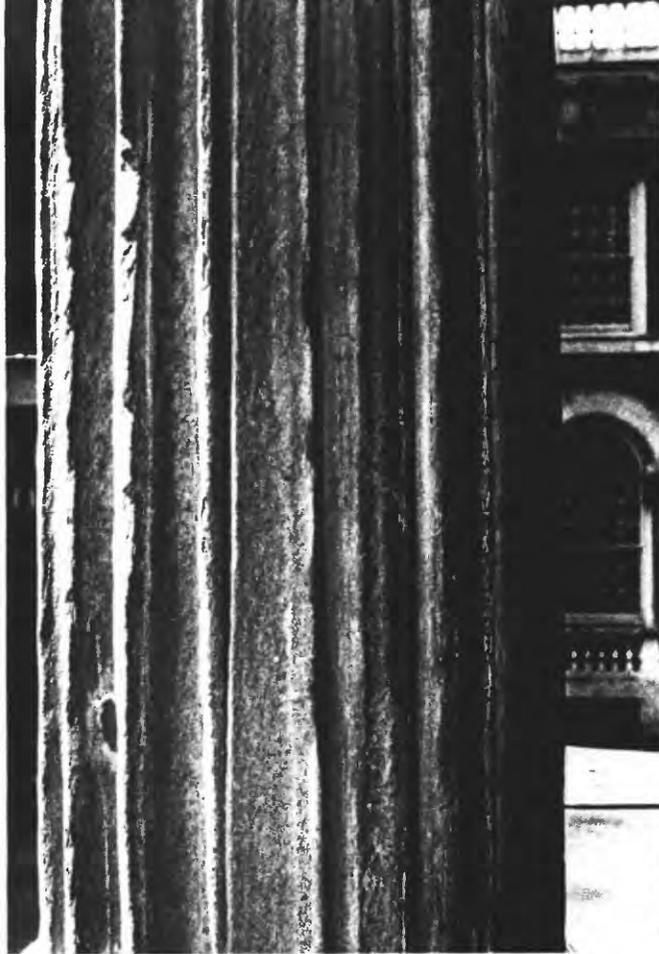
Figure 20. Pennsylvania marble column shaft on the east facade shows a transition from exposed to sheltered areas marked by the accumulation of black alteration crusts in the sheltered area.

The second floor portico column shafts also have tough black crusts on the inside. The black crusts form in visible zones on the columns, prominent in the sheltered areas but becoming thinner where there is occasional rain washing (Figure 20). The crusts are particularly striking on the arrises of the column flutes. Some of these crusts are cracked and fractured parallel to the stone foliation, and while they appear fragile, pieces of the blackened layers are very difficult to remove. Thinner, orange crusts have accumulated on the sides of the arrises and in the flutes. The orange and black crust distribution on the column shafts reflect the presence of moisture, evaporation, and pollutant exposure. Because they are more protected, the troughs of the flutes probably retain surface moisture from condensation longer than the arrises, resulting in longer cycles between dissolution and reprecipitation of gypsum. The darker appearance of the arrises may reflect that the deposition here is enhanced relative to that on the flutes.

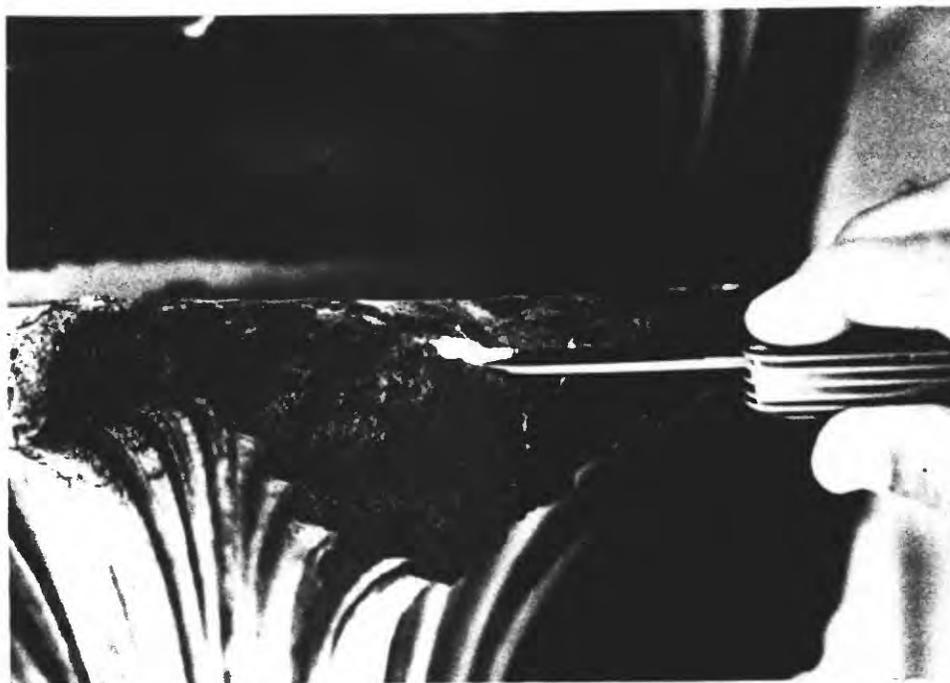
Figure 22. Carrara marble underneath a black alteration crust on the east facade is completely disaggregated into loose grains, seen on a knife blade.

While the colored alteration crusts appear to preserve the original detailed features of the carved stone, the marble can be severely disaggregated underneath (Figure 22). The black crusts on the Carrara marble consist of a distinct black outer layer (about 0.1 mm thick) underlain by a dense light-colored transition zone (up to 0.6 mm thick) under which the marble is disaggregated. Some new gypsum crystals are found in the disaggregated zone (Figure 25), but it is not clear whether these small intergranular gypsum crystals formed before or after the disaggregated marble was exposed. The black crusts on the Pennsylvania marble are thinner and consist of a black layer (0.03 mm to 0.07 mm thick) with no discernible transition layer. The marble appears more intact under these thinner black crusts. While it appears that the Carrara marble is more susceptible to disaggregation beneath the alteration crusts than the Pennsylvania marble, the integrity of the underlying marble may in part reflect their relative exposure, rather than the original petrographic character.

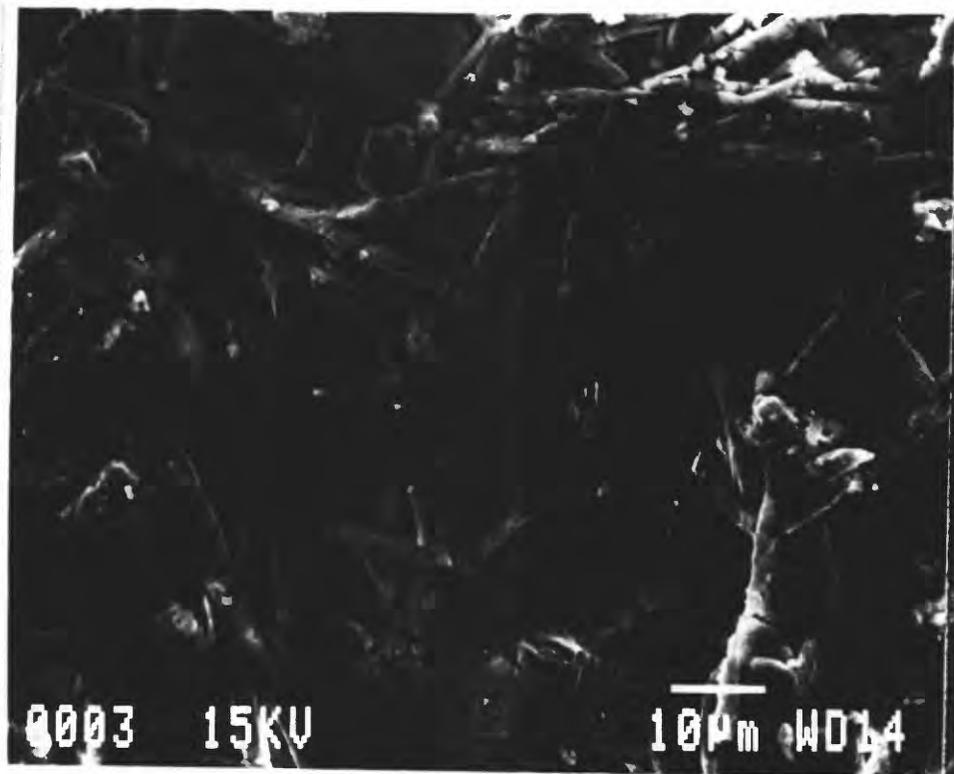
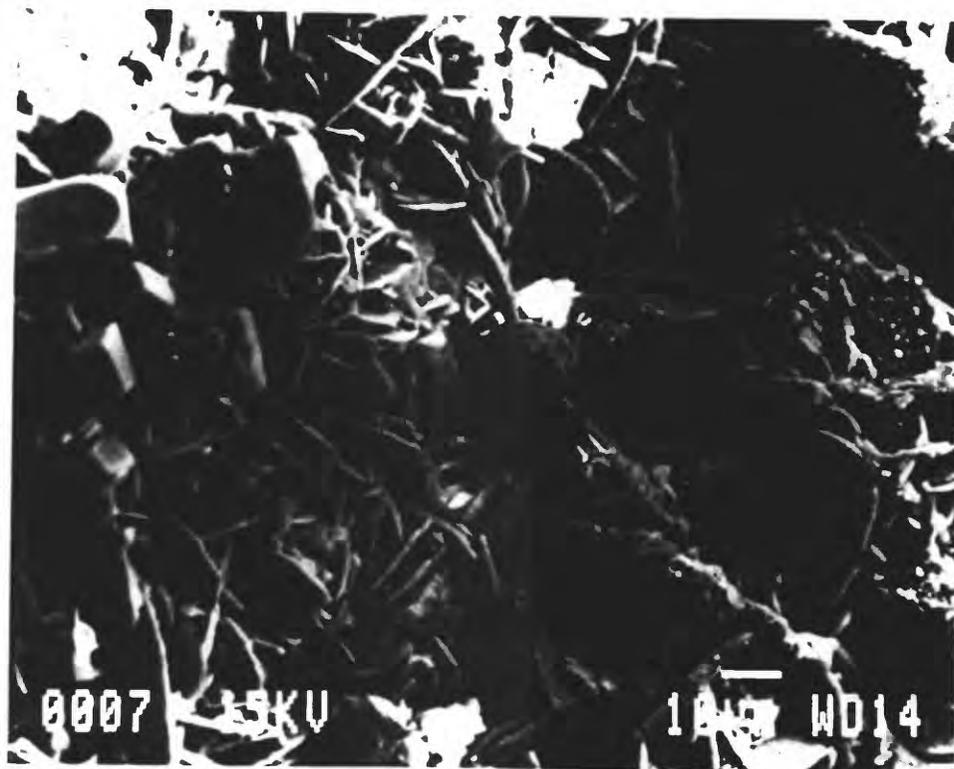
Figure 23. Scanning electron micrograph of black alteration crusts on Pennsylvania marble of Column 14; a) bladed gypsum crystals form a network that covers the stone surface and b) pollutant particles (center), dirt, and salt crystals (cube, left-hand side) are readily trapped by the open network formed by the gypsum crystals.

Chemical alteration of the Pennsylvania and Carrara marbles at the Exchange is manifested by the blackening or discoloration of the surface. The alteration crusts vary in appearance from soft thin orange crusts (Figure 21) to thick, hard black crusts (Figure 22). Under the microscope, the thinnest crusts appear as an opaque orange glaze that obscures the underlying marble; randomly scattered fine black particles on the surface of the glaze are the only discernible feature. Black crusts appear as rough hummocky surfaces covered by fine black particles; the marble is fully obscured by the dirt. X-ray diffraction and scanning electron microscopy with energy dispersive X-ray analysis show that both types of crusts are predominantly composed of gypsum (Appendix A). The gypsum in the alteration crusts consists of elongate crystals that range in shape from blocky, rectangular blades to thin needle-like crystals (Figure 23a). The elongate crystal habit and the random orientation of the gypsum crystals on the marble surface forms a mat that traps airborne particles (Figure 23b) giving a blackened appearance to the crust.

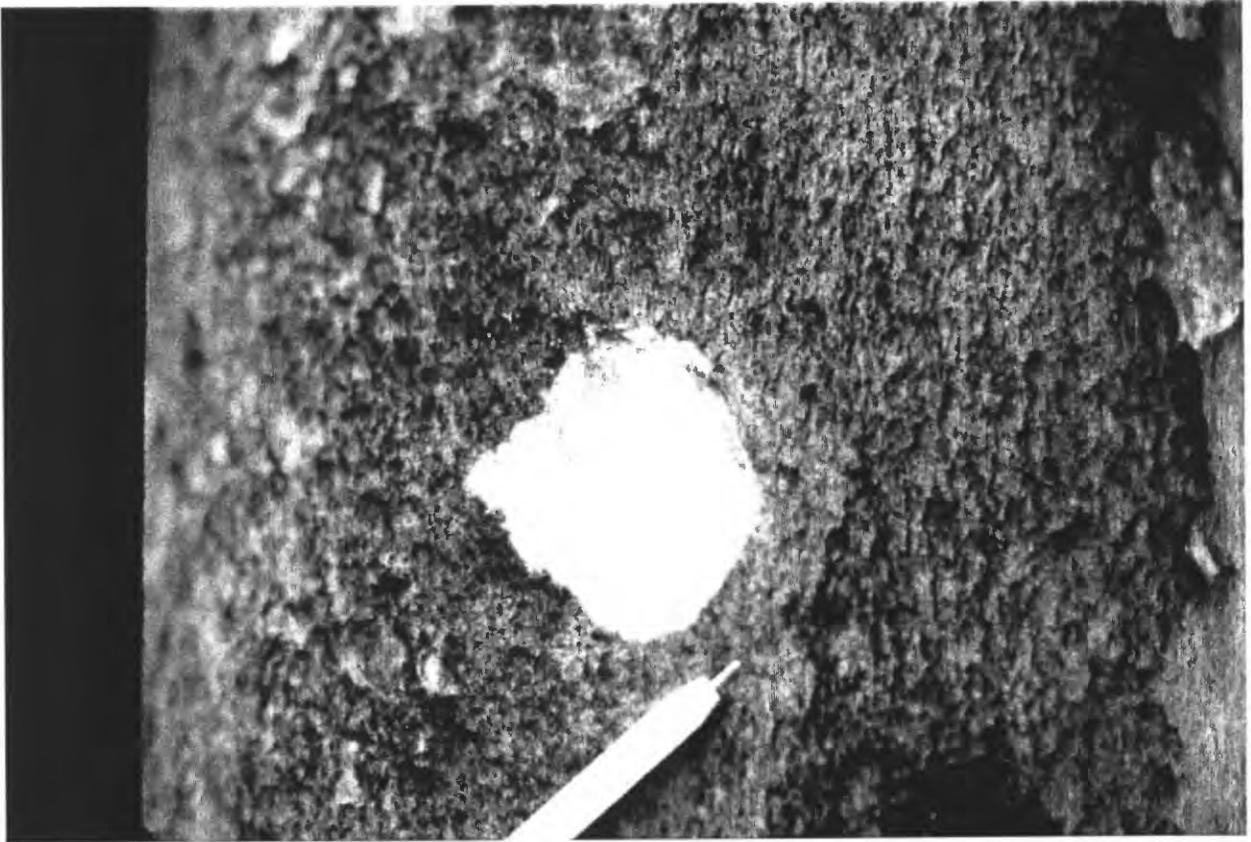
Figure 24. The blackened alteration crust on a ground level column on the west facade has blistered off, exposing white, newly-revealed and disaggregated Pennsylvania marble underneath. Smooth area on right appears to be the original surface of the column.

Black crusts on the ground level columns are concentrated where the stone faces the building, but outward facing areas close to the street are also black. The impact of traffic is evident in the abundance and type of particles in the crusts. Particles from auto emission are common, as are salt (NaCl) crystals. These crusts are particularly notable because, although they are thin (0.03 - 0.07 mm), the crusts have blistered in patches (Figure 24) and have exposed crumbling stone underneath the crust.

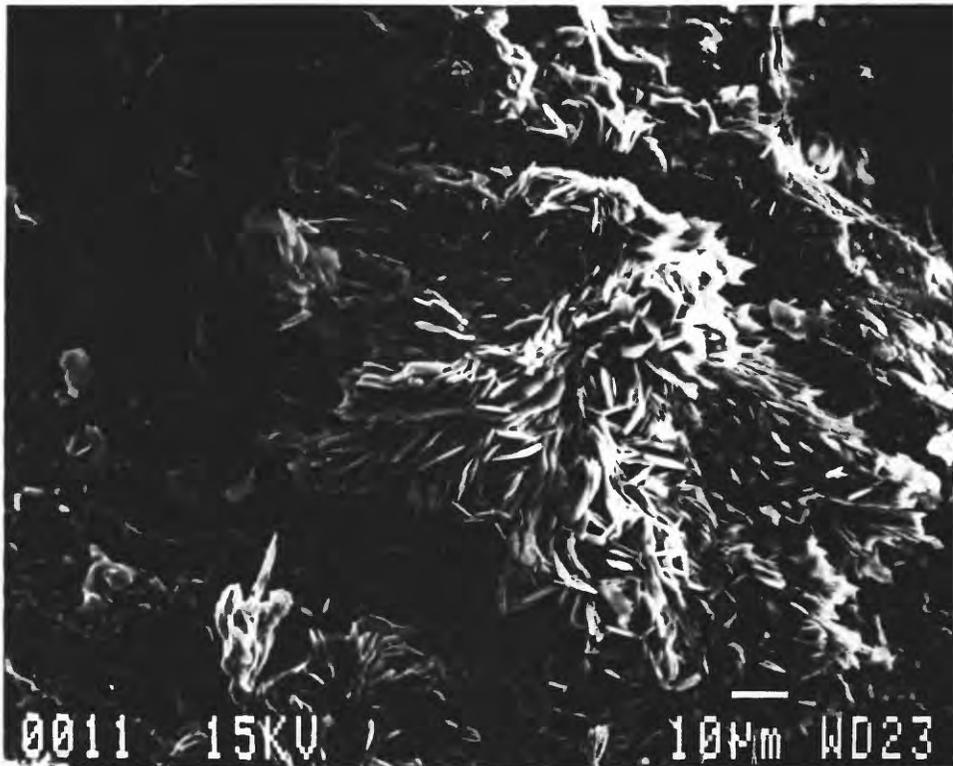
Figure 25. New gypsum crystals (white, fine grains at center) have formed on a calcite grain (dark grain in background) that was underneath a black alteration crust on a Carrara marble capital on the east facade.

that has formed on the grain surface, their source is unknown. A significant number of Carrara calcite grains collected from under a thick black alteration crust have surficial gypsum crystals (Figure 25). It is unclear, however, whether this intergranular gypsum developed after the stone was significantly disaggregated, or whether early growth of the gypsum was the mechanism that caused the disaggregation. It is possible that the intergranular crystals are an artifact, because accumulation of gypsum crystals is predominantly a surficial phenomenon. Analysis and examination of limestone from an older building has shown that although elevated levels of sulfate are detected for some distance into the stone, gypsum in crystal form is restricted to the near surface area (McGee and Mossotti, 1992).

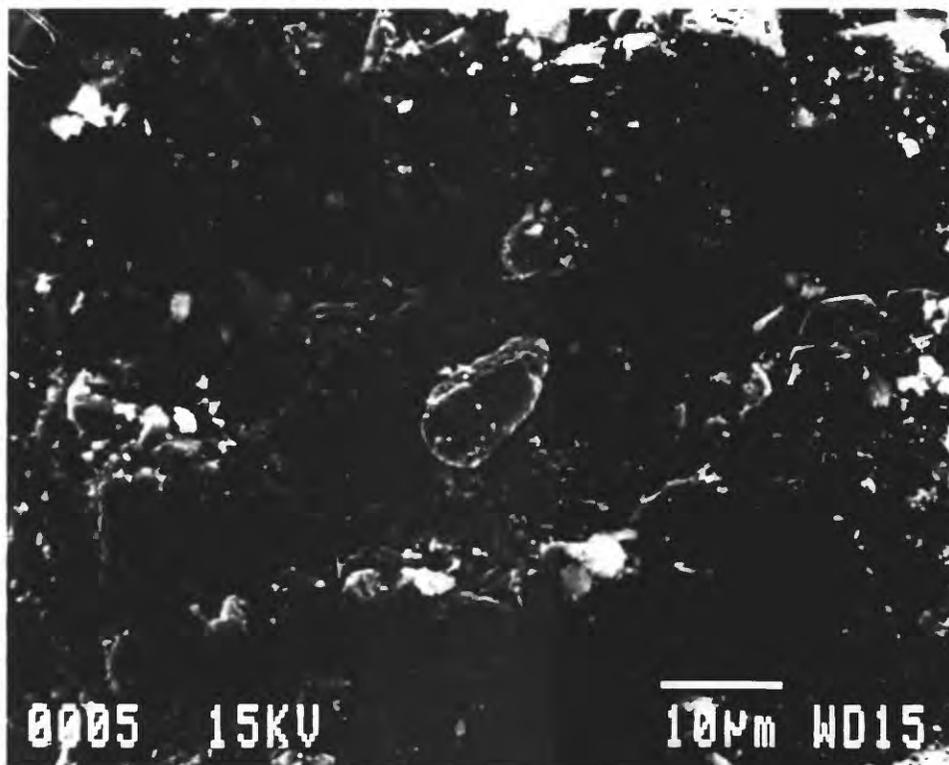
Figure A-2. SEM micrograph of a typical quartz particle in an alteration crust sample.

Using the SEM we are able to see many of the phases that are present in the sample, but SEM identification does not give us an adequate representation of the abundance of the phases. X-ray diffraction gives more of a bulk identification of phases in the sample; it will detect phases with a crystalline structure that constitute at least 10% of the sample. Table A-1 summarizes the phases identified in each sample. The crusts consist of calcite, gypsum, quartz, and fluorite(?). We did not detect any oxalates in the samples that we analyzed. The main constituent of the crusts is either calcite or gypsum. In some cases, especially where the proportion of calcite is high, we suspect that part of the calcite that was detected is grains of the underlying marble that came off when the alteration crust was sampled. The SEM images substantiate this explanation, as seen in sample MX210-4, where grains of calcite have thin crusts of gypsum crystals (Figure A-1). Quartz is an accessory phase, present mainly in the black alteration crusts and seen in the SEM as individual grains sitting in the network of gypsum crystals (Figure A-2).

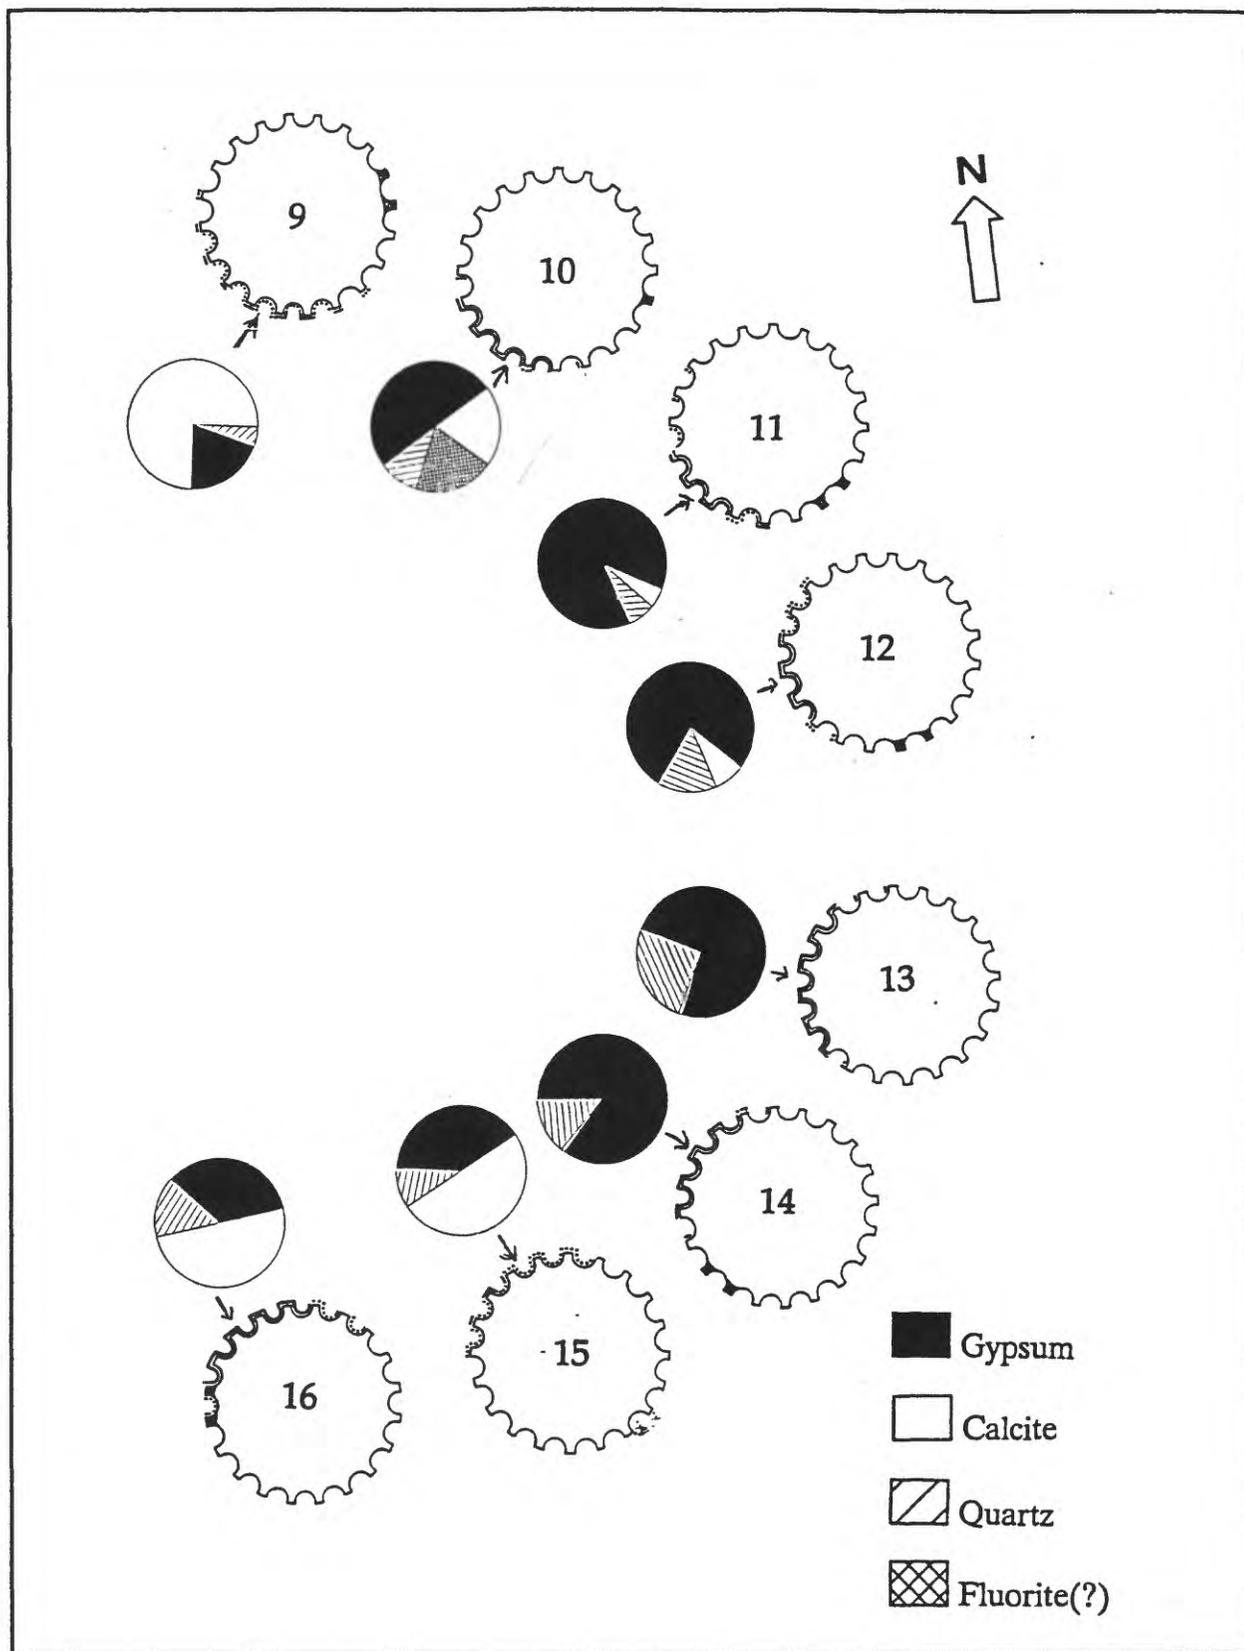
Figure 47. Encrustation on columns; distribution and composition.

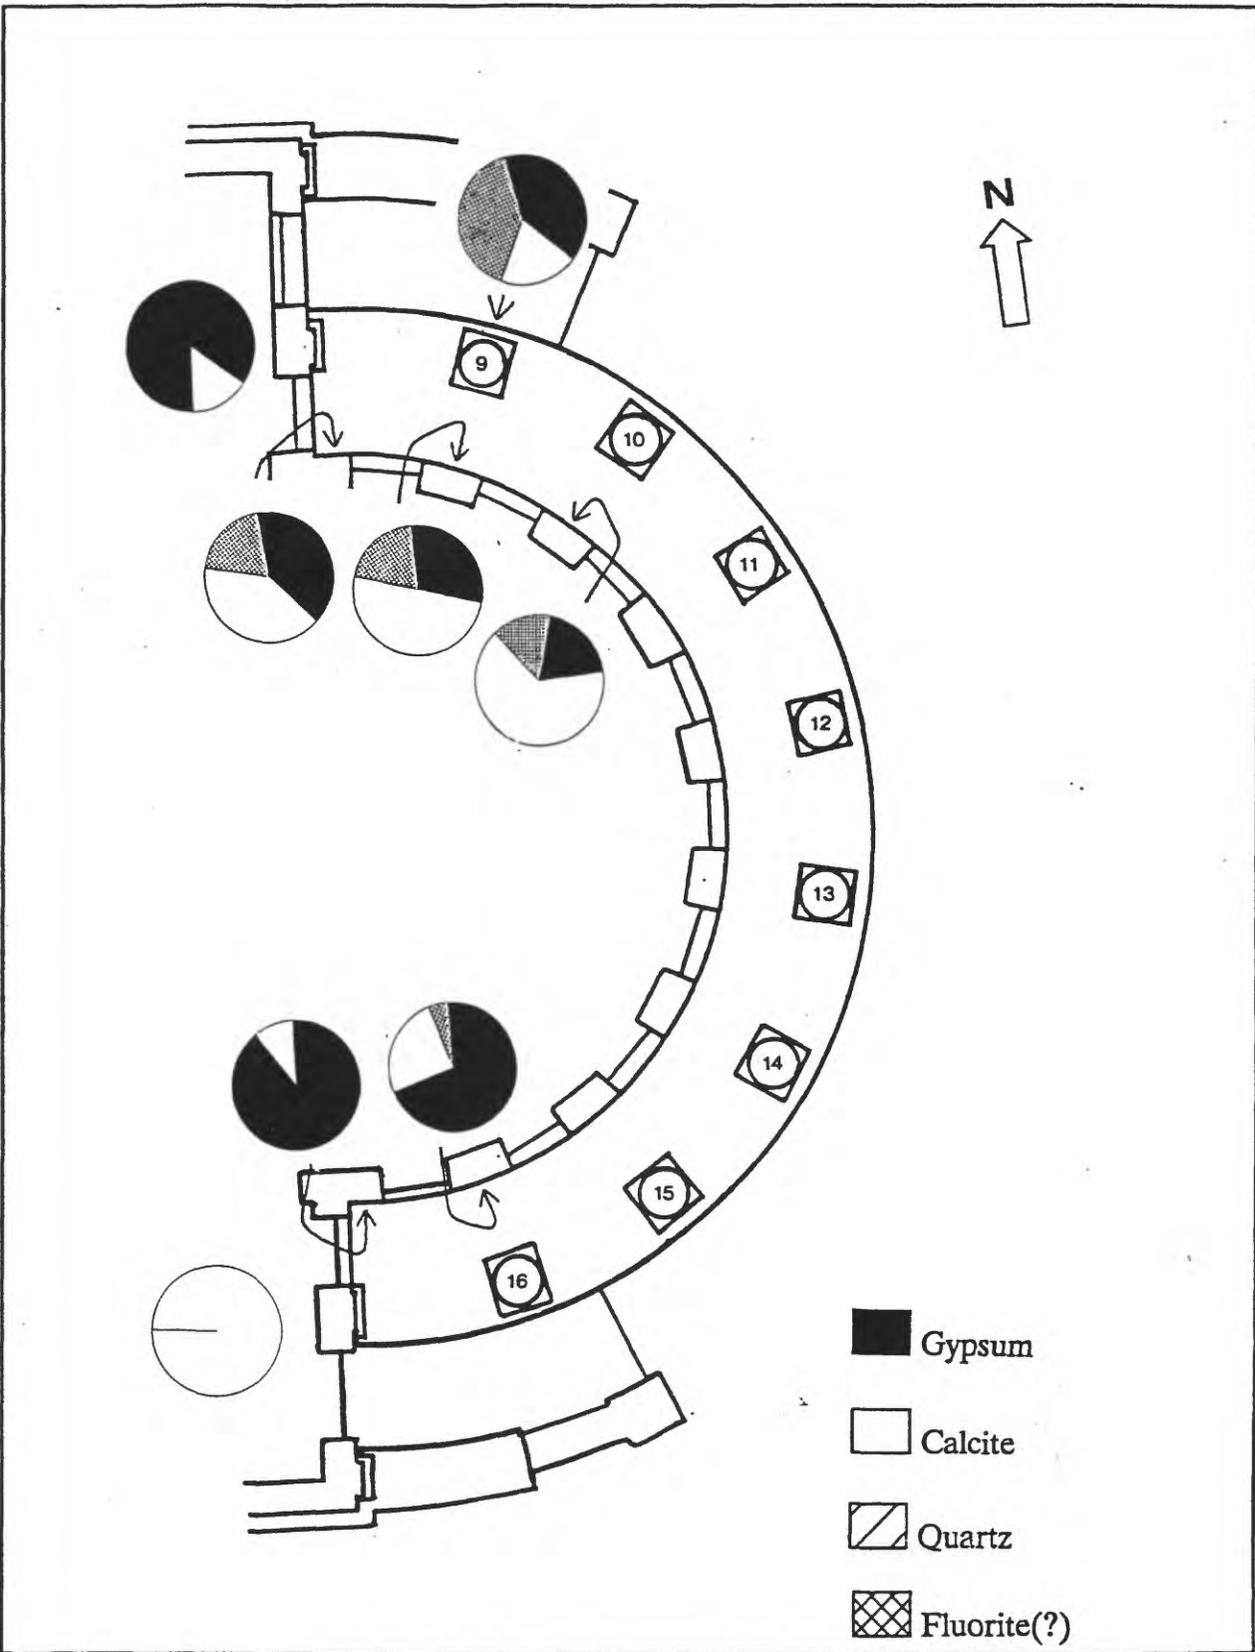
Figure 49. Composition of crusts on east portico walls.
