LEVEL II SCOUR ANALYSIS FOR
BRIDGE 5 (IRASTH00010005) on
TOWN HIGHWAY 1, crossing
LORDS CREEK,
IRASBURG, VERMONT

U.S. Geological Survey
Open-File Report 96-571

Prepared in cooperation with
VERMONT AGENCY OF TRANSPORTATION
and
FEDERAL HIGHWAY ADMINISTRATION

By Erick M. Boehmler and Donald L. Song

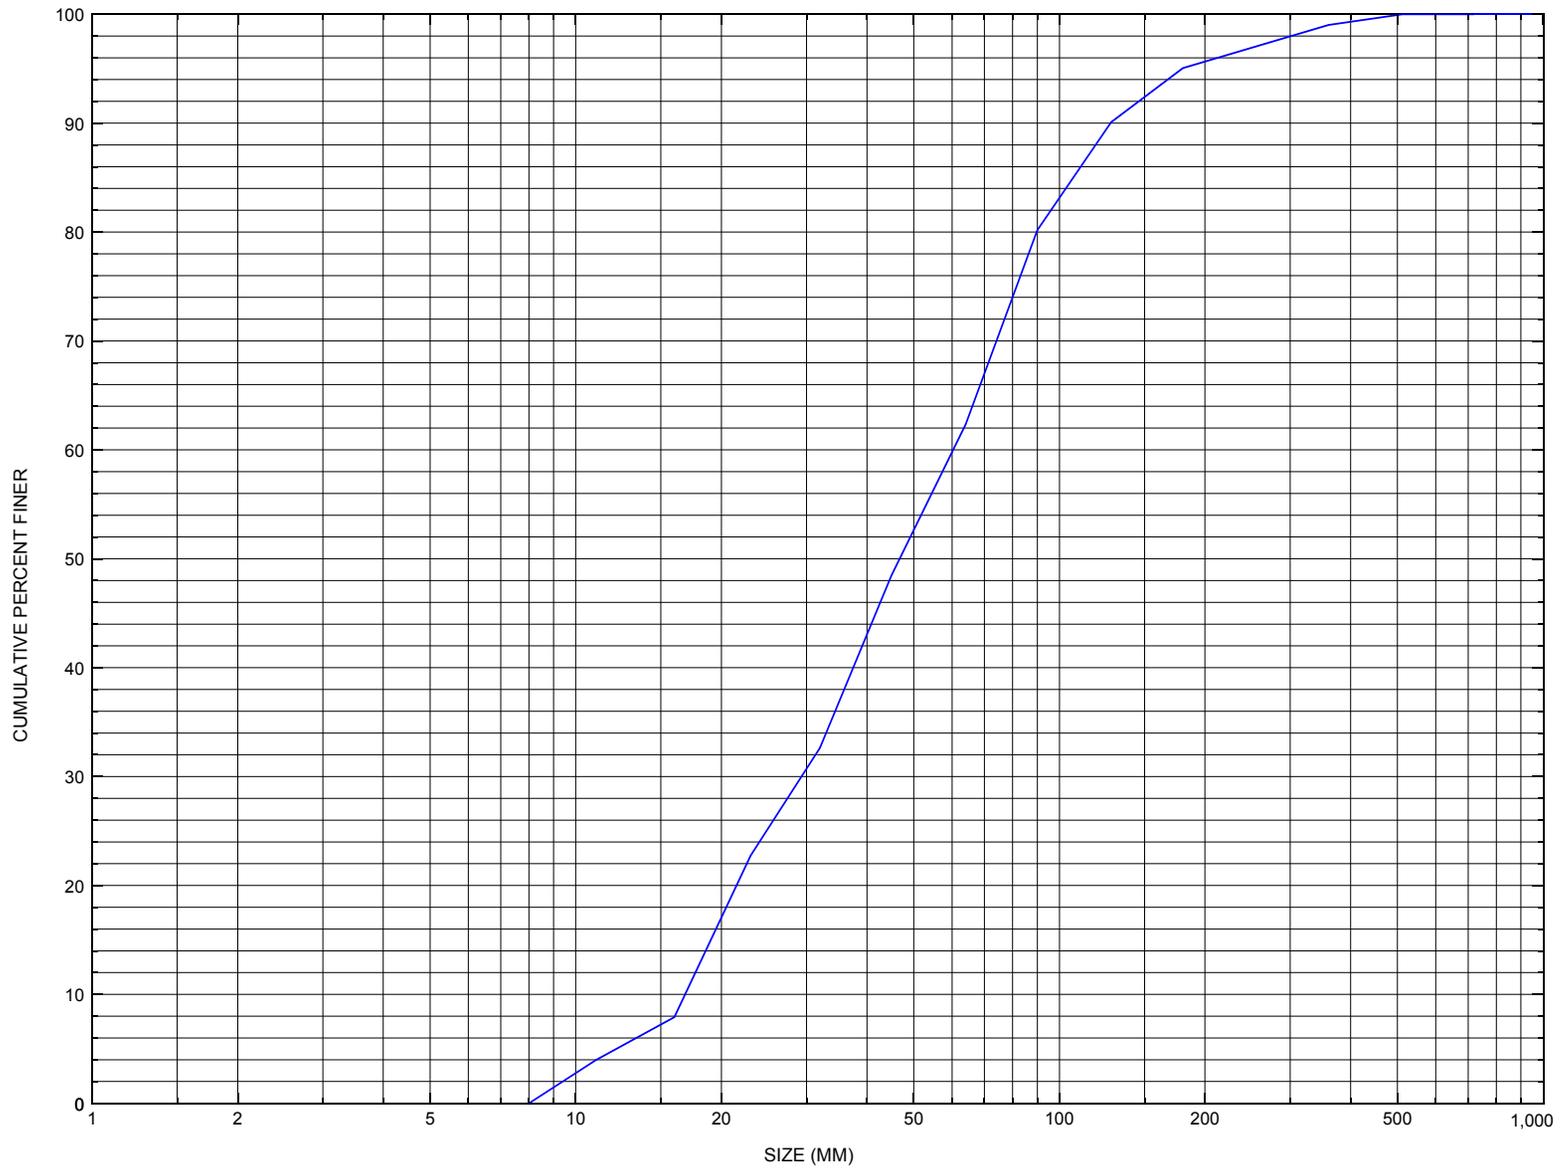
Appendix C. Bed material particle-size distribution for one pebble count transect at the approach cross-section for structure [IRASTH00010005](#), in [Irasburg](#), Vermont.

For this site, the channel composite sieve analyses resulted in a bed-material median diameter of 0.0033 ft., while the pebble count analysis result was 0.153 ft. Field inspection notes indicate the coarser bed material was detected about one foot beneath the silt/clay layer in the bridge section. The difference in median diameter gives conflicting indications of live-bed and clear-water contraction scour conditions as the governing process during the 100- and 500-year discharges.

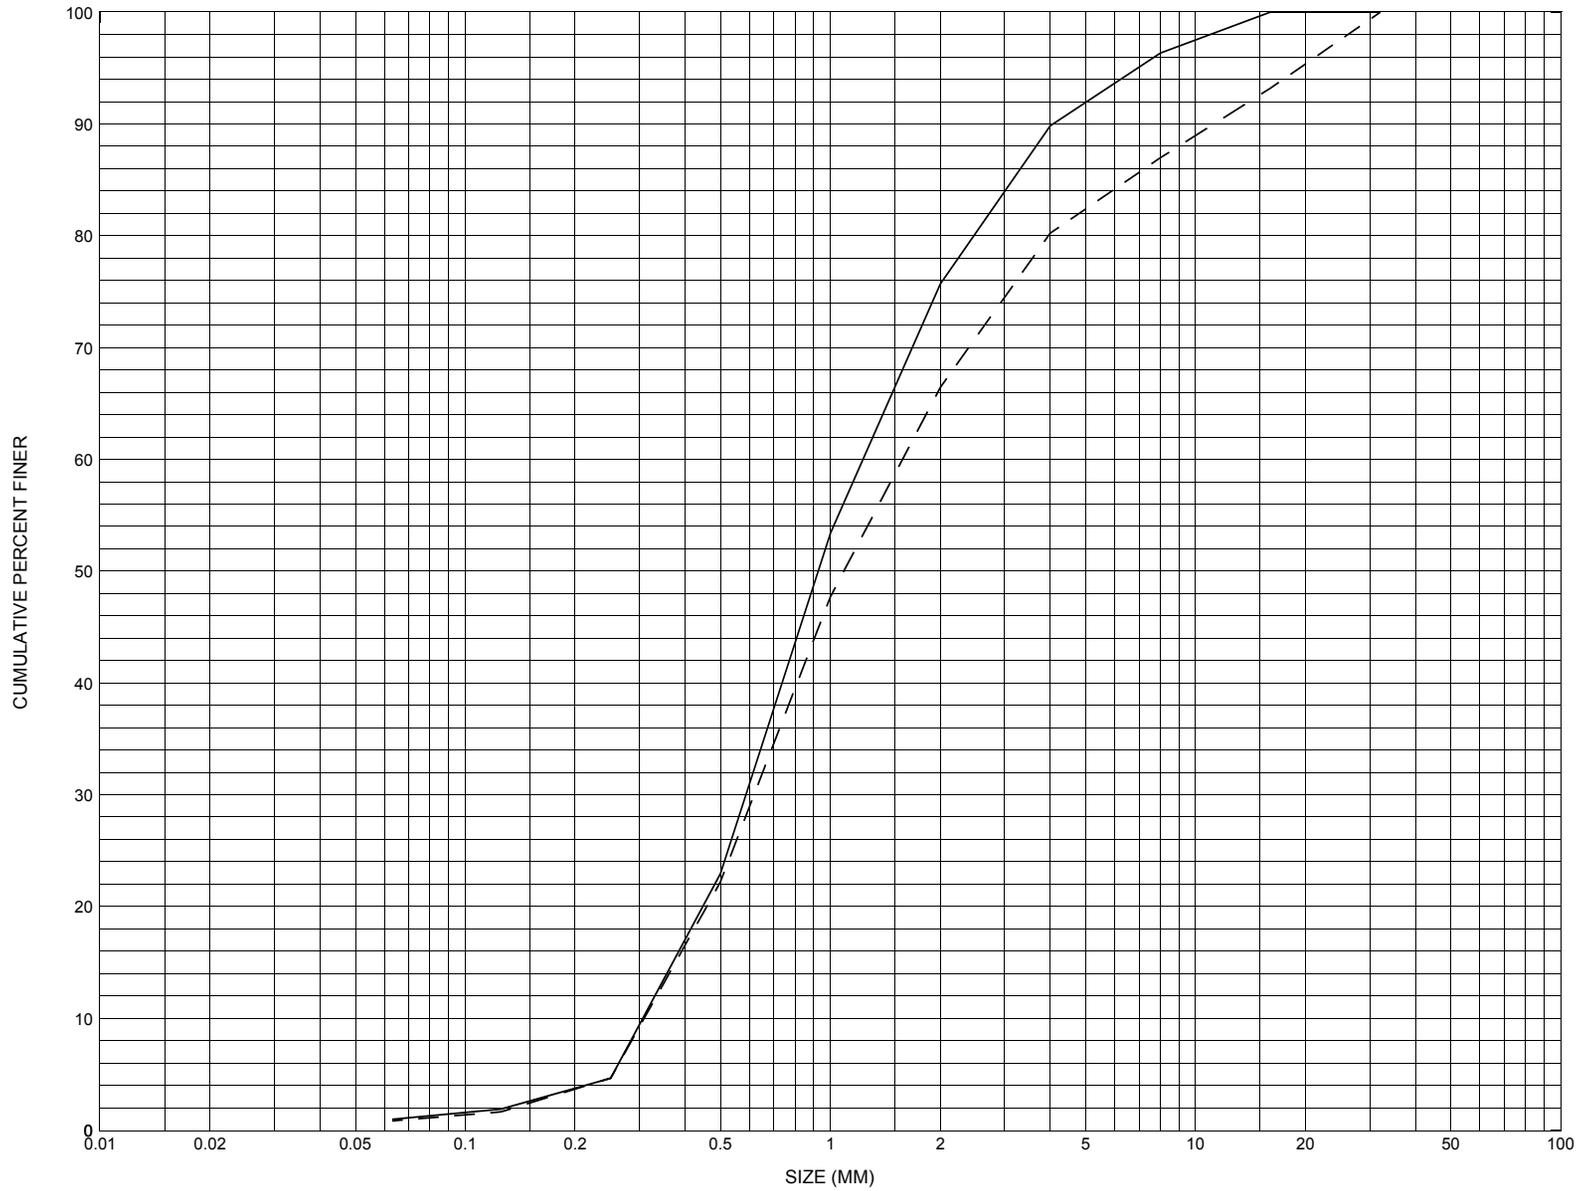
Appendix C. Bed material particle-size distribution for two composite channel sample transects at the approach cross-section for structure [IRASTH00010005](#), in Irasburg, Vermont.
