LEVEL II SCOUR ANALYSIS FOR
BRIDGE 99 (LUDLVT01000099) on
STATE HIGHWAY 100, crossing
BRANCH BROOK,
LUDLOW, VERMONT

U.S. Geological Survey
Open-File Report 96-572

Prepared in cooperation with
VERMONT AGENCY OF TRANSPORTATION
and
FEDERAL HIGHWAY ADMINISTRATION

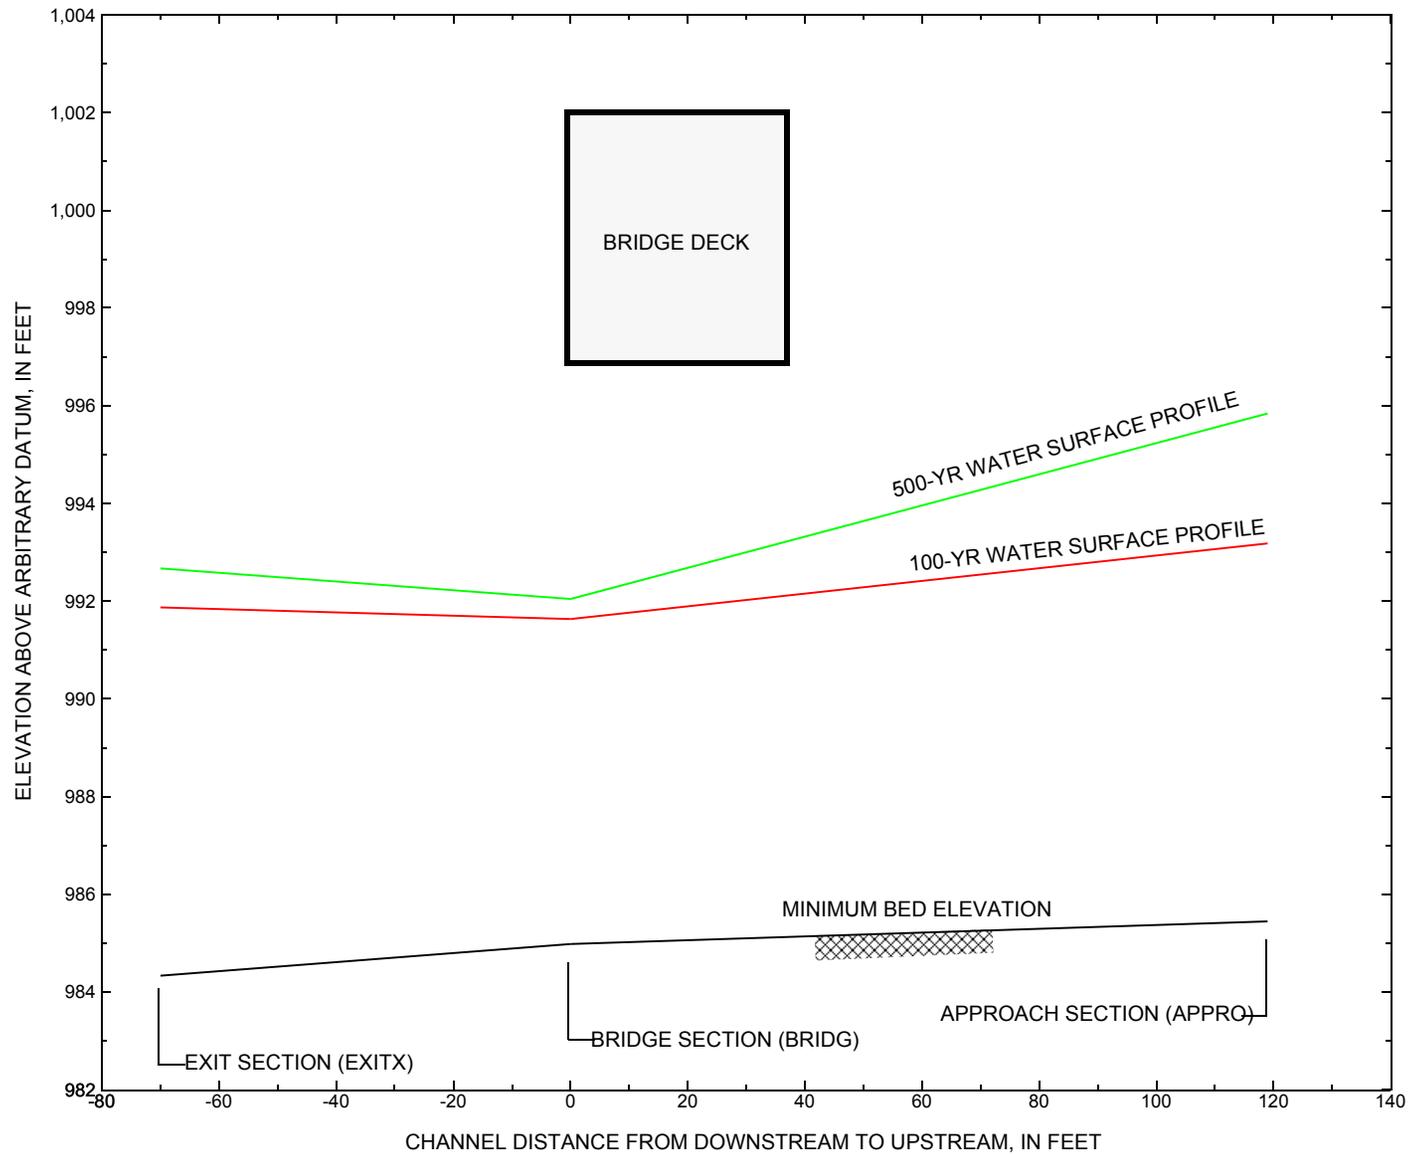
Figure 7. Water-surface profiles for the 100- and 500-yr discharges at structure [LUDLVT01000099](#) on State Highway 100, crossing [Branch Brook, Ludlow, Vermont](#).

Hydraulic analyses of the reach were done by use of the Federal Highway Administration's WSPRO step-backwater computer program (Shearman and others, 1986, and Shearman, 1990). The analyses reported herein reflect conditions existing at the site at the time of the study. The beaver dam, about 400 feet downstream, was ignored in the analyses. Furthermore, in the development of the model it was necessary to assume no accumulation of debris or ice at the site. Results of the hydraulic model are presented in the Bridge Hydraulic Summary, Appendix B, and figure 7.

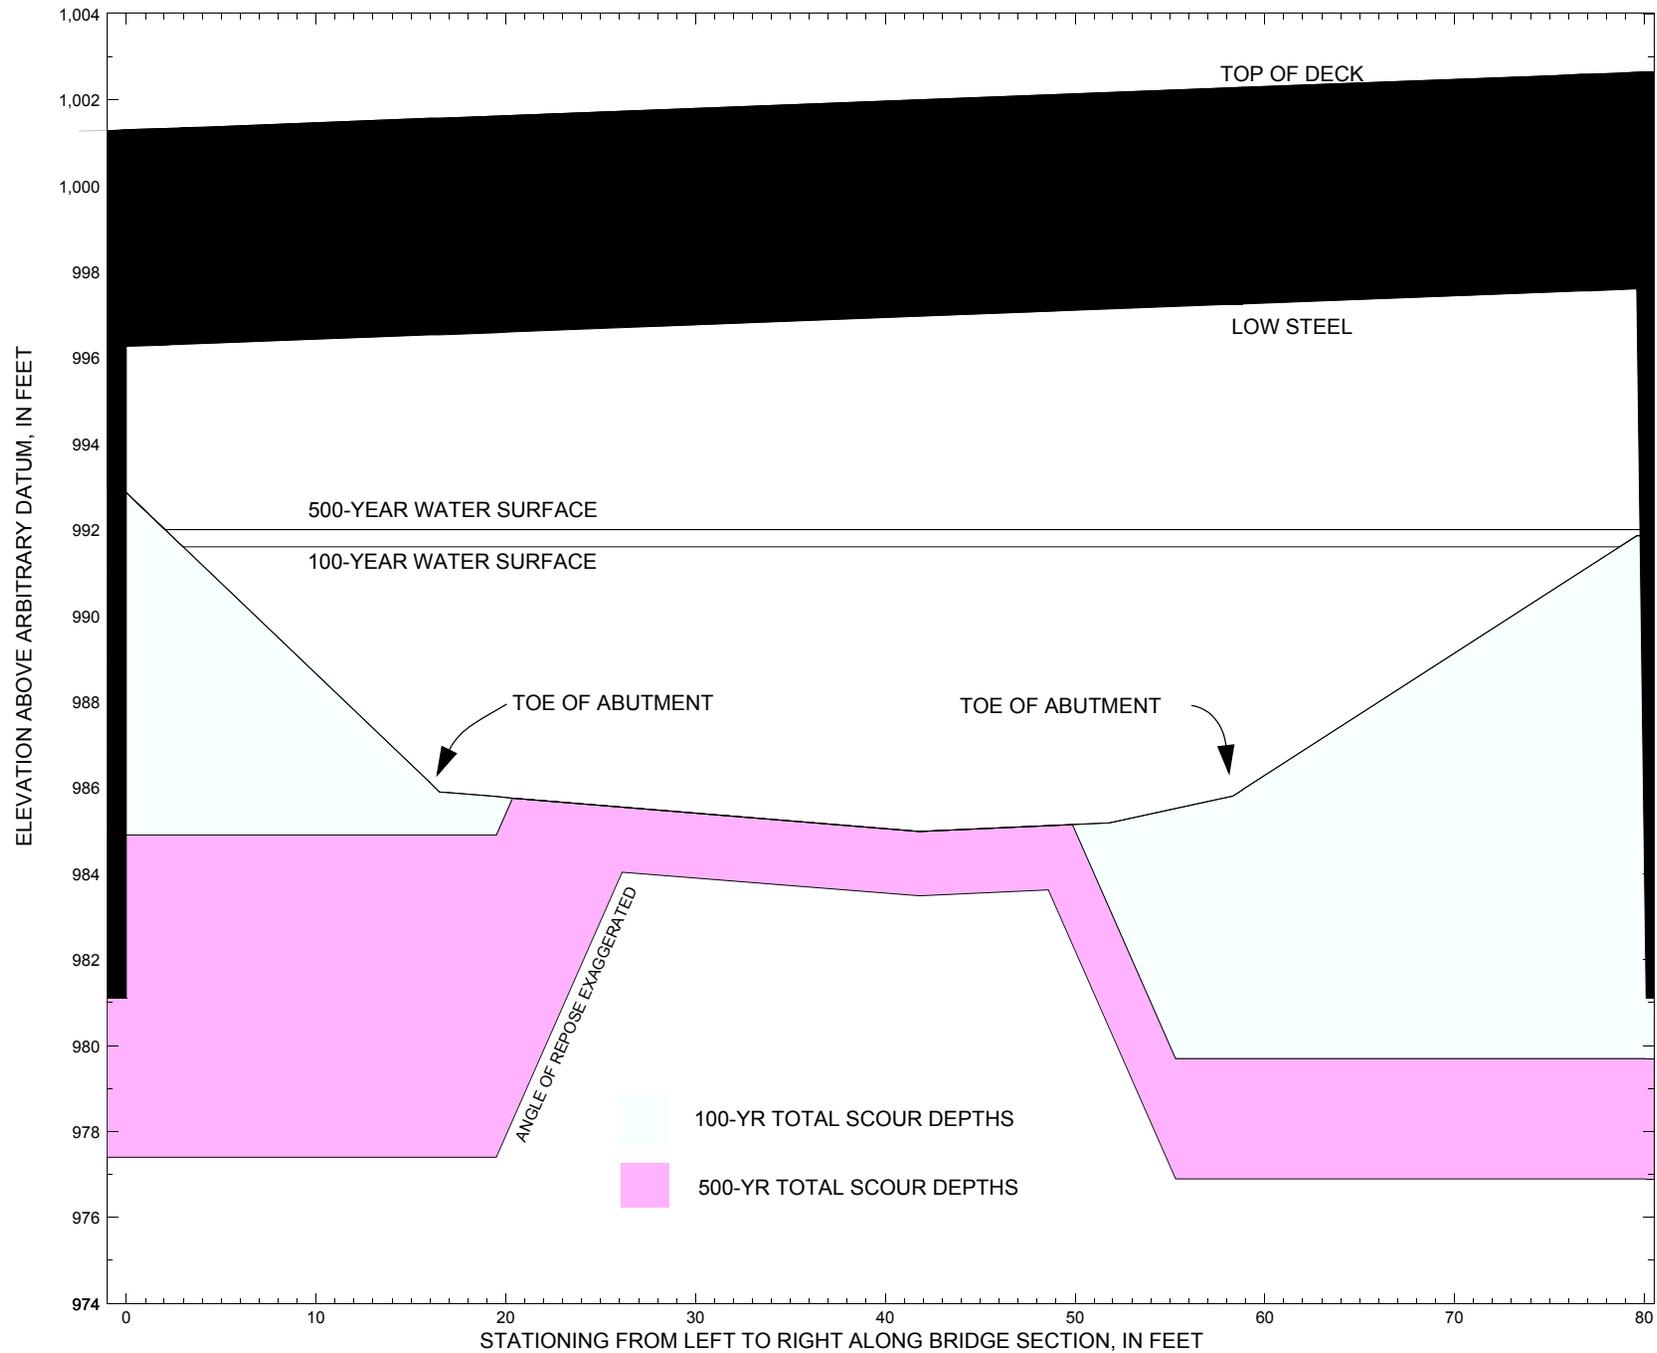
Figure 8. Scour elevations for the 100-yr and 500-yr discharges at structure [LUDLVT01000099](#) on State Highway 100, crossing [Branch Brook, Ludlow, Vermont](#).

Scour depths were computed using the general guidelines described in Hydraulic Engineering Circular 18 (Richardson and others, 1995). Scour depths were calculated assuming an infinite depth of erosive material and a homogeneous particle-size distribution. The results of the scour analysis are presented in tables 1 and 2 and a graph of the scour depths is presented in figure 8.

The angle of repose shown in Figure 8 was exaggerated for plotting purposes. The plotted angle is 45 degrees; the true angle would be smaller.

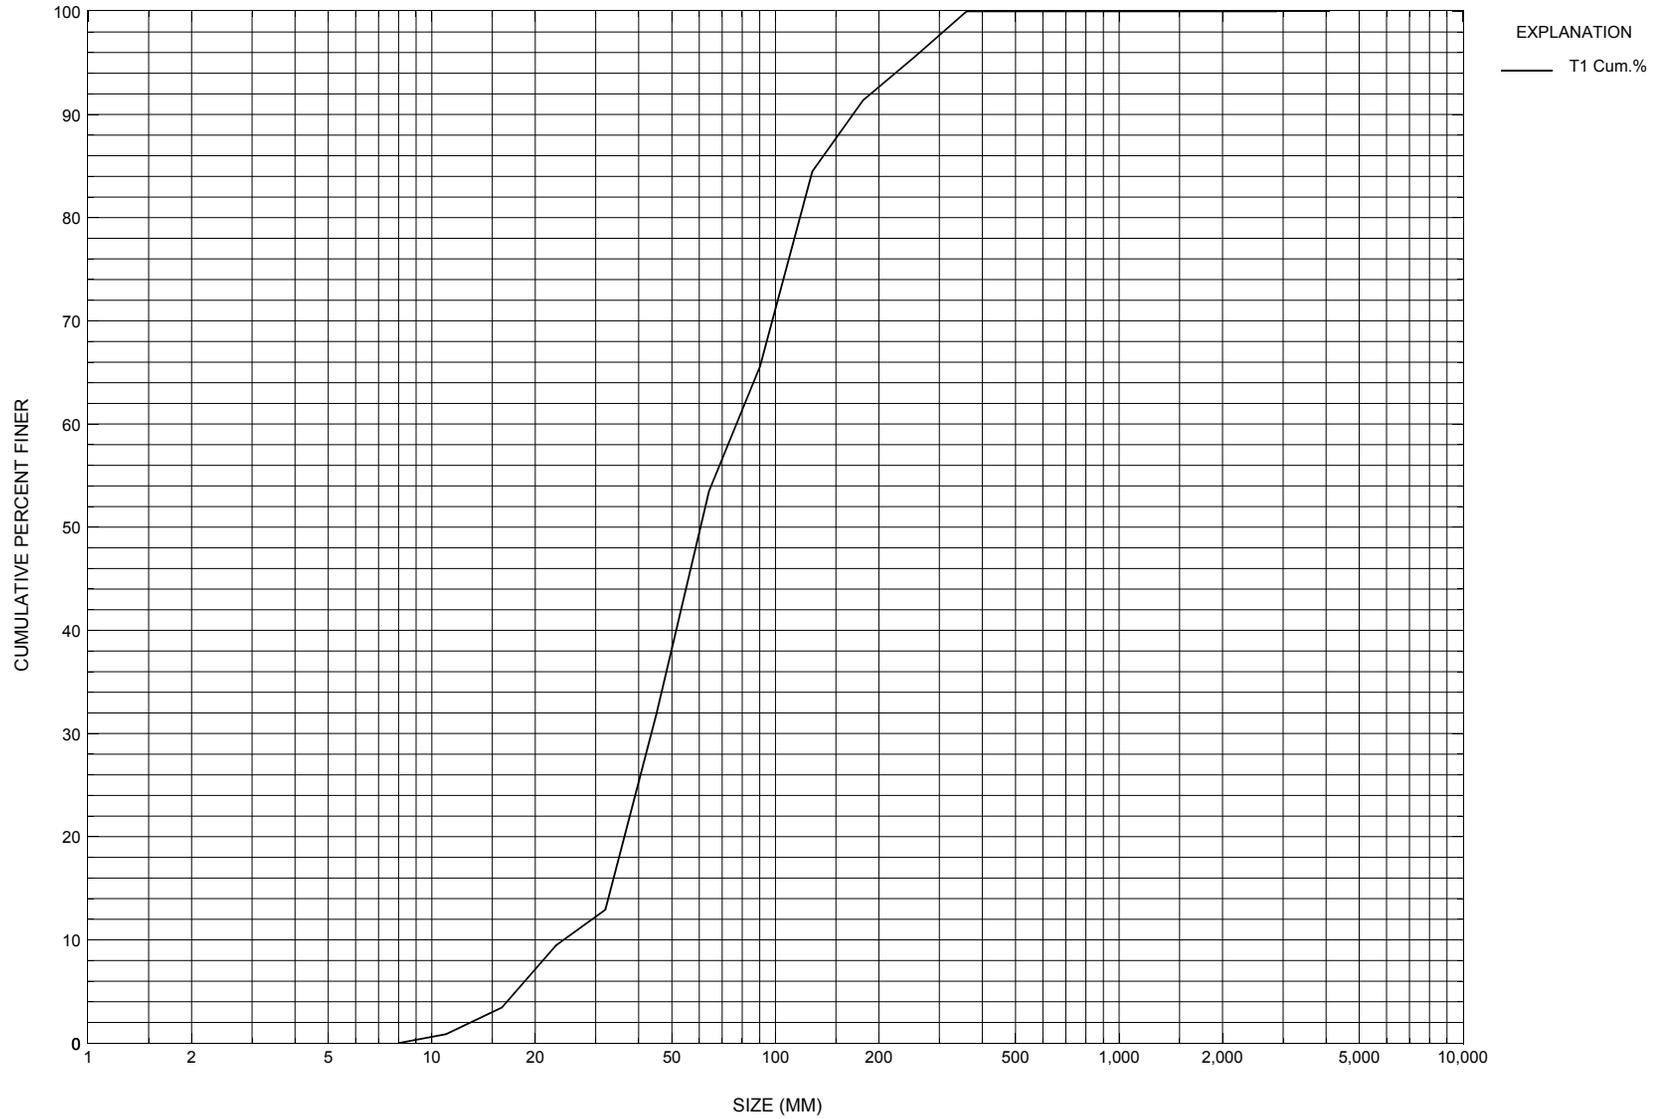
Appendix C. Bed material particle-size distribution for one pebble count transect at the approach cross-section for structure LUDLVT01000099, in Ludlow, Vermont.
