LEVEL II SCOUR ANALYSIS FOR  
BRIDGE 46 (ENOSVT01080046) on  
STATE ROUTE 108, crossing an  
UNNAMED "THE BRANCH" TRIBUTARY,  
ENOSBURG, VERMONT

U.S. Geological Survey  
Open-File Report [96-585](#)

Prepared in cooperation with  
VERMONT AGENCY OF TRANSPORTATION  
and  
FEDERAL HIGHWAY ADMINISTRATION

By Erick M. Boehmler and Laura Medalie

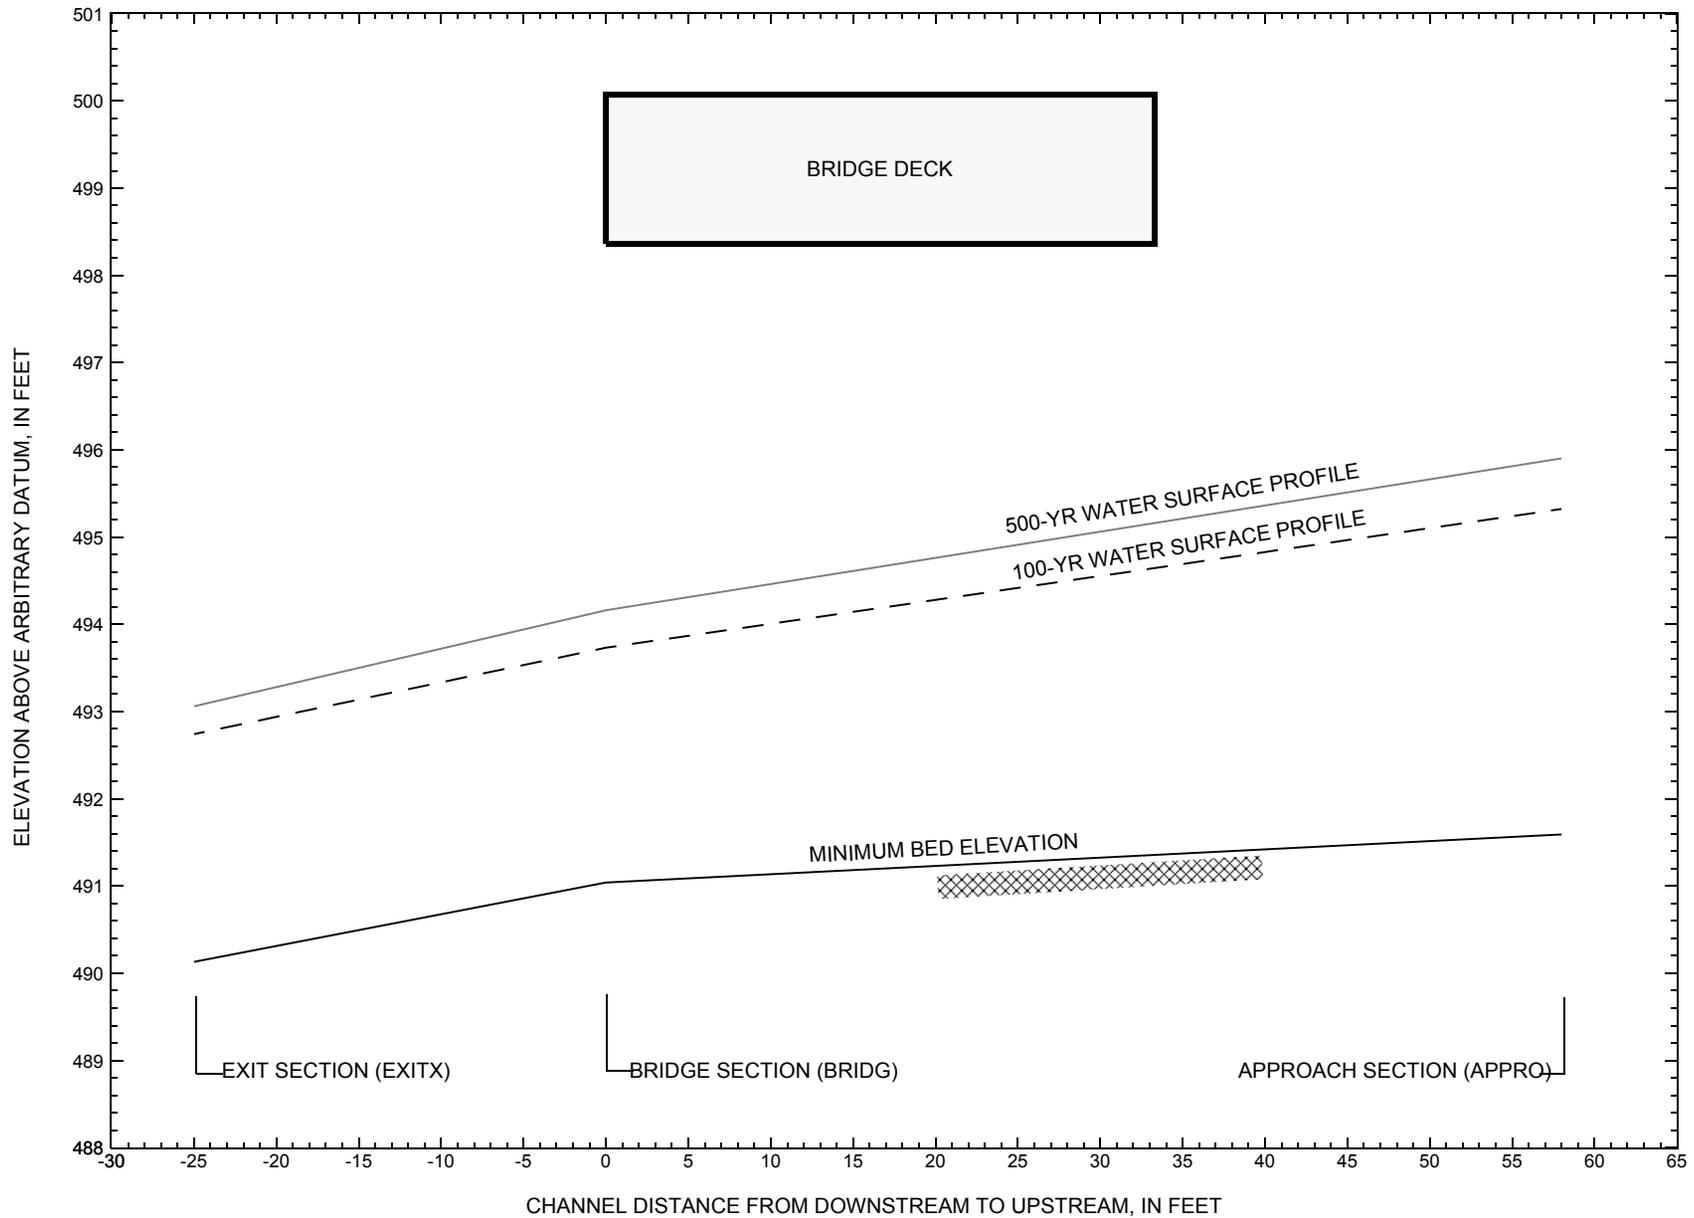
Figure 7. Water-surface profiles for the 100- and 500-yr discharges at structure [ENOSVT01080046](#) on State Route 108, crossing [An Unnamed "The Branch" Tributary, Enosburg, Vermont](#).

Hydraulic analyses of the reach were done by use of the Federal Highway Administration's WSPRO step-backwater computer program (Shearman and others, 1986, and Shearman, 1990). The analyses reported herein reflect conditions existing at the site at the time of the study. Furthermore, in the development of the model it was necessary to assume no accumulation of debris or ice at the site. Although this unnamed brook enters "The Branch" about 350 feet downstream of this site, no backwater effects were assumed as the timing of the peak discharges on each waterway probably are not coincident. Results of the hydraulic model are presented in the Bridge Hydraulic Summary, Appendix B, and figure 7.

100-year discharge 425 ft<sup>3</sup>/s  
 Water-surface elevation in bridge opening 493.7 ft  
 Road overtopping? No Discharge over road -- ft/s  
 Area of flow in bridge opening 50.0 ft<sup>2</sup>  
 Average velocity in bridge opening 8.5 ft/s  
 Maximum WSPRO tube velocity at bridge 9.7 ft/s

500-year discharge 550 ft<sup>3</sup>/s  
 Water-surface elevation in bridge opening 494.2 ft  
 Road overtopping? No Discharge over road -- ft/s  
 Area of flow in bridge opening 59.6 ft<sup>2</sup>  
 Average velocity in bridge opening 9.2 ft/s  
 Maximum WSPRO tube velocity at bridge 10.6 ft/s

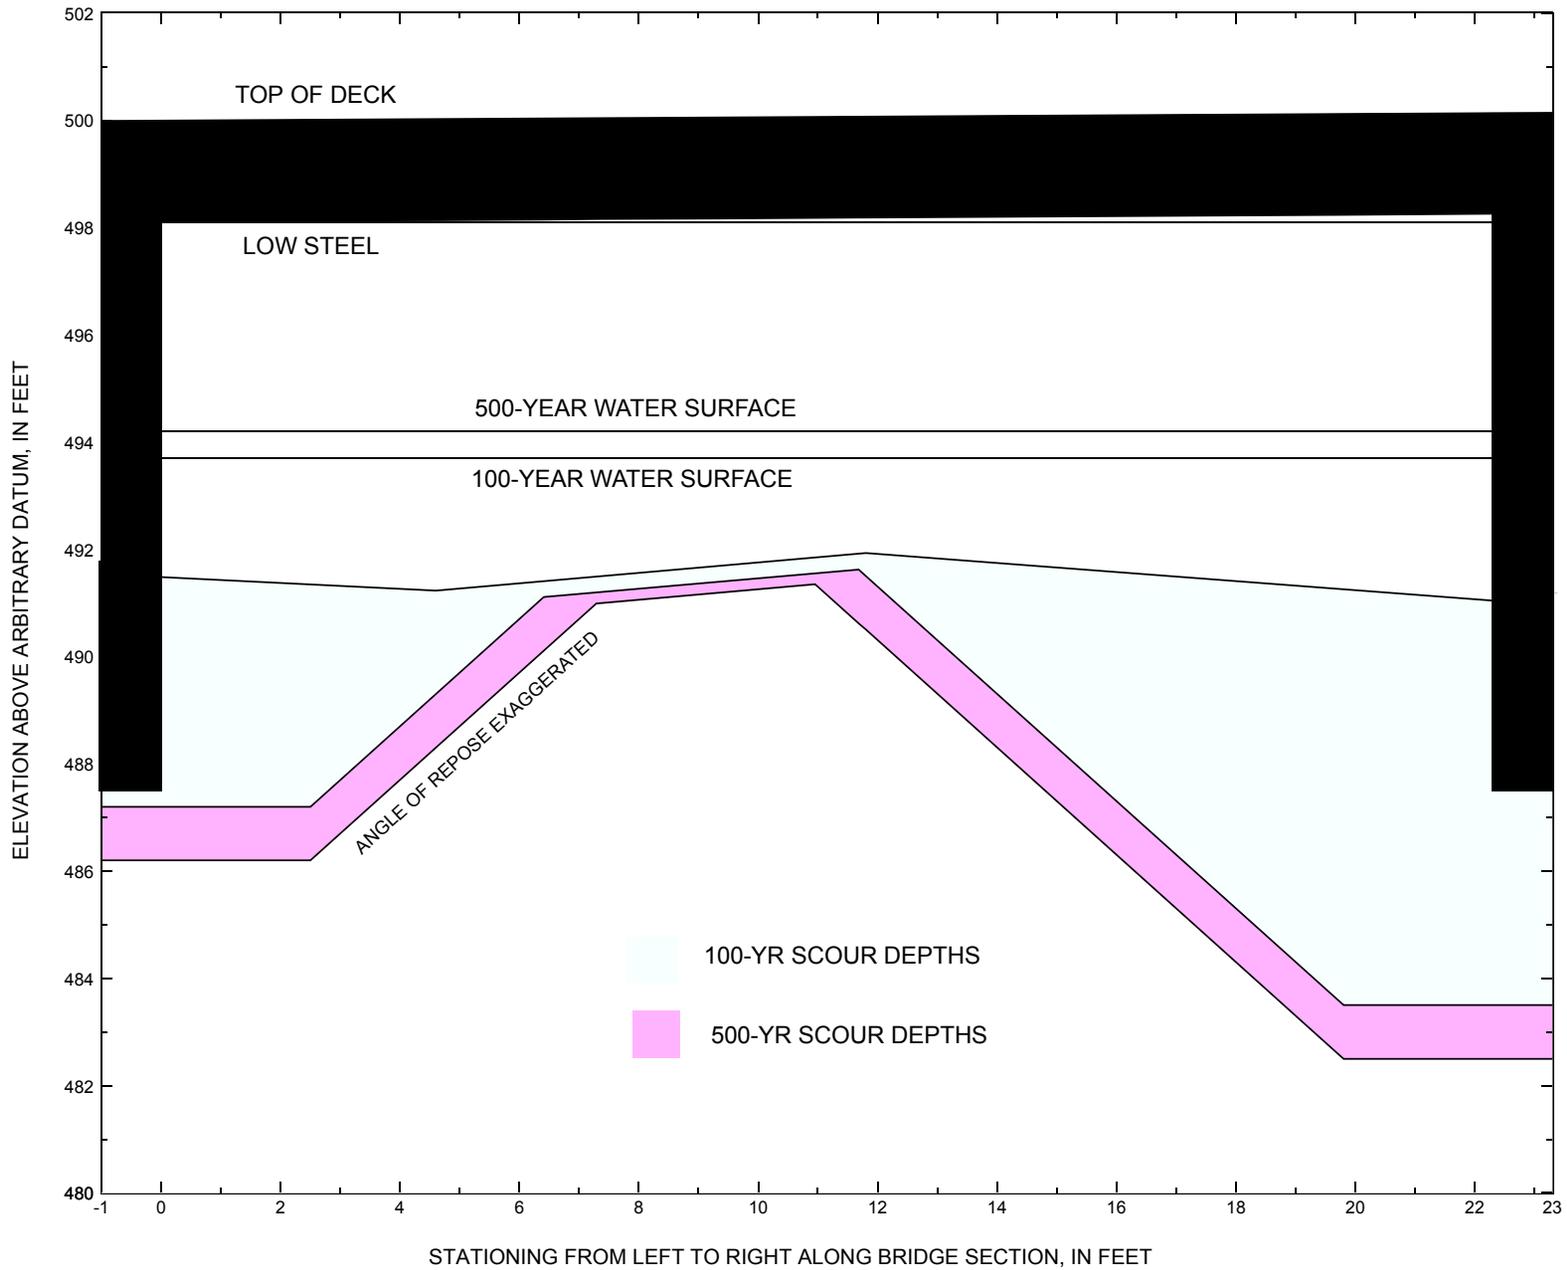
Figure 8. Scour elevations for the 100-yr and 500-yr discharges at structure [ENOSVT01080046](#) on State Route 108, crossing [An Unnamed "The Branch" Tributary, Enosburg, Vermont](#).

Scour depths were computed using the general guidelines described in Hydraulic Engineering Circular 18 (Richardson and others, 1995). Scour depths were calculated assuming an infinite depth of erosive material and a homogeneous particle-size distribution. The results of the scour analysis are presented in tables 1 and 2 and a graph of the scour depths is presented in figure 8.

<i>Abutment scour</i>	4.0	4.8	--
<i>Left abutment</i>	7.2	8.0	--
<i>Right abutment</i>	-----	-----	-----
<i>Pier scour</i>	--	--	--
<i>Pier 1</i>	-----	-----	-----
<i>Pier 2</i>	-----	-----	-----
<i>Pier 3</i>	-----	-----	-----

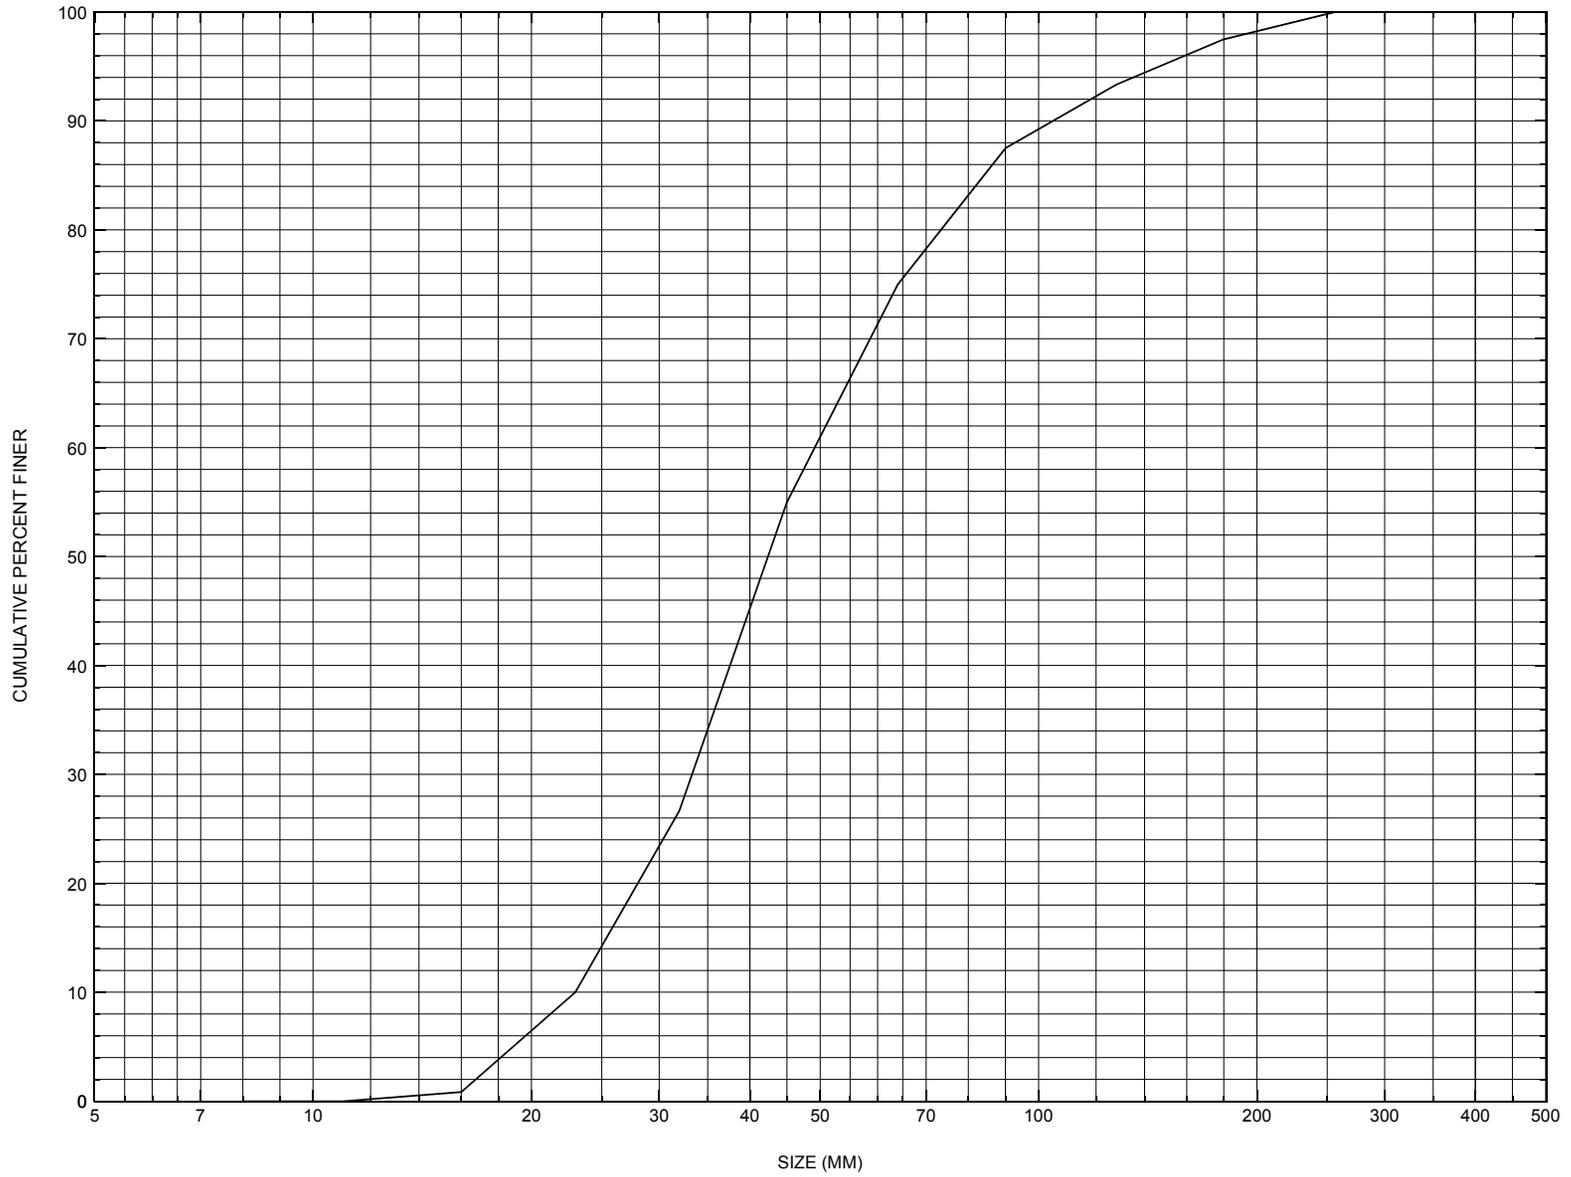
Appendix C. Bed material particle-size distribution for one pebble count transect at the channel approach of structure ENOSVT01080046, in Enosburg, Vermont.
