LEVEL II SCOUR ANALYSIS FOR  
BRIDGE 41 ([BAKEVT01080041](#)) on  
[STATE ROUTE 108](#), crossing  
[THE BRANCH](#),  
[BAKERSFIELD](#), VERMONT

U.S. Geological Survey  
Open-File Report [96-643](#)

Prepared in cooperation with  
VERMONT AGENCY OF TRANSPORTATION  
and  
FEDERAL HIGHWAY ADMINISTRATION

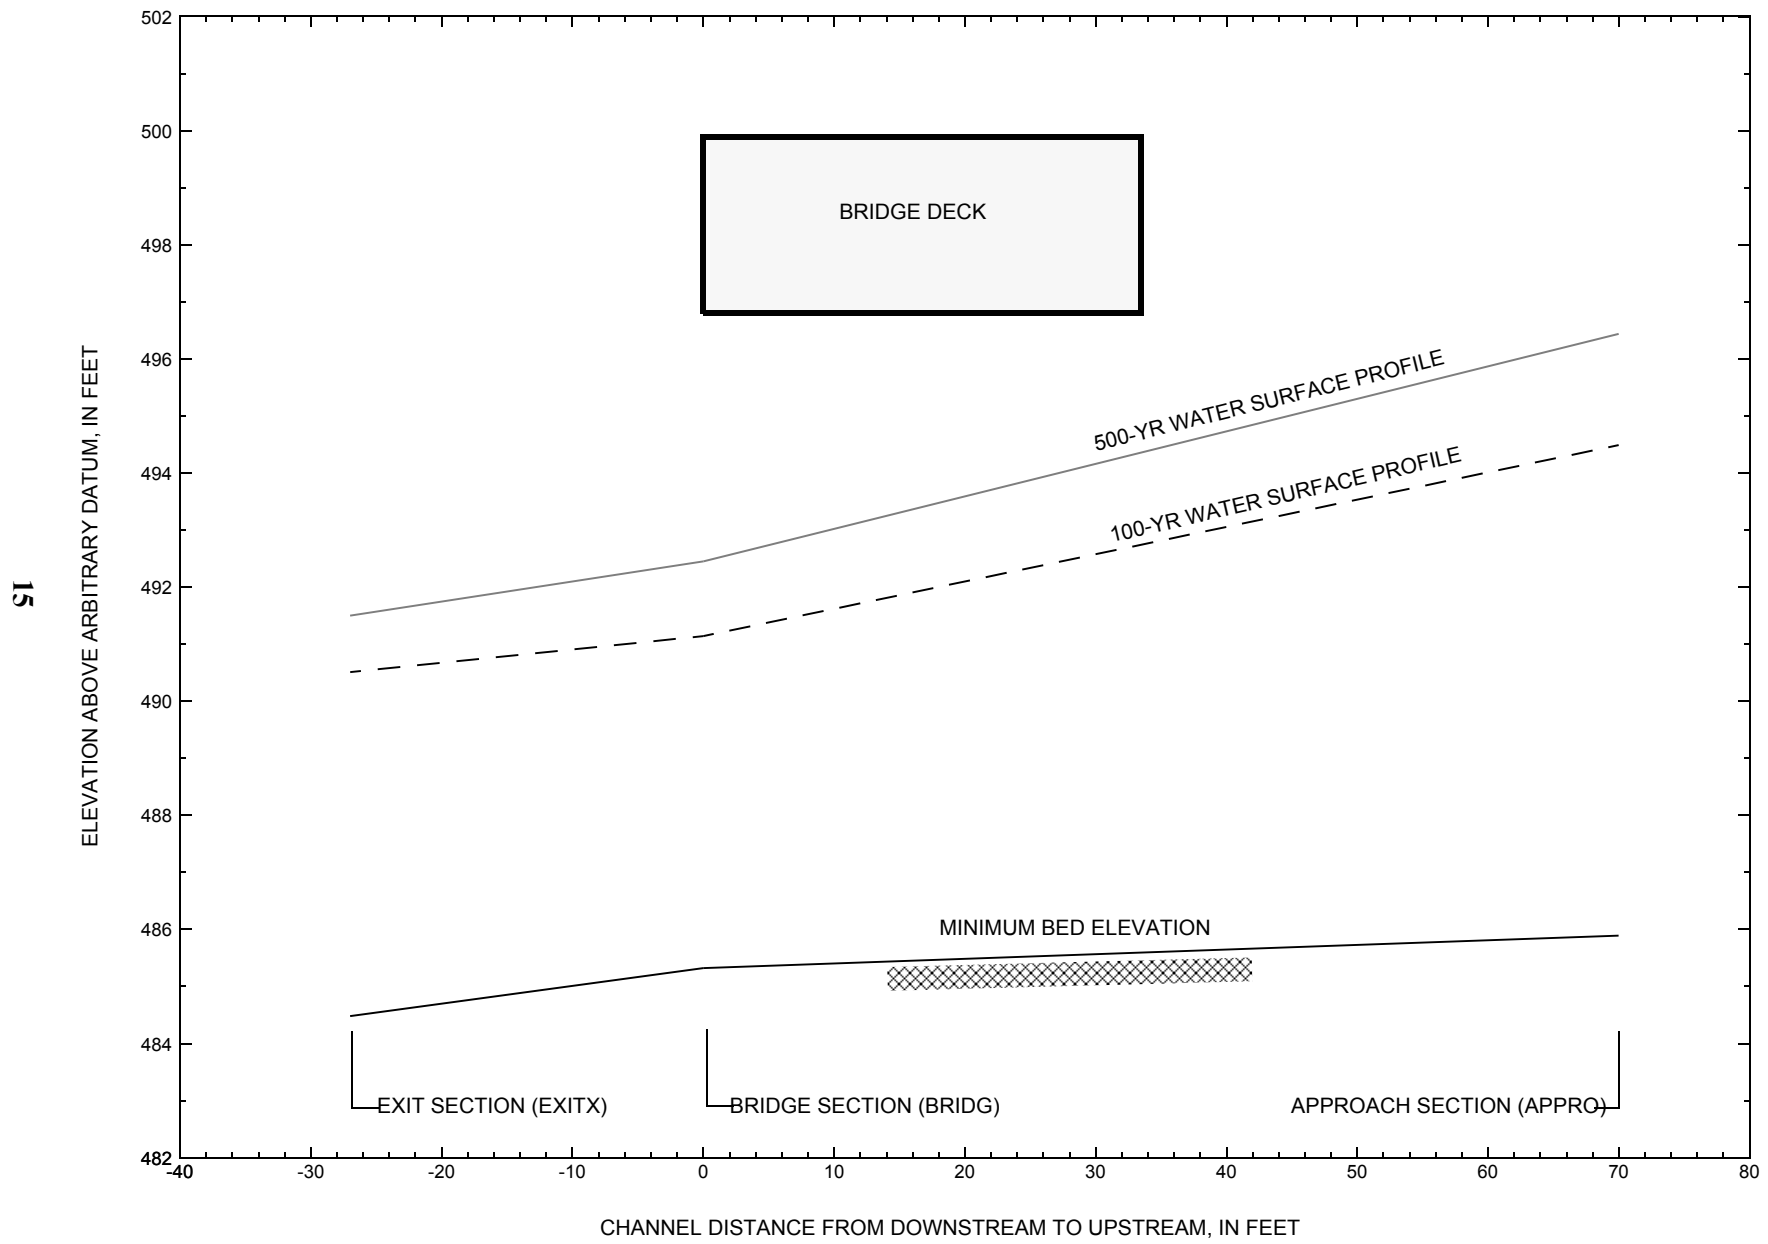
Figure 7. Water-surface profiles for the 100- and 500-yr discharges at structure [BAKEVT01080041](#) on State Route 108, crossing [The Branch, Bakersfield, Vermont](#).

Hydraulic analyses of the reach were done by use of the Federal Highway Administration's WSPRO step-backwater computer program (Shearman and others, 1986, and Shearman, 1990). The analyses reported herein reflect conditions existing at the site at the time of the study. Furthermore, in the development of the model it was necessary to assume no accumulation of debris or ice at the site. Results of the hydraulic model are presented in the Bridge Hydraulic Summary, Appendix B, and figure 7.

Water-surface elevation at Approach section with bridge 494.5  
 Water-surface elevation at Approach section without bridge 492.2  
 Amount of backwater caused by bridge 2.3 ft

Water-surface elevation at Approach section with bridge 496.4  
 Water-surface elevation at Approach section without bridge 493.3  
 Amount of backwater caused by bridge 3.1 ft

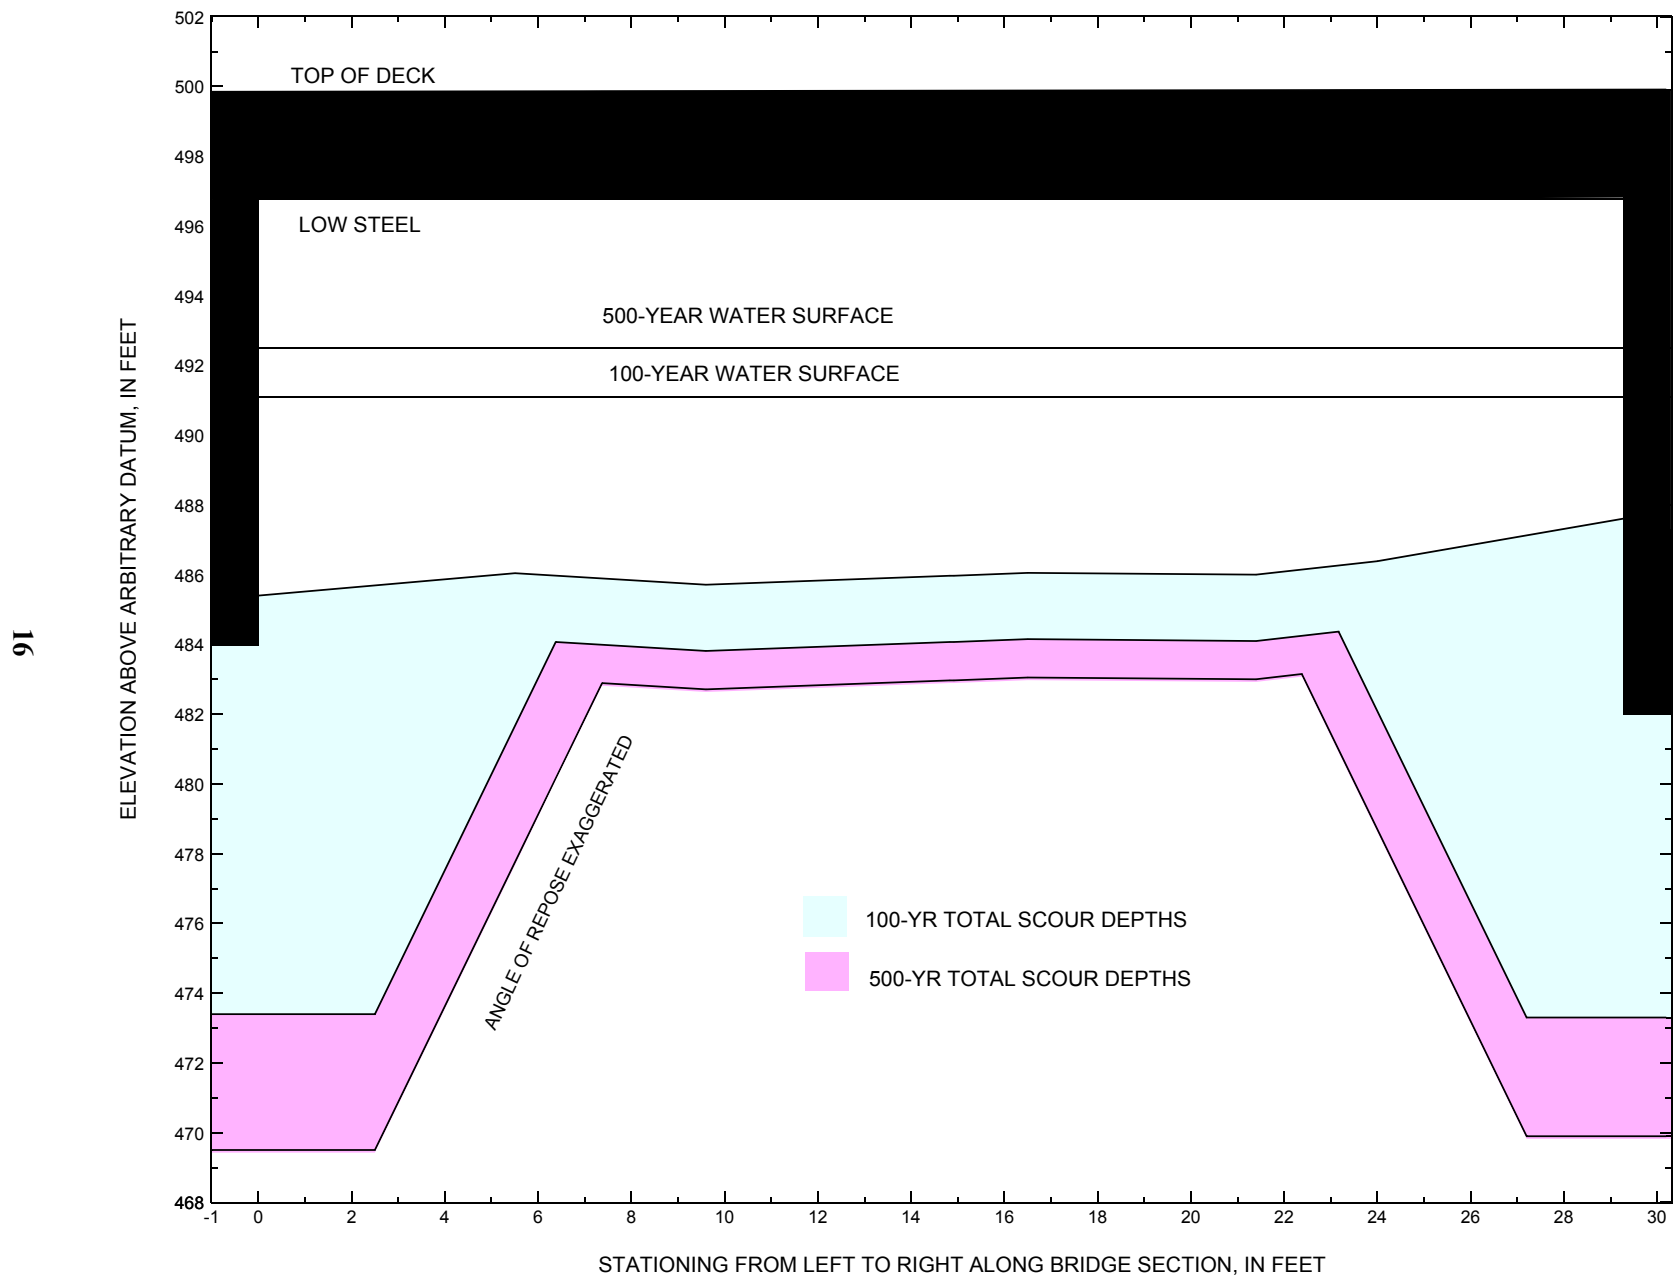
Figure 8. Scour elevations for the 100-yr and 500-yr discharges at structure [BAKEVT01080041](#) on State Route 108, crossing [The Branch, Bakersfield](#), Vermont.

Scour depths were computed using the general guidelines described in Hydraulic Engineering Circular 18 (Richardson and others, 1995). Scour depths were calculated assuming an infinite depth of erosive material and a homogeneous particle-size distribution. The results of the scour analysis are presented in tables 1 and 2 and a graph of the scour depths is presented in figure 8.

<i>Abutment scour</i>	10.1	12.9	--
<i>Left abutment</i>	11.2	13.5	--
<i>Right abutment</i>	--	--	--
<i>Pier scour</i>	--	--	--
<i>Pier 1</i>	--	--	--
<i>Pier 2</i>	--	--	--
<i>Pier 3</i>	--	--	--

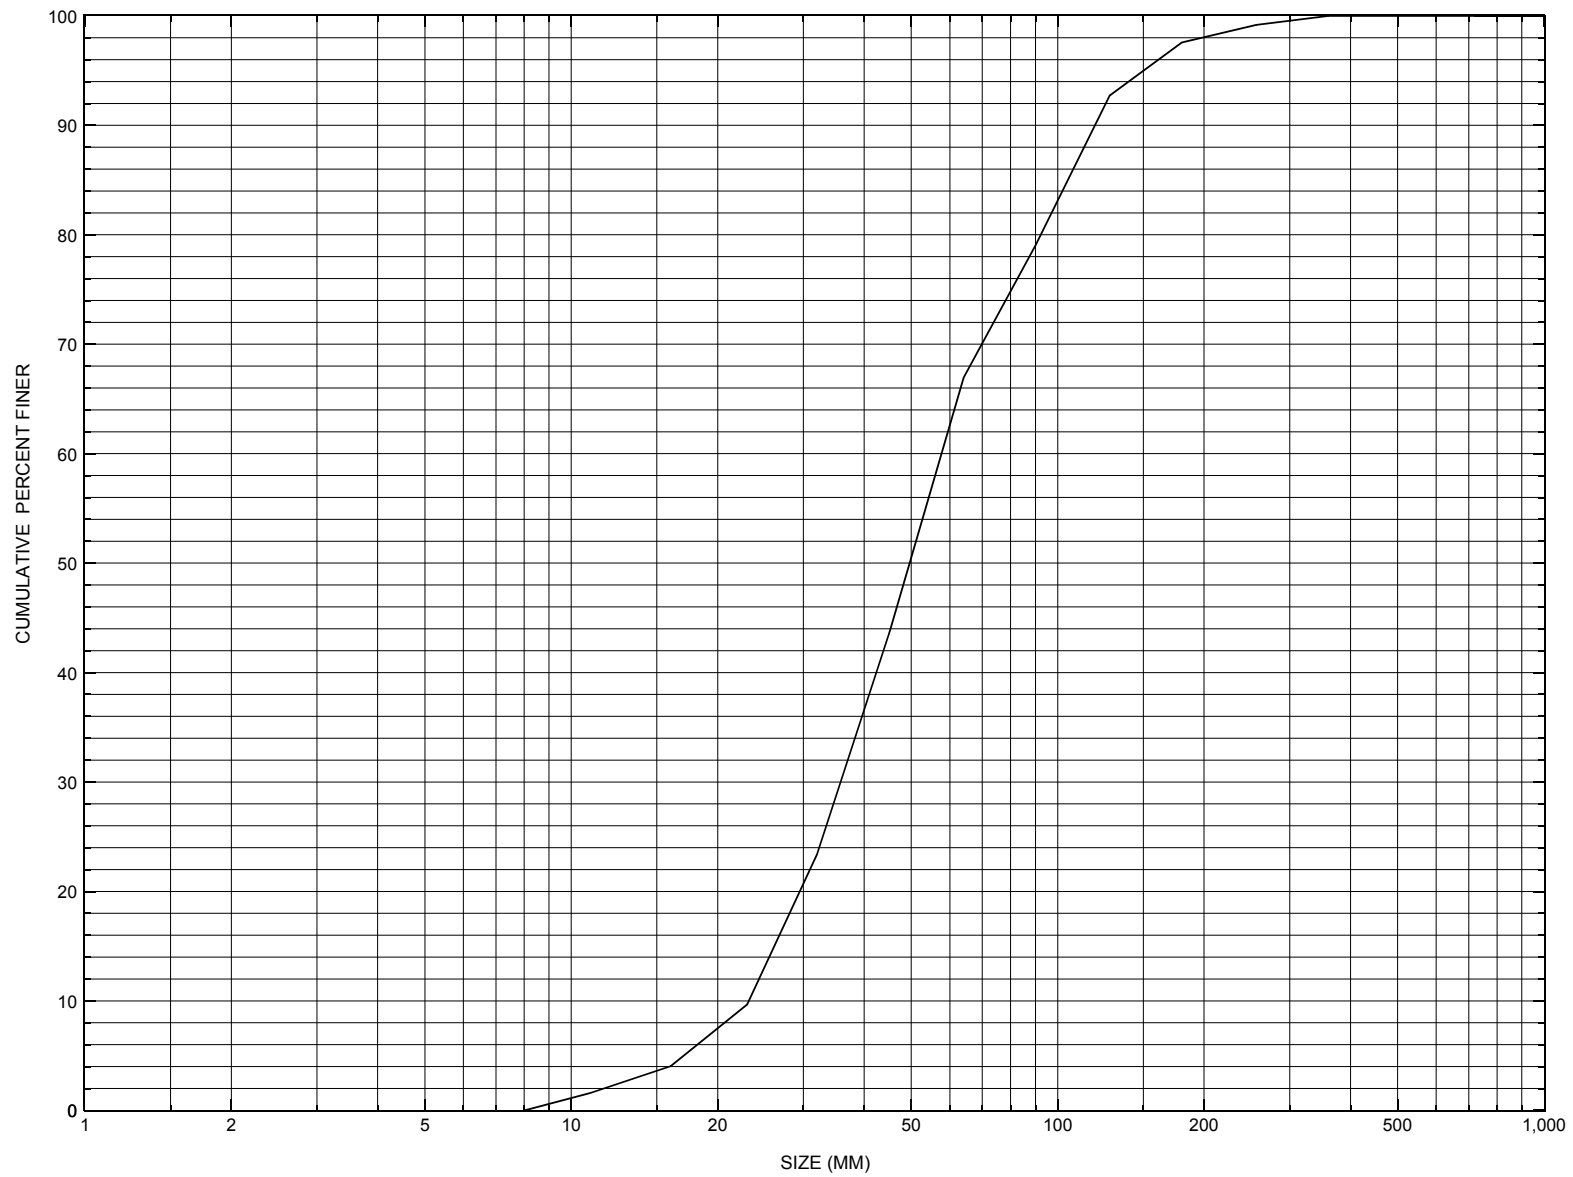
Appendix C. Bed material particle-size distribution for one pebble count transect in the channel approach of structure [BAKEVT01080041](#), in [Bakersfield](#), Vermont.
