PRELIMINARY MAPPING OF OVERWASH FROM HURRICANE FRAN, SEPTEMBER 5, 1996 CAPE FEAR TO BOGUE INLET, NORTH CAROLINA

U.S. GEOLOGICAL SURVEY

Richard P. Stumpf, M. Dennis Krohn, Karen L. M.
Morgan, Russell Peterson, Dana Wiese

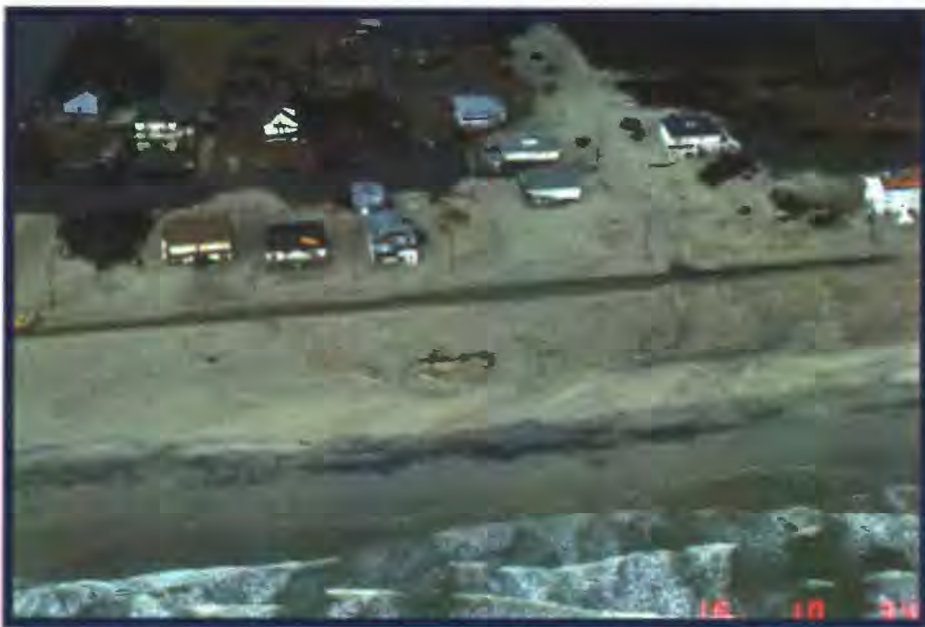
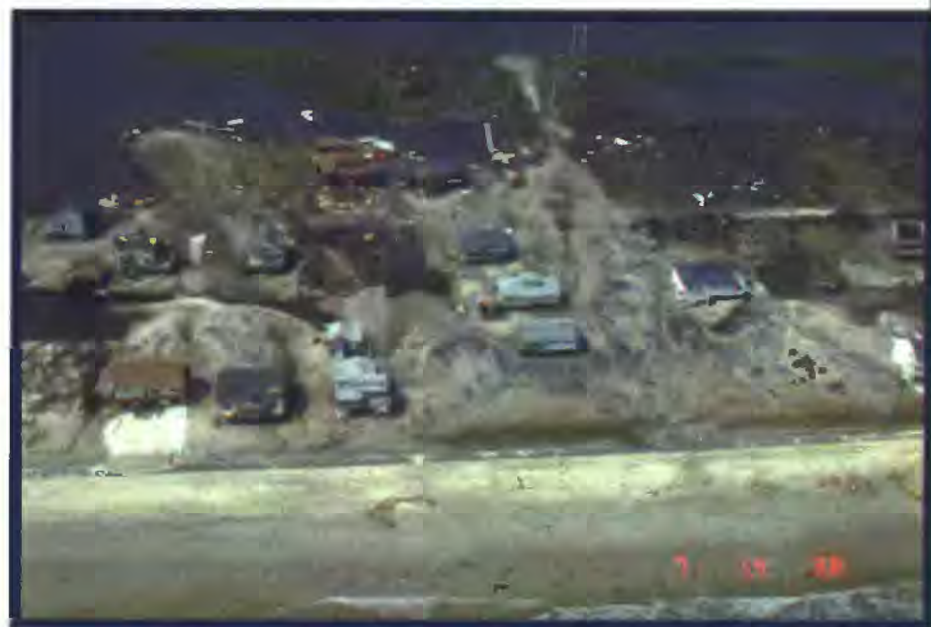
BEFORE**AFTER****West Onslow Beach Overwash 34° 30.70'N 77° 22.16'W**

**Bertha 7/16/96 10:34 EDT****Fran 9/07/96 14:38 EDT**

Areas overwashed by Bertha were more susceptible to erosion and overwash by Fran. At West Onslow Beach, overwash fans are observed after both storms but are more extensive after Fran. Overwash that initially carried sand into the finger channels behind the first row of houses during Bertha completely filled the channels during Fran. Initially susceptible to erosion during a category 2 hurricane, the area affected by the category 3 storm was greatly expanded. Standing water appears in many areas after Fran.

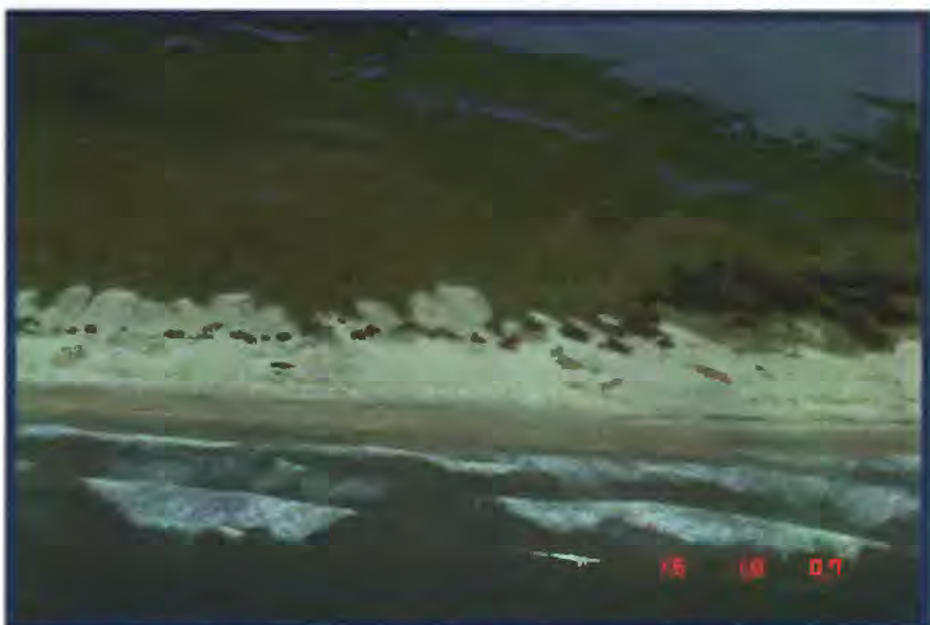
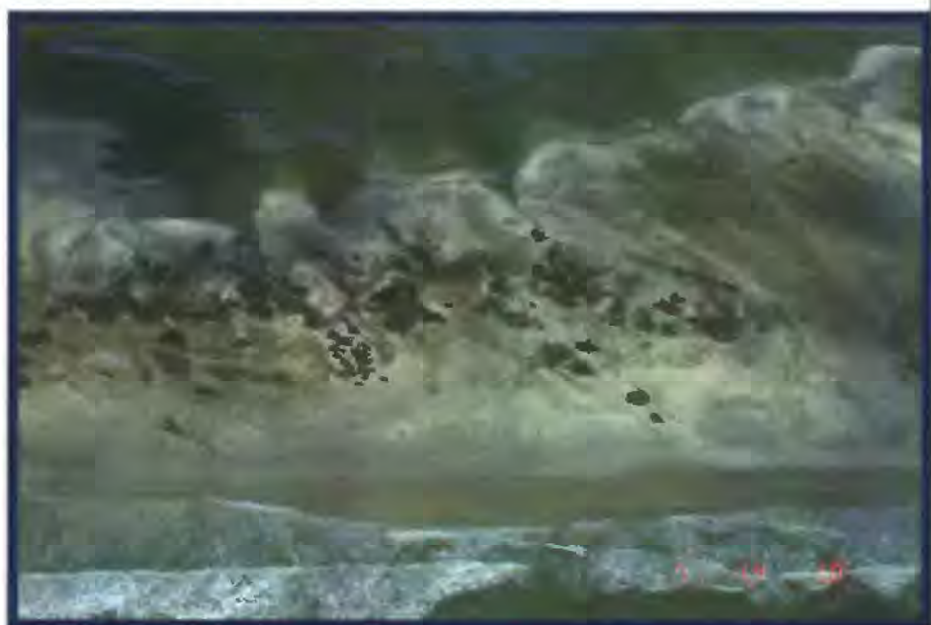
BEFORE**AFTER****Undeveloped beach of Smith Island 33° 53.43'N 77° 57.08'W**

**Bertha 7/16/96 10:07 EDT****Fran 9/07/96 14:10 EDT**

Photographs of an undeveloped coastline illustrate the contrast between Bertha, a category 2 hurricane and Fran, a category 3 hurricane. Some erosion as shown by the dune scarp and minor overwash occurred during Bertha; Fran caused major overwash fan deposits that extended into the back marsh. Finger-like projections visible as small overwash fans after Bertha were greatly extended after Fran. The large difference between these deposits show the value of surveying the undeveloped coastline for understanding geologic processes.

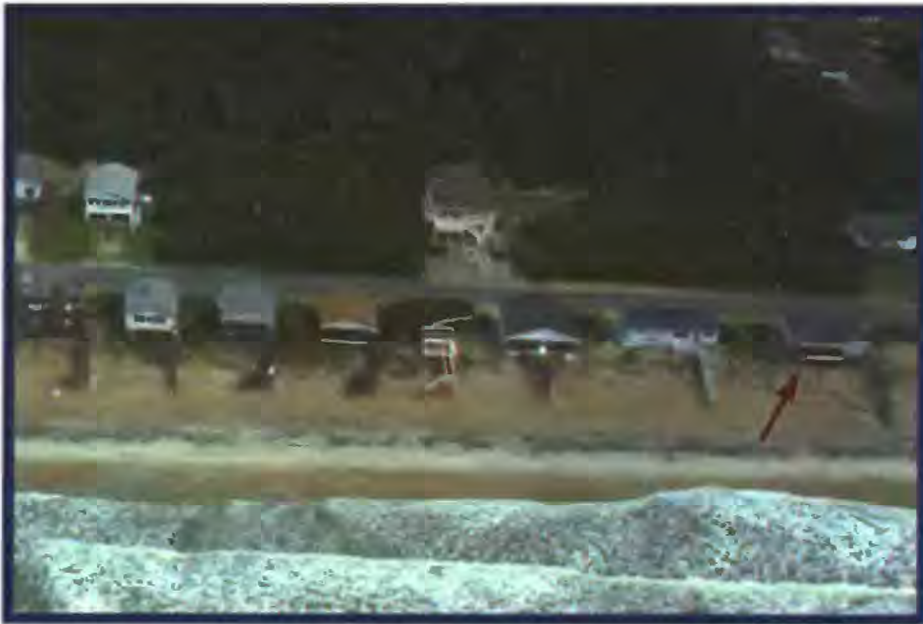
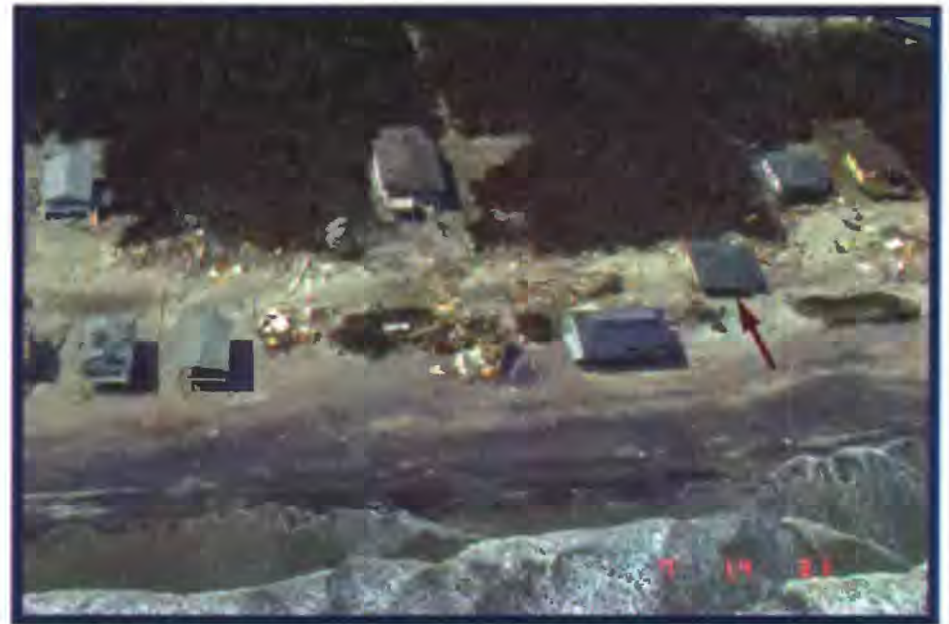
BEFORE**AFTER****Topsail Beach Overwash 34° 24.05'N 77° 34.80'W**

**Bertha 7/16/96 10:27 EDT**

**Fran 9/07/96 14:31 EDT**

The duneline, which was eroded but remained intact during Bertha, was destroyed and overwashed during Fran. Erosion has undercut many houses causing severe damage or total destruction. The force of the waves overwashing the dunes moved one house off its foundation and into the sand covered road behind its former location (red arrows). The storm surge deposited sand within vegetated areas, but the geometry of the overwash is obscured by the canopy. The dark sand on the beach is formed by heavy minerals that are typically concentrated on the beach during erosion. A thin band appears after Bertha with a wide deposit as a result of Fran.

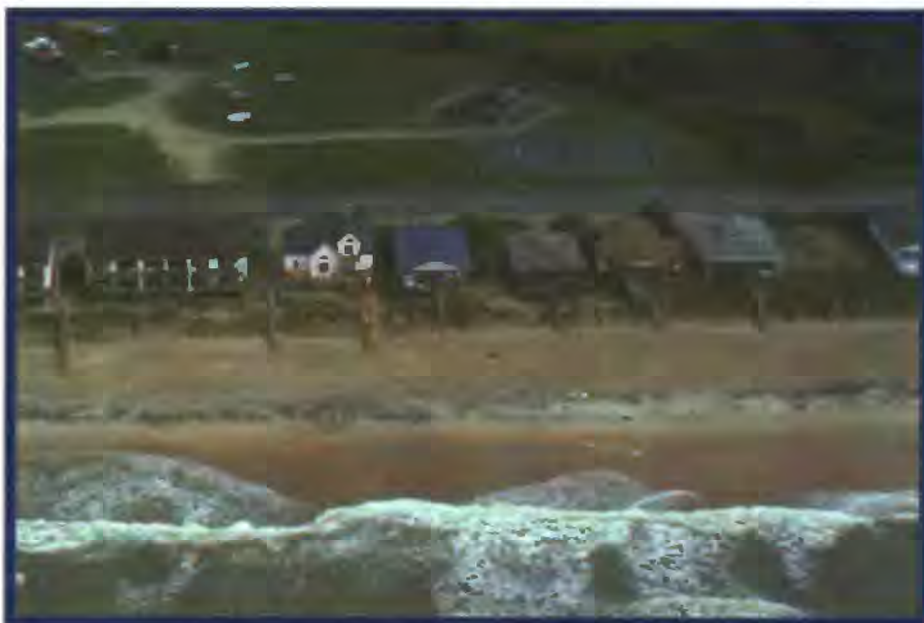
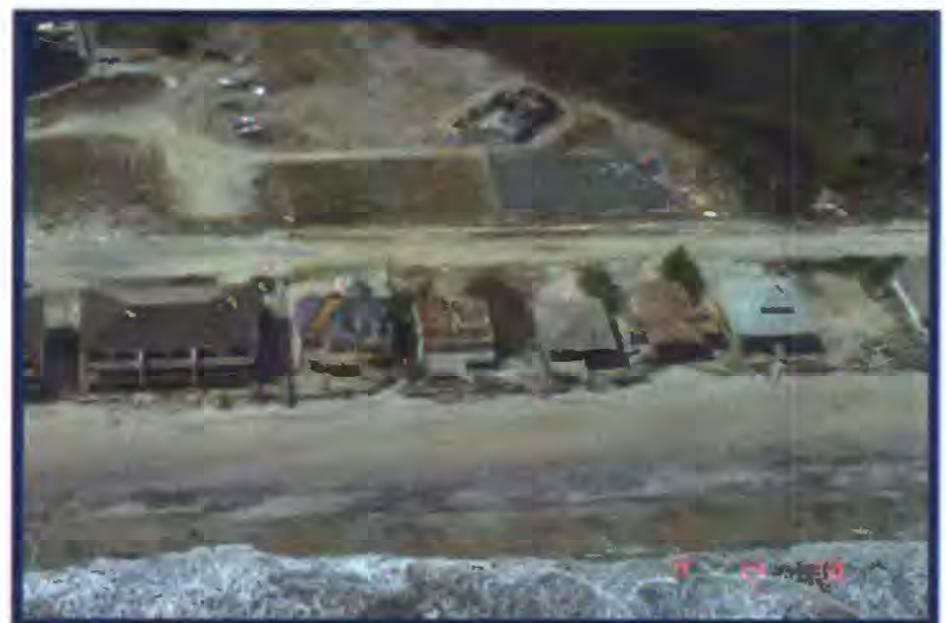
BEFORE**AFTER****Topsail Beach Dune Erosion 34° 22.79'N 77° 36.47'W**

**Bertha 7/16/96 10:26 EDT**

**Fran 9/07/96 14:30 EDT**

The dune line in front of the apartments seems intact with minor erosion at the base after the passage of Bertha. After Fran, the dune was eroded to the first line of houses, leaving a new scalloped scarp line. In a few places the dune was breached.

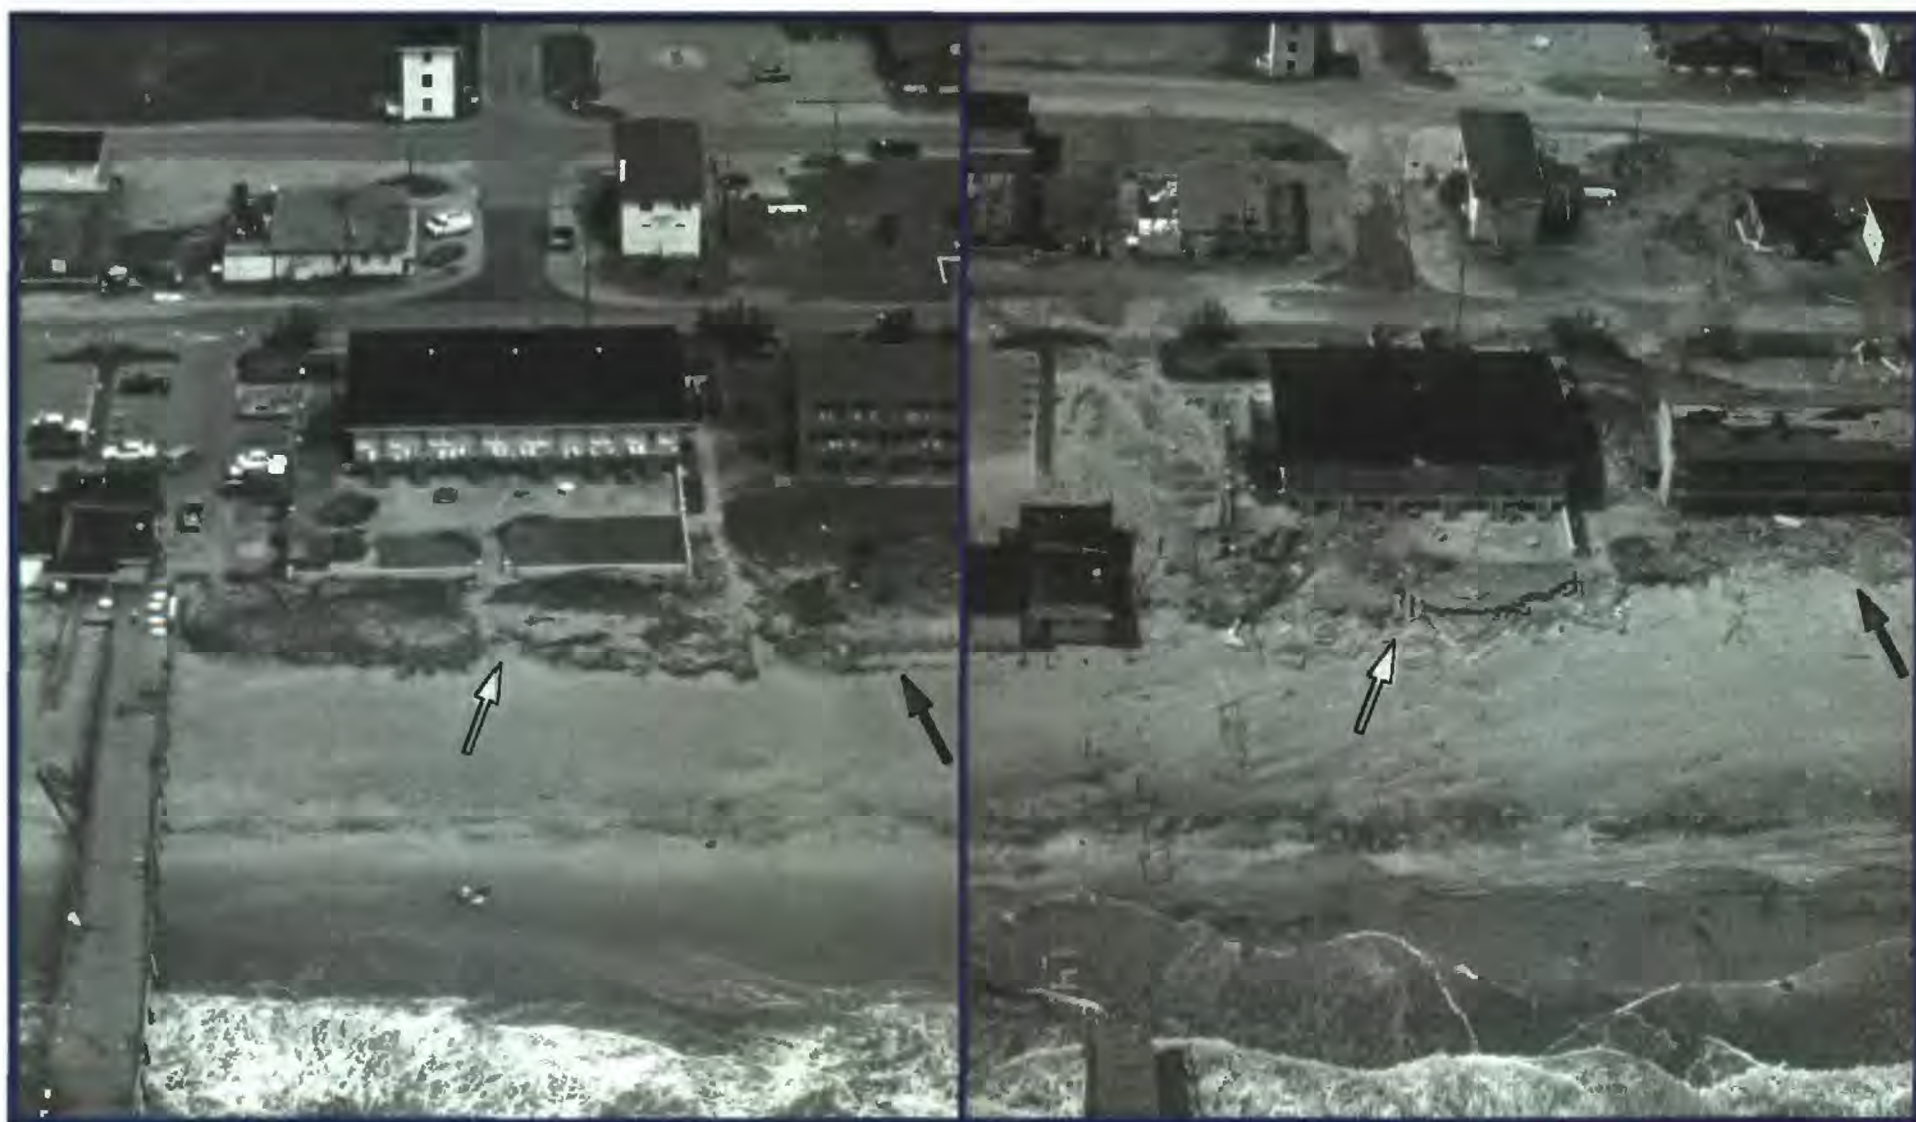
BEFORE**AFTER****Topsail Beach Pier 34° 21.87'N 77° 37.59'W**

**Bertha****7/16/96****10:25 EDT****Fran****9/07/96****14:29 EDT**

Many piers damaged during Bertha were destroyed during Fran. The pier at Topsail Beach sustained only minor damage after Bertha and was open a few days after the storm. Storm waves from Fran removed the section of the pier closest to the beach. The dune line which held during Bertha (to the left of the pier) was completely removed and the retaining wall behind it destroyed, leaving debris scattered in front of the buildings (light arrows). Further to the right a low dune line is replaced by an erosional scarp (dark arrows). Sand extends to third row of houses and appears to come from the left.
