# LEVEL II SCOUR ANALYSIS FOR BRIDGE 13 (IRA-VT01330013) on STATE ROUTE 133, crossing an IRA BROOK TRIBUTARY, IRA, VERMONT

U.S. Geological Survey  
Open-File Report 96-749

Prepared in cooperation with  
VERMONT AGENCY OF TRANSPORTATION  
and  
FEDERAL HIGHWAY ADMINISTRATION

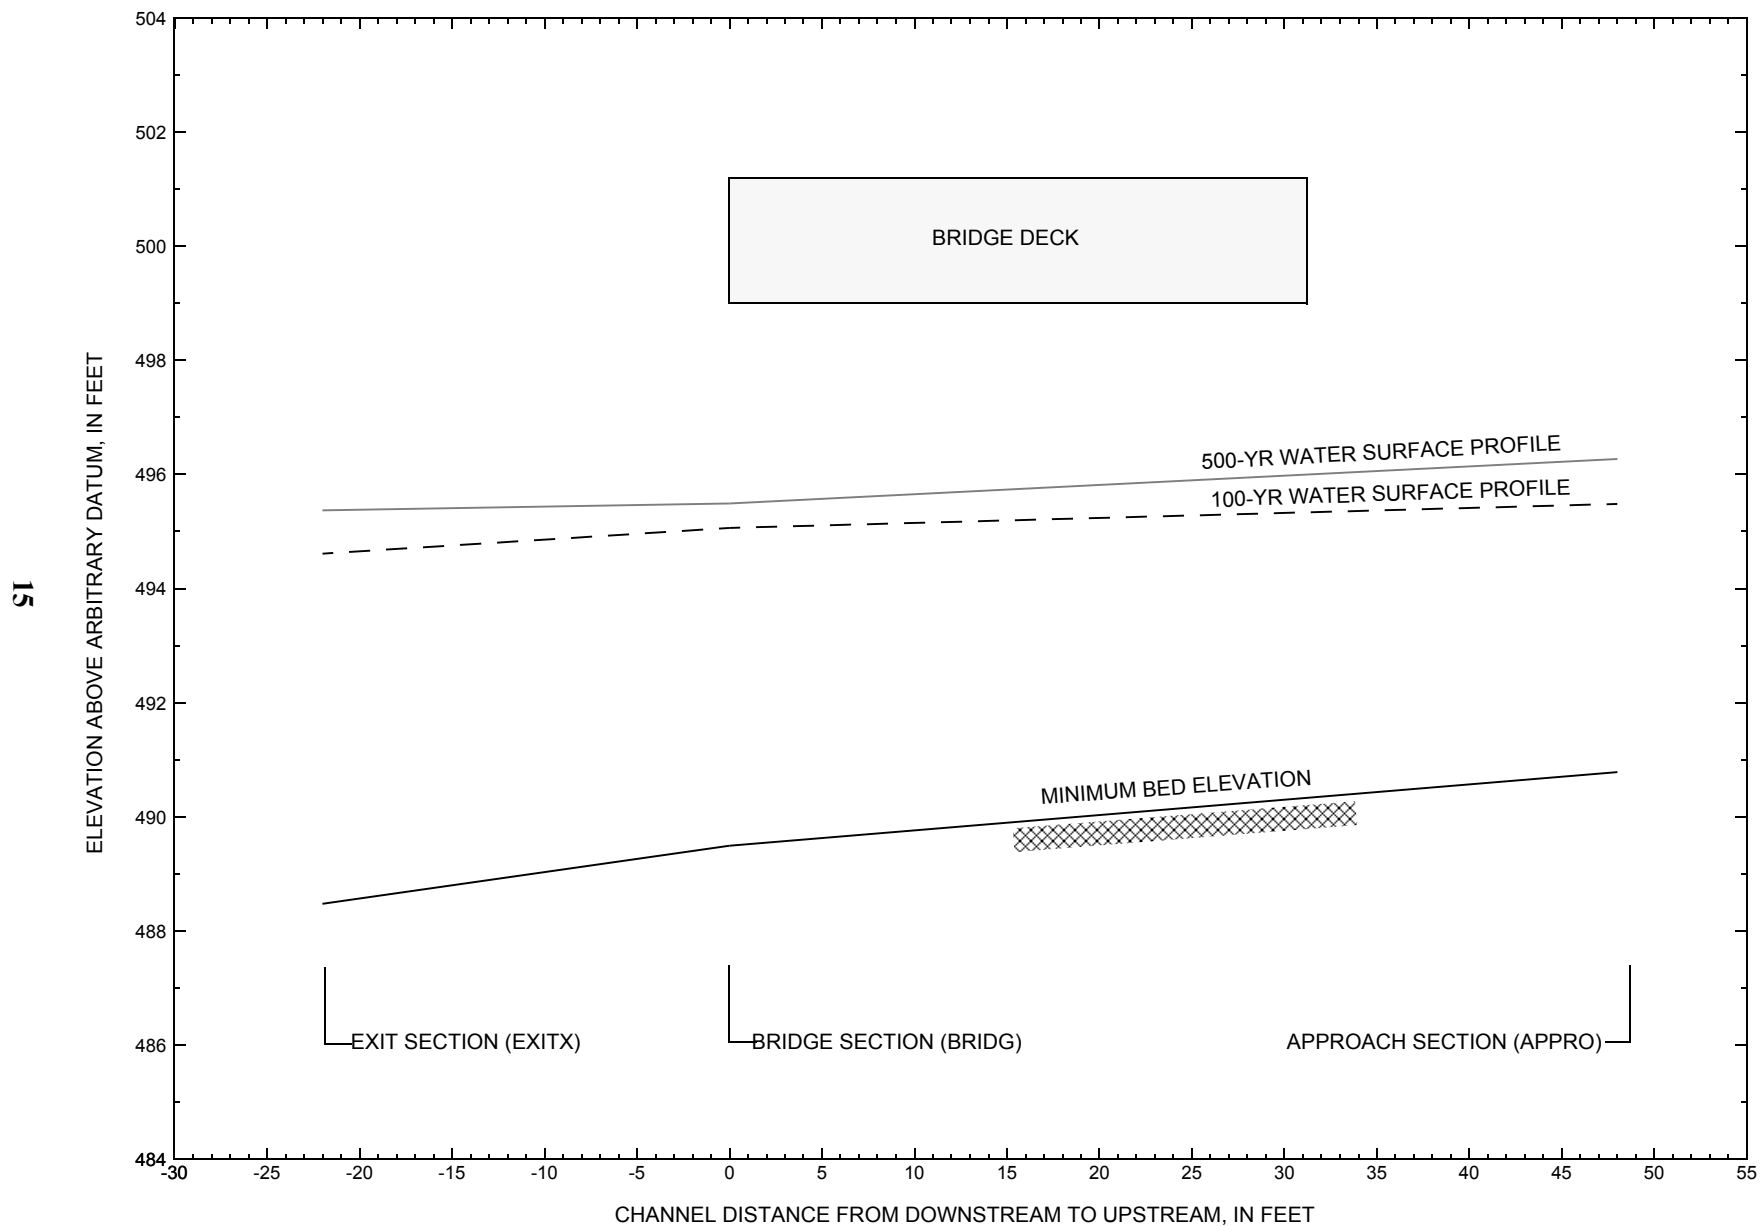
Figure 7. Water-surface profiles for the 100- and 500-yr discharges at structure IRA-VT01330013 on State Route 133, crossing an Ira Brook Tributary, Ira, Vermont.

Hydraulic analyses of the reach were done by use of the Federal Highway Administration's WSPRO step-backwater computer program (Shearman and others, 1986, and Shearman, 1990). The analyses reported herein reflect conditions existing at the site at the time of the study. Furthermore, in the development of the model it was necessary to assume no accumulation of debris or ice at the site. Results of the hydraulic model are presented in the Bridge Hydraulic Summary, Appendix B, and figure 7.

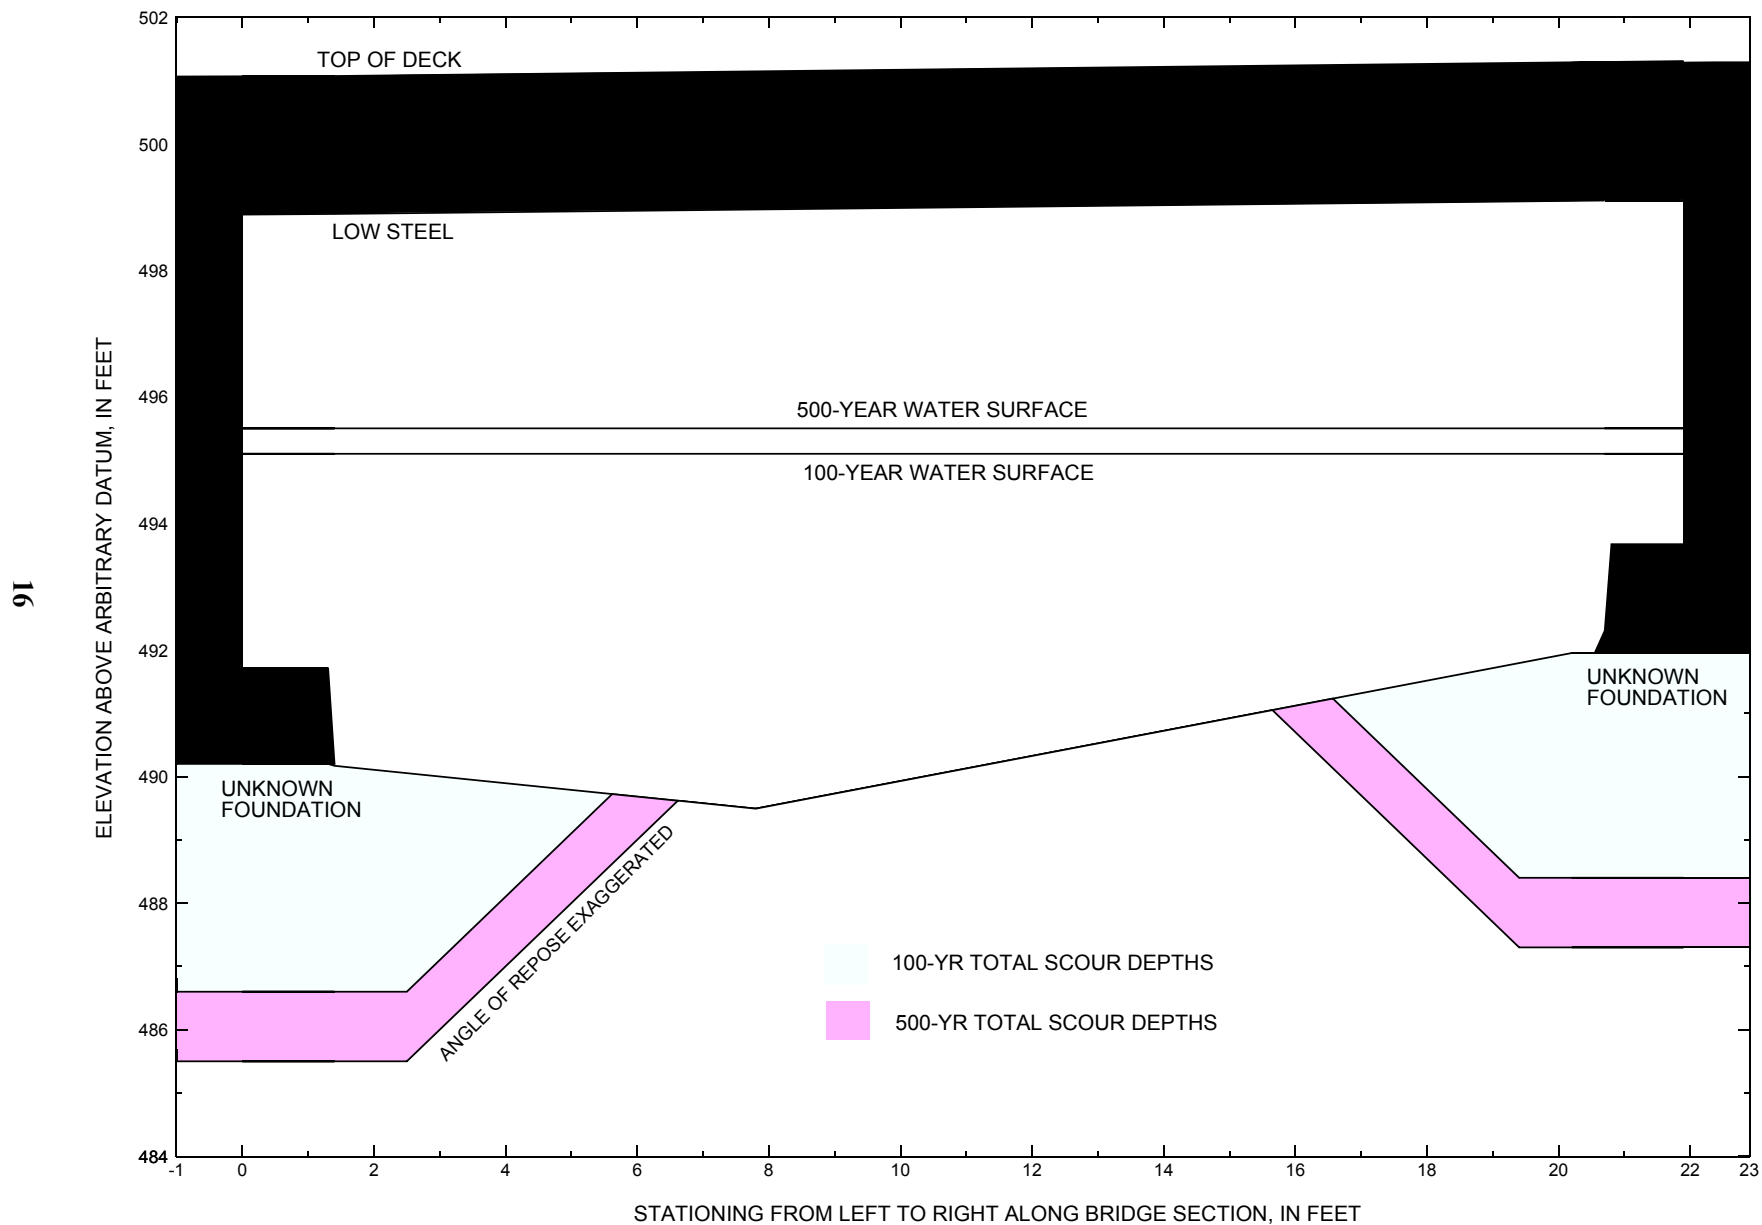
Figure 8. Scour elevations for the 100-yr and 500-yr discharges at structure IRA-VT01330013 on State Route 133, crossing an Ira Brook Tributary, Ira, Vermont.

Scour depths were computed using the general guidelines described in Hydraulic Engineering Circular 18 (Richardson and others, 1995). Scour depths were calculated assuming an infinite depth of erosive material and a homogeneous particle-size distribution. The results of the scour analysis are presented in tables 1 and 2 and a graph of the scour depths is presented in figure 8.

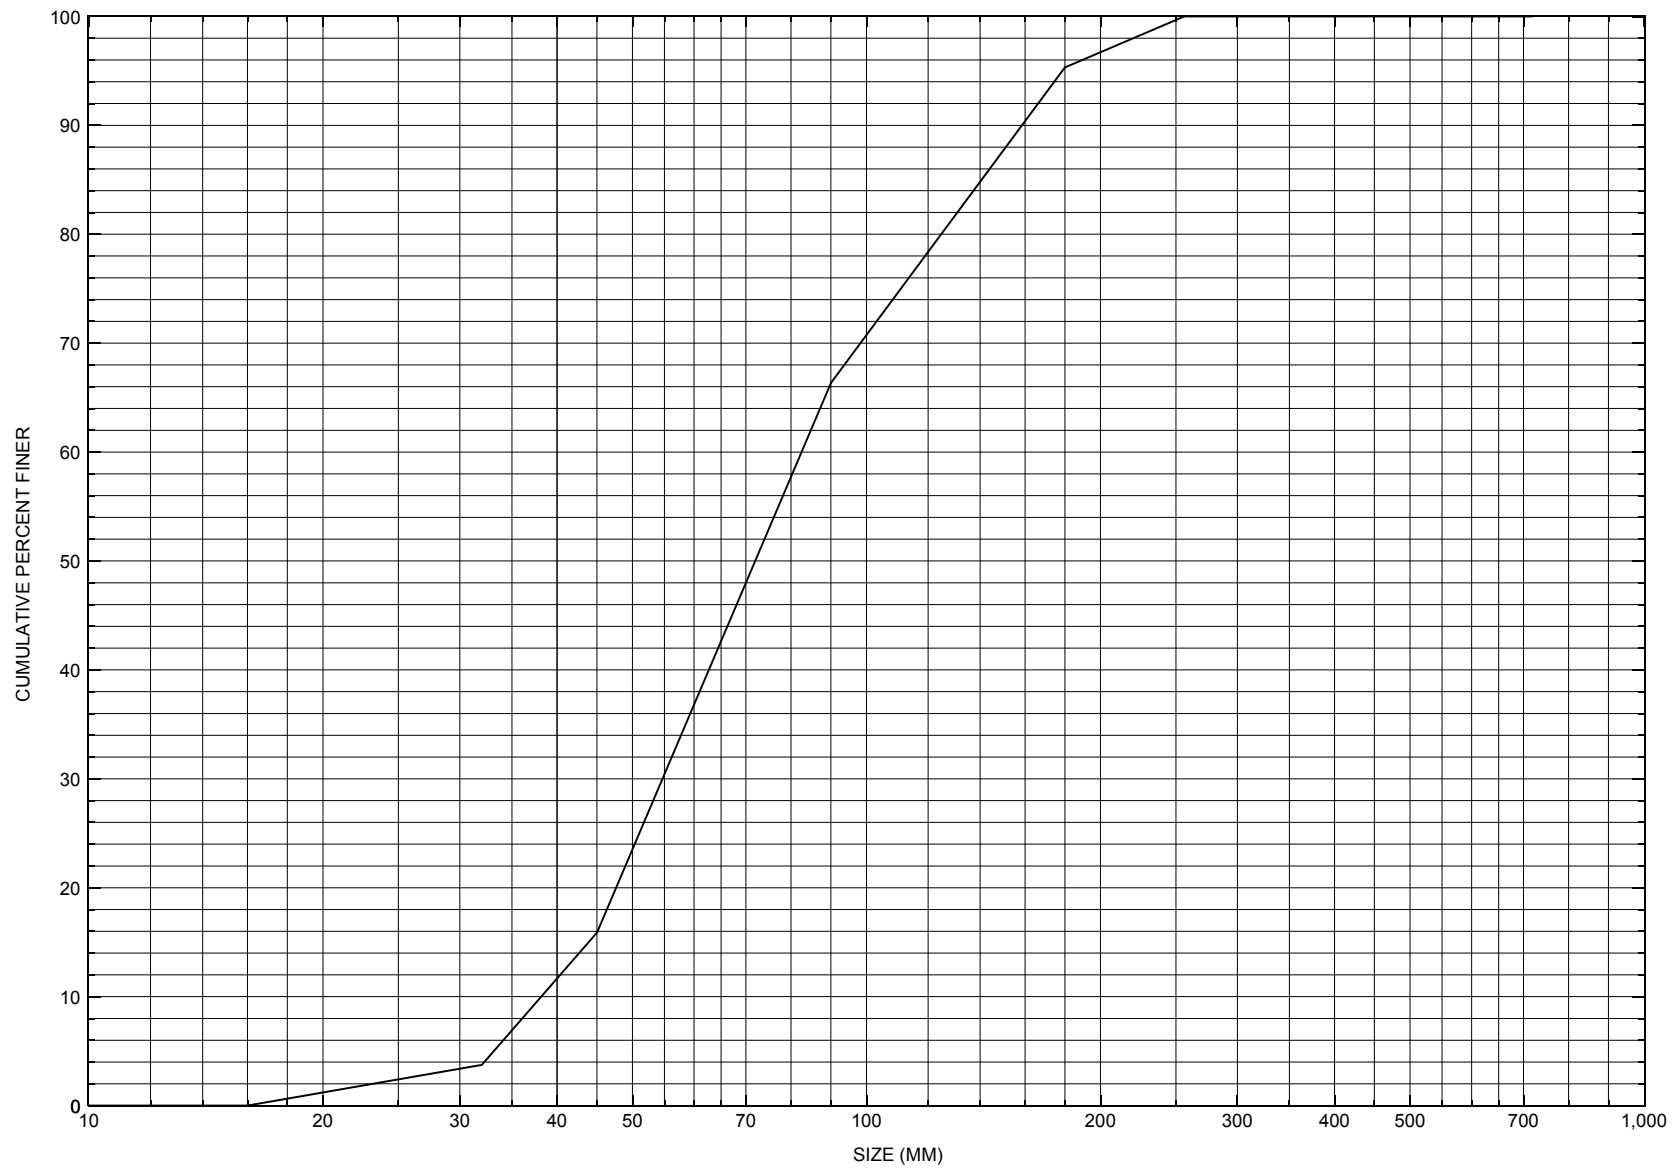
Appendix C. Bed material particle-size distribution for one pebble count transect in the channel approach of structure IRA-VT01330013, in Ira, Vermont.
