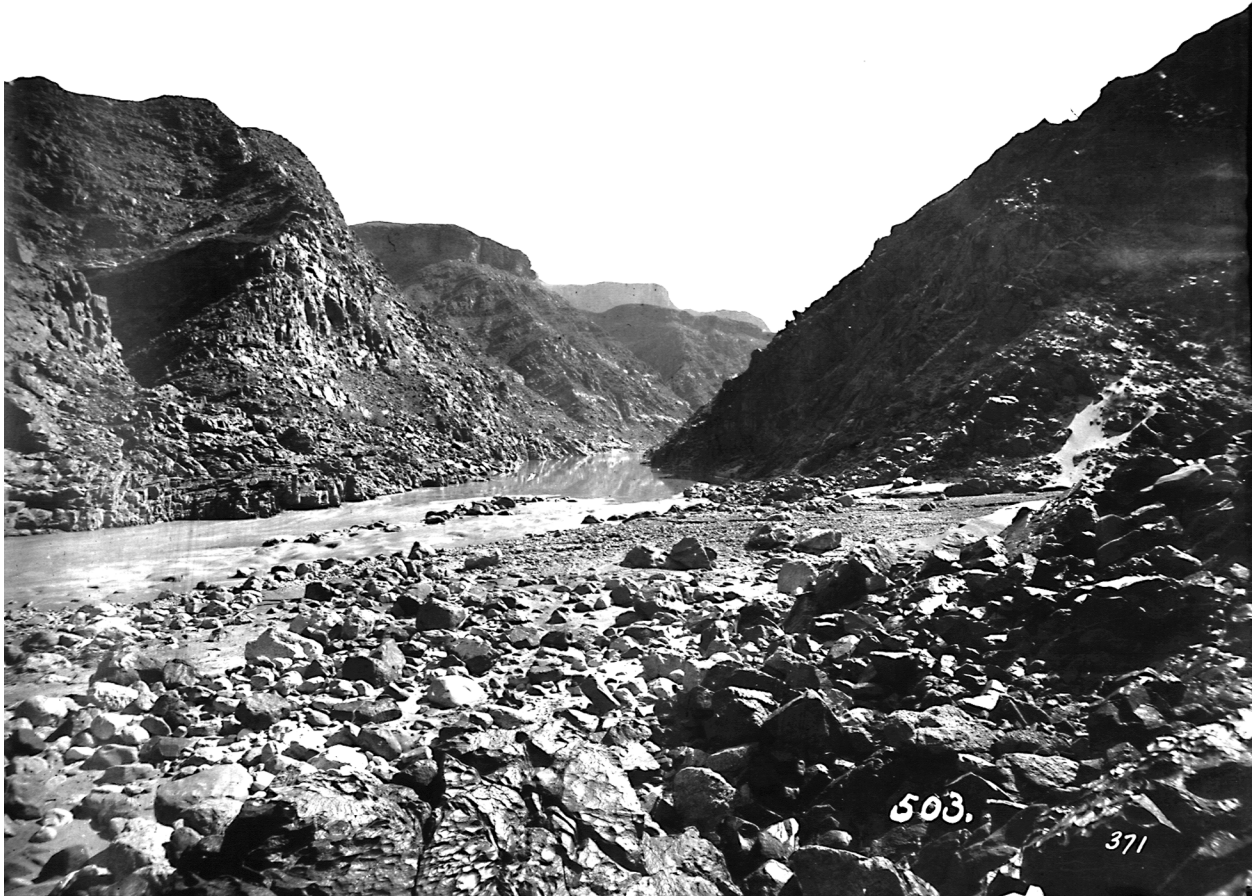
**Figure 5.** Replicate photographs showing the debris fan at Ruby Rapid (river mile 104.8-L) (Webb, 1996). A. Photograph taken on February 15, 1890 at 1:00 PM by Robert B. Stanton. Lack of sand in the canyon mouth, and fresh-looking gravels all the way to the river, indicates a flash flood had recently occurred in Ruby Canyon, probably in the summer of 1889.

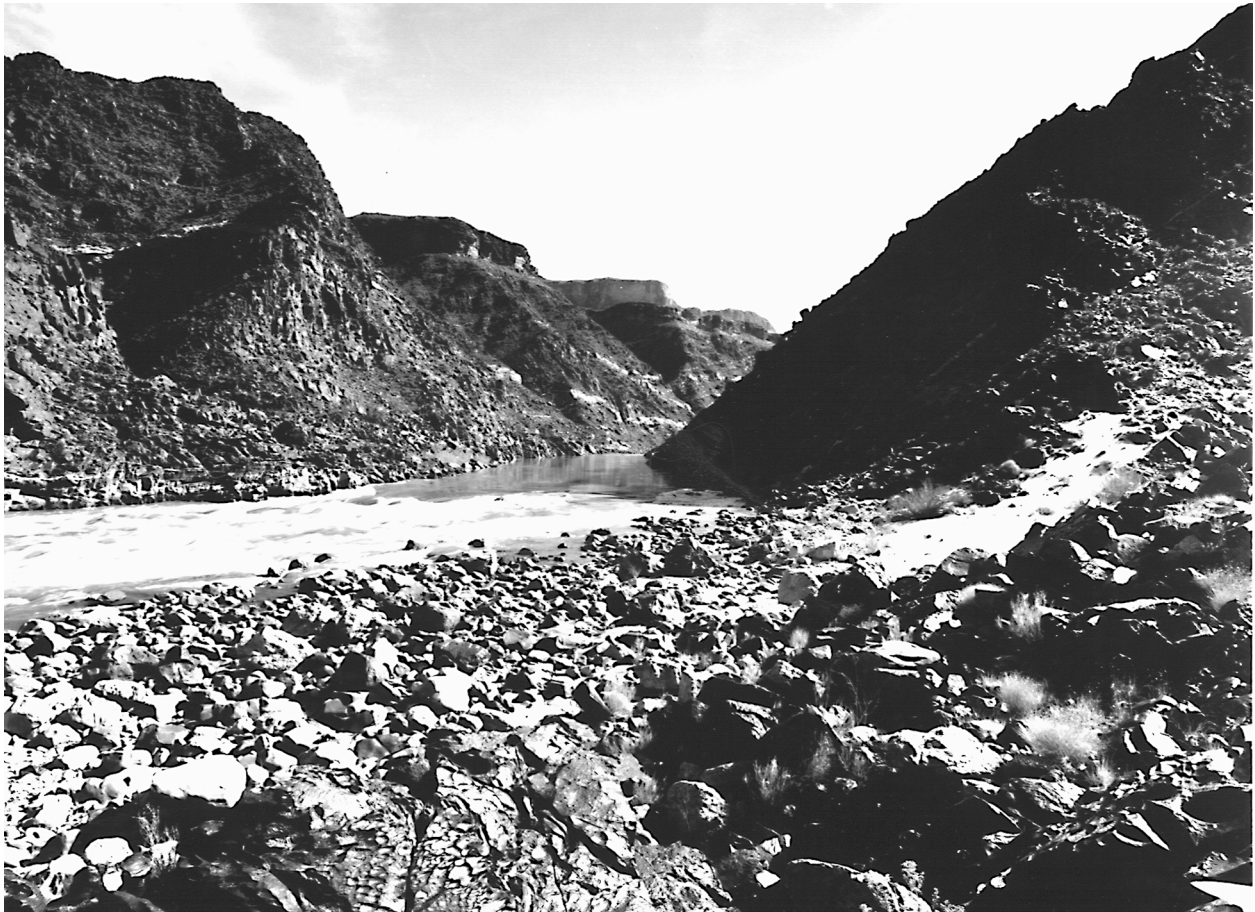
**Figure 5.** Continued.

B. Replicate view taken on February 14, 1991 at 2:11 PM by T.S. Melis. Despite higher water in 1991, the rapid and debris fan are unchanged after a century. Erosion and deposition by the Colorado River have caused the only changes in the debris fan. Instead of fresh-looking gravels at the mouth of the canyon, cobbles and boulders are now exposed. A large sand bar has been deposited at right center, obscuring a clear view of the channel mouth.
