LEVEL II SCOUR ANALYSIS FOR
BRIDGE 120 (LEICUS00070120) on
U. S. ROUTE 7, crossing the
LEICESTER RIVER,
LEICESTER, VERMONT

U.S. Geological Survey
Open-File Report 97-3

Prepared in cooperation with
VERMONT AGENCY OF TRANSPORTATION
and
FEDERAL HIGHWAY ADMINISTRATION

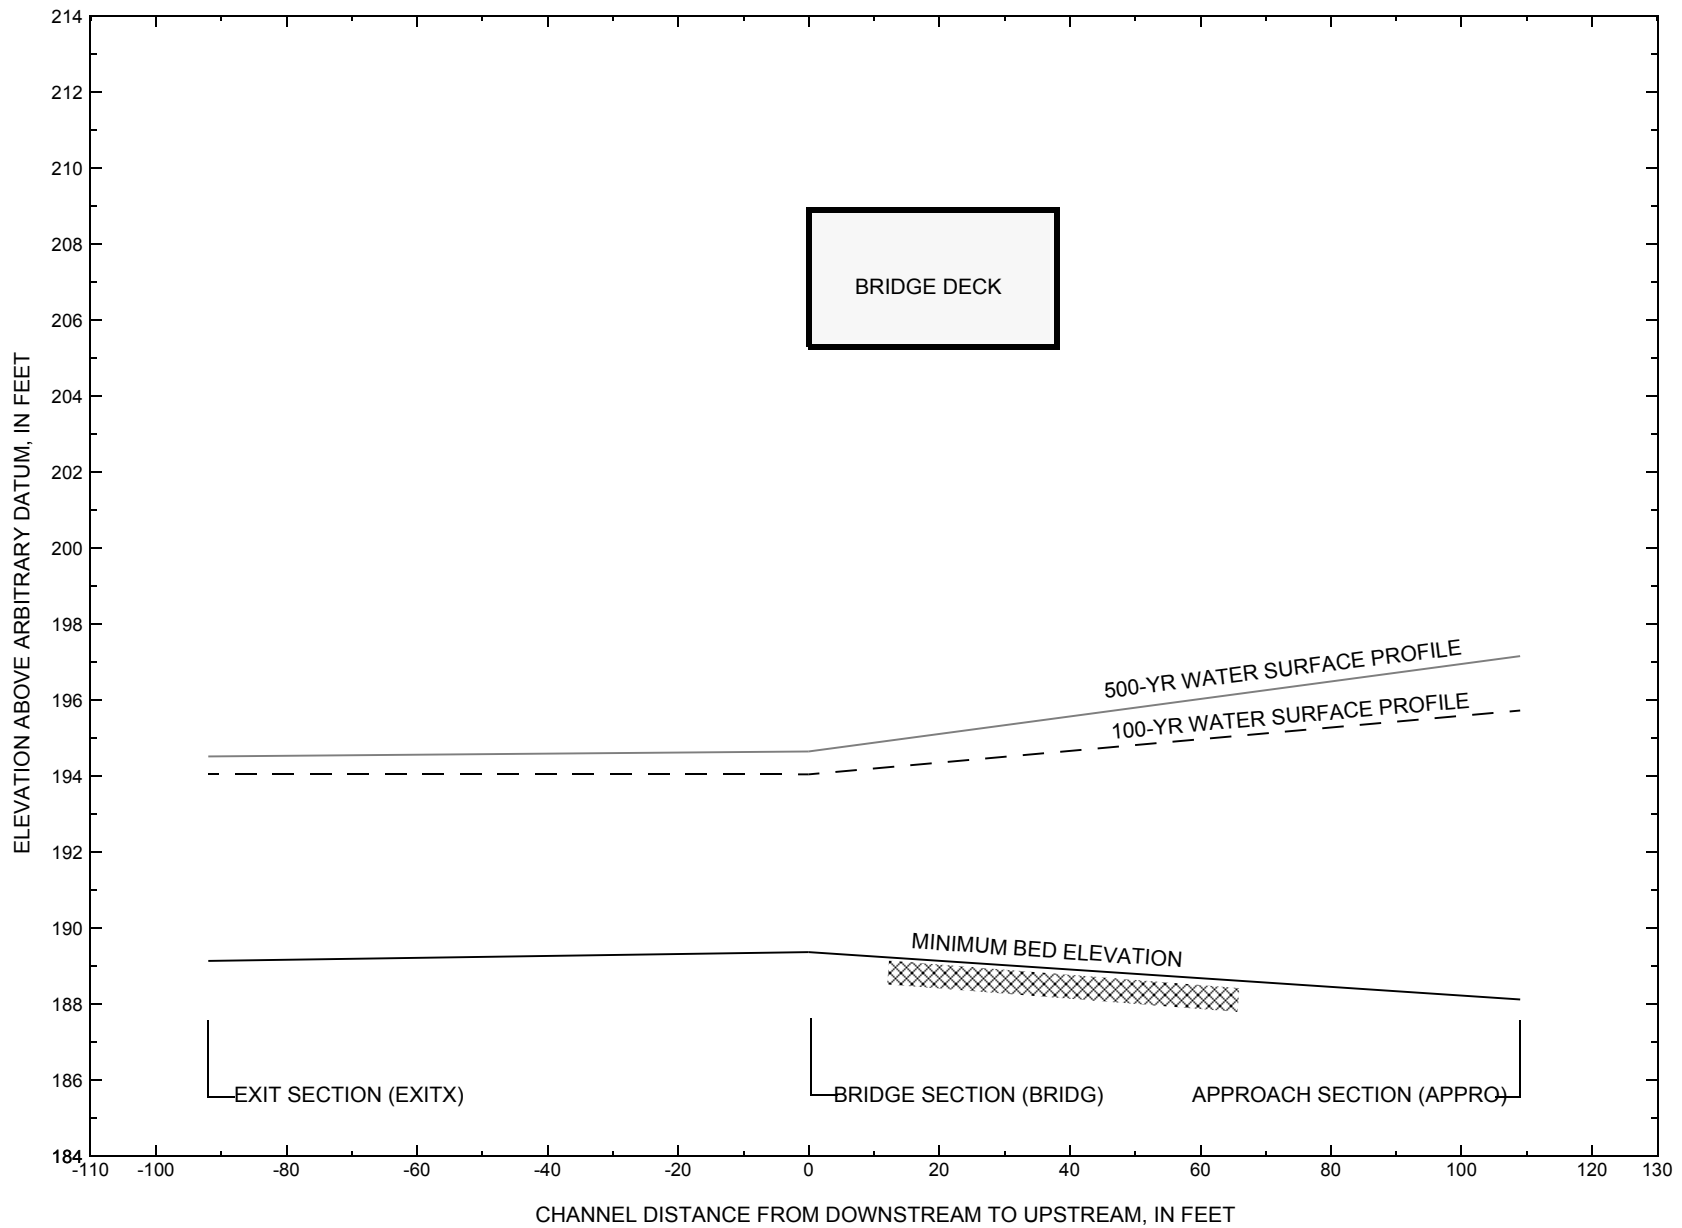
Figure 7. Water-surface profiles for the 100- and 500-yr discharges at structure [LEICUS00070120](#) on U. S. Route 7, crossing the [Leicester River, Leicester, Vermont](#).

Hydraulic analyses of the reach were done by use of the Federal Highway Administration's WSPRO step-backwater computer program (Shearman and others, 1986, and Shearman, 1990). The analyses reported herein reflect conditions existing at the site at the time of the study. Furthermore, in the development of the model it was necessary to assume no accumulation of debris or ice at the site. Results of the hydraulic model are presented in the Bridge Hydraulic Summary, Appendix B, and figure 7.
