LEVEL II SCOUR ANALYSIS FOR  
BRIDGE 108 (STJOUS00020108) on  
U.S. HIGHWAY 2, crossing  
MOOSE RIVER,  
ST. JOHNSBURY, VERMONT

U.S. Geological Survey  
Open-File Report 97-107

Prepared in cooperation with  
VERMONT AGENCY OF TRANSPORTATION  
and  
FEDERAL HIGHWAY ADMINISTRATION

By MICHAEL A. IVANOFF

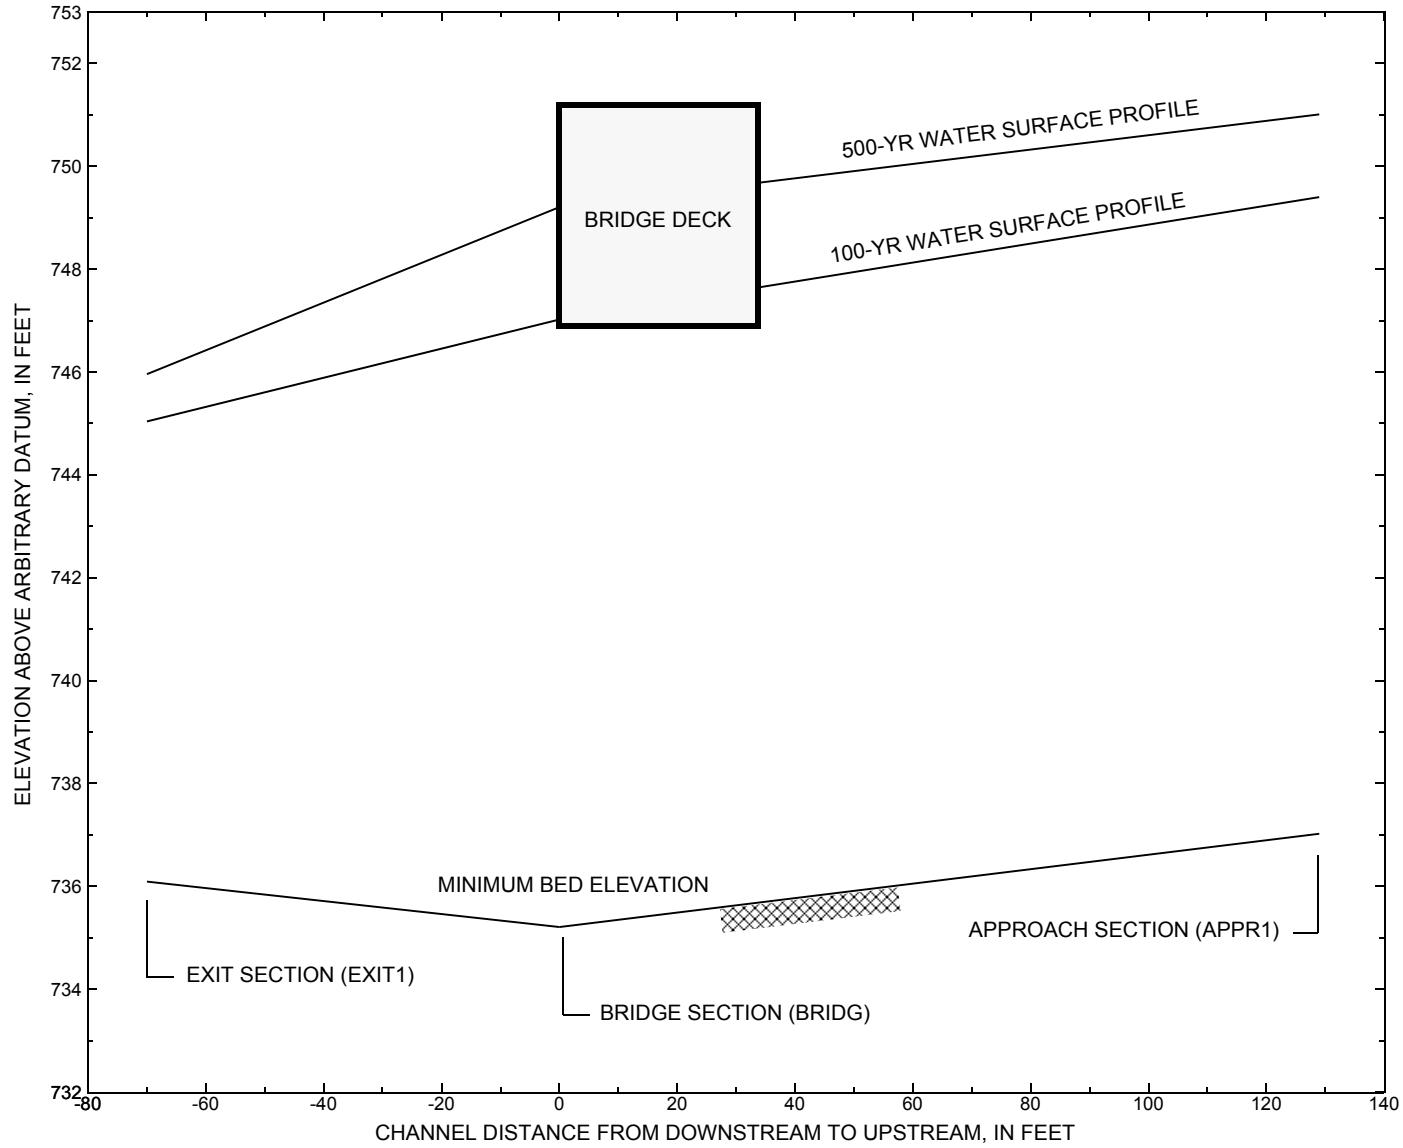
Figure 7. Water-surface profiles for the 100- and 500-yr discharges at structure STJOUS00020108 on U.S. Highway 2, crossing Moose River, St. Johnsbury, Vermont.

Hydraulic analyses of the reach were done by use of the Federal Highway Administration's WSPRO step-backwater computer program (Shearman and others, 1986, and Shearman, 1990). The analyses reported herein reflect conditions existing at the site at the time of the study. Furthermore, in the development of the model it was necessary to assume no accumulation of debris or ice at the site. Results of the hydraulic model are presented in the Bridge Hydraulic Summary, Appendix B, and figure 7.

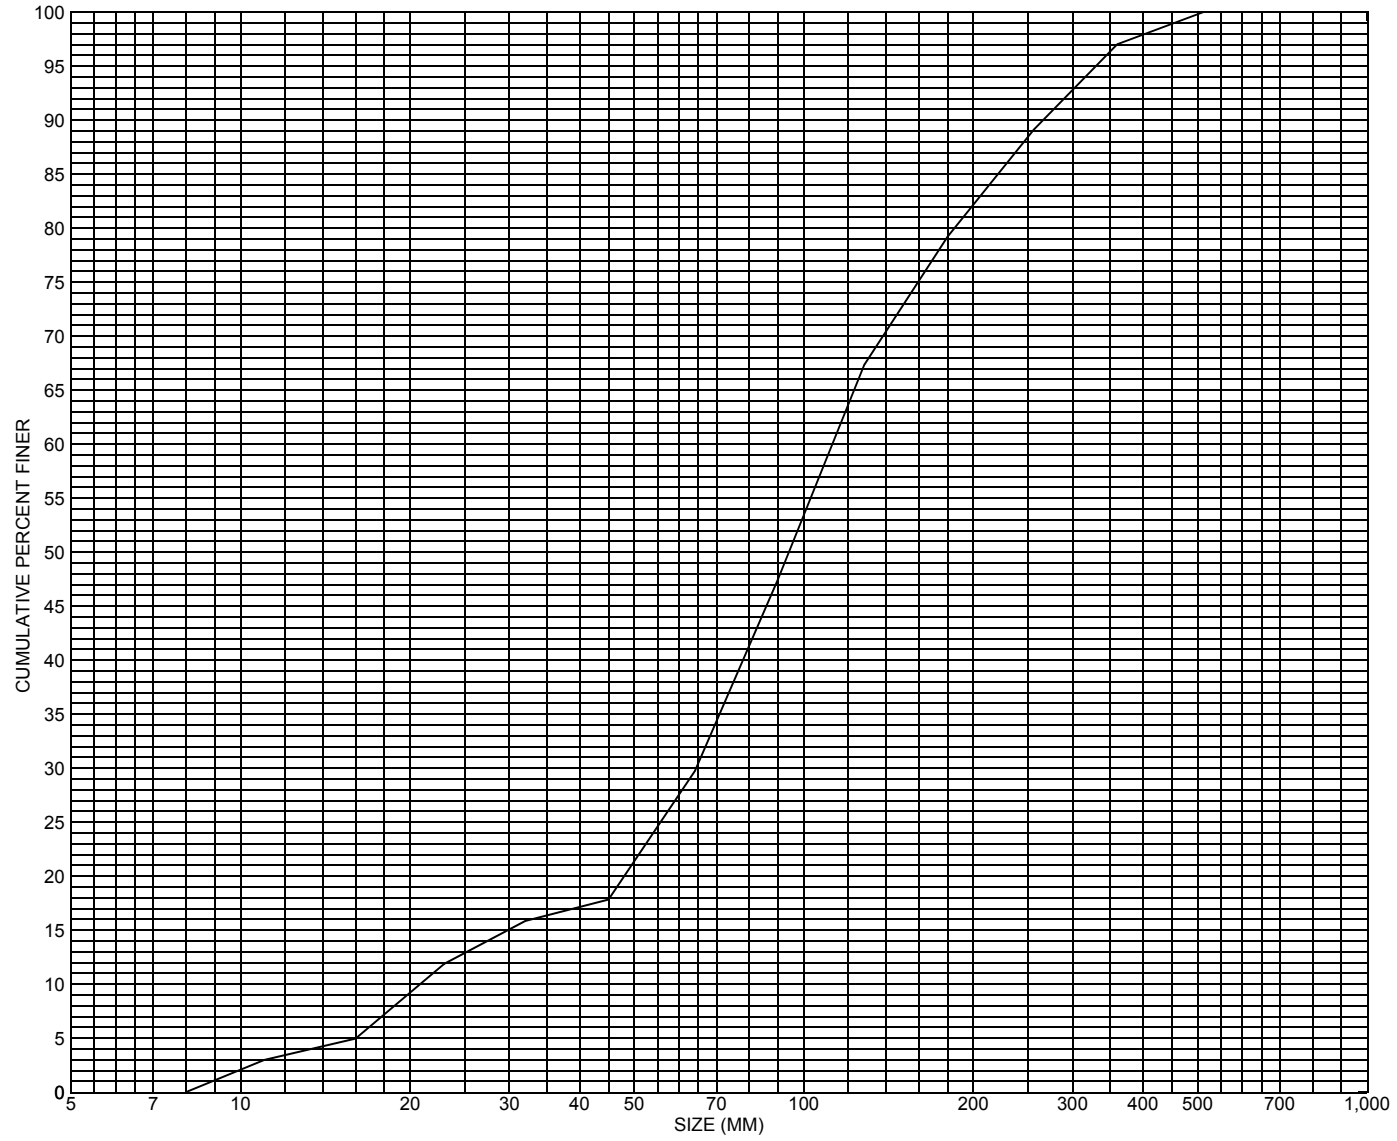
Appendix C. Bed material particle-size distribution for a pebble count in the channel approach of structure [STJOUS00020108](#), in [St. Johnsbury](#), Vermont.
