LEVEL II SCOUR ANALYSIS FOR BRIDGE 13 (PFRDTH00030013) ON TOWN HIGHWAY 3, CROSSING FURNACE BROOK, PITTSFORD, VERMONT

U.S. Geological Survey
Open-File Report 97-110

Prepared in cooperation with
VERMONT AGENCY OF TRANSPORTATION
and
FEDERAL HIGHWAY ADMINISTRATION

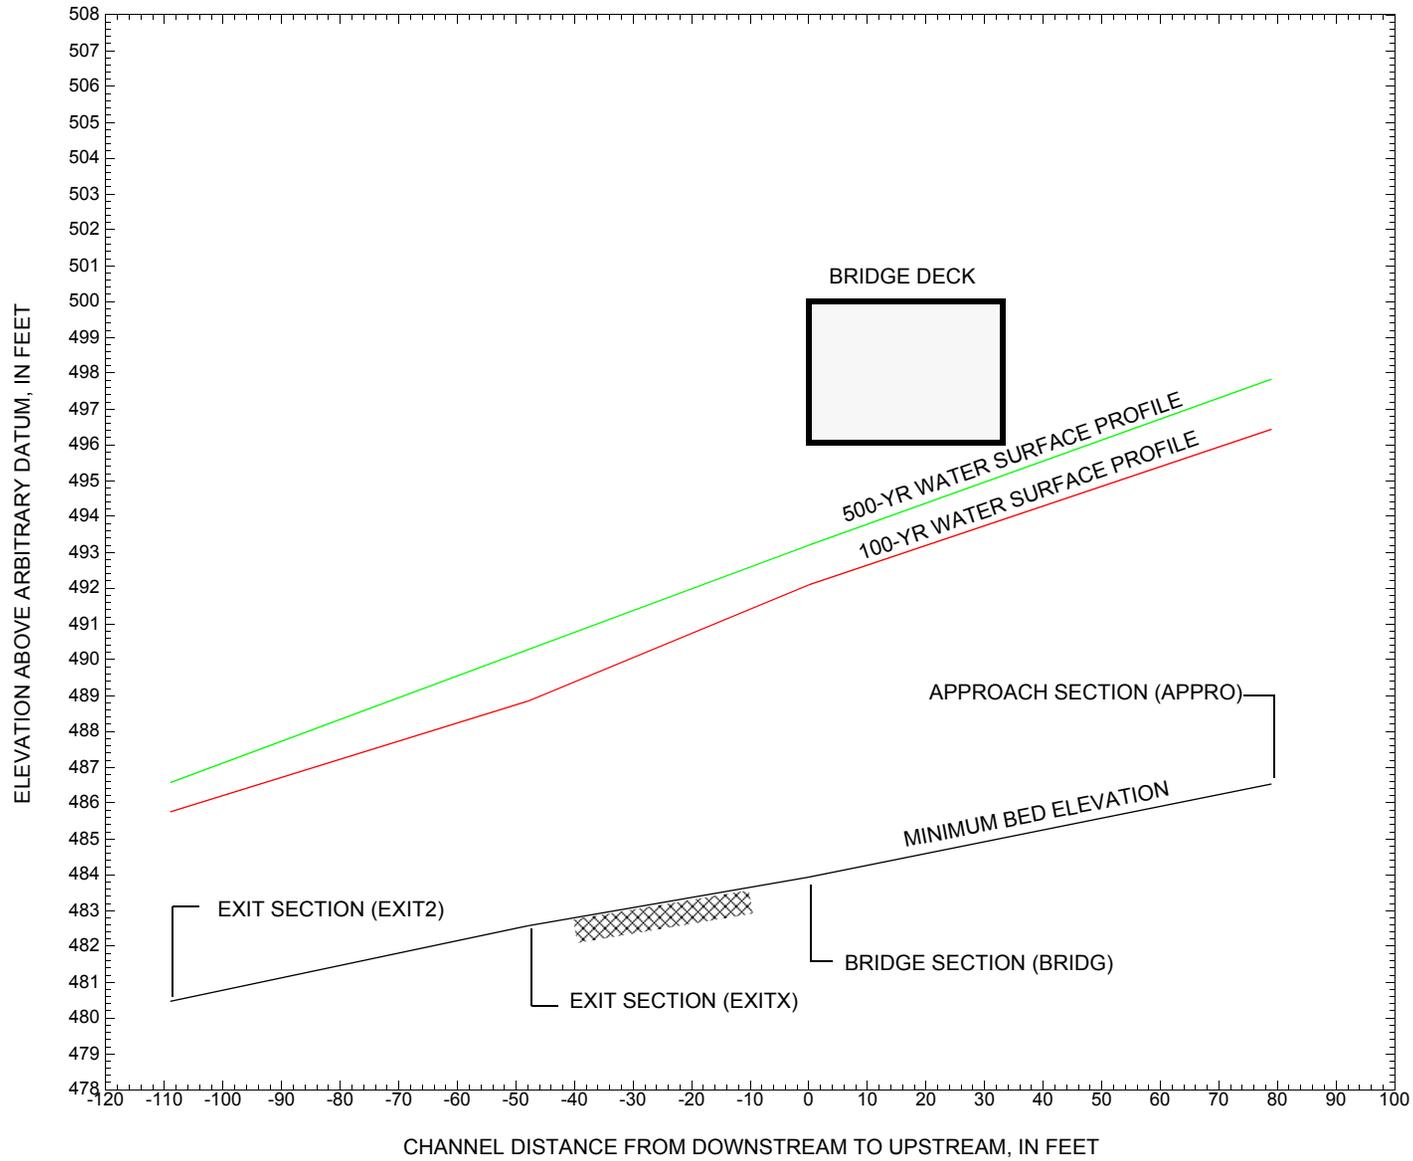
Figure 7. Water-surface profiles for the 100- and 500-yr discharges at structure PFRDTH00030013 on Town Highway 3, crossing Furnace Brook, Pittsford, Vermont.

Hydraulic analyses of the reach were done by use of the Federal Highway Administration's WSPRO step-backwater computer program (Shearman and others, 1986, and Shearman, 1990). The analyses reported herein reflect conditions existing at the site at the time of the study. Furthermore, in the development of the model it was necessary to assume no accumulation of debris or ice at the site. Results of the hydraulic model are presented in the Bridge Hydraulic Summary, Appendix B, and figure 7.

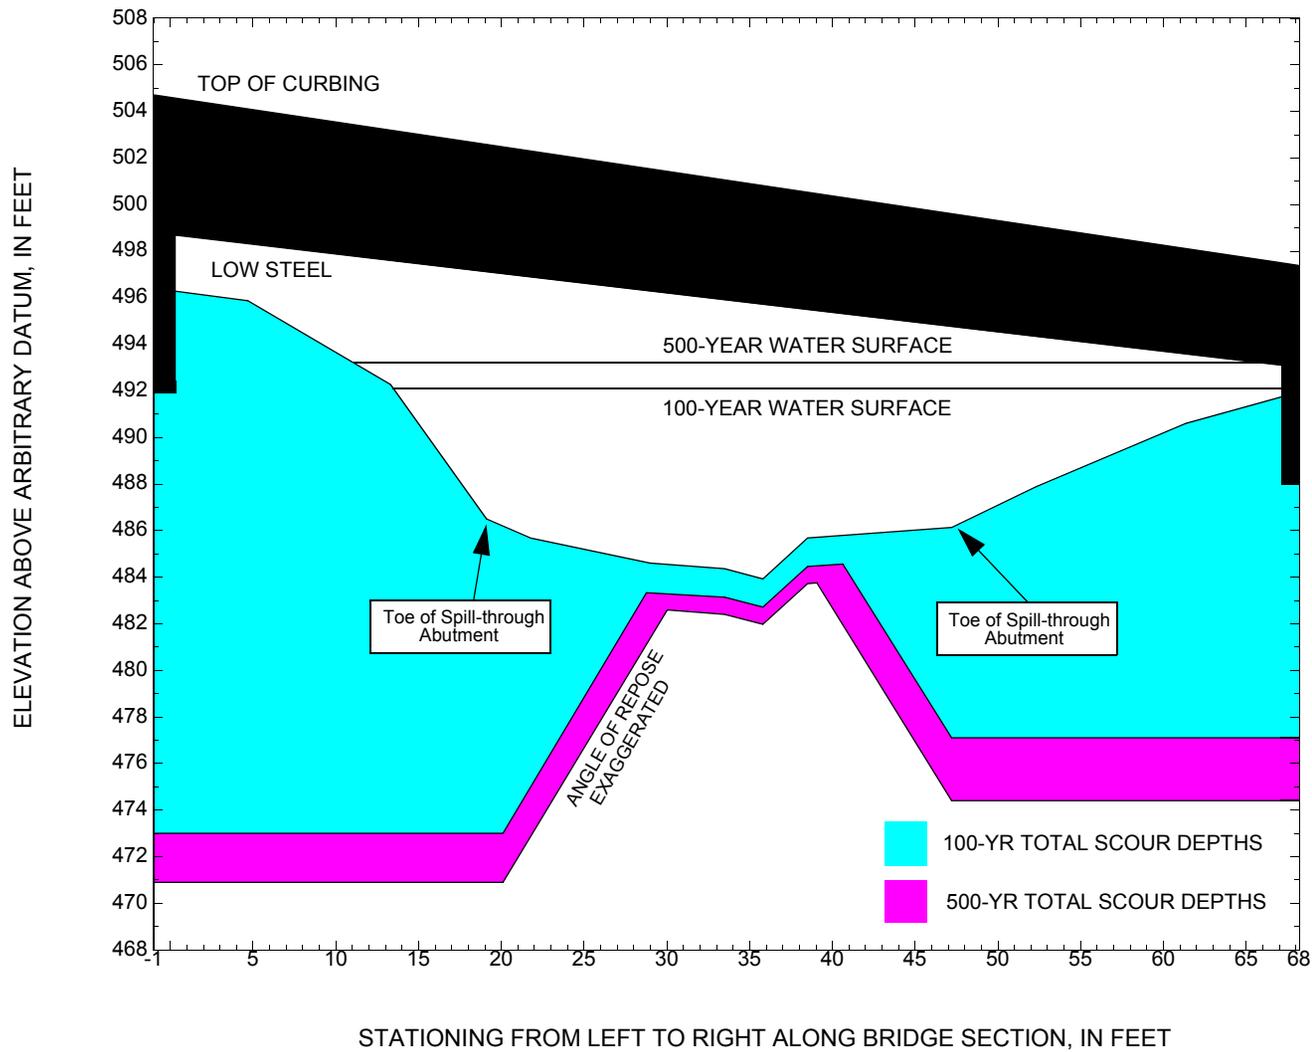
Figure 8. Scour elevations for the 100-yr and 500-yr discharges at structure PFRDTH00030013 on Town Highway 3, crossing Furnace Brook, Pittsford, Vermont.

Scour depths were computed using the general guidelines described in Hydraulic Engineering Circular 18 (Richardson and others, 1995). Scour depths were calculated assuming an infinite depth of erosive material and a homogeneous particle-size distribution. The results of the scour analysis are presented in tables 1 and 2 and a graph of the scour depths is presented in figure 8.

Abutment scour for the left and right abutments was computed by use of the Froehlich equation (Richardson and others, 1995, p. 48, equation 28). Variables for the Froehlich equation include the Froude number of the flow approaching the embankments, the length of the embankment blocking flow, and the depth of flow approaching the embankment less any roadway overtopping. Because scour processes on the spill-through embankment material is uncertain, the scour depth at the vertical concrete abutment walls is unknown. Therefore, the total scour depths were applied for the entire spill-through embankment below the elevation at the toe of each embankment and extended to the vertical concrete abutment wall as shown in figure 8.

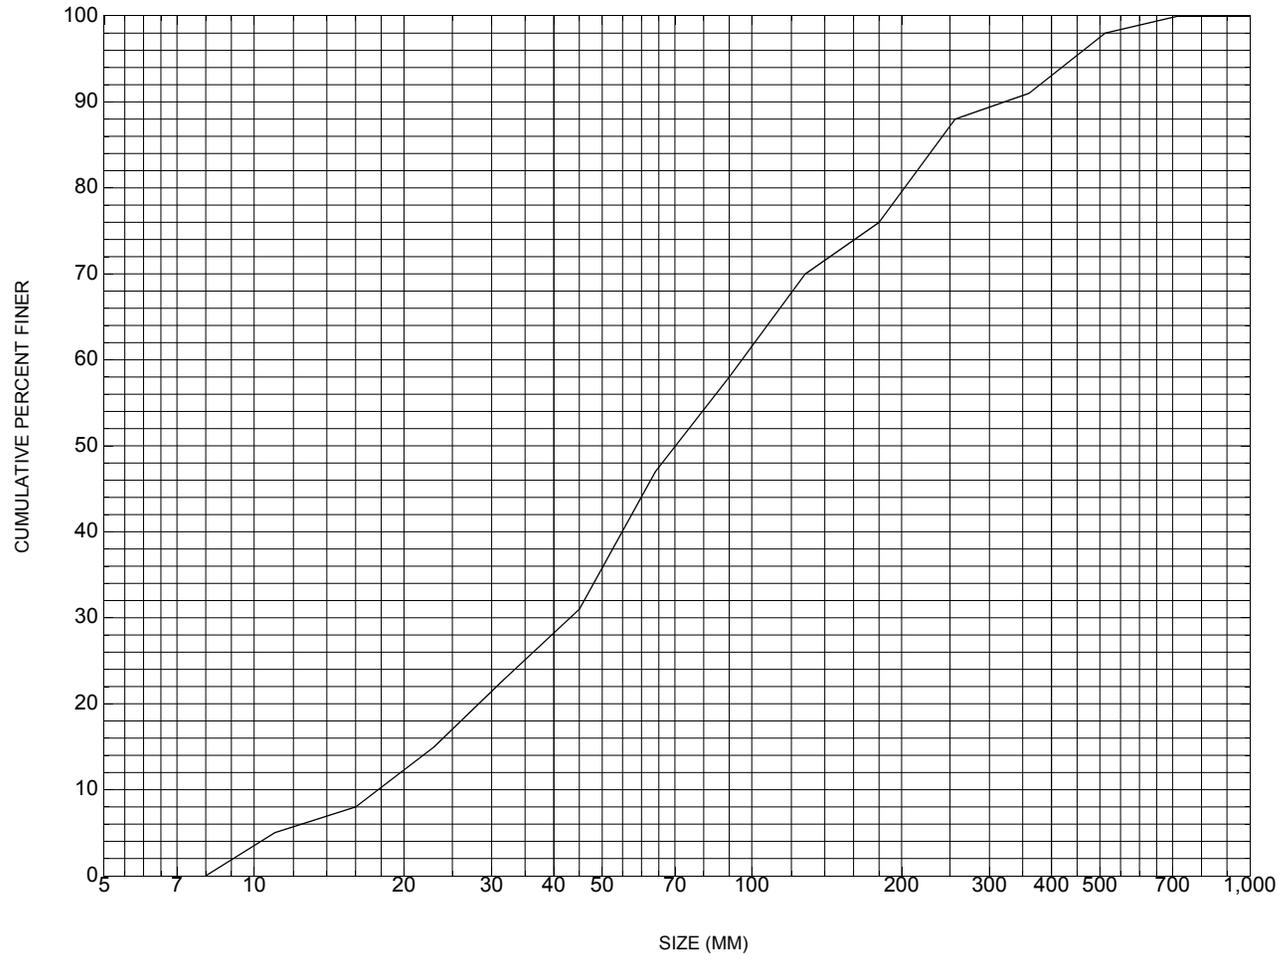
Appendix C. Bed material particle-size distribution for a pebble count in the channel approach of structure PFRDTH00030013, in Pittsford, Vermont.
