U.S. Geological Survey

Evaluation of the Potential for Debris and Hyperconcentrated
Flows in Capulin Canyon as a Result of the 1996 Dome Fire,
Bandelier National Monument , New Mexico

Open-File Report 97-136

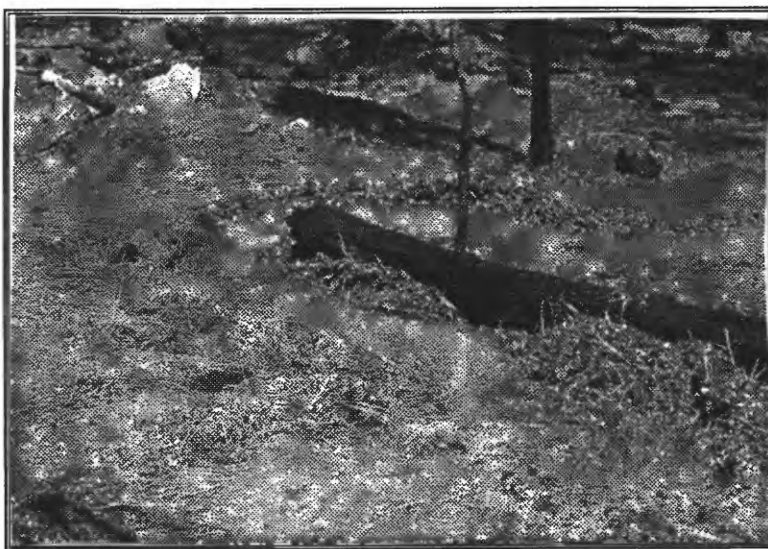
Figure 6. Photograph of debris flow generated on hillslopes during the June 26, 1996, rainstorm. The path of the flow is lined by levees up to 15-cm high. The levees consist of pine needles, pumice and charcoal fragments, and some silty matrix. Note that the flow was deflected around the burnt log in the center of the photograph.

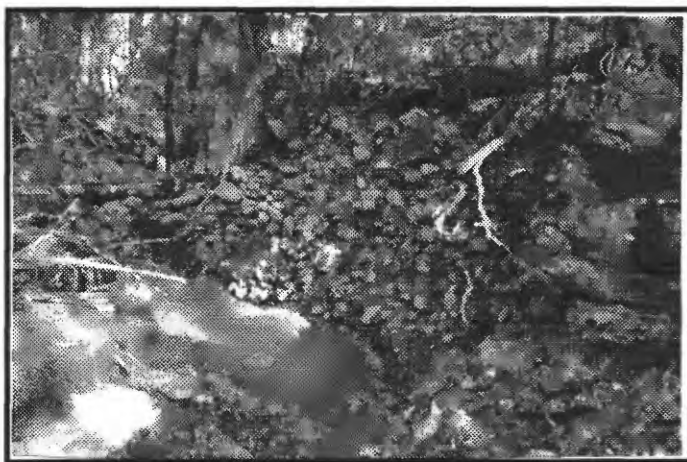
Figure 7. Photograph of typical high-energy stream-flow deposits in Capulin Canyon. The deposits consist of boulders in a loose, sandy matrix. Note that the incision to bedrock occurred during the June 26, 1996, rainfall event.
