# LEVEL II SCOUR ANALYSIS FOR BRIDGE 12 (HUNTTH00010012) on TOWN HIGHWAY 1, crossing BRUSH BROOK, HUNTINGTON, VERMONT

U.S. Geological Survey  
Open-File Report 97-226

Prepared in cooperation with  
VERMONT AGENCY OF TRANSPORTATION  
and  
FEDERAL HIGHWAY ADMINISTRATION

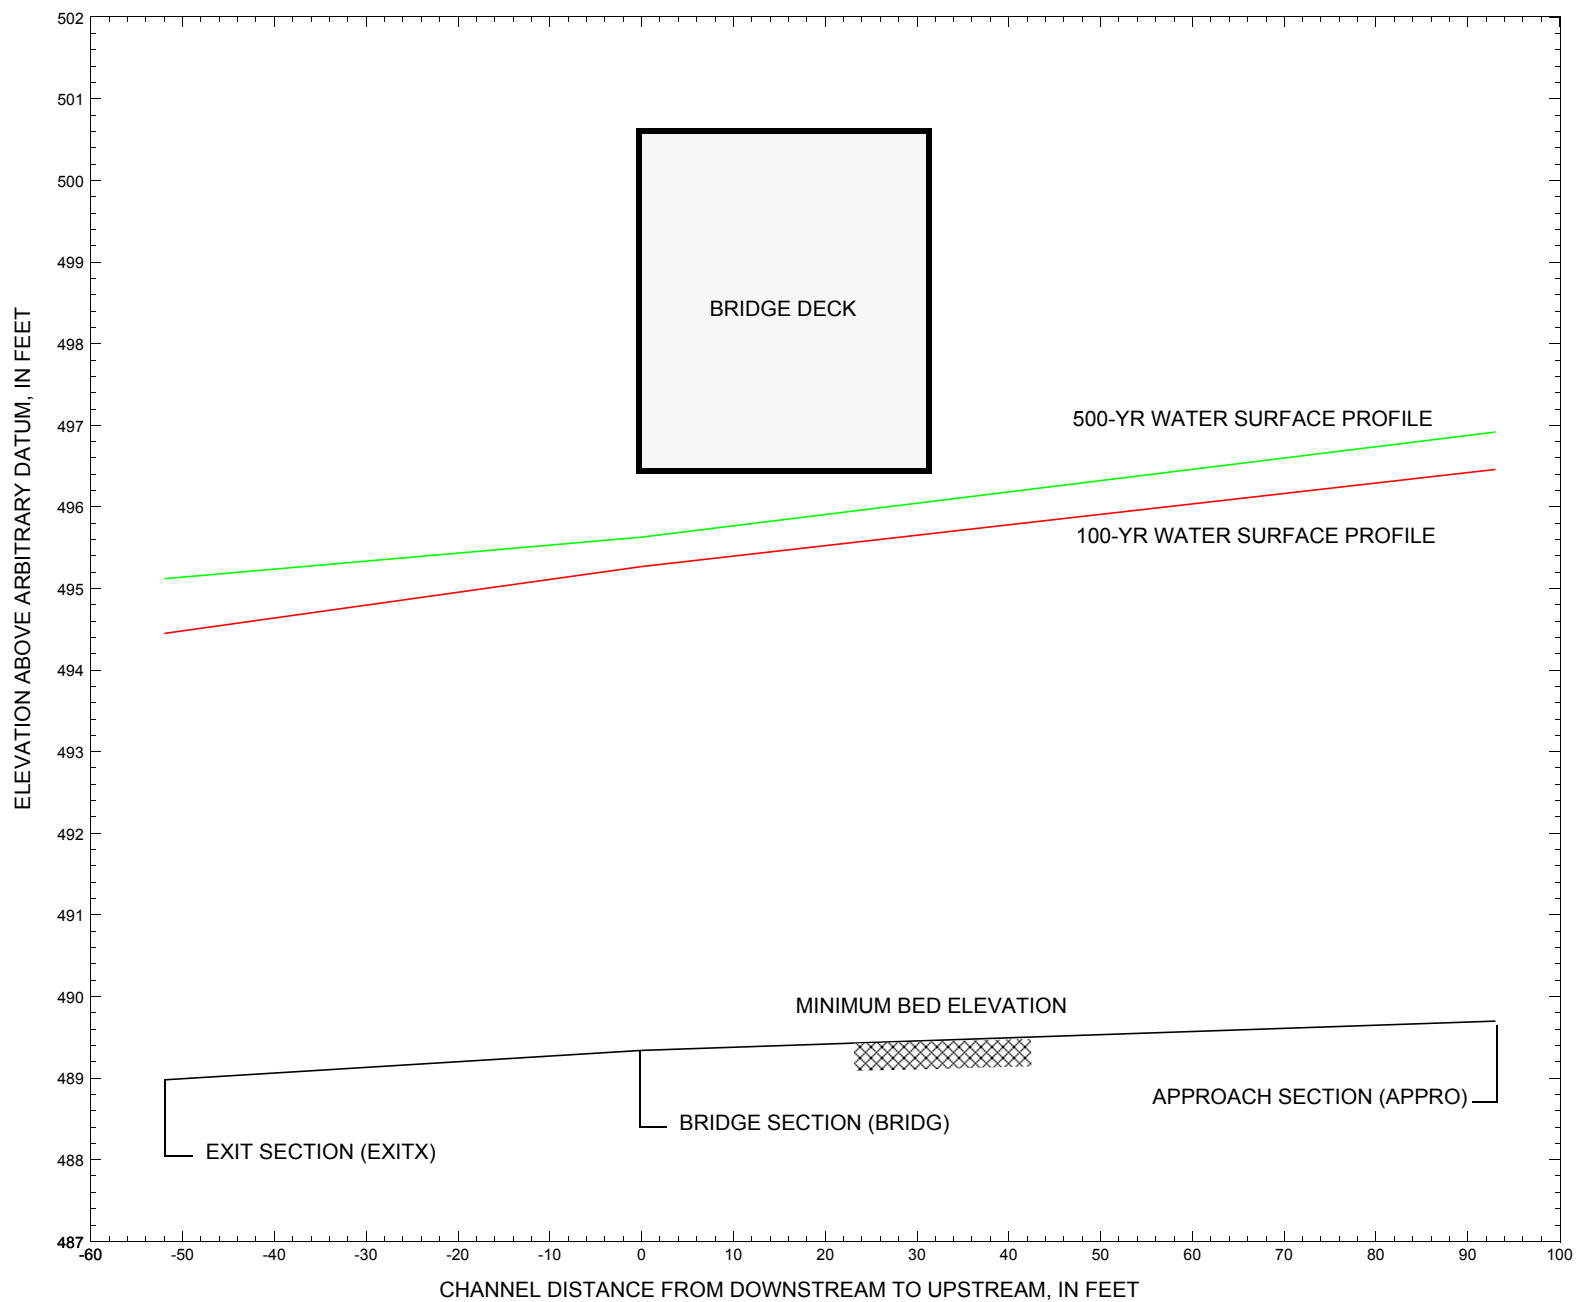
Figure 8. Water-surface profiles for the 100- and 500-yr discharges at structure HUNTTH00010012 on Town Highway 01, crossing Brush Brook, Huntington, Vermont.

Hydraulic analyses of the reach were done by use of the Federal Highway Administration's WSPRO step-backwater computer program (Shearman and others, 1986, and Shearman, 1990). The analyses reported herein reflect conditions existing at the site at the time of the study. Furthermore, in the development of the model it was necessary to assume no accumulation of debris or ice at the site. Results of the hydraulic model are presented in the Bridge Hydraulic Summary, Appendix B, and figure 8.

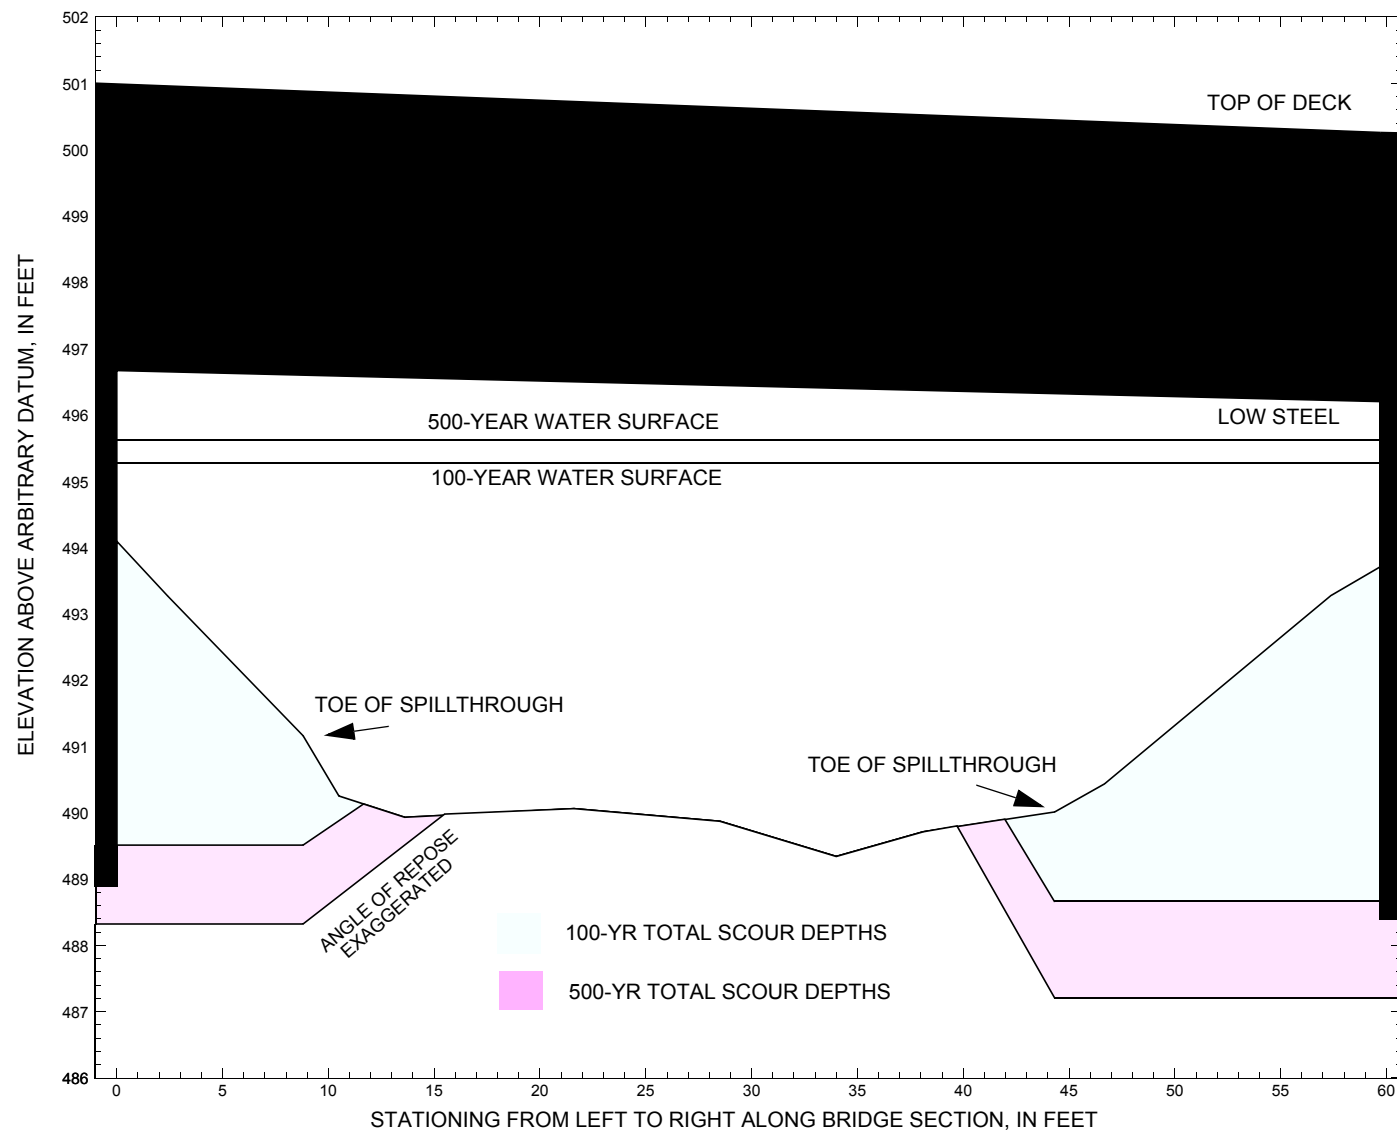
Figure 9. Scour elevations for the 100-yr and 500-yr discharges at structure HUNTTH00010012 on Town Highway 01, crossing Brush Brook, Huntington, Vermont.

Scour depths were computed using the general guidelines described in Hydraulic Engineering Circular 18 (Richardson and others, 1995). Scour depths were calculated assuming an infinite depth of erosive material and a homogeneous particle-size distribution. The results of the scour analysis are presented in tables 1 and 2 and a graph of the scour depths is presented in figure 9.

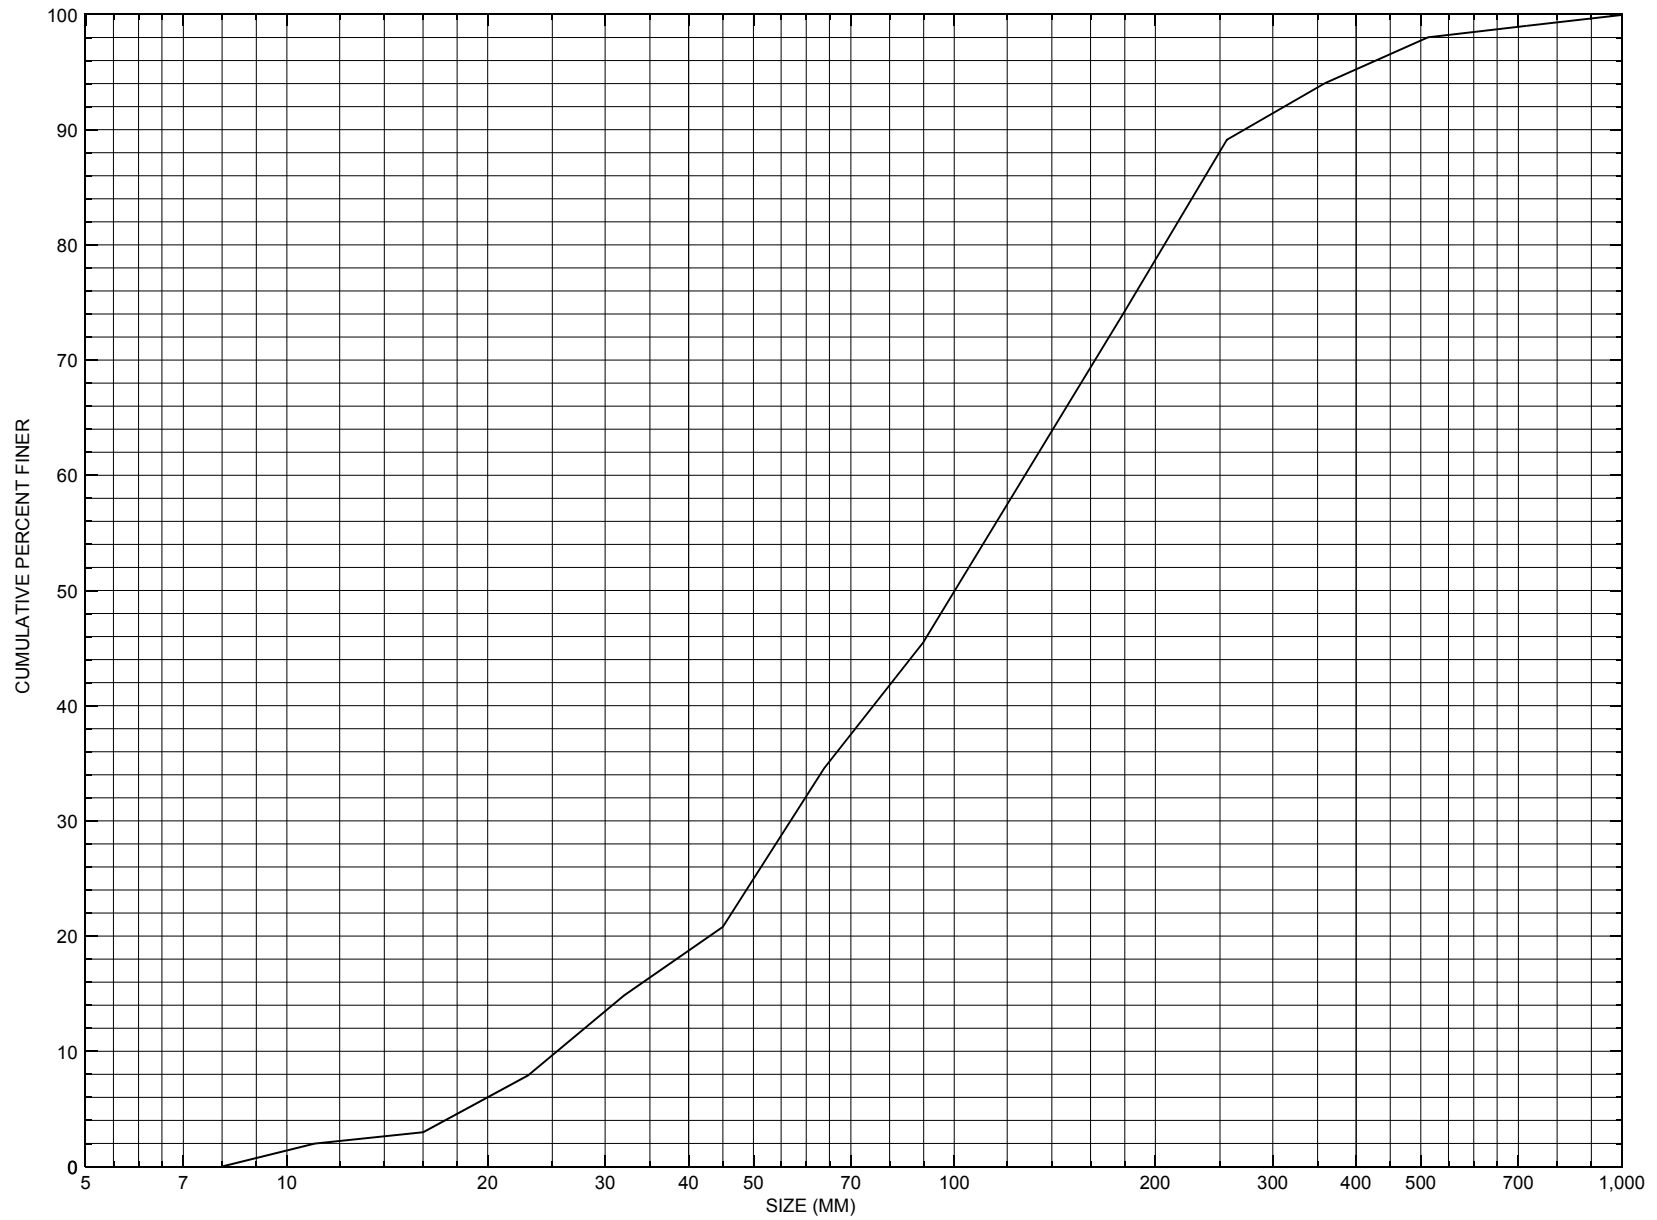
Appendix C. Bed material particle-size distribution for a pebble count at the approach cross-section for structure HUNTTH00010012, in Huntington, Vermont.
