LEVEL II SCOUR ANALYSIS FOR  
BRIDGE 43 (SPRICYBRIG0043) on  
BRIDGE STREET, crossing the  
BLACK RIVER,  
SPRINGFIELD, VERMONT

U.S. Geological Survey  
Open-File Report 97-227

By MICHAEL A. IVANOFF and LAURA MEDALIE

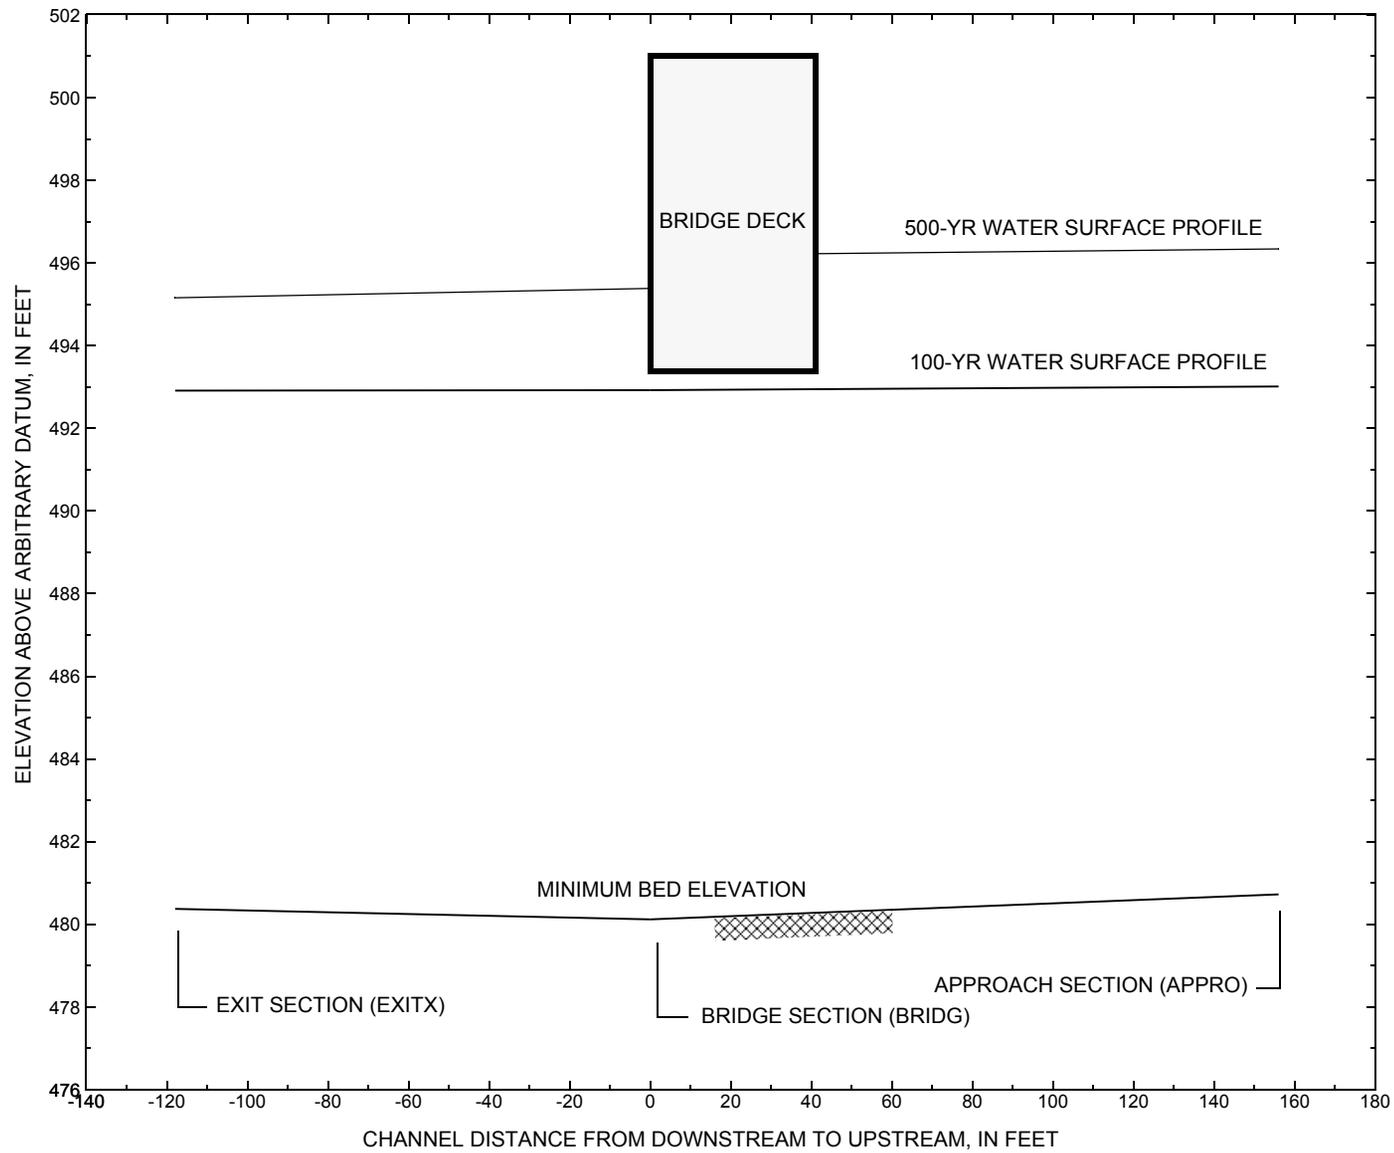
Figure 7. Water-surface profiles for the 100- and 500-yr discharges at structure SPRICYBRIG0043 on Bridge Street, crossing the Black River, Springfield, Vermont.

Hydraulic analyses of the reach were done by use of the Federal Highway Administration's WSPRO step-backwater computer program (Shearman and others, 1986, and Shearman, 1990). The analyses reported herein reflect conditions existing at the site at the time of the study. Furthermore, in the development of the model it was necessary to assume no accumulation of debris or ice at the site. Results of the hydraulic model are presented in the Bridge Hydraulic Summary, Appendix B, and figure 7.

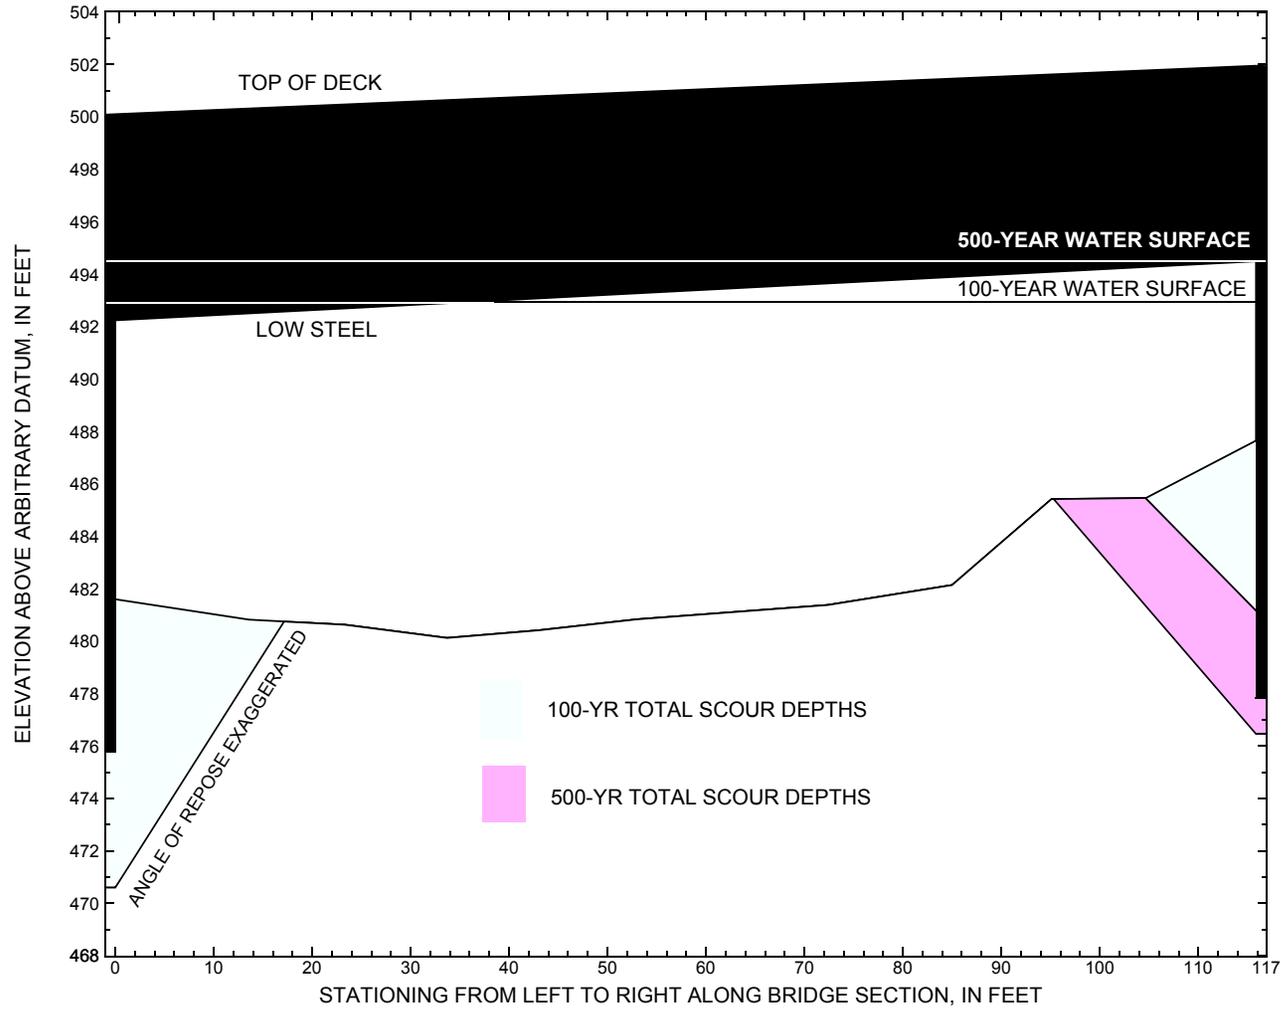
Figure 8. Scour elevations for the 100-yr and 500-yr discharges at structure SPRICYBRIG0043 on Bridge Street, crossing Black River, Springfield, Vermont.

Scour depths were computed using the general guidelines described in Hydraulic Engineering Circular 18 (Richardson and others, 1995). Scour depths were calculated assuming an infinite depth of erosive material and a homogeneous particle-size distribution. The results of the scour analysis are presented in tables 1 and 2 and a graph of the scour depths is presented in figure 8.

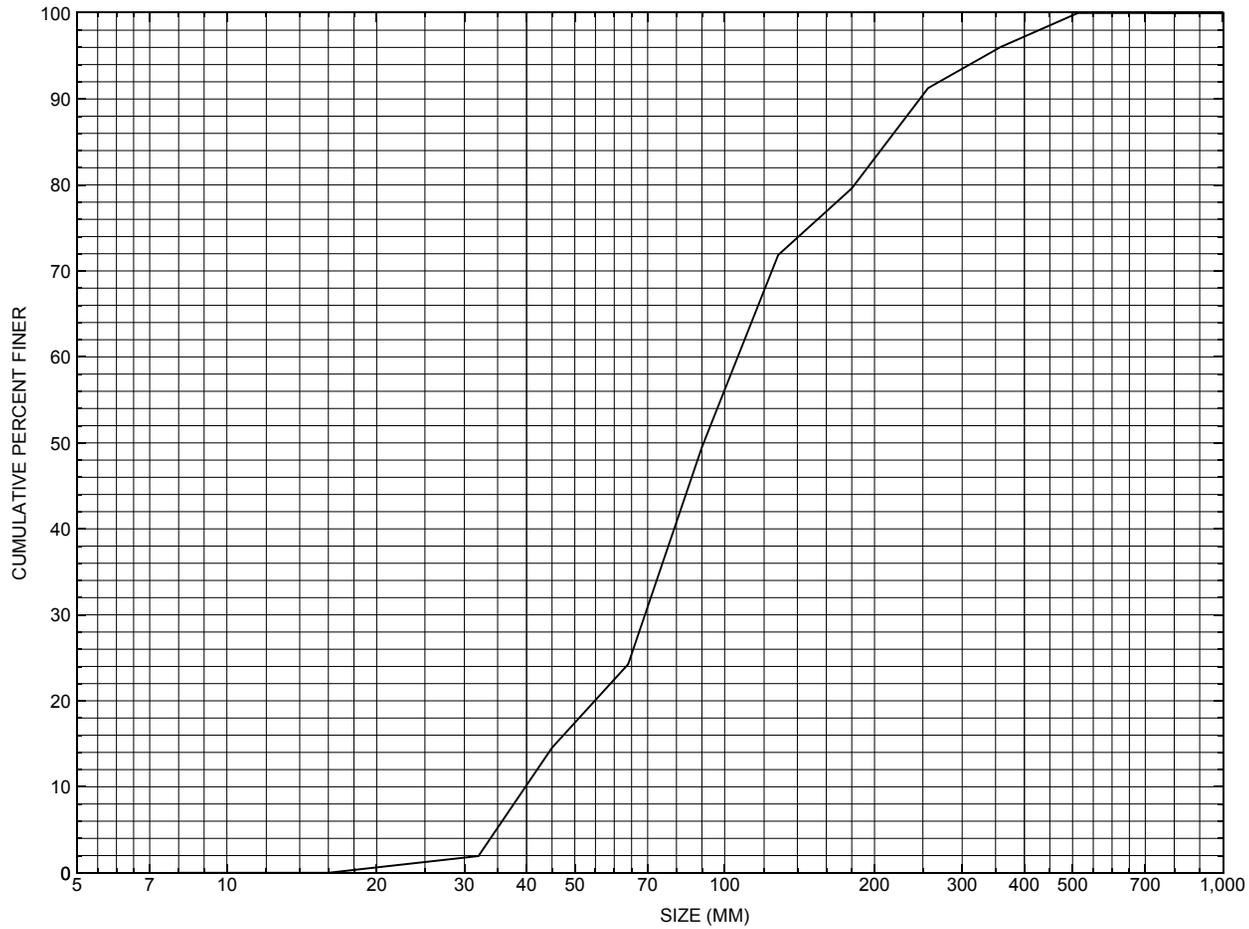
Appendix C. Bed material particle-size distribution for a pebble count in the channel approach of structure SPRICYBRIG0043, in Springfield, Vermont.
