Surficial Alteration at the Cathedral of Learning in Pittsburgh, Pennsylvania

Open-File Report 97- 275

# **Surficial Alteration at the Cathedral of Learning in Pittsburgh, Pennsylvania**

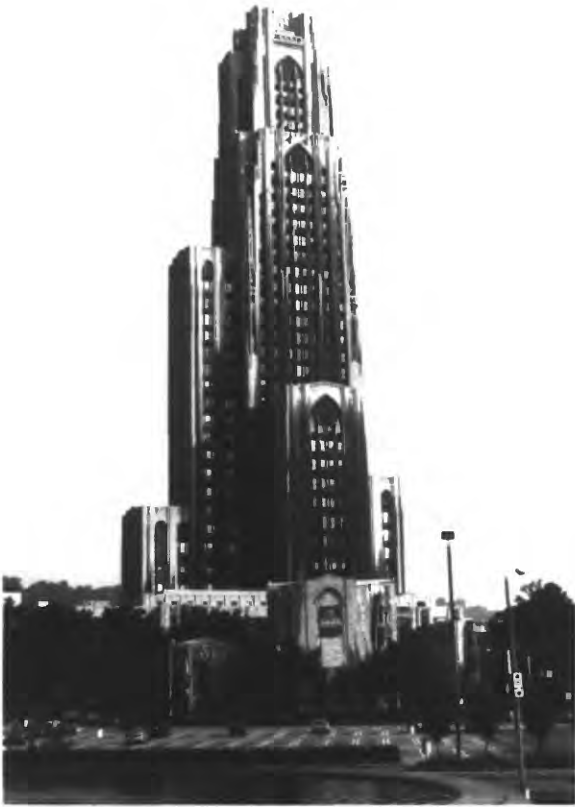
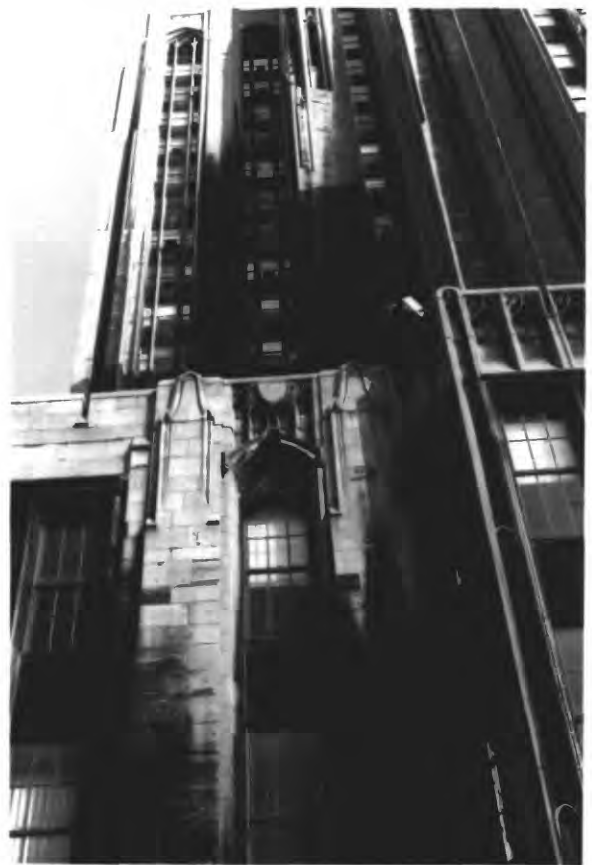
**Figure 1.** The Cathedral of Learning in Pittsburgh, Pennsylvania has distinctive patterns of dark and light areas that are readily visible even from a distance. **A.** The building as seen from Forbes Avenue. **B.** Detail of “V” drip pattern, on the Forbes Avenue side of the building.

"V" or "W" shape to the pattern of the dark and light areas (Fig. 1B) that may reflect the way water flows on the building when it rains.

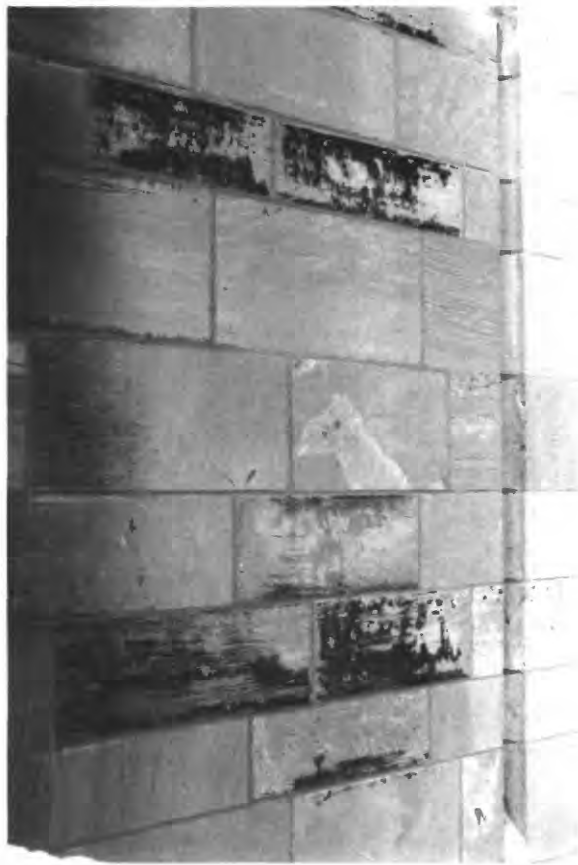
**Figure 6.** Red brown discolorations stand out on many of the light blocks of limestone. They may occur as small isolated spots, or may cover large areas of a single block of stone. The black area at the left edge of the photo is an area of black surficial crusts.

An unusual red-brown surficial encrustation also occurs on the Cathedral of Learning. The red-brown stains occur in small concentrated discolored areas, of approximately one square centimeter, or they may cover up to nearly one third of the surface of a block of limestone (Fig. 6). The red-brown accumulations resemble rust, but they are widely and randomly

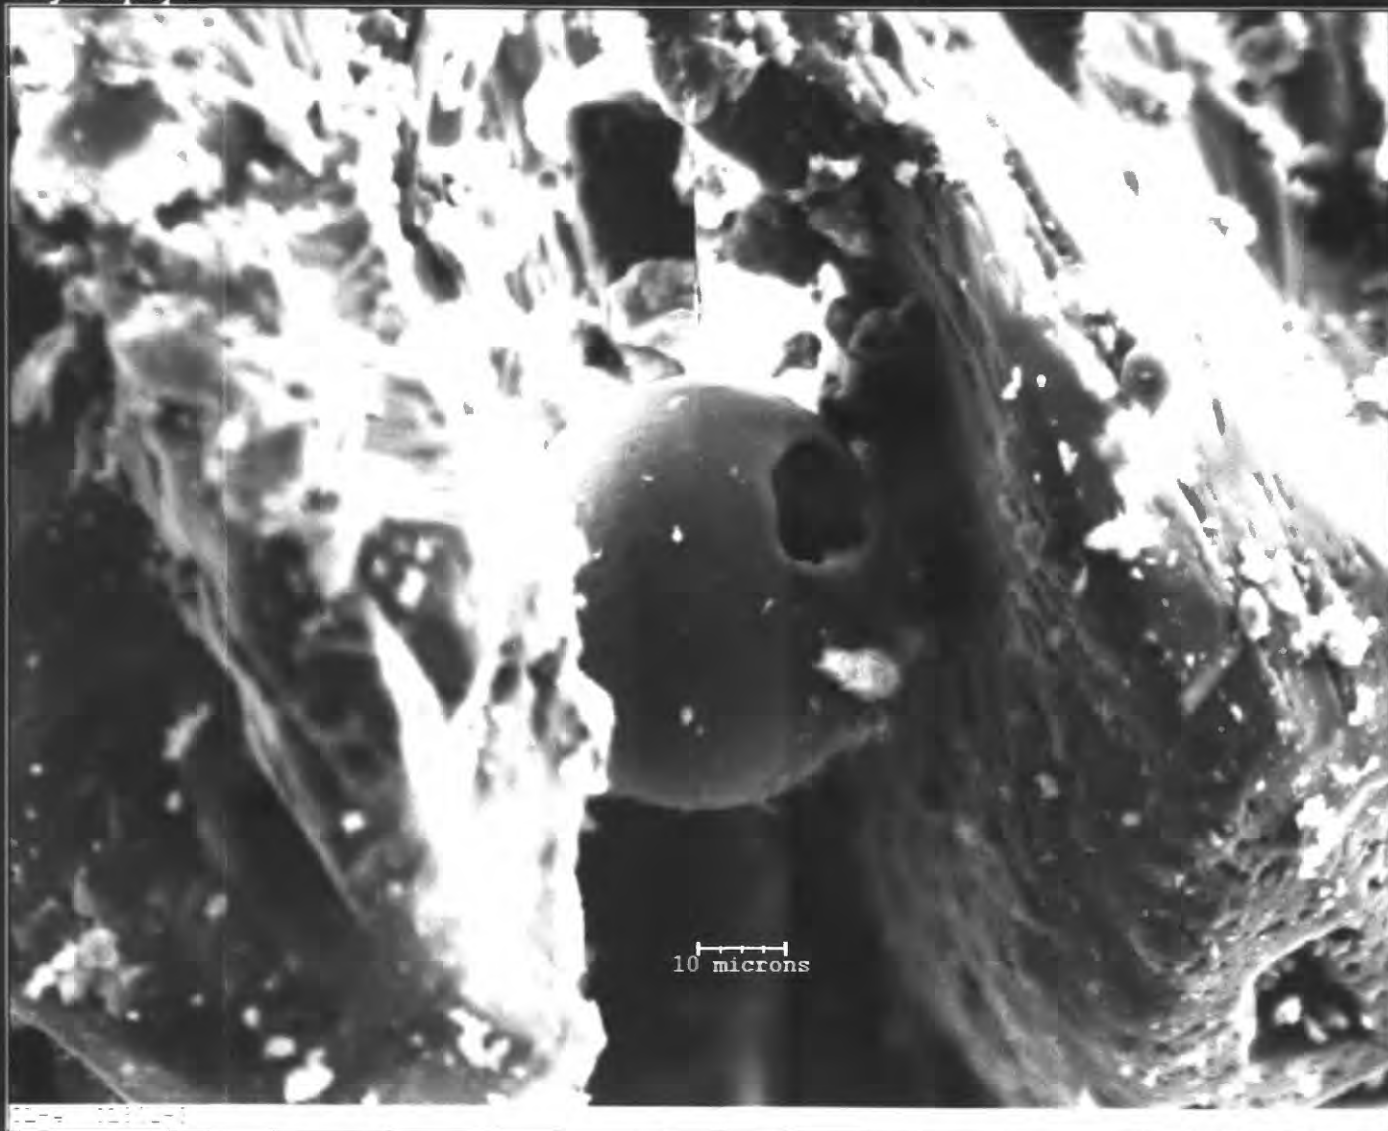
**Figure 9.** A hollow fly ash sphere with a smooth glassy surface is also Si- Al-rich.
