LEVEL II SCOUR ANALYSIS FOR
BRIDGE 7H (HUNTTH0001007H) on
TOWN HIGHWAY 1, crossing
COBB BROOK,
HUNTINGTON, VERMONT

U.S. Geological Survey
Open-File Report 97-339

Prepared in cooperation with
VERMONT AGENCY OF TRANSPORTATION
and
FEDERAL HIGHWAY ADMINISTRATION

By EMILY C. WILD

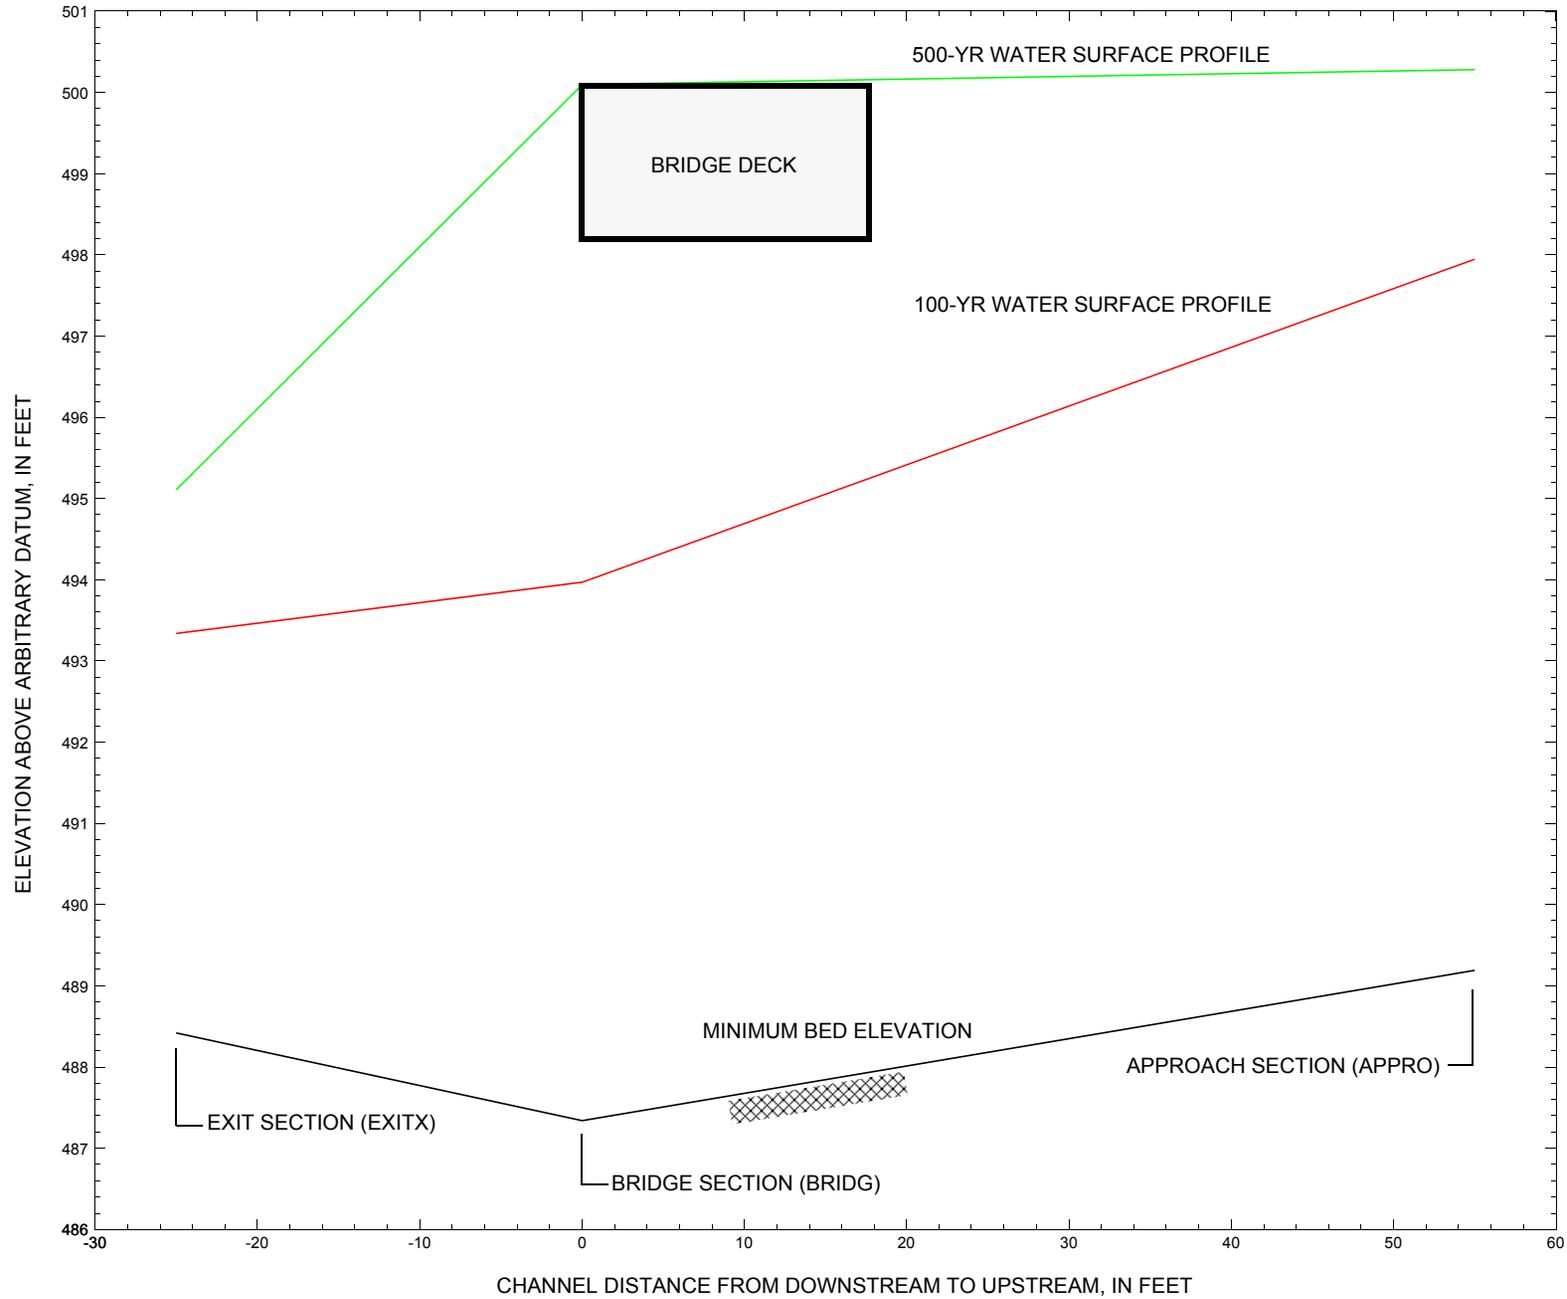
Figure 9. Water-surface profiles for the 100- and 500-yr discharges at structure HUNTTH0001007H on Town Highway 34, crossing Cobb Book, Huntington, Vermont.

Hydraulic analyses of the reach were done by use of the Federal Highway Administration's WSPRO step-backwater computer program (Shearman and others, 1986, and Shearman, 1990). The analyses reported herein reflect conditions existing at the site at the time of the study. Furthermore, in the development of the model it was necessary to assume no accumulation of debris or ice at the site. Results of the hydraulic model are presented in the Bridge Hydraulic Summary, Appendix B, and figure 9.

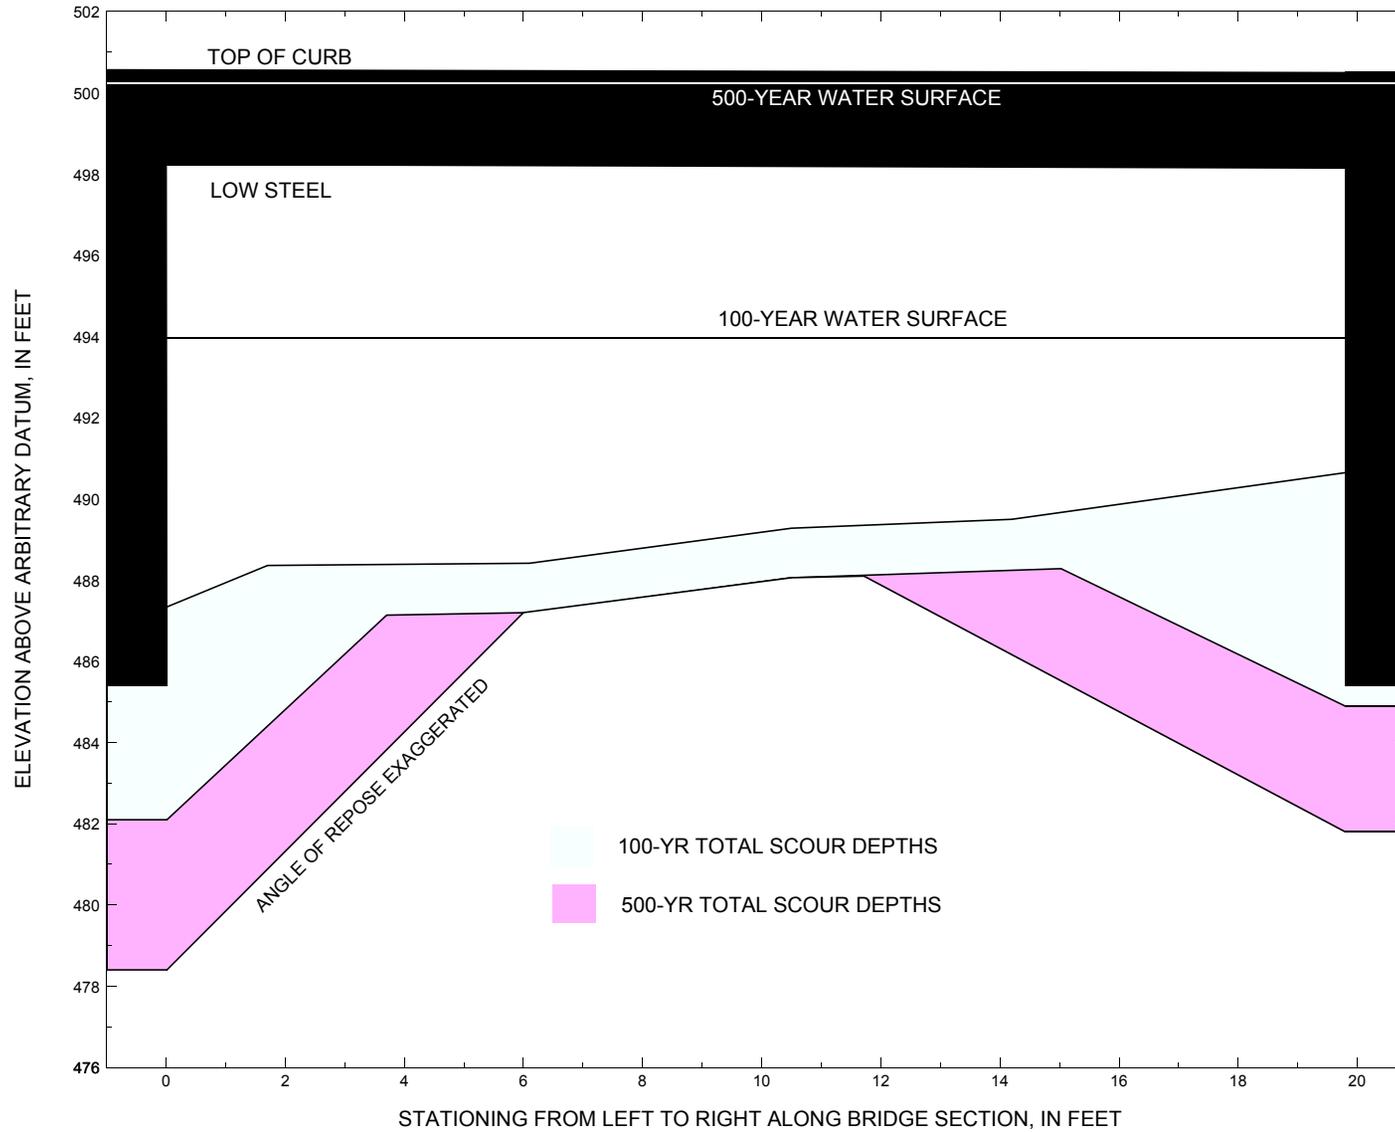
Figure 10. Scour elevations for the 100-yr and 500-yr discharges at structure HUNTTTH0001007H on Town Highway 1, crossing Cobb Brook, Huntington Vermont.

Scour depths were computed using the general guidelines described in Hydraulic Engineering Circular 18 (Richardson and others, 1995). Scour depths were calculated assuming an infinite depth of erosive material and a homogeneous particle-size distribution. The results of the scour analysis are presented in tables 1 and 2 and a graph of the scour depths is presented in figure 10.

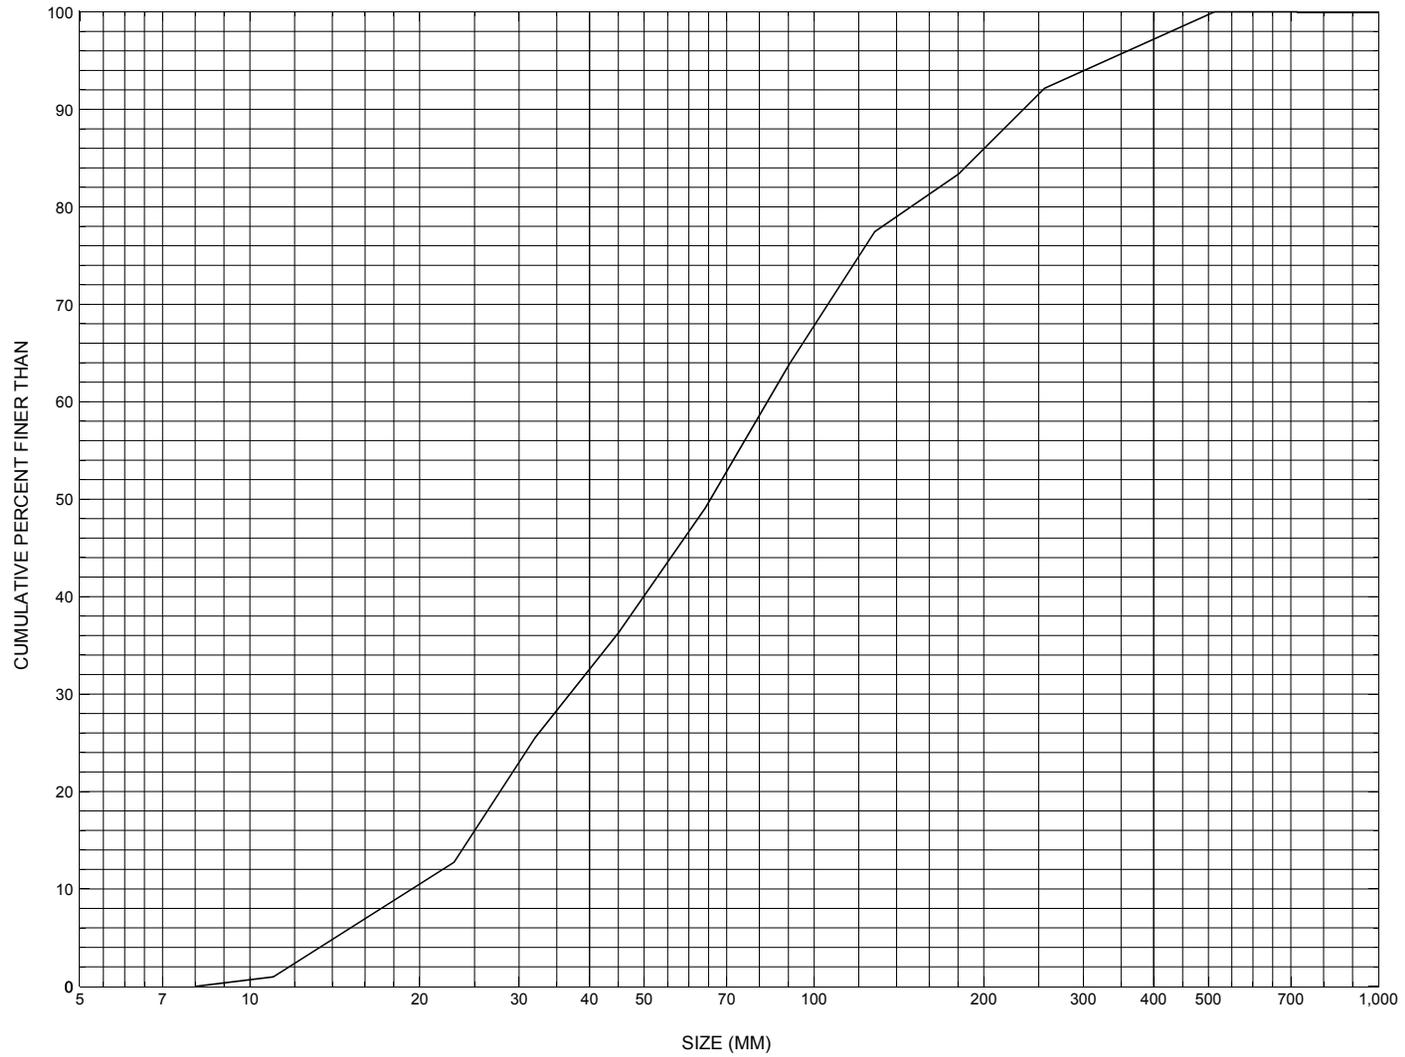
Appendix C. Bed material particle-size distribution for a pebble count in the channel approach of structure HUNTTH0001007H, in Huntington, Vermont.
