LEVEL II SCOUR ANALYSIS FOR BRIDGE 25 (ANDOTH00230025) on TOWN HIGHWAY 23, crossing the ANDOVER BRANCH, ANDOVER, VERMONT

U.S. Geological Survey
Open-File Report 97-372

Prepared in cooperation with
VERMONT AGENCY OF TRANSPORTATION
and
FEDERAL HIGHWAY ADMINISTRATION

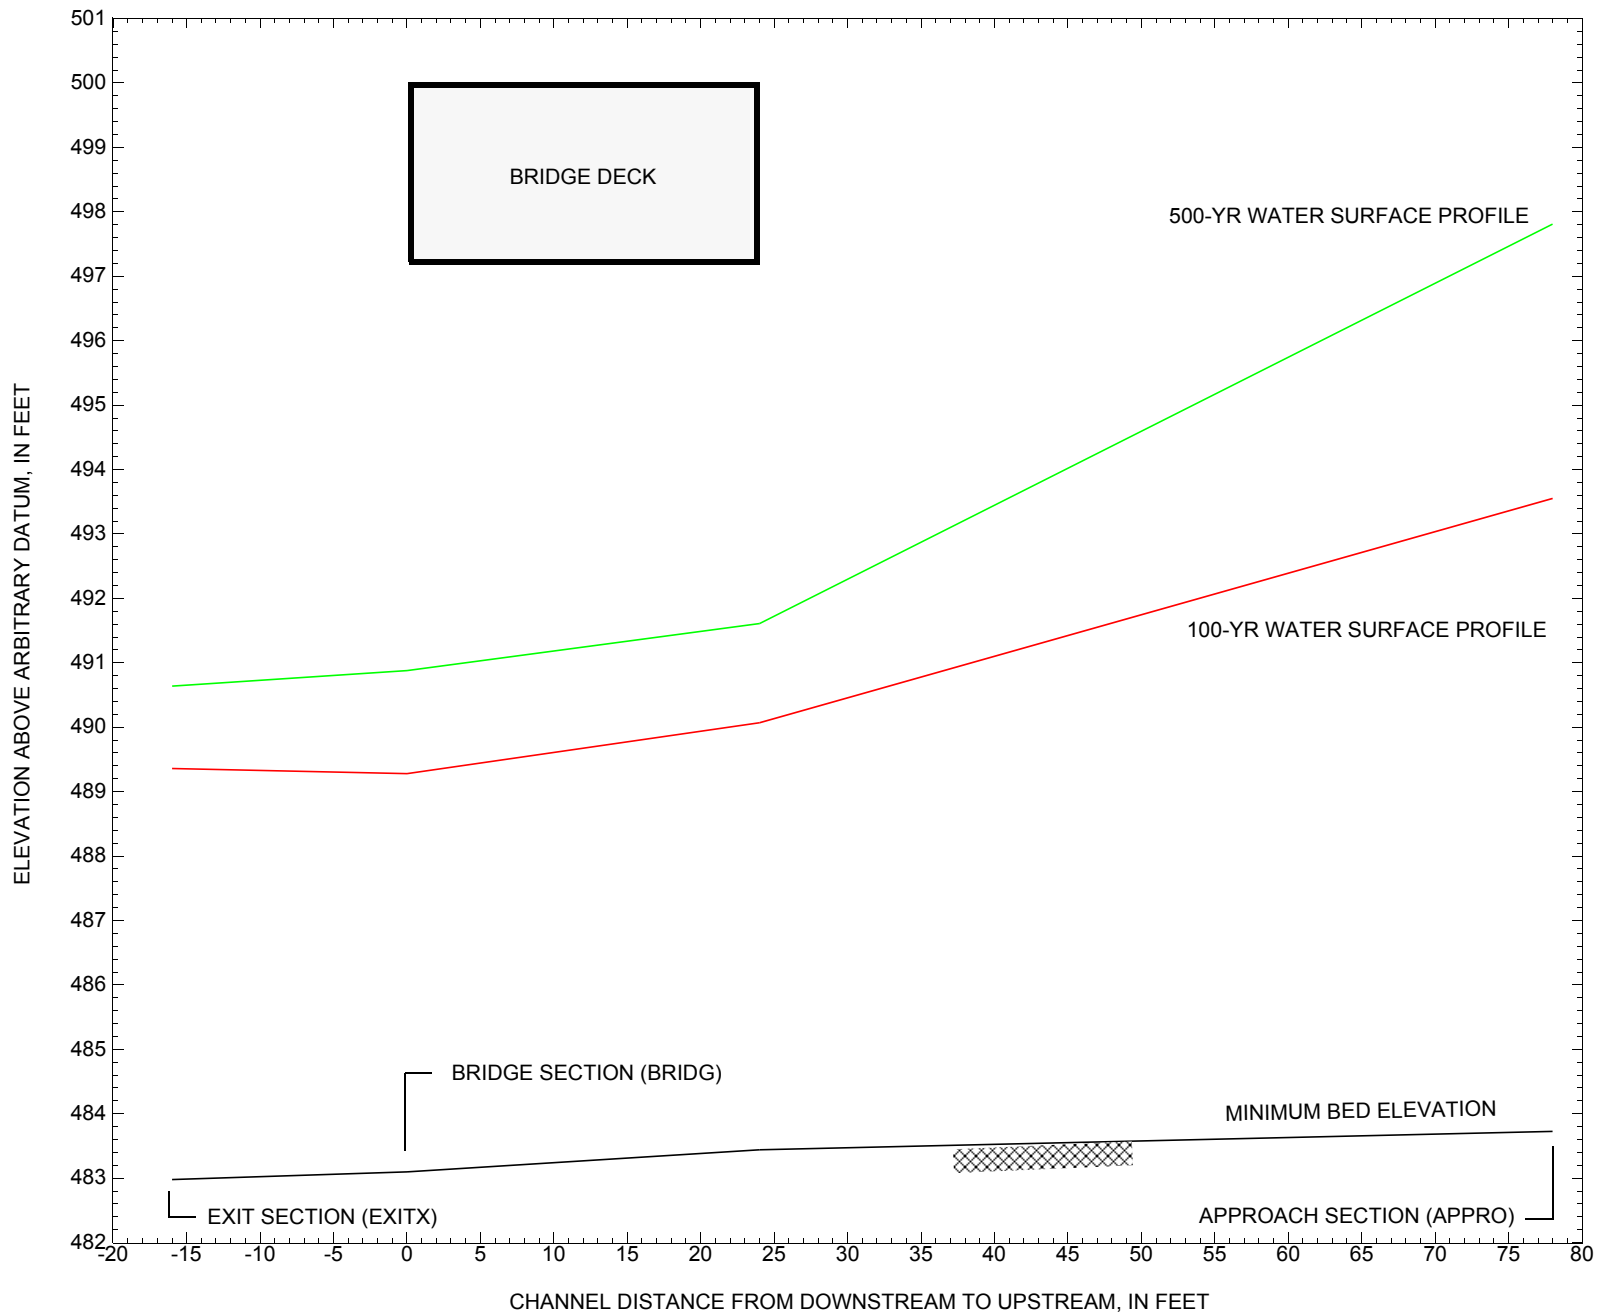
Figure 7. Water-surface profiles for the 100- and 500-yr discharges at structure ANDOTH00230025 on Town Highway 23, crossing Andover Branch, Andover, Vermont.
