LEVEL II SCOUR ANALYSIS FOR BRIDGE 36 (ANDOVTT00110036) on STATE ROUTE 11, crossing the MIDDLE BRANCH WILLIAMS RIVER, ANDOVER, VERMONT

U.S. Geological Survey
Open-File Report 97-393

Prepared in cooperation with
VERMONT AGENCY OF TRANSPORTATION
and
FEDERAL HIGHWAY ADMINISTRATION

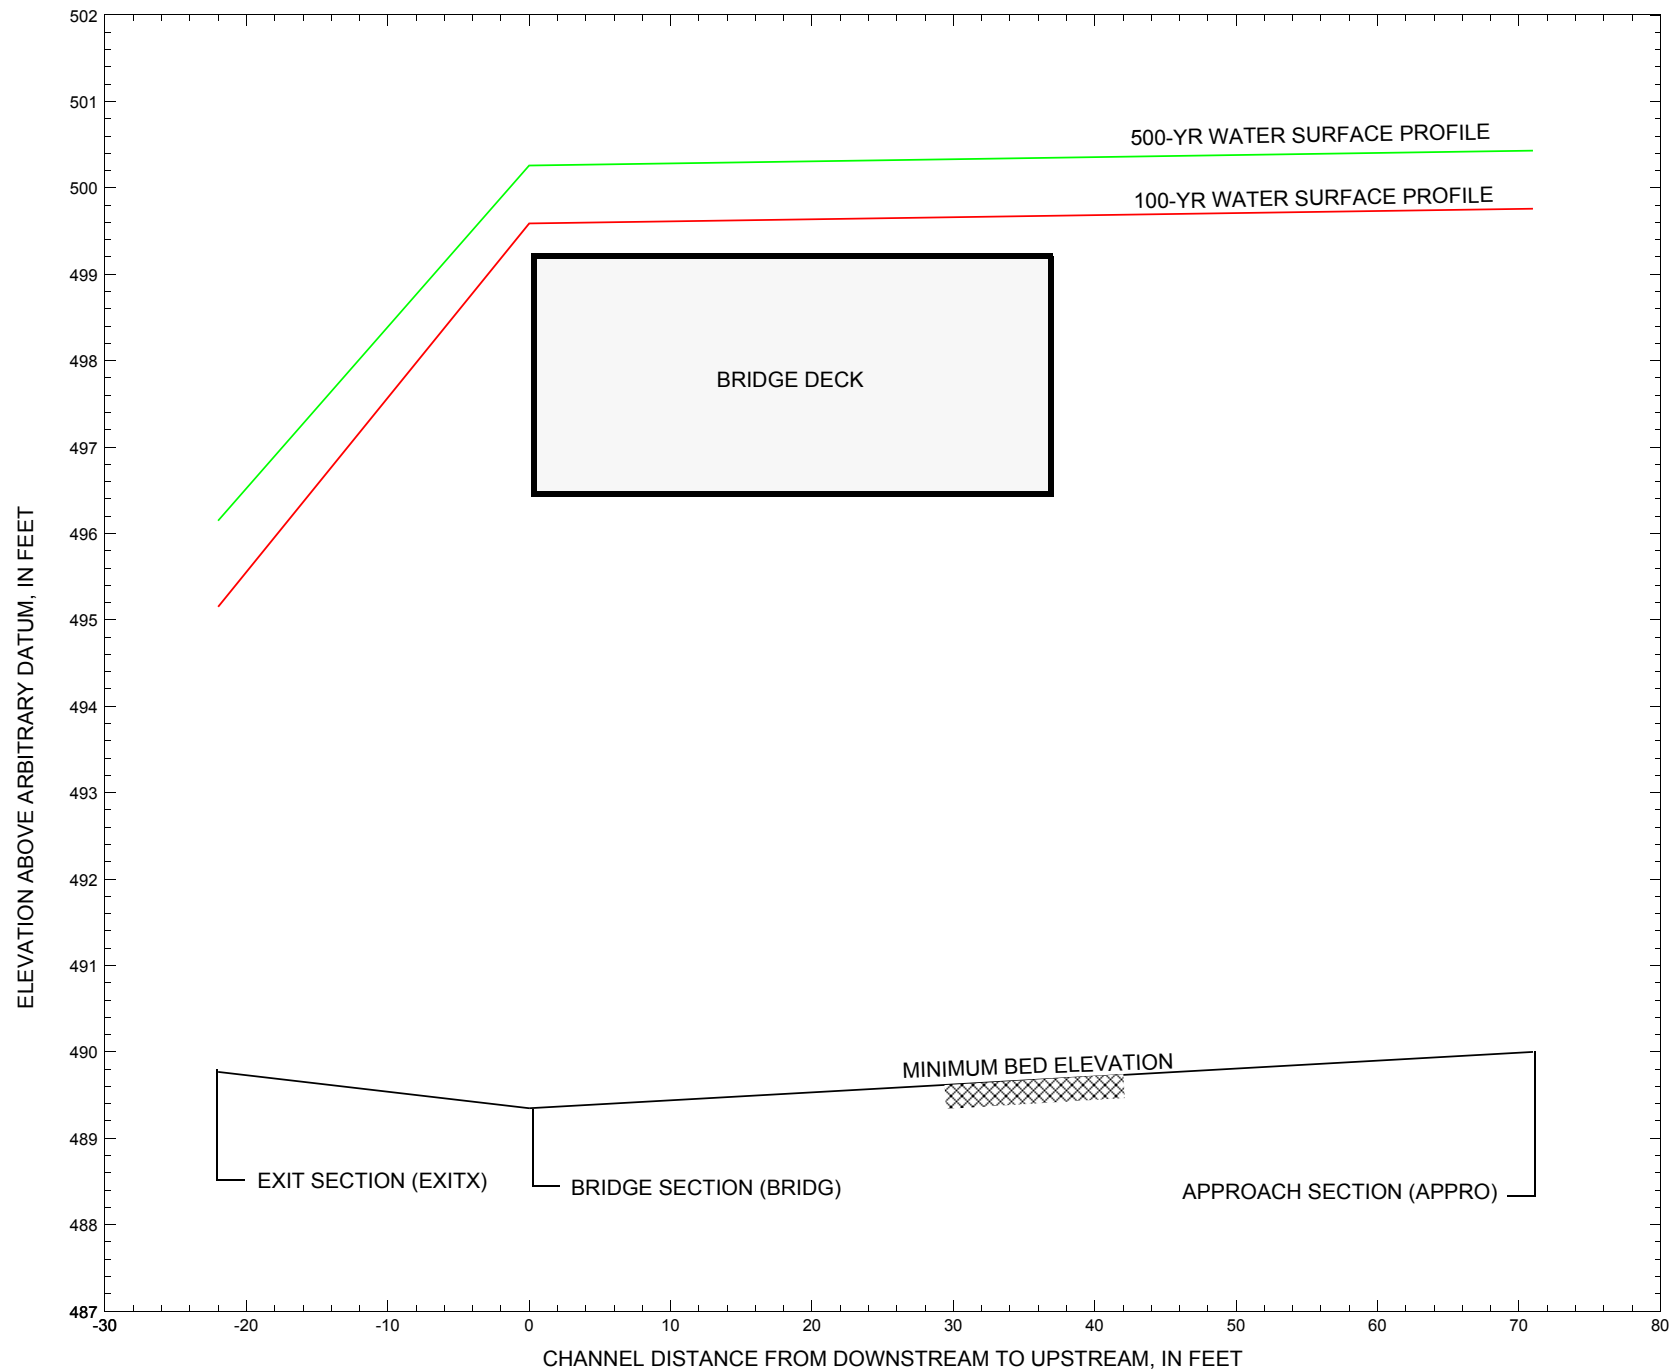
Figure 7. Water-surface profiles for the 100- and 500-yr discharges at structure ANDOVT00110036 on State Route 11, crossing the Middle Branch Williams River, Andover, Vermont.

Hydraulic analyses of the reach were done by use of the Federal Highway Administration's WSPRO step-backwater computer program (Shearman and others, 1986, and Shearman, 1990). The analyses reported herein reflect conditions existing at the site at the time of the study. Furthermore, in the development of the model it was necessary to assume no accumulation of debris or ice at the site. Results of the hydraulic model are presented in the Bridge Hydraulic Summary, Appendix B, and figure 7.

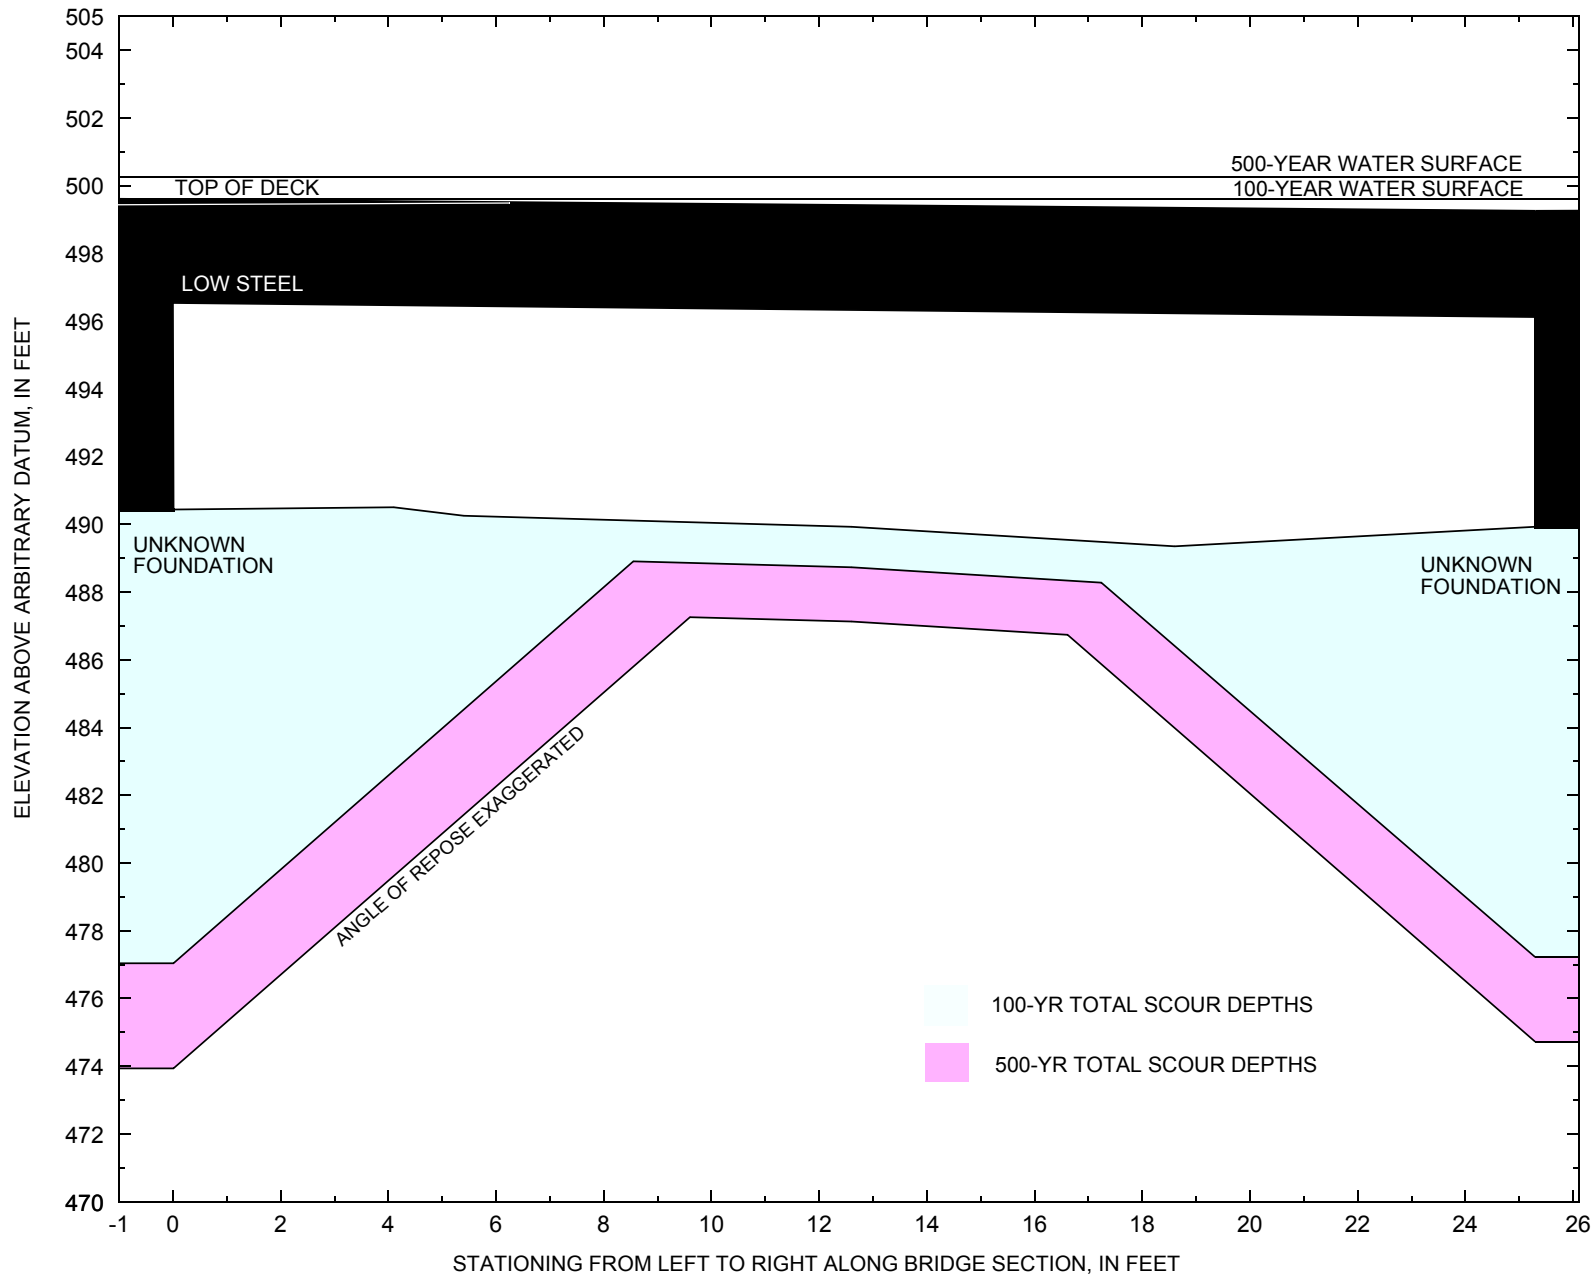
Figure 8. Scour elevations for the 100-yr and 500-yr discharges at structure ANDOVT00110036 on State Route 11, crossing the Middle Branch Williams River, Andover, Vermont.

Scour depths were computed using the general guidelines described in Hydraulic Engineering Circular 18 (Richardson and others, 1995). Scour depths were calculated assuming an infinite depth of erosive material and a homogeneous particle-size distribution. The results of the scour analysis are presented in tables 1 and 2 and a graph of the scour depths is presented in figure 8.
