LEVEL II SCOUR ANALYSIS FOR  
BRIDGE 6 (ALBUTH00150006) on  
TOWN HIGHWAY 15, crossing  
MUD CREEK,  
ALBURG, VERMONT

U.S. Geological Survey  
Open-File Report 97-397

Prepared in cooperation with  
VERMONT AGENCY OF TRANSPORTATION  
and  
FEDERAL HIGHWAY ADMINISTRATION

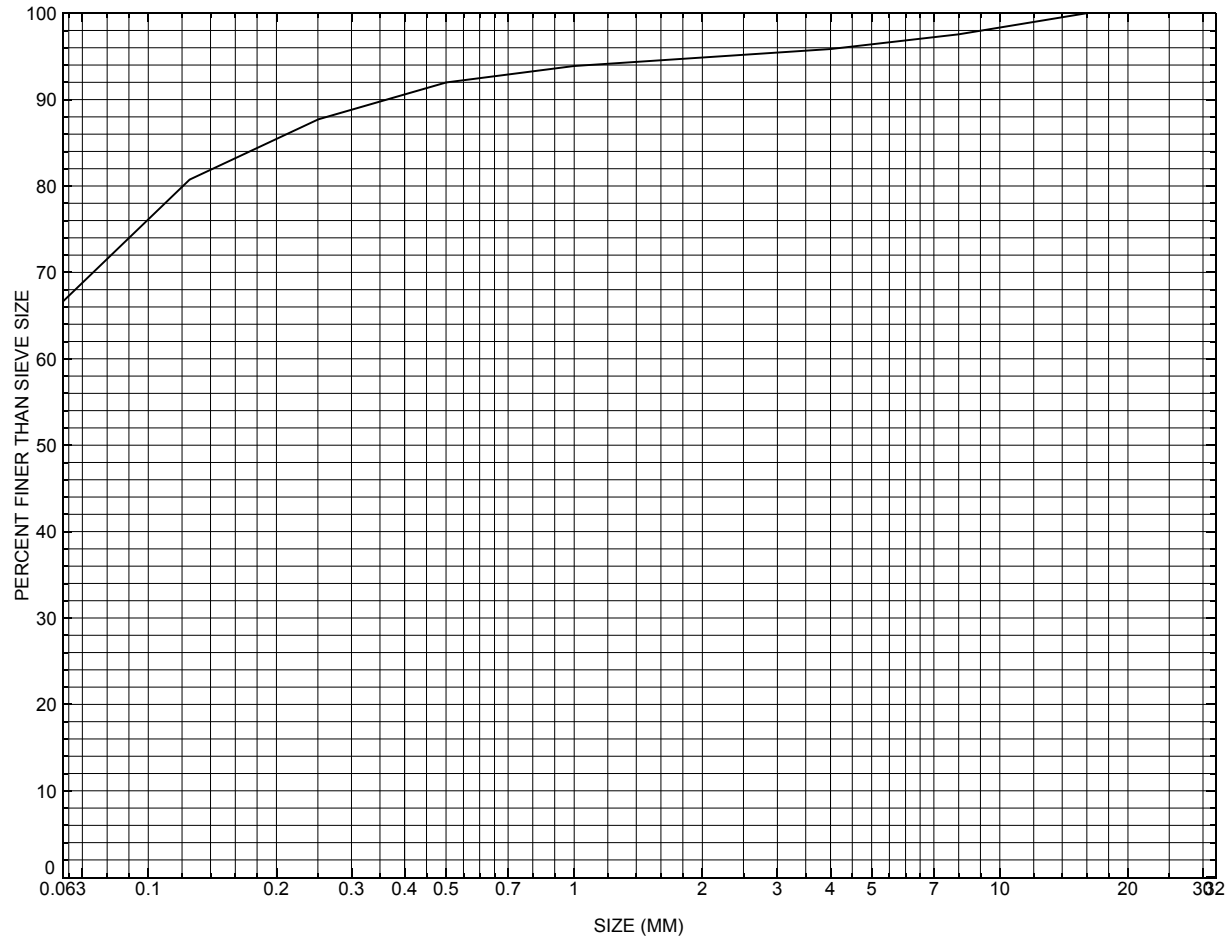
Appendix C. Bed material particle-size distribution for a pebble count in the channel approach of structure ALBUTH00150006, in Alburg, Vermont.

Field observations during the Level I data collection indicated that the bed material was silt and clay with some fine sand and covered with organics. When the bed sample from this site was sieved, 66.7 percent of the sample passed through the smallest available sieve size, 0.063 mm. Therefore, it was necessary to estimate the median grain size by interpolating between the 0.063 mm sieve and zero. The result was 0.047 mm, which is in the coarse silt range. The 0.047 mm grain size was used as the  $D_{50}$  in the scour analysis. Increasing the  $D_{50}$  from 0.047 mm to 0.063 mm decreased contraction scour by less than 10 percent.
