# LEVEL II SCOUR ANALYSIS FOR BRIDGE 81 (NFIETH00PL0081) on PLEASANT STREET, crossing UNION BROOK, NORTHFIELD, VERMONT

U.S. Geological Survey  
Open-File Report 97-404

Prepared in cooperation with  
VERMONT AGENCY OF TRANSPORTATION  
and  
FEDERAL HIGHWAY ADMINISTRATION

By RONDA L. BURNS and LAURA MEDALIE

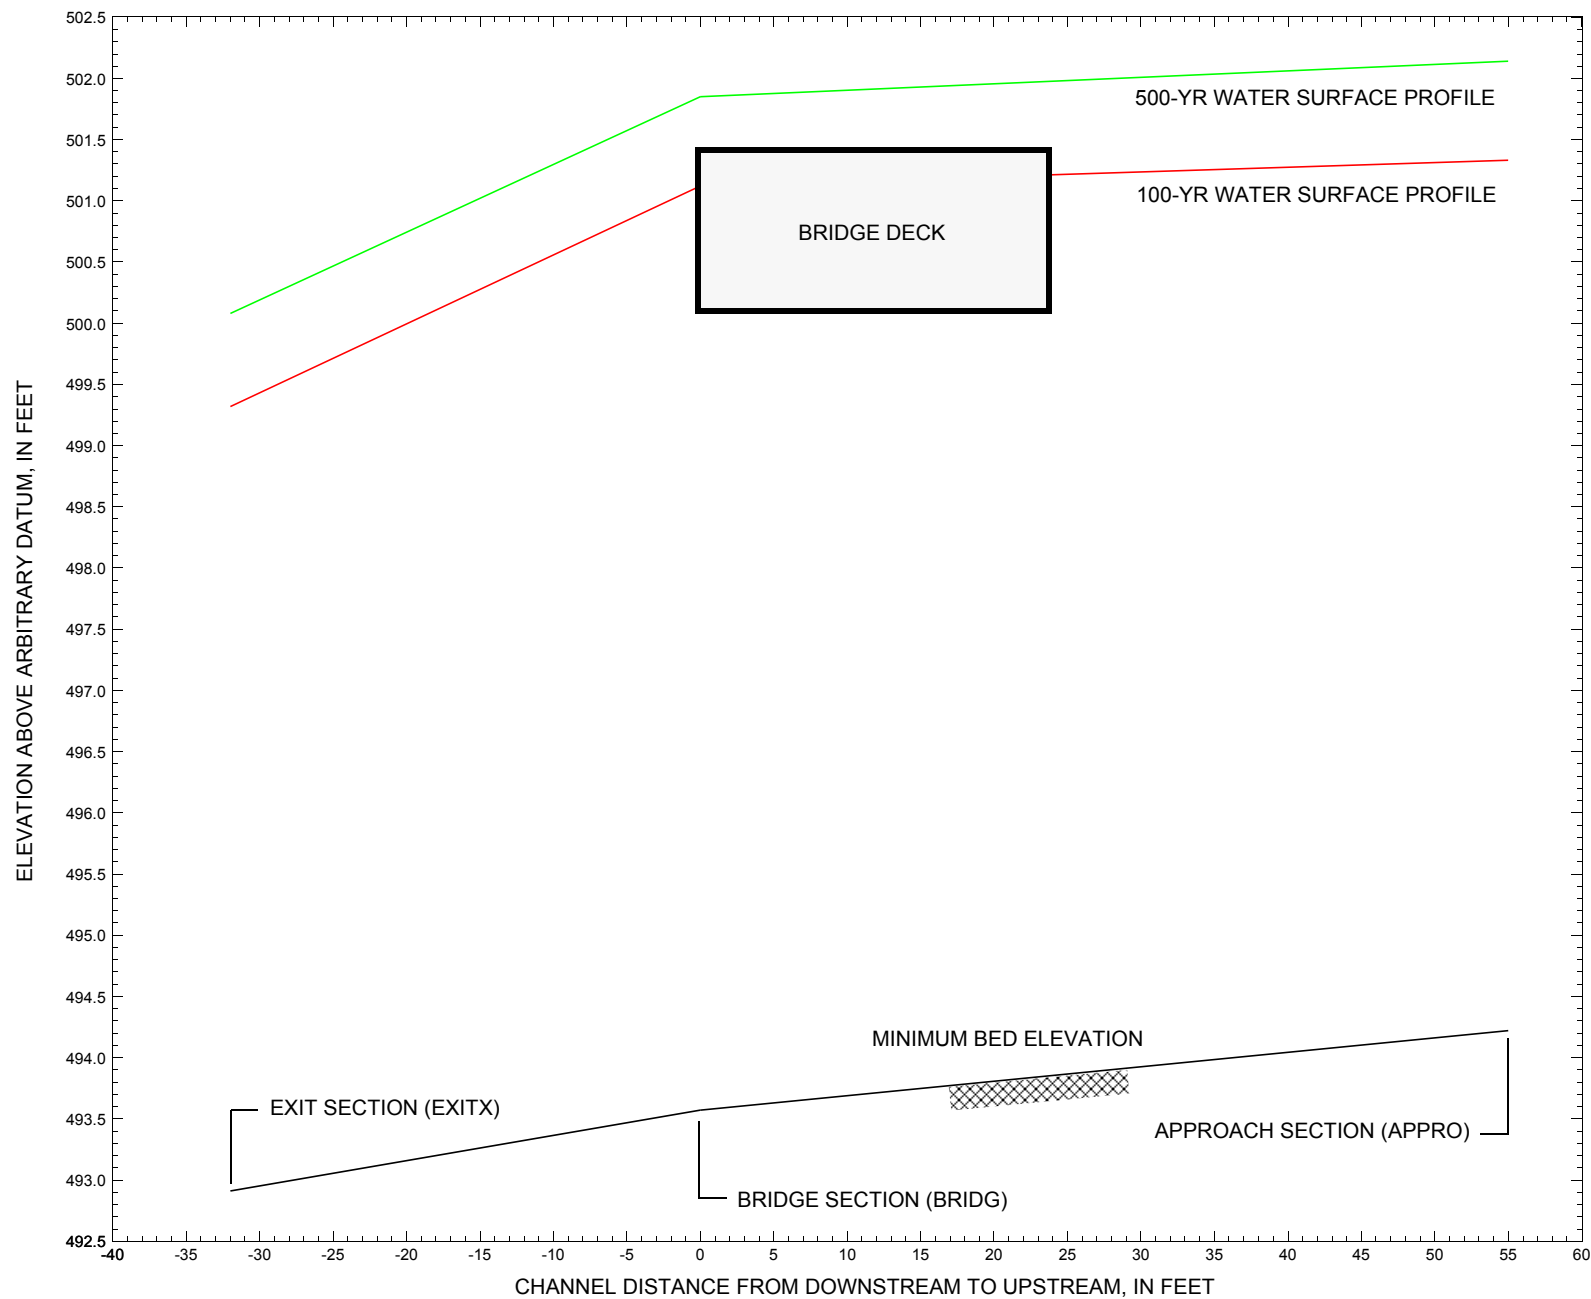
Figure 7. Water-surface profiles for the 100- and 500-yr discharges at structure NFIETH00PL0081 on Pleasant Street, crossing Union Brook, Northfield, Vermont.

Hydraulic analyses of the reach were done by use of the Federal Highway Administration's WSPRO step-backwater computer program (Shearman and others, 1986, and Shearman, 1990). The analyses reported herein reflect conditions existing at the site at the time of the study. Furthermore, in the development of the model it was necessary to assume no accumulation of debris or ice at the site. Results of the hydraulic model are presented in the Bridge Hydraulic Summary, Appendix B, and figure 7.

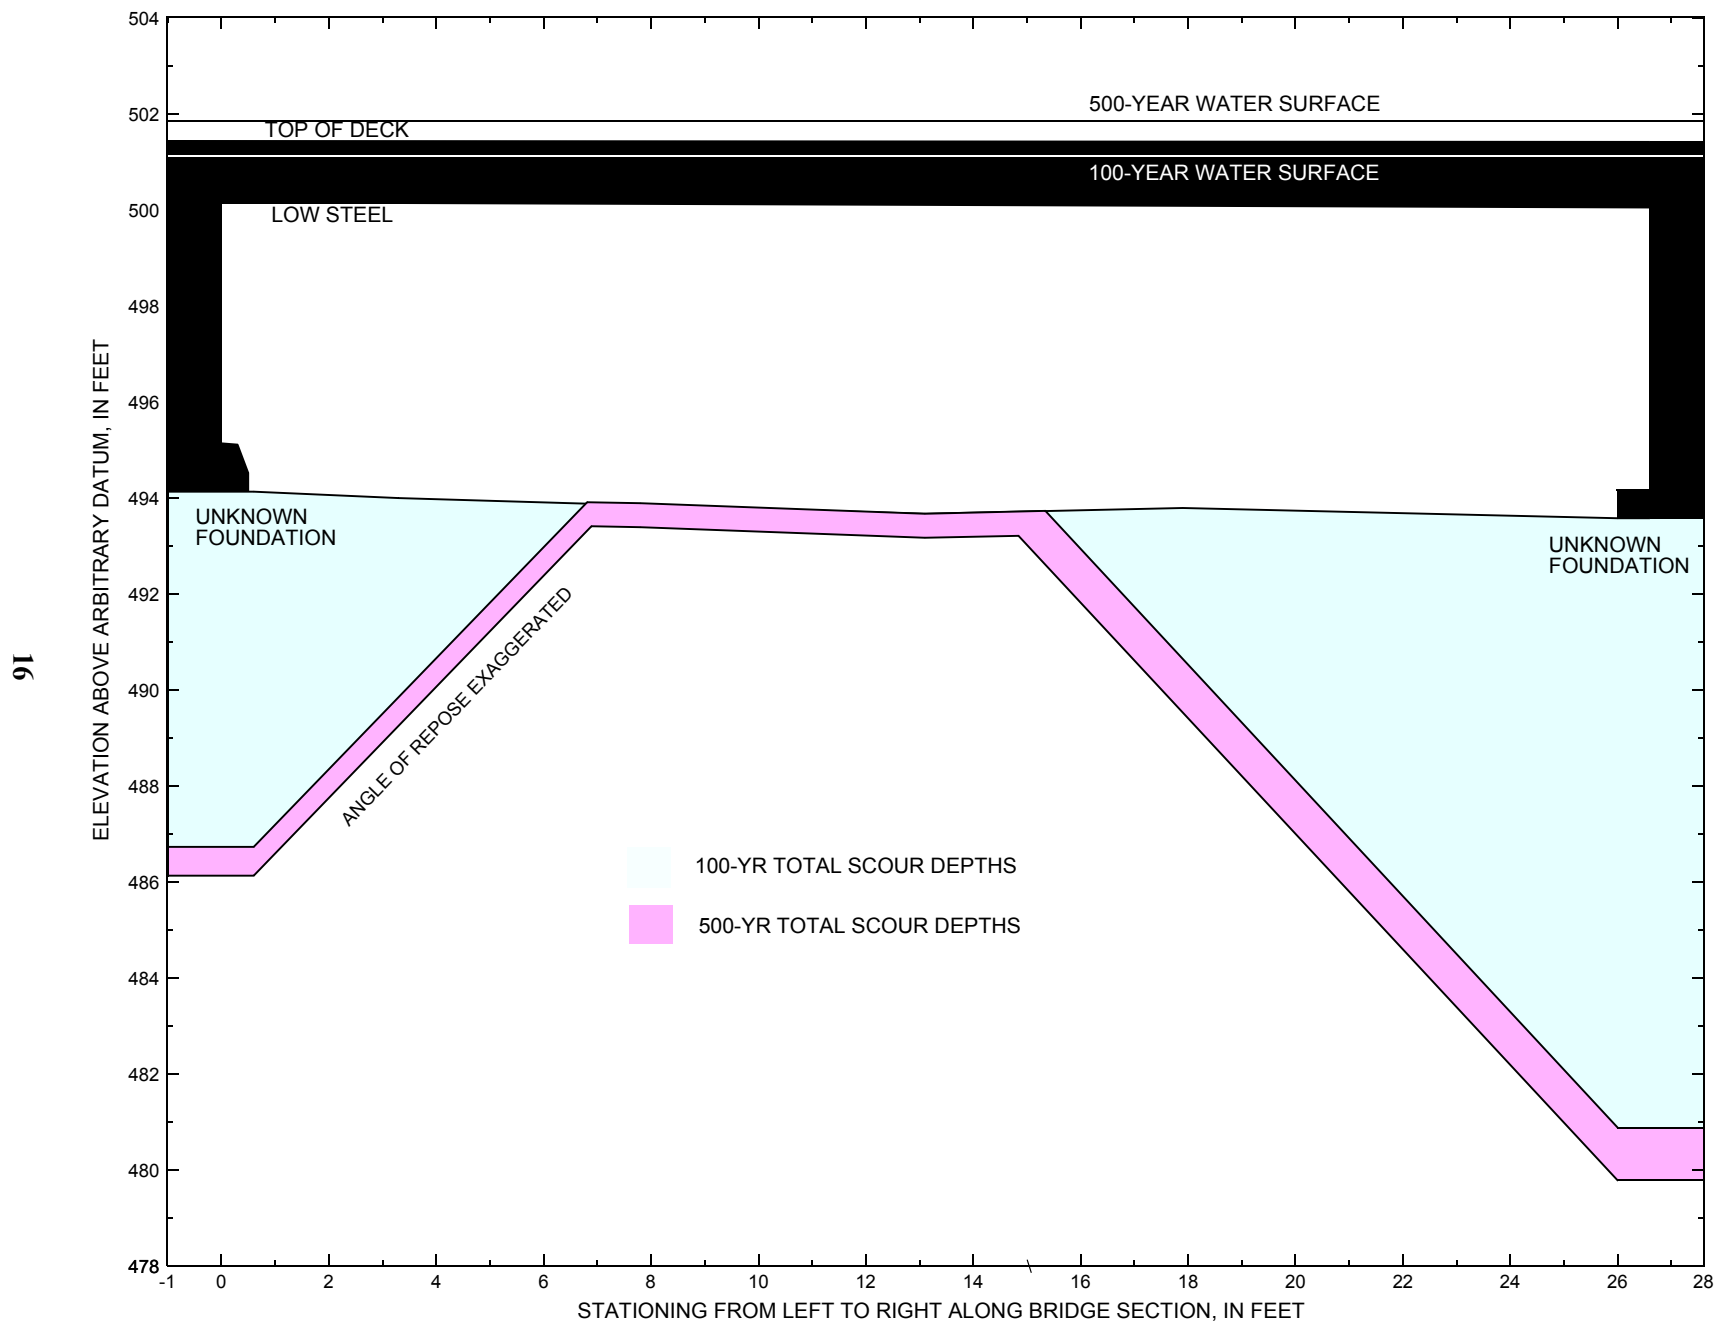
Figure 8. Scour elevations for the 100-yr and 500-yr discharges at structure NFIETH00PL0081 on Pleasant Street, crossing Union Brook, Northfield, Vermont.

Scour depths were computed using the general guidelines described in Hydraulic Engineering Circular 18 (Richardson and others, 1995). Scour depths were calculated assuming an infinite depth of erosive material and a homogeneous particle-size distribution. The results of the scour analysis are presented in tables 1 and 2 and a graph of the scour depths is presented in figure 8.

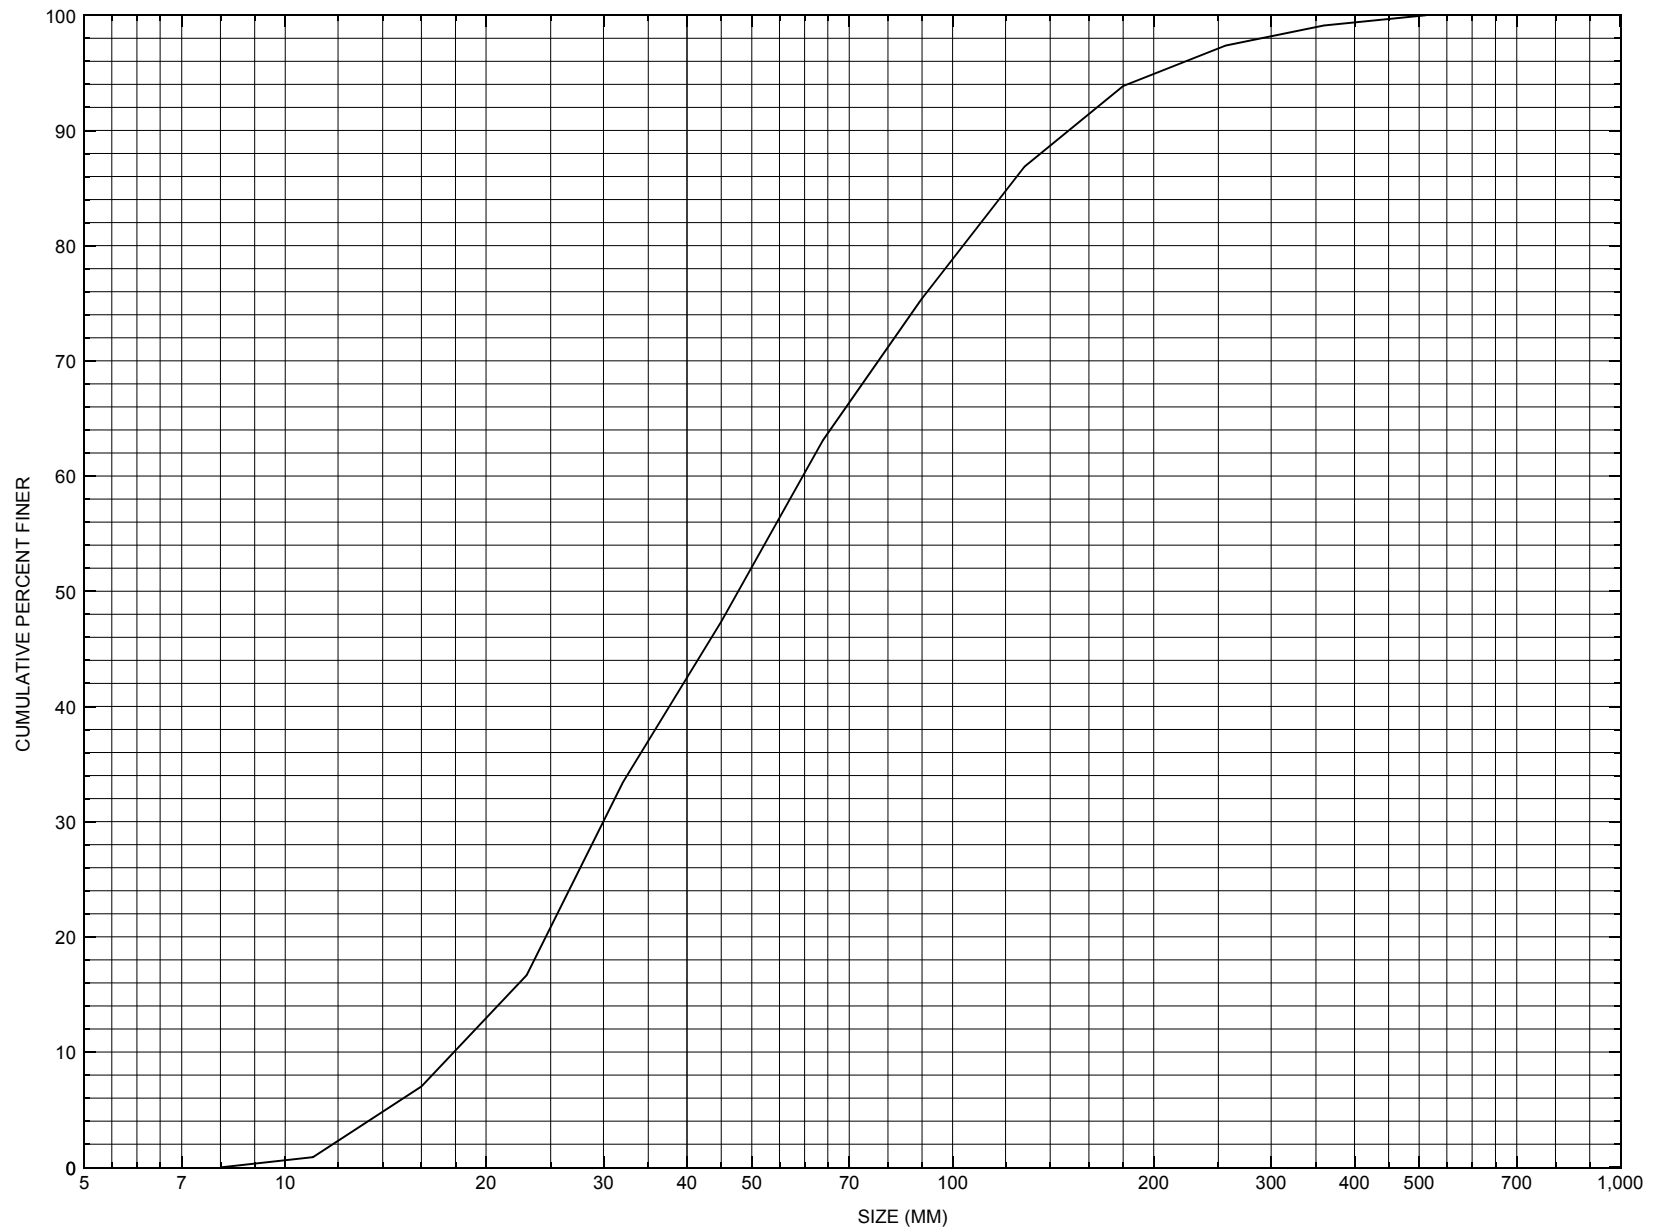
Appendix C. Bed material particle-size distribution for a pebble count in the channel approach of structure NFIETH00PL0081, in Northfield, Vermont.
