LEVEL II SCOUR ANALYSIS FOR
BRIDGE 48 (FFIETH00300048) on
TOWN HIGHWAY 30 crossing
WANZER BROOK,
FAIRFIELD, VERMONT

U.S. Geological Survey
Open-File Report 97-592

Prepared in cooperation with
VERMONT AGENCY OF TRANSPORTATION
and
FEDERAL HIGHWAY ADMINISTRATION

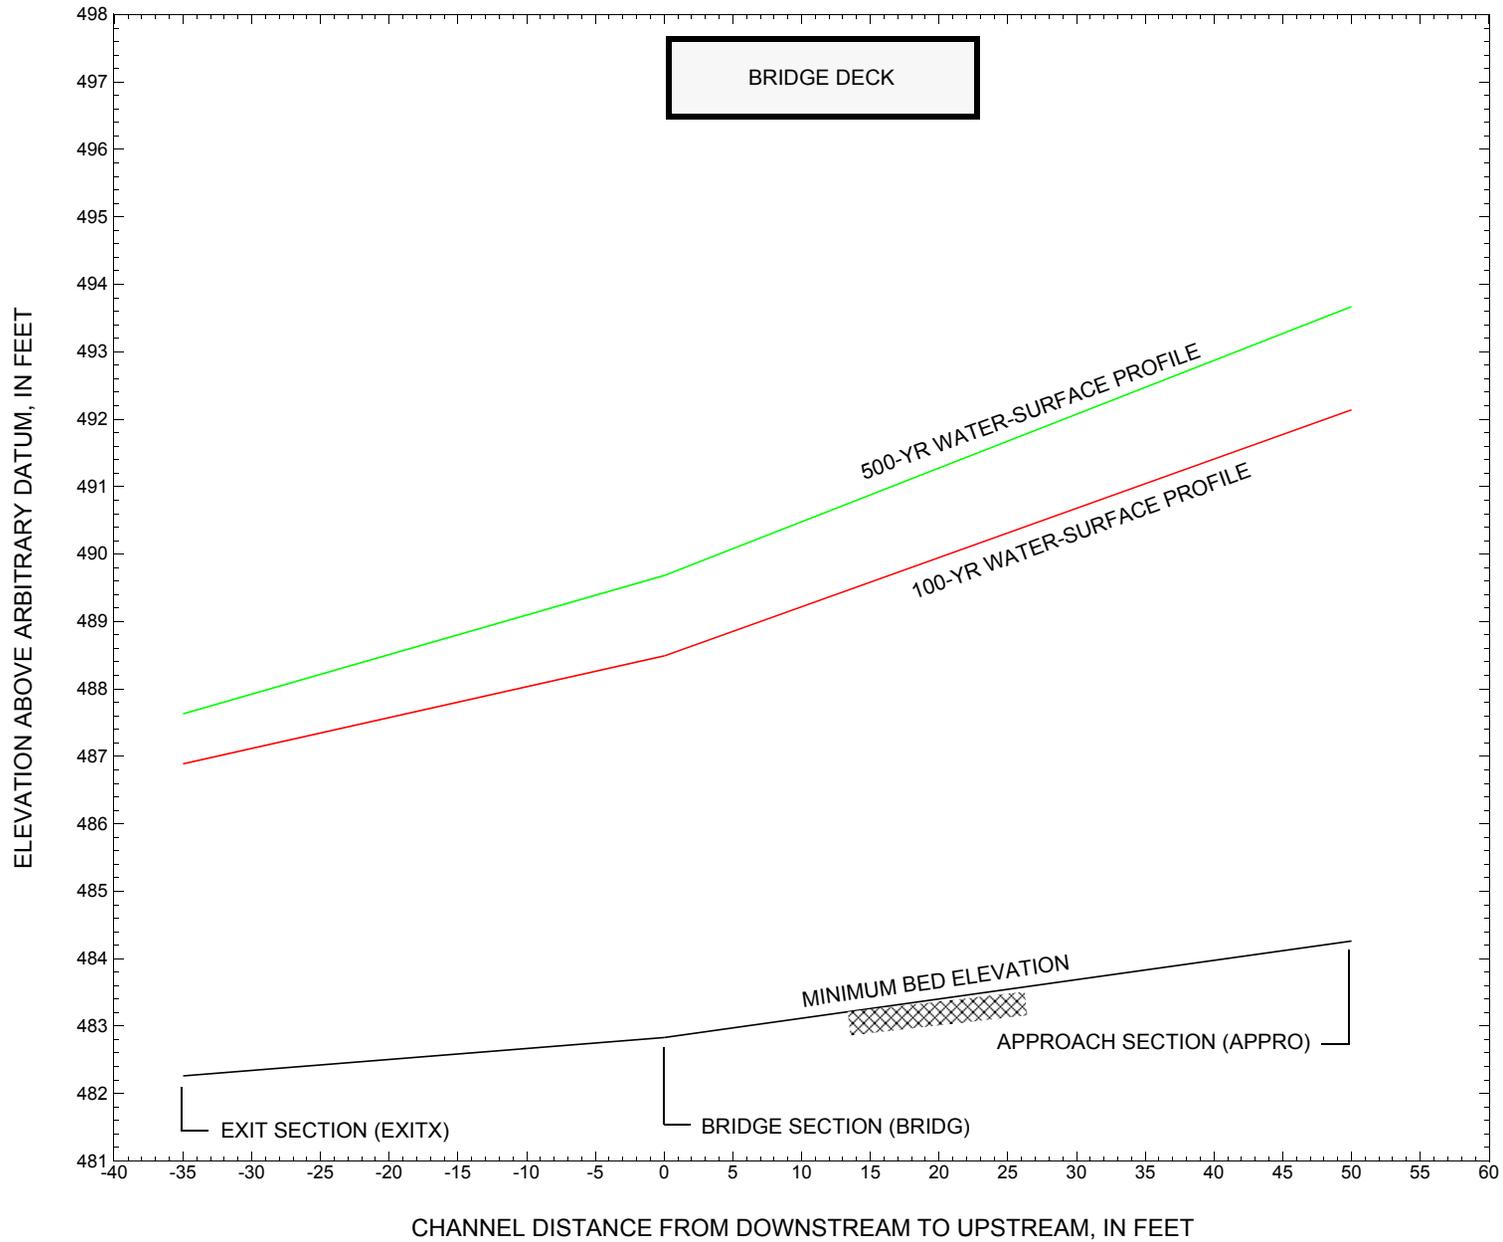
Figure 7. Water-surface profiles for the 100- and 500-yr discharges at structure FFIETH00300048 on Town Highway 30, crossing Wanzer Brook, Fairfield, Vermont.

Hydraulic analyses of the reach were done by use of the Federal Highway Administration's WSPRO step-backwater computer program (Shearman and others, 1986, and Shearman, 1990). The analyses reported herein reflect conditions existing at the site at the time of the study. Furthermore, in the development of the model it was necessary to assume no accumulation of debris or ice at the site. Results of the hydraulic model are presented in the Bridge Hydraulic Summary, Appendix B, and figure 7.

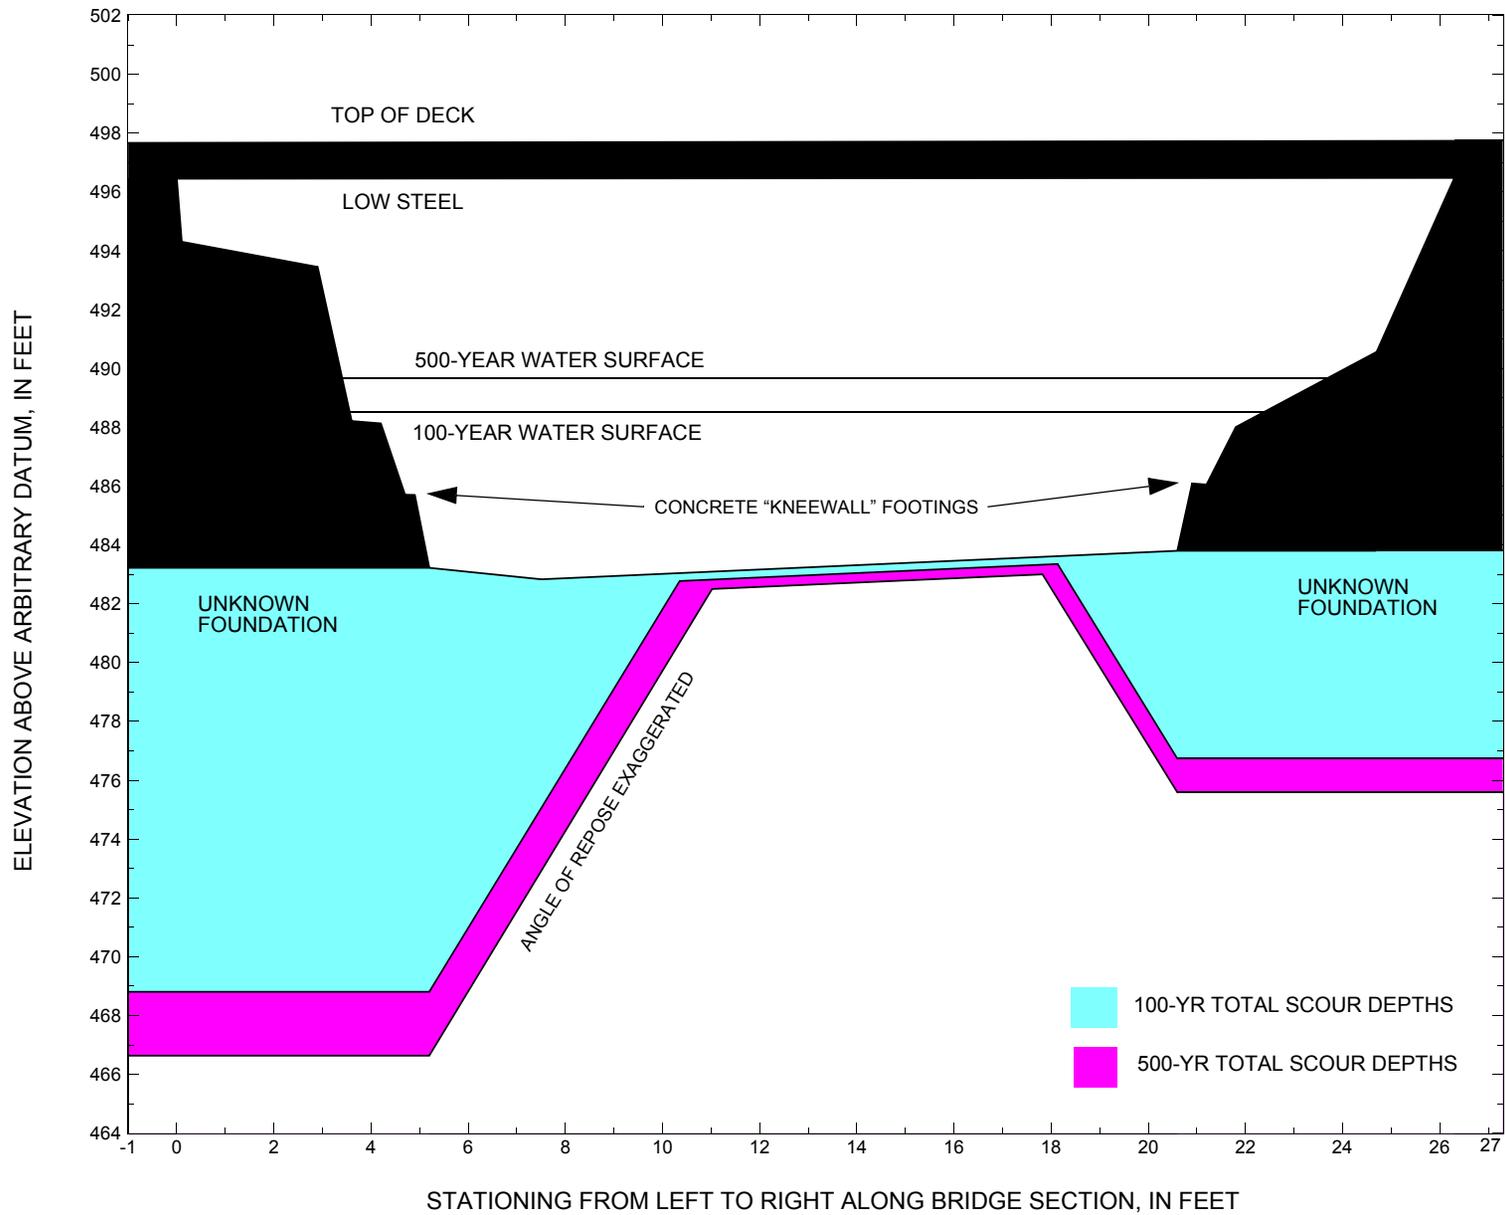
Figure 8. Scour elevations for the 100-yr and 500-yr discharges at structure FFIETH00300048 on Town Highway 30, crossing Wanzer Brook, Fairfield, Vermont.

Scour depths were computed using the general guidelines described in Hydraulic Engineering Circular 18 (Richardson and others, 1995). Scour depths were calculated assuming an infinite depth of erosive material and a homogeneous particle-size distribution. The bed material particle-size distribution was obtained from a pebble count in the channel approach of the bridge. At this site, the channel under the bridge is a “corduroy” log mat floor composed of 13 logs which are parallel to the bridge face and extend from 5 ft under the bridge to the downstream bridge face. Although these logs may serve as a countermeasure against scour under the bridge, this analysis assumed that they would not remain in place during a major flood event. The results of the scour analysis are presented in tables 1 and 2 and a graph of the scour depths is presented in figure 8.

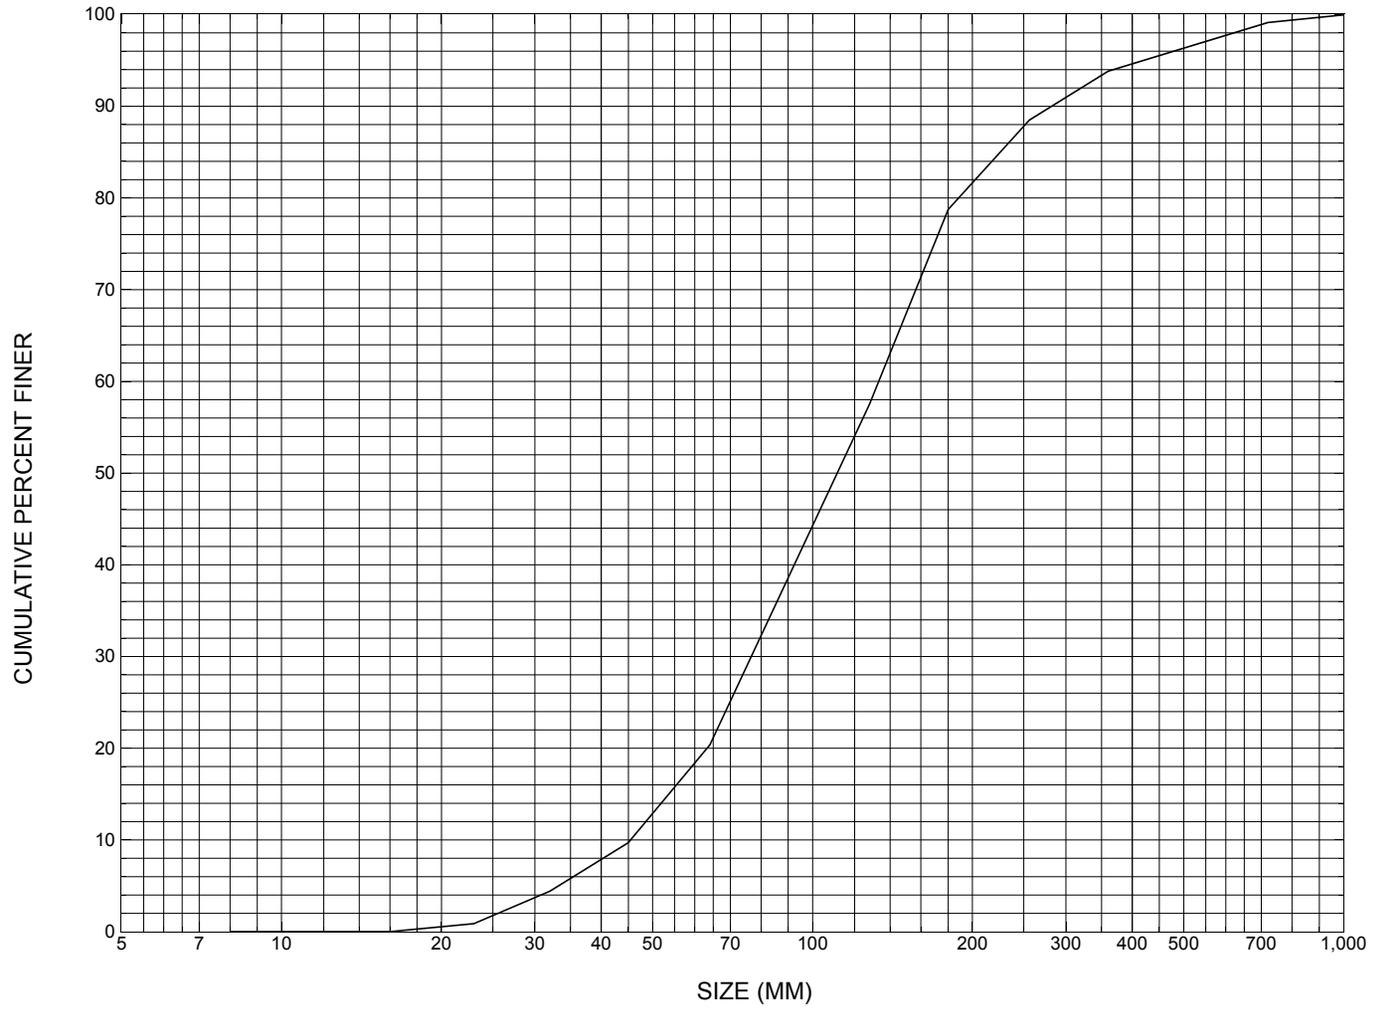
Appendix C. Bed material particle-size distribution for a pebble count in the channel approach of structure FFIETH00300048, in Fairfield, Vermont.
