LEVEL II SCOUR ANALYSIS FOR BRIDGE 25 (REDSTH00360025) on TOWN HIGHWAY 36, crossing the WEST BRANCH DEERFIELD RIVER, READSBORO, VERMONT

U.S. Geological Survey
Open-File Report 97-653

Prepared in cooperation with
VERMONT AGENCY OF TRANSPORTATION
and
FEDERAL HIGHWAY ADMINISTRATION

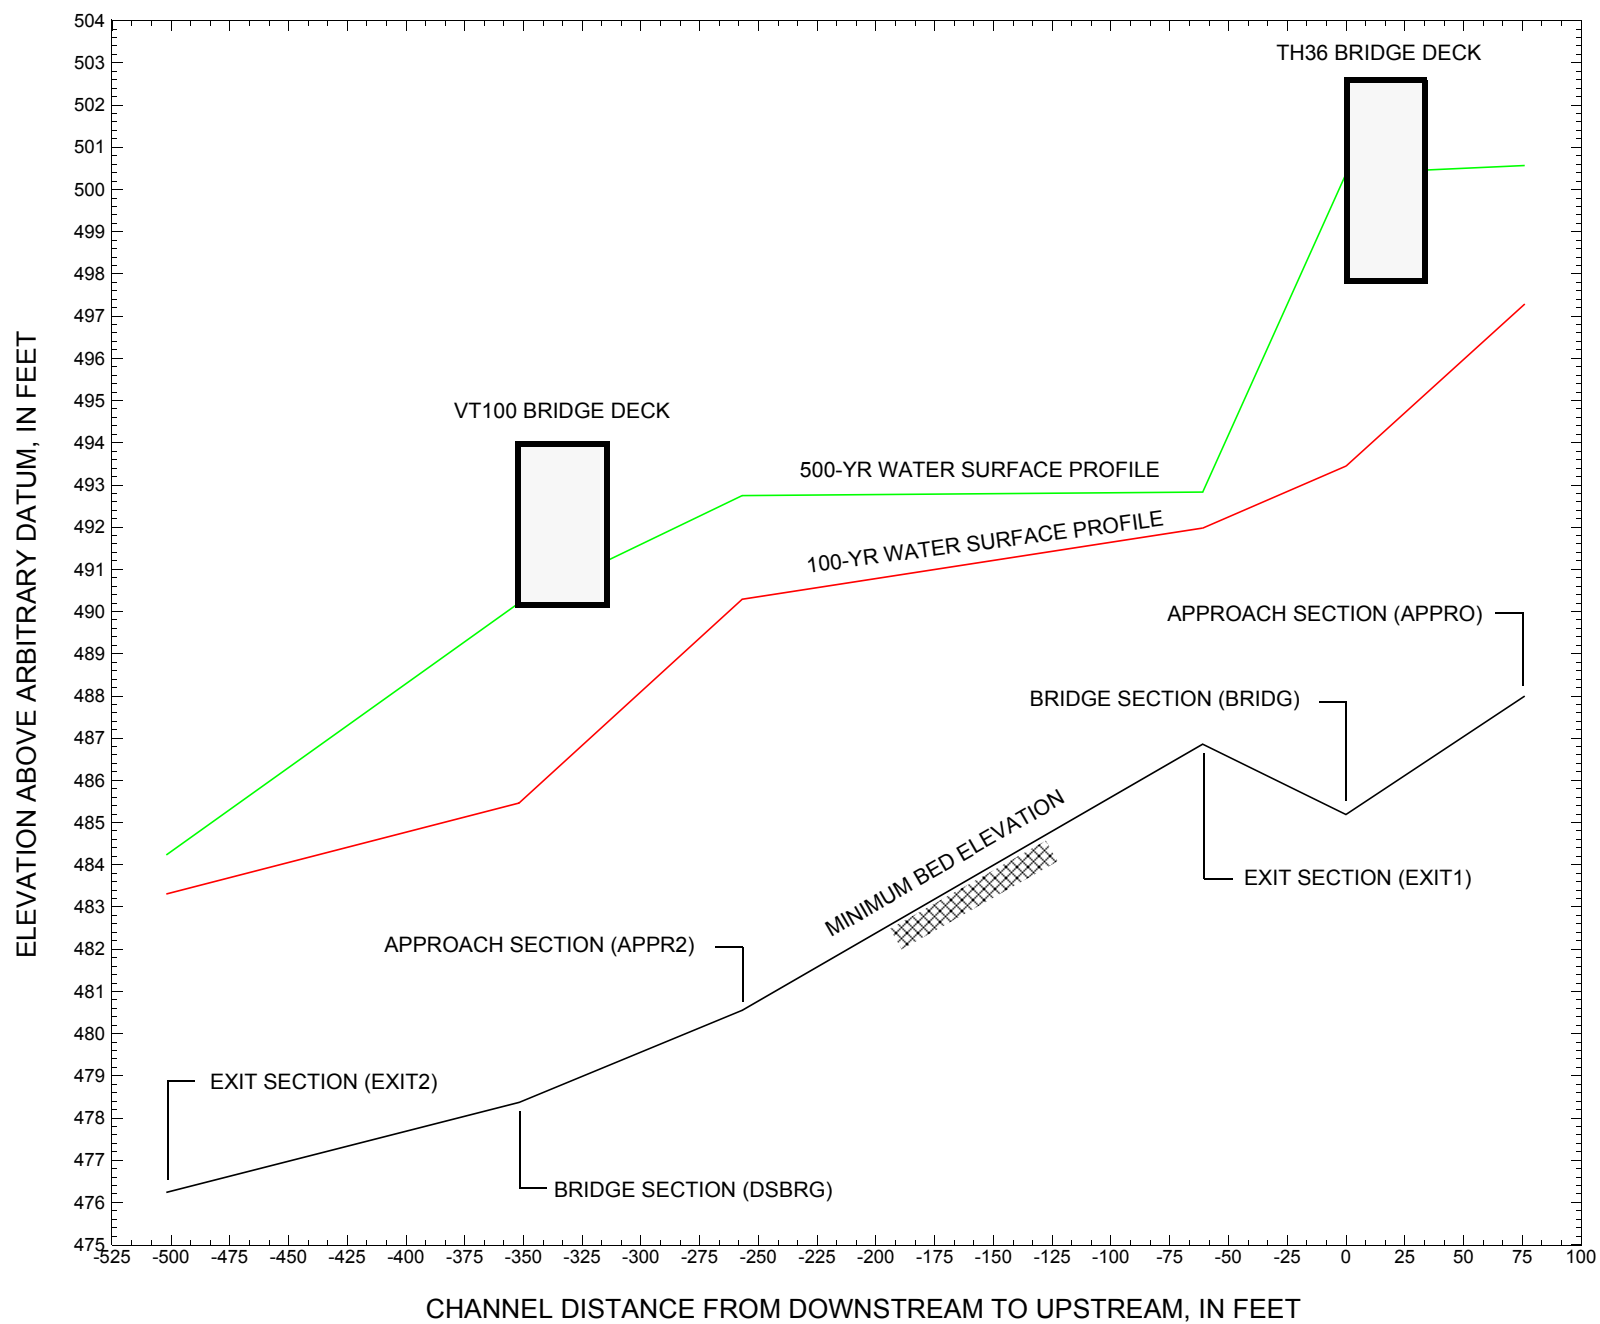
Figure 7. Water-surface profiles for the 100- and 500-yr discharges at structure REDSTH00360025 on Town Highway 36, crossing the West Branch Deerfield River, Readsboro, Vermont.

Hydraulic analyses of the reach were done by use of the Federal Highway Administration's WSPRO step-backwater computer program (Shearman and others, 1986, and Shearman, 1990). The analyses reported herein reflect conditions existing at the site at the time of the study. Furthermore, in the development of the model it was necessary to assume no accumulation of debris or ice at the site. Results of the hydraulic model are presented in the Bridge Hydraulic Summary, Appendix B, and figure 7.

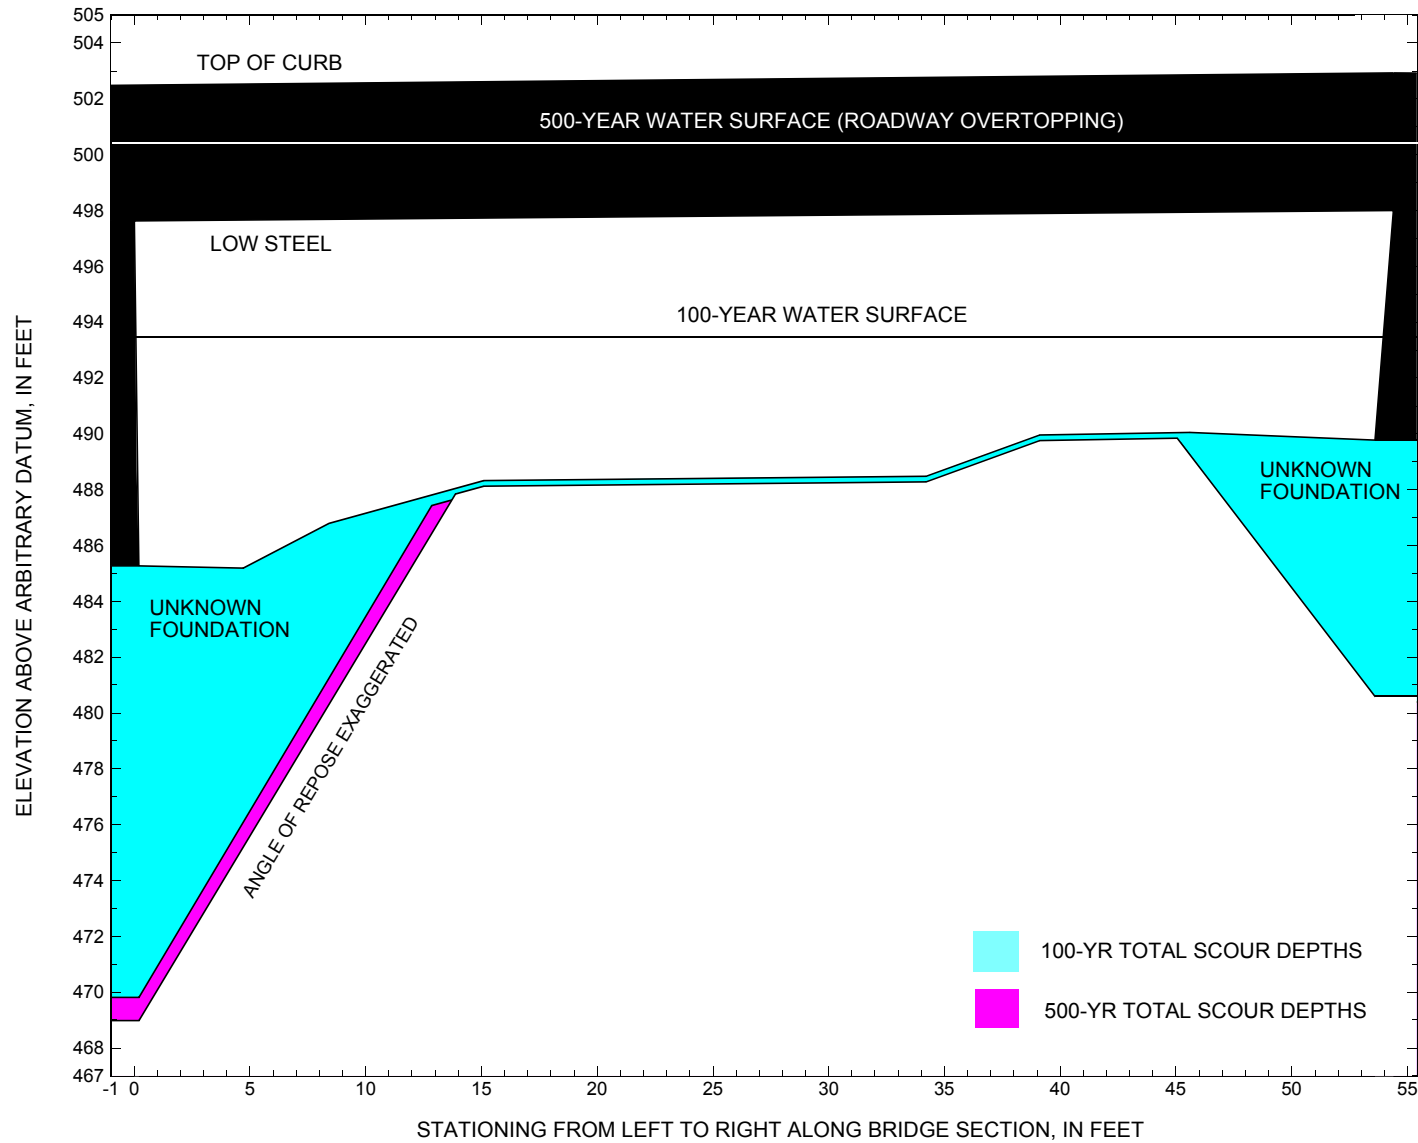
Figure 8. Scour elevations for the 100-yr and 500-yr discharges at structure REDSTH00360025 on Town Highway 36, crossing the West Branch Deerfield River, Readsboro, Vermont.

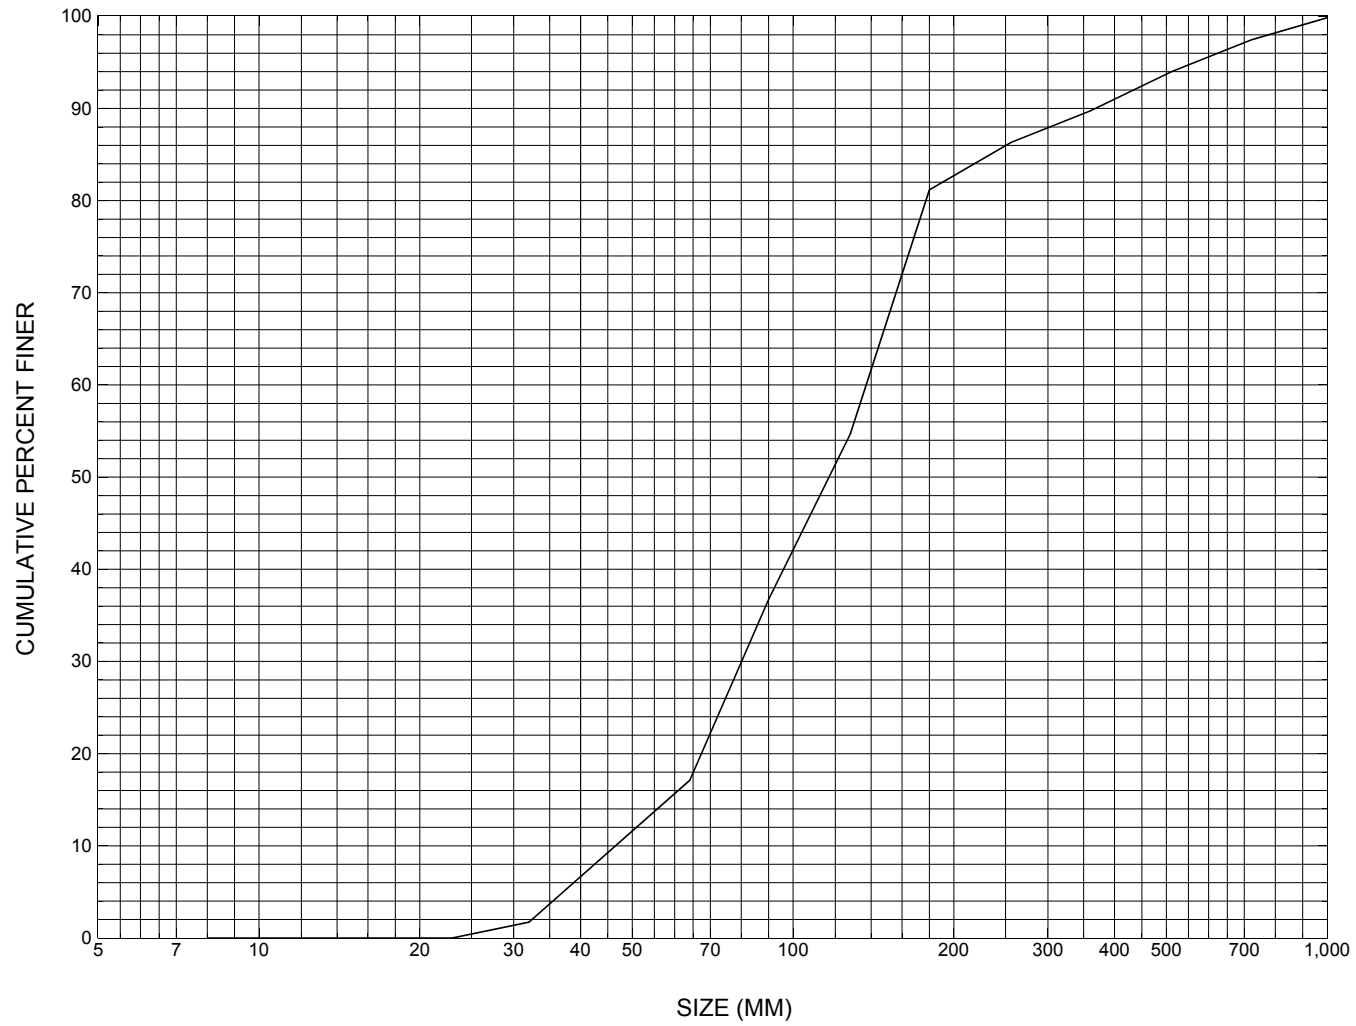
Appendix C. Bed material particle-size distribution for a pebble count in the channel approach of structure REDSTH00360025, in Readsboro, Vermont.
