LEVEL II SCOUR ANALYSIS FOR BRIDGE 17 (RIPTTH00180017) on TOWN HIGHWAY 18, crossing the SOUTH BRANCH MIDDLEBURY RIVER, RIPTON, VERMONT

Open-File Report 97-658

By RONDA L. BURNS AND LAURA MEDALIE

U.S. Geological Survey
Open-File Report 97-658

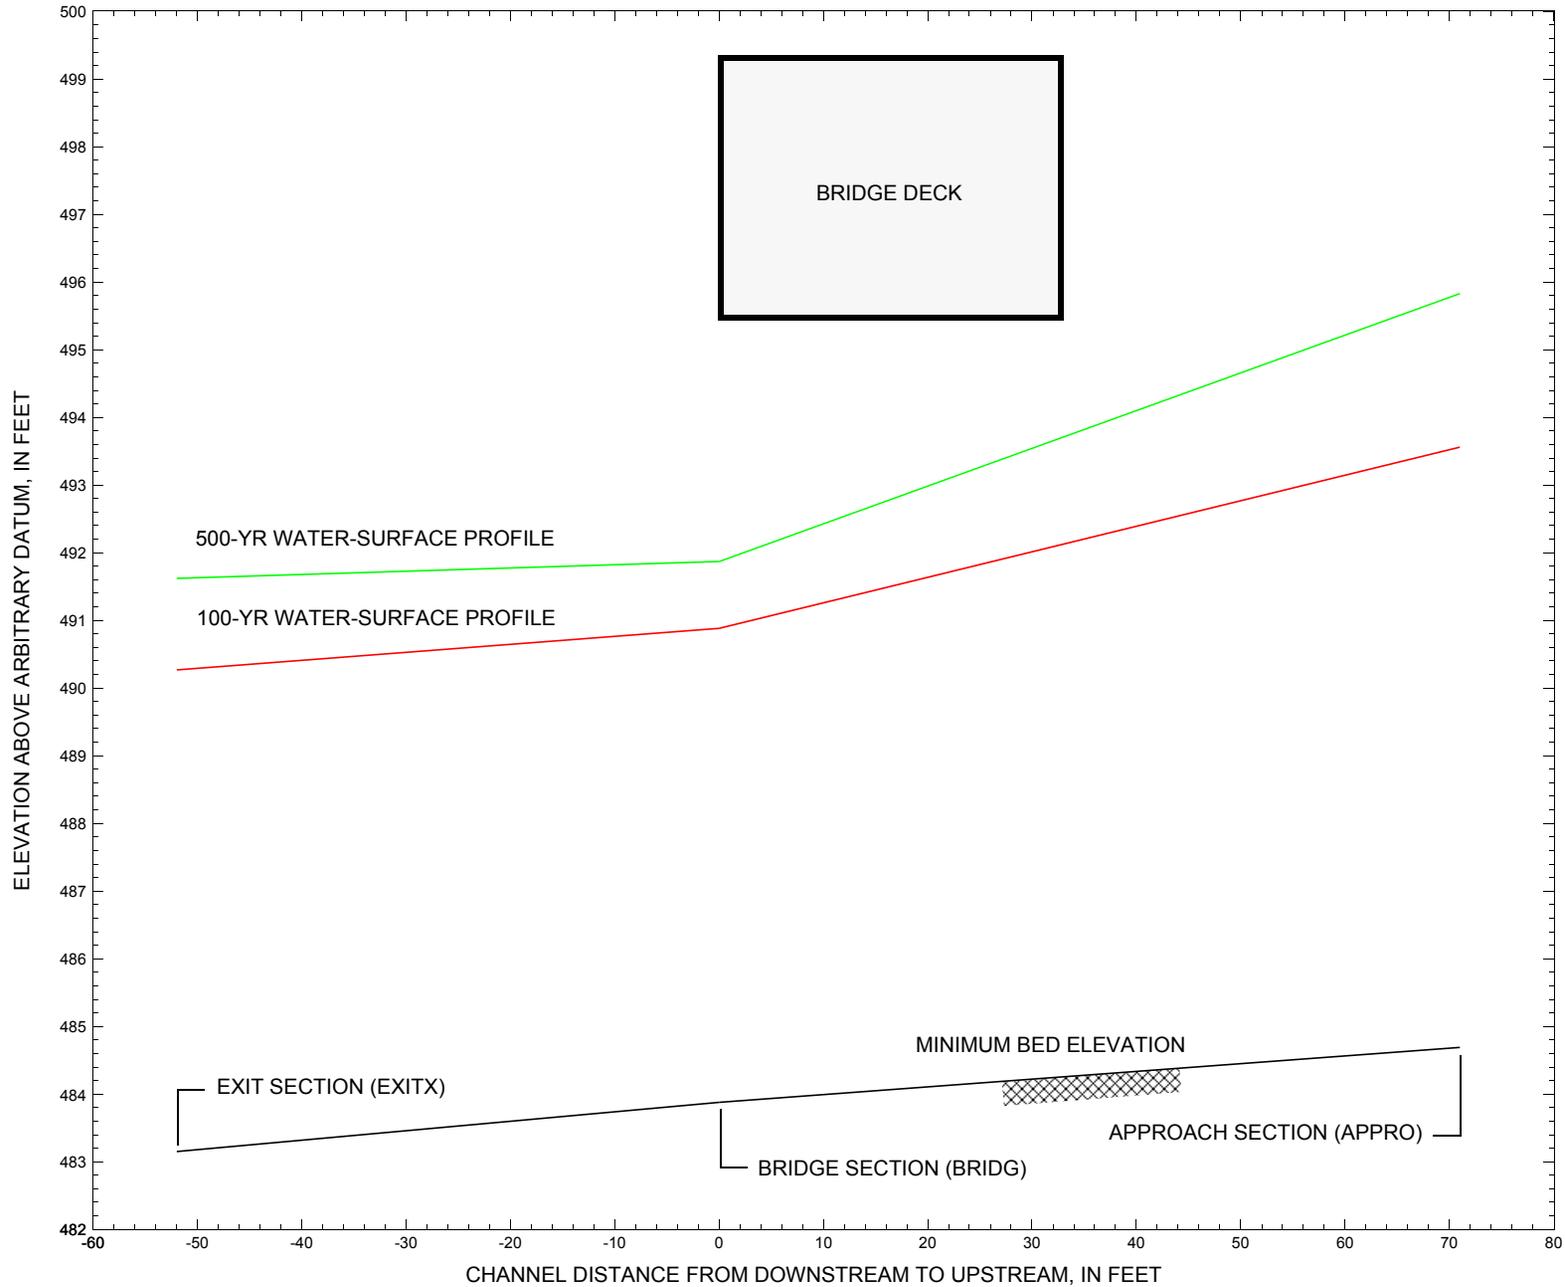
Figure 7. Water-surface profiles for the 100- and 500-yr discharges at structure RIPTTH00180017 on Town Highway 18, crossing the South Branch Middlebury River, Ripton, Vermont.

Hydraulic analyses of the reach were done by use of the Federal Highway Administration's WSPRO step-backwater computer program (Shearman and others, 1986, and Shearman, 1990). The analyses reported herein reflect conditions existing at the site at the time of the study. Furthermore, in the development of the model it was necessary to assume no accumulation of debris or ice at the site. Results of the hydraulic model are presented in the Bridge Hydraulic Summary, Appendix B, and figure 7.

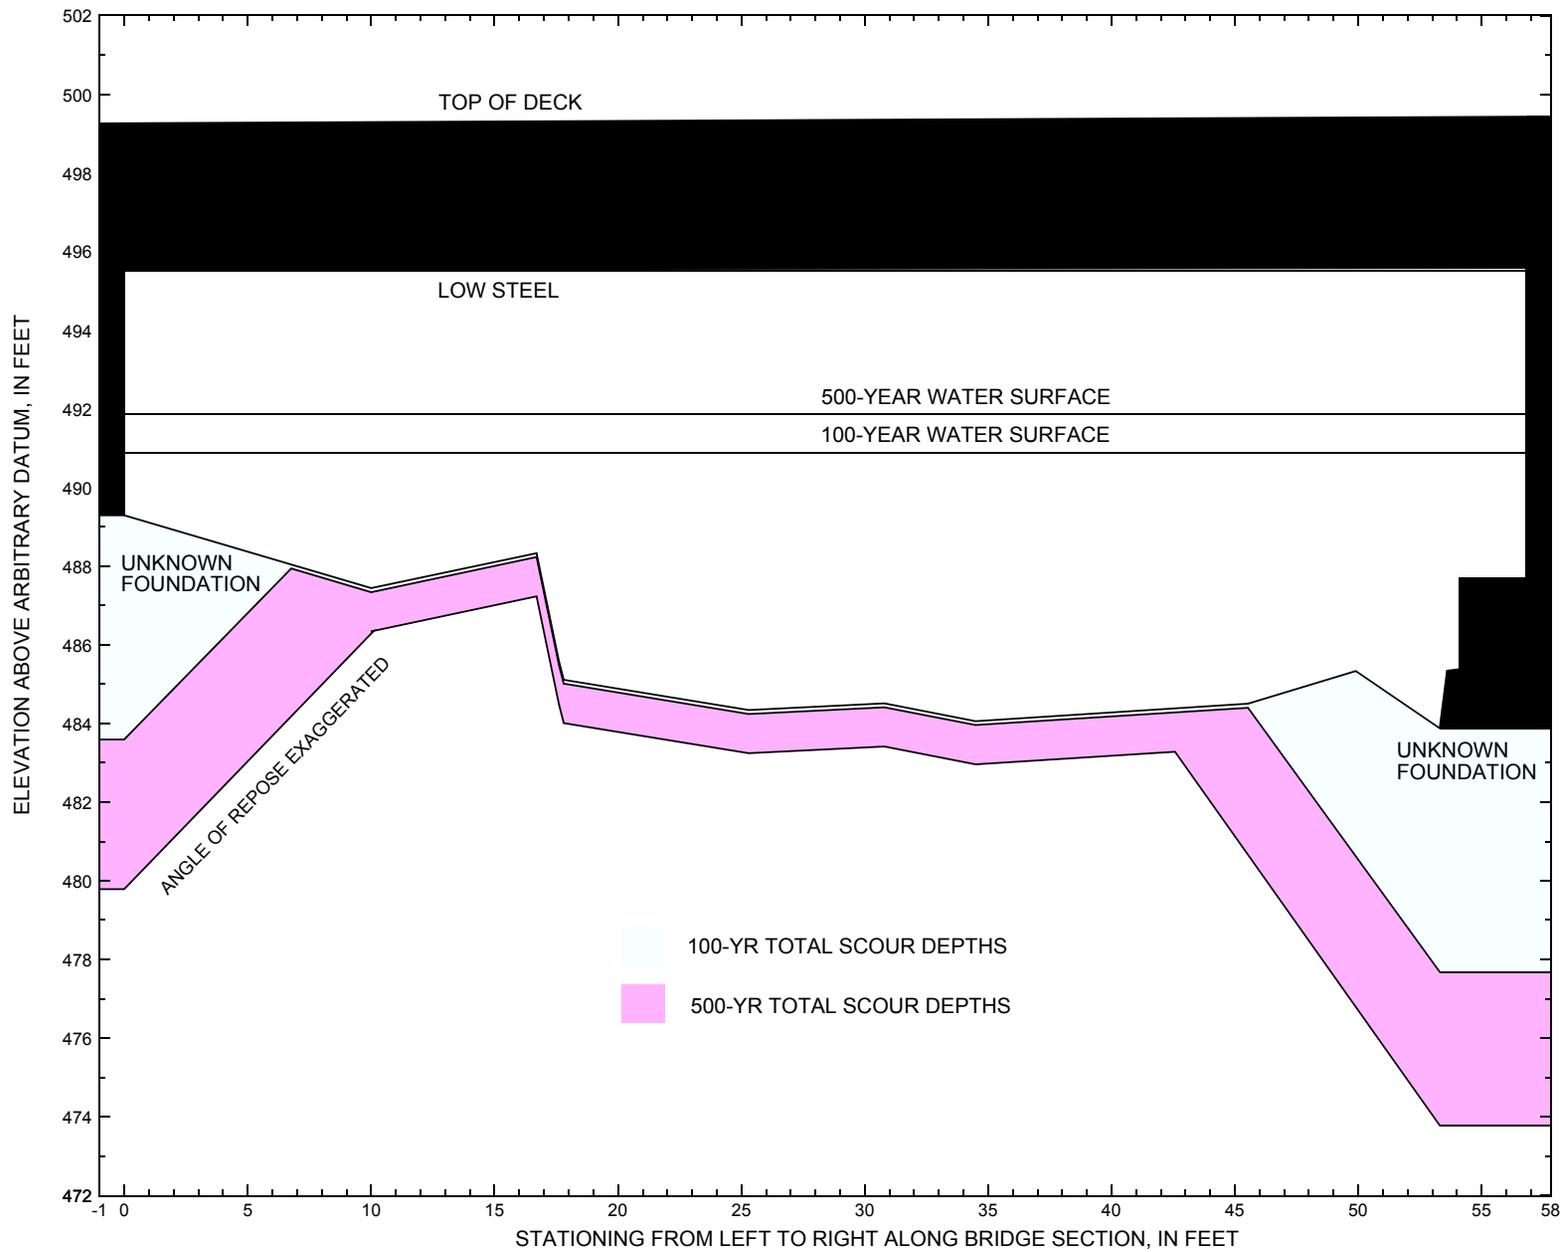
Figure 8. Scour elevations for the 100-yr and 500-yr discharges at structure RIPTTH00180017 on Town Highway 18, crossing the South Branch Middlebury River, Ripton, Vermont.

Contraction scour for all modelled flows ranged from 0.1 to 1.1 ft. The worst-case contraction scour occurred at the 500-year discharge. Abutment scour ranged from 5.6 to 9.0 ft. The worst-case abutment scour occurred at the 500-year discharge. Additional information on scour depths and depths to armoring are included in the section titled "Scour Results". Scoured-streambed elevations, based on the calculated scour depths, are presented in tables 1 and 2. A cross-section of the scour computed at the bridge is presented in figure 8. Scour depths were calculated assuming an infinite depth of erosive material and a homogeneous particle-size distribution.

Scour depths were computed using the general guidelines described in Hydraulic Engineering Circular 18 (Richardson and others, 1995). Scour depths were calculated assuming an infinite depth of erosive material and a homogeneous particle-size distribution. However, bedrock is exposed across the channel immediately downstream of the bridge. The results of the scour analysis are presented in tables 1 and 2 and a graph of the scour depths is presented in figure 8.

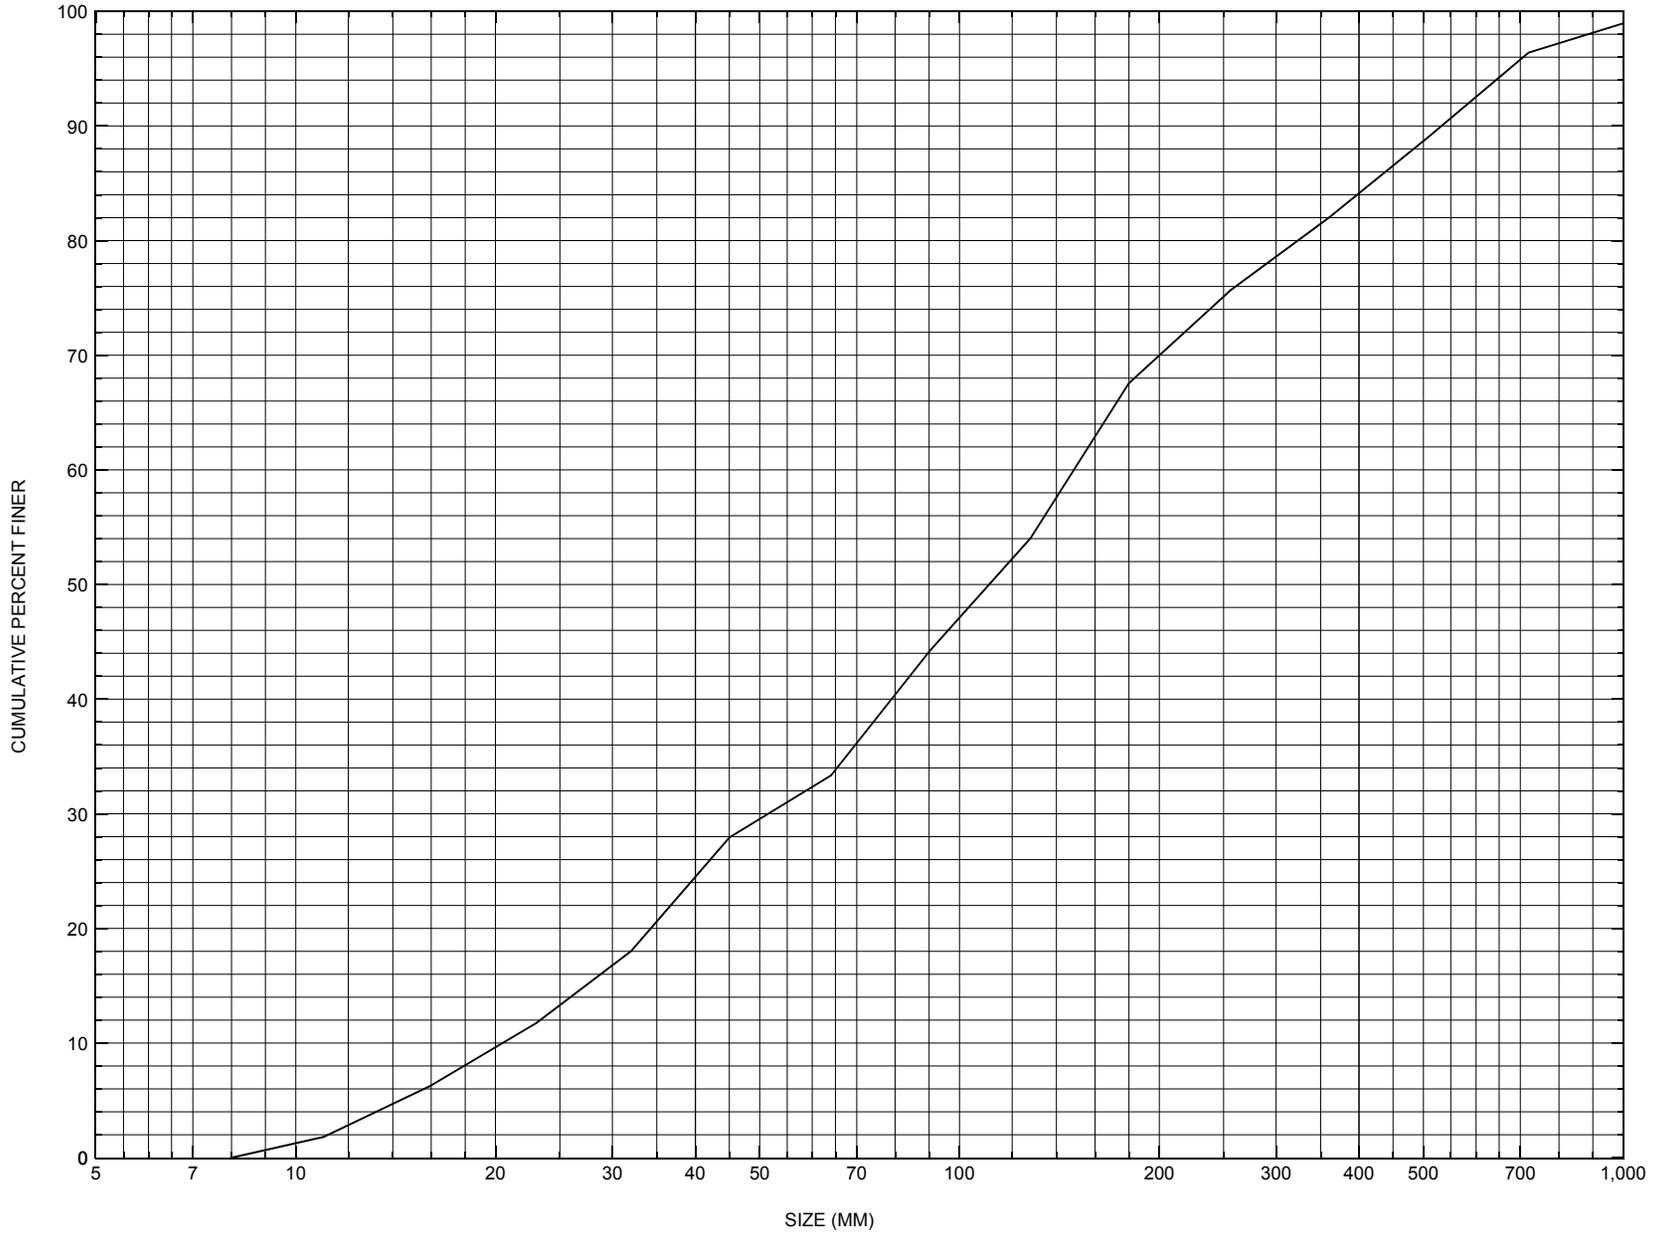
Appendix C. Bed material particle-size distribution for a pebble count in the channel approach of structure RIPTTH00180017, in Ripton, Vermont.
