LEVEL II SCOUR ANALYSIS FOR
BRIDGE 17 (LYNDTH00020017) on
TOWN HIGHWAY 2, crossing
HAWKINS BROOK,
LYNDON, VERMONT

Open-File Report 97-752

Prepared in cooperation with
VERMONT AGENCY OF TRANSPORTATION
and
FEDERAL HIGHWAY ADMINISTRATION

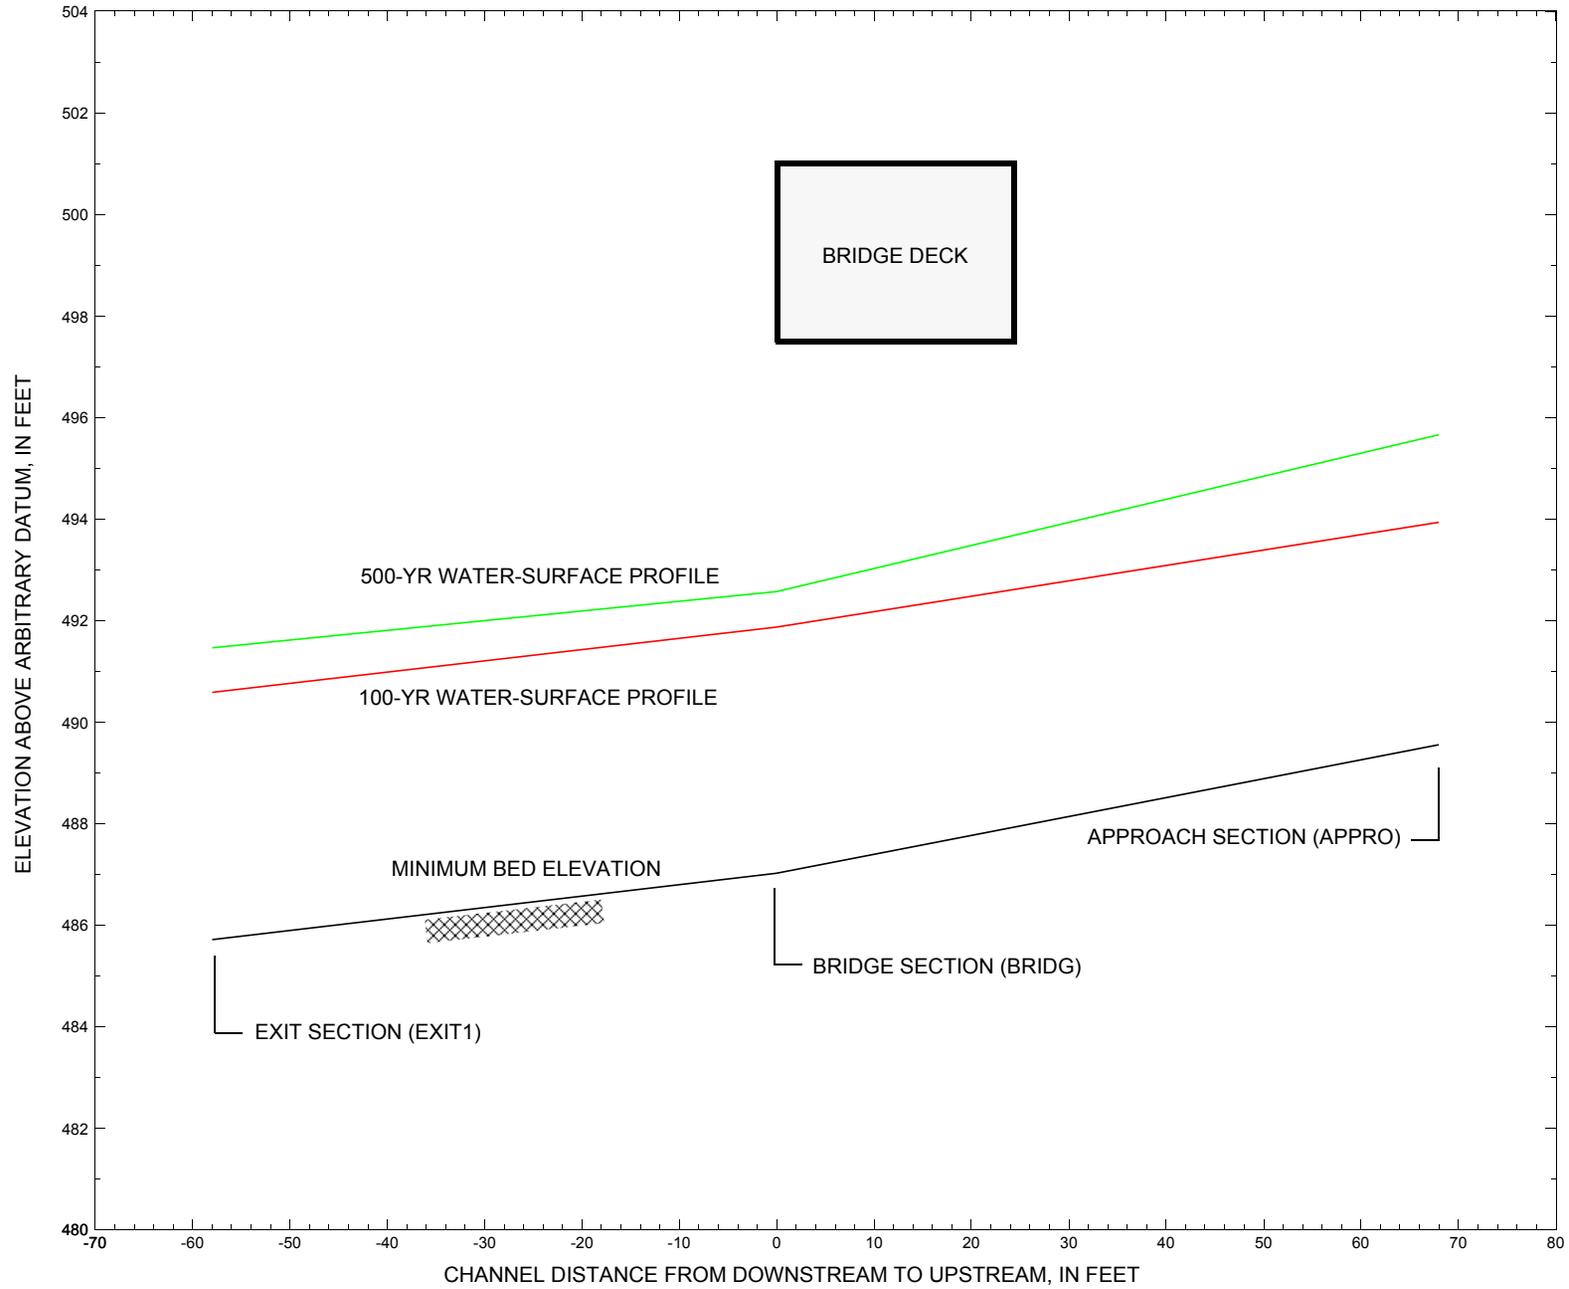
Figure 7. Water-surface profiles for the 100- and 500-yr discharges at structure LYNDTH00020017 on Town Highway 2, crossing Hawkins Brook, Lyndon, Vermont.

Hydraulic analyses of the reach were done by use of the Federal Highway Administration's WSPRO step-backwater computer program (Shearman and others, 1986, and Shearman, 1990). The analyses reported herein reflect conditions existing at the site at the time of the study. Furthermore, in the development of the model it was necessary to assume no accumulation of debris or ice at the site. Results of the hydraulic model are presented in the Bridge Hydraulic Summary, Appendix B, and figure 7.

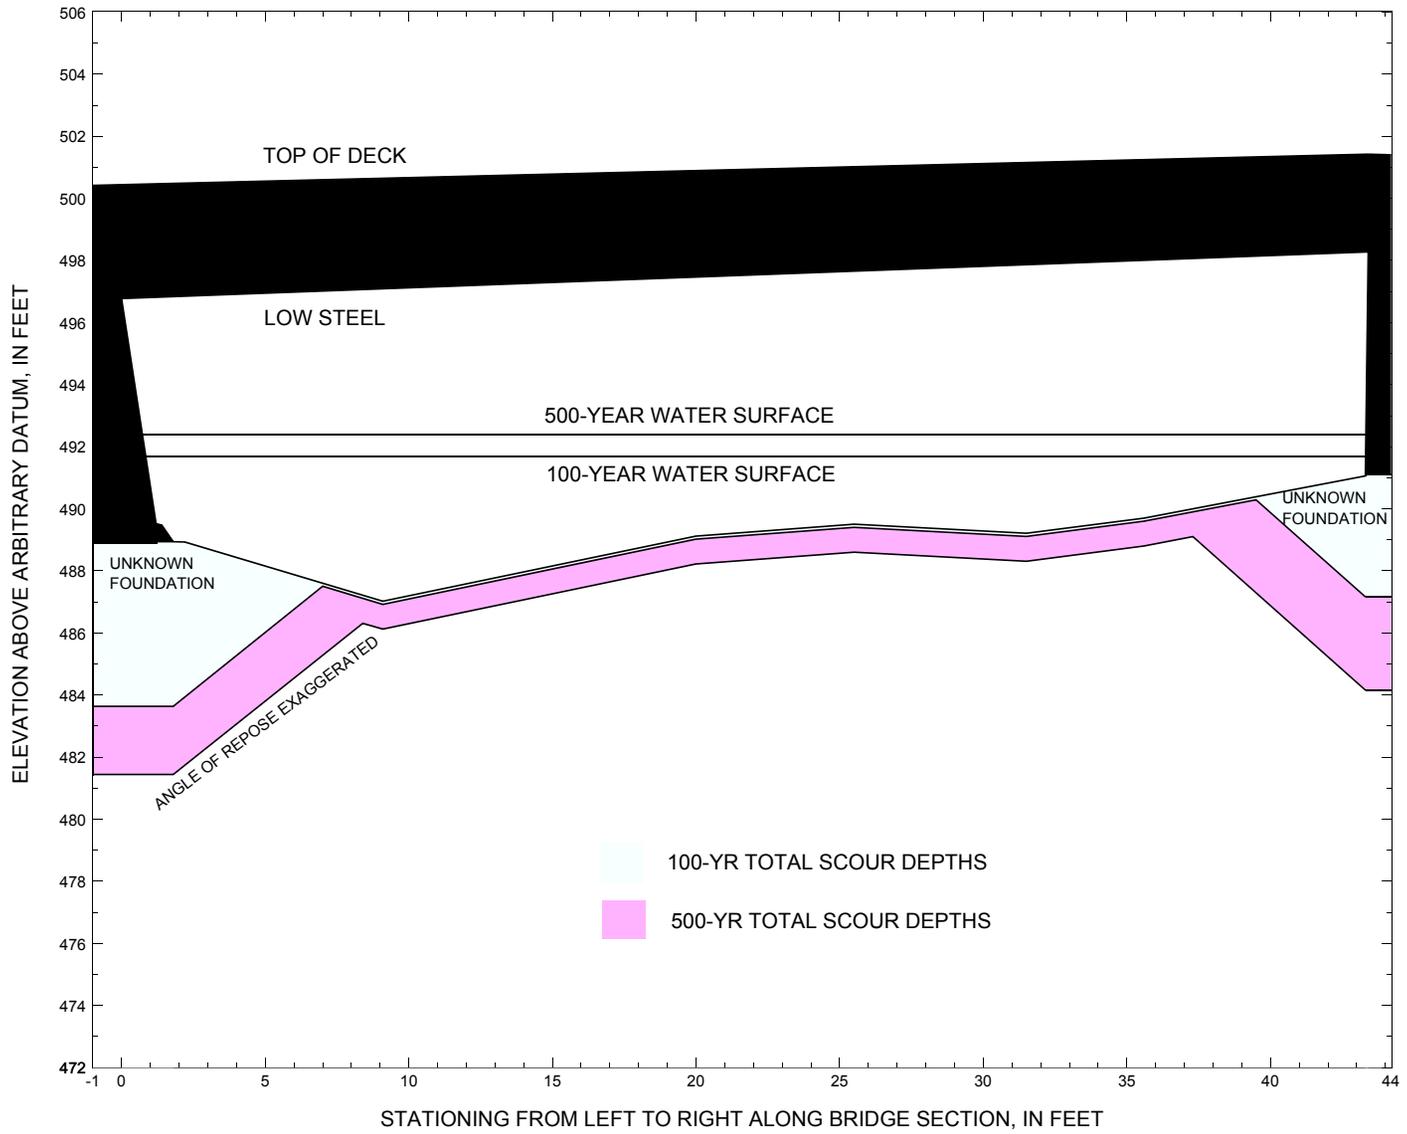
Figure 8. Scour elevations for the 100-yr and 500-yr discharges at structure LYNDTH00020017 on Town Highway 2, crossing Hawkins Brook, Lyndon, Vermont.

Scour depths were computed using the general guidelines described in Hydraulic Engineering Circular 18 (Richardson and others, 1995). Scour depths were calculated assuming an infinite depth of erosive material and a homogeneous particle-size distribution. The results of the scour analysis are presented in tables 1 and 2 and a graph of the scour depths is presented in figure 8.

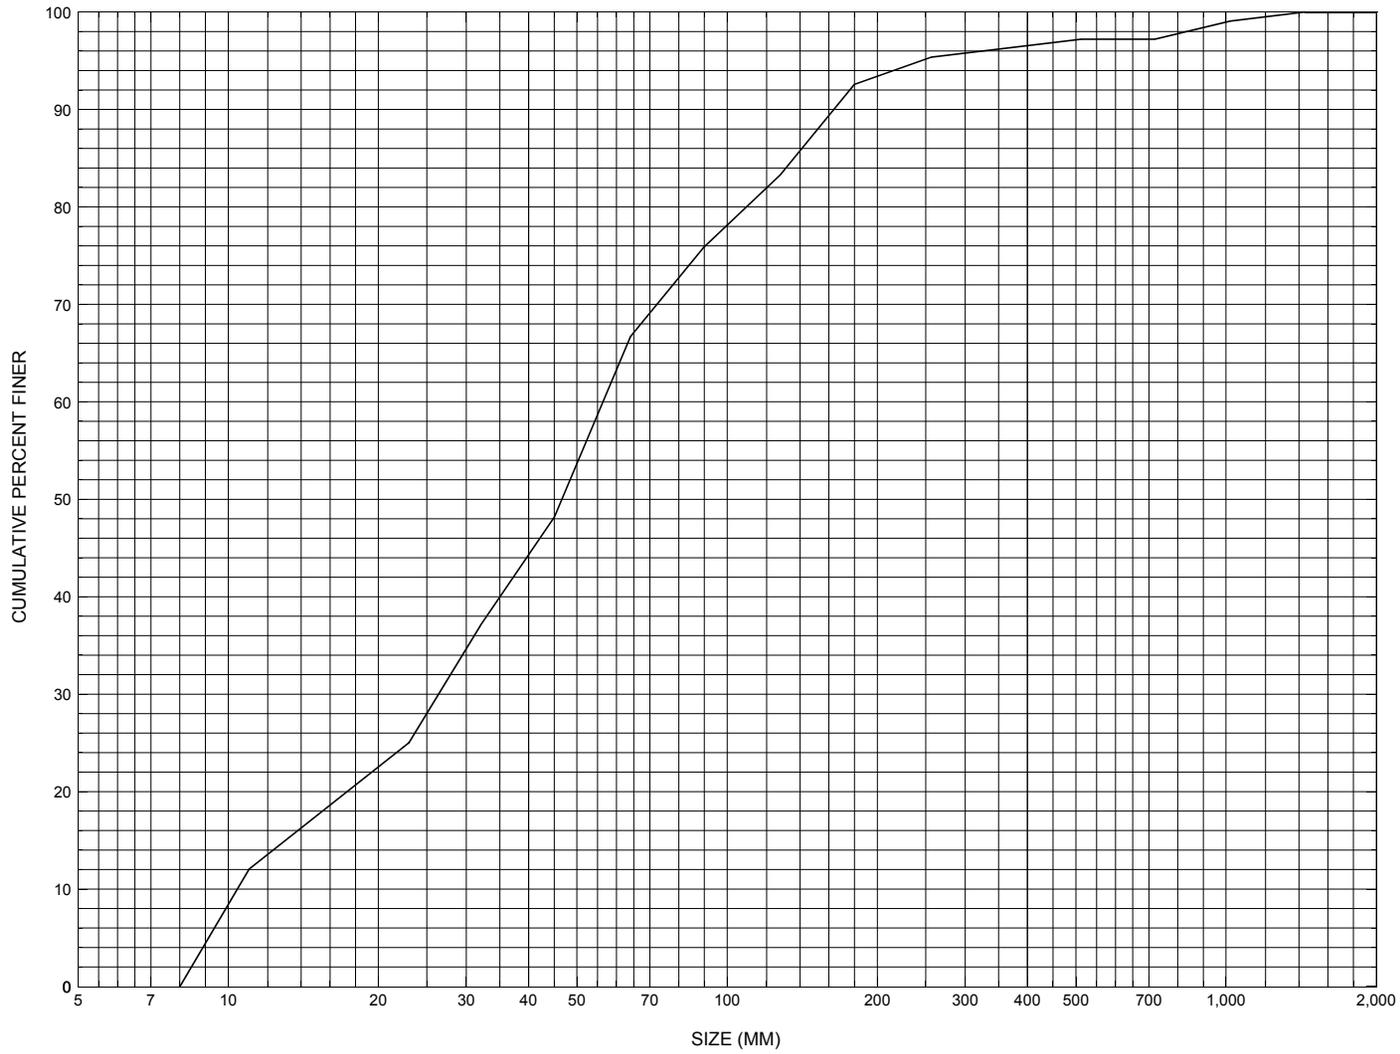
Appendix C. Bed material particle-size distribution for a pebble count in the channel approach of structure LYNDTH00020017, in Lyndon, Vermont.
