LEVEL II SCOUR ANALYSIS FOR BRIDGE 45 (BRNETH00070045) on TOWN HIGHWAY 7, crossing the STEVENS RIVER, BARNET, VERMONT

Open-File Report 97-753

U.S. Geological Survey
Open-File Report 97-753

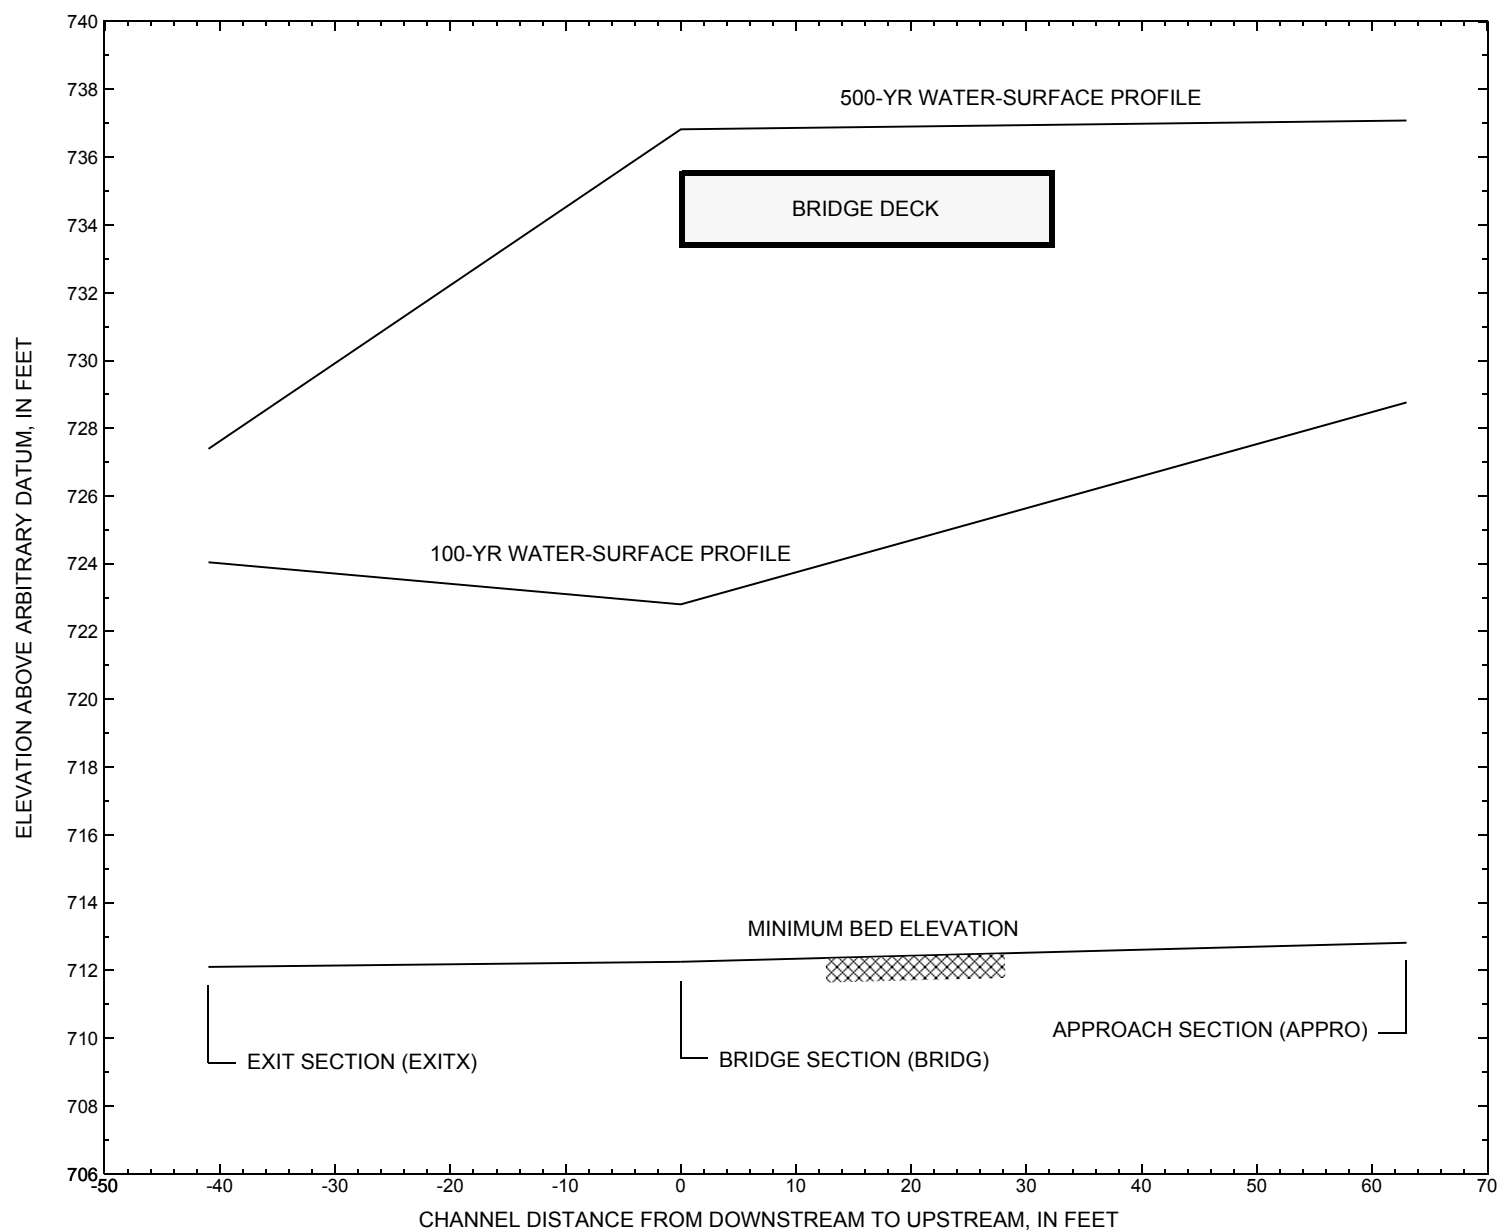
Figure 7. Water-surface profiles for the 100- and 500-yr discharges at structure BRNETH00070045 on Town Highway 7, crossing the Stevens River, Barnet, Vermont.

Hydraulic analyses of the reach were done by use of the Federal Highway Administration's WSPRO step-backwater computer program (Shearman and others, 1986, and Shearman, 1990). The analyses reported herein reflect conditions existing at the site at the time of the study. Furthermore, in the development of the model it was necessary to assume no accumulation of debris or ice at the site. Results of the hydraulic model are presented in the Bridge Hydraulic Summary, Appendix B, and figure 7.

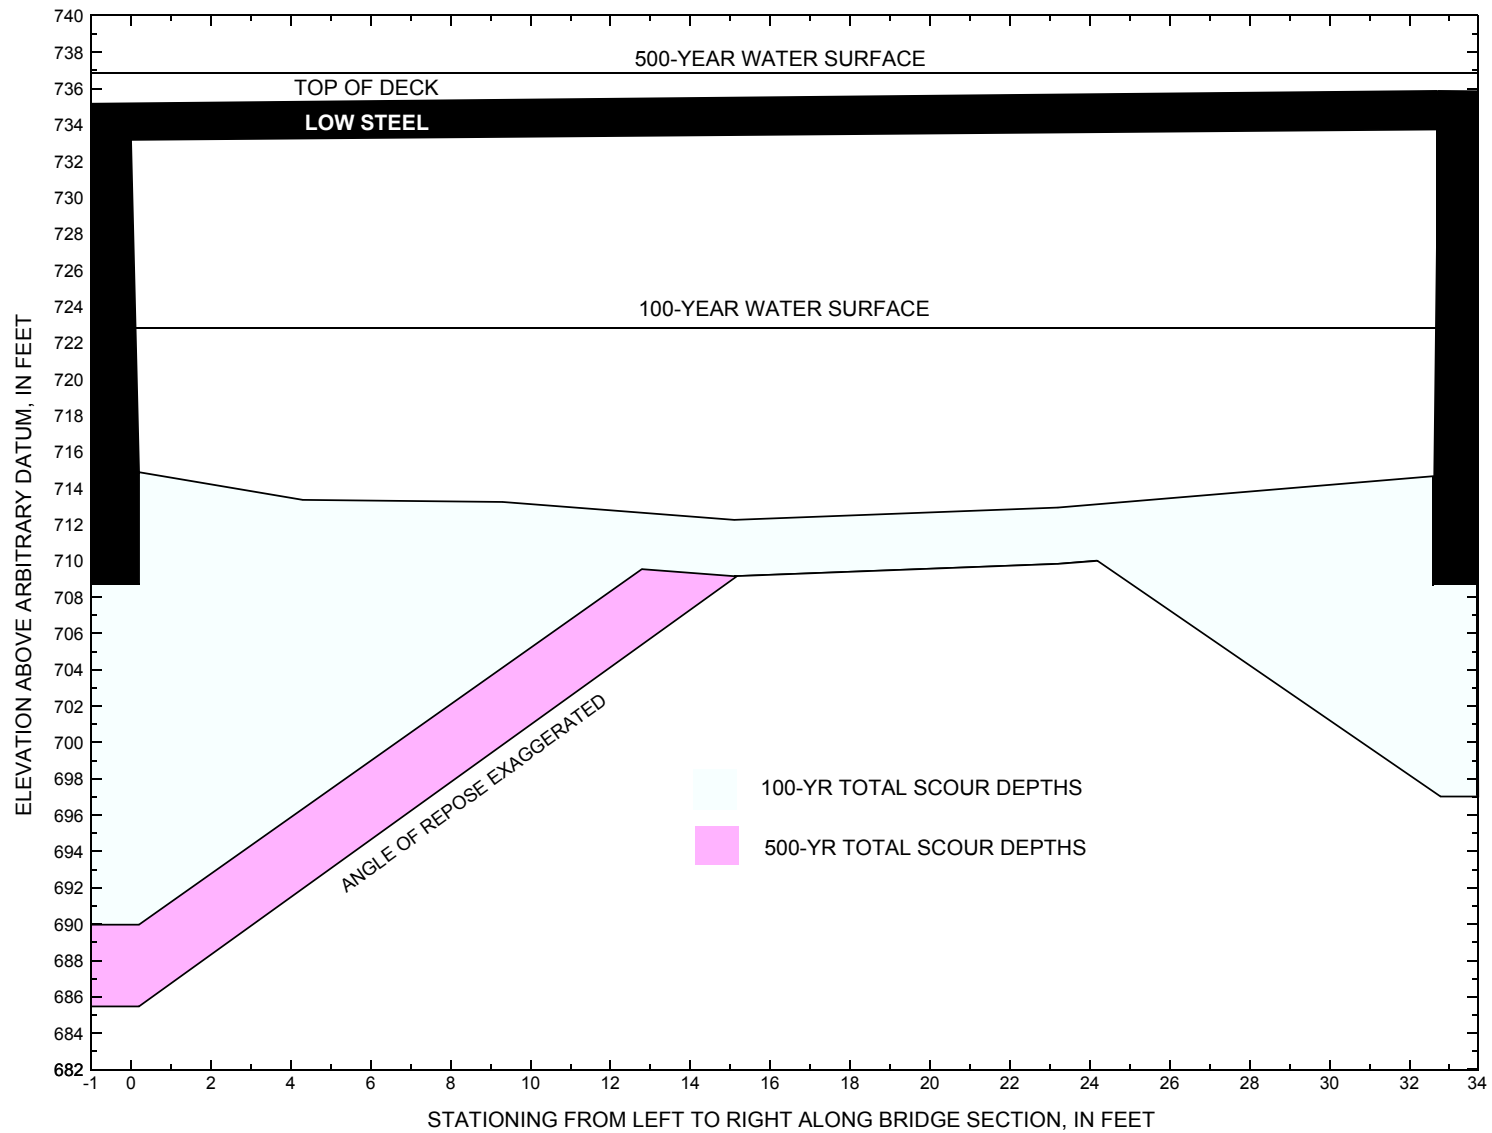
Figure 8. Scour elevations for the 100-yr and 500-yr discharges at structure BRNETH00070045 on Town Highway 7, crossing the Stevens River, Barnet, Vermont.

Scour depths were computed using the general guidelines described in Hydraulic Engineering Circular 18 (Richardson and others, 1995). Scour depths were calculated assuming an infinite depth of erosive material and a homogeneous particle-size distribution. The results of the scour analysis are presented in tables 1 and 2 and a graph of the scour depths is presented in figure 8.

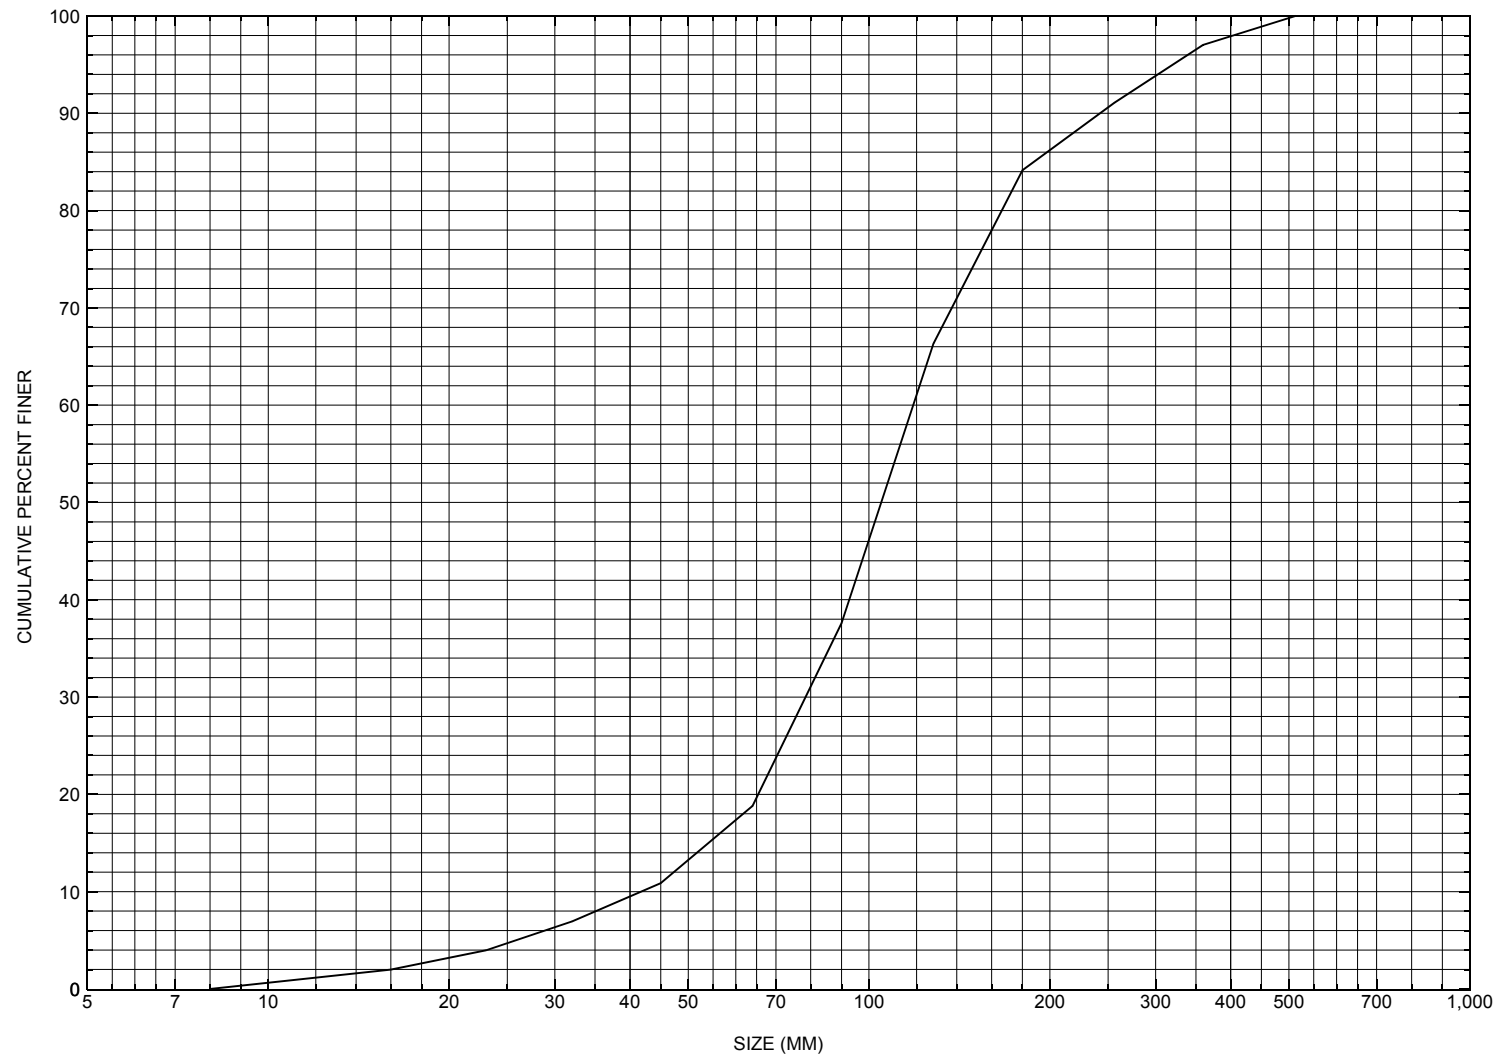
Appendix C. Bed material particle-size distribution for a pebble count in the channel approach of structure BRNETH00070045, in Barnet, Vermont.
