LEVEL II SCOUR ANALYSIS FOR
BRIDGE 20 (BRISTH00270020) on
TOWN HIGHWAY 27, crossing
LITTLE NOTCH BROOK,
BRISTOL, VERMONT

Open-File Report 97-756

Prepared in cooperation with
VERMONT AGENCY OF TRANSPORTATION
and
FEDERAL HIGHWAY ADMINISTRATION

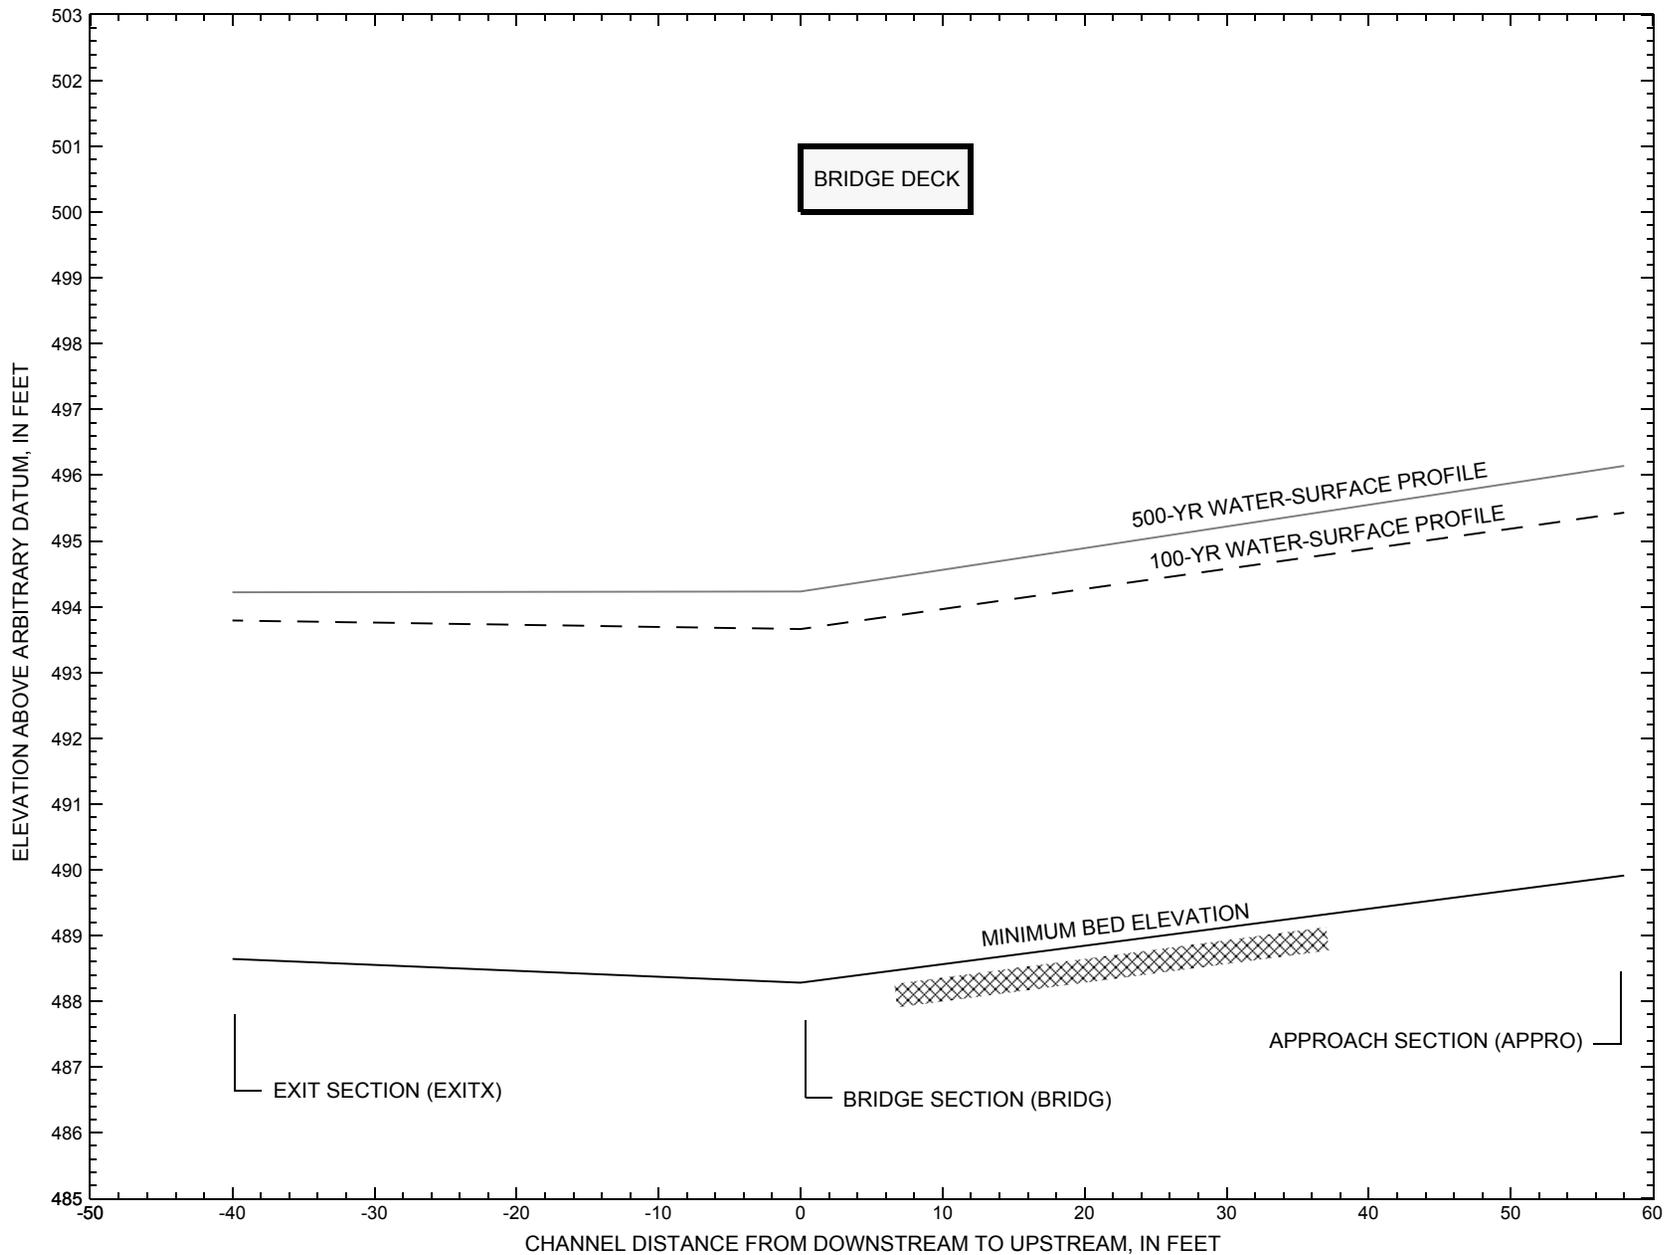
Figure 7. Water-surface profiles for the 100- and 500-yr discharges at structure BRISTH00270020 on Town Highway 27, crossing Little Notch Brook, Bristol, Vermont.

Hydraulic analyses of the reach were done by use of the Federal Highway Administration's WSPRO step-backwater computer program (Shearman and others, 1986, and Shearman, 1990). The analyses reported herein reflect conditions existing at the site at the time of the study. Furthermore, in the development of the model it was necessary to assume no accumulation of debris or ice at the site. Results of the hydraulic model are presented in the Bridge Hydraulic Summary, Appendix B, and figure 7.

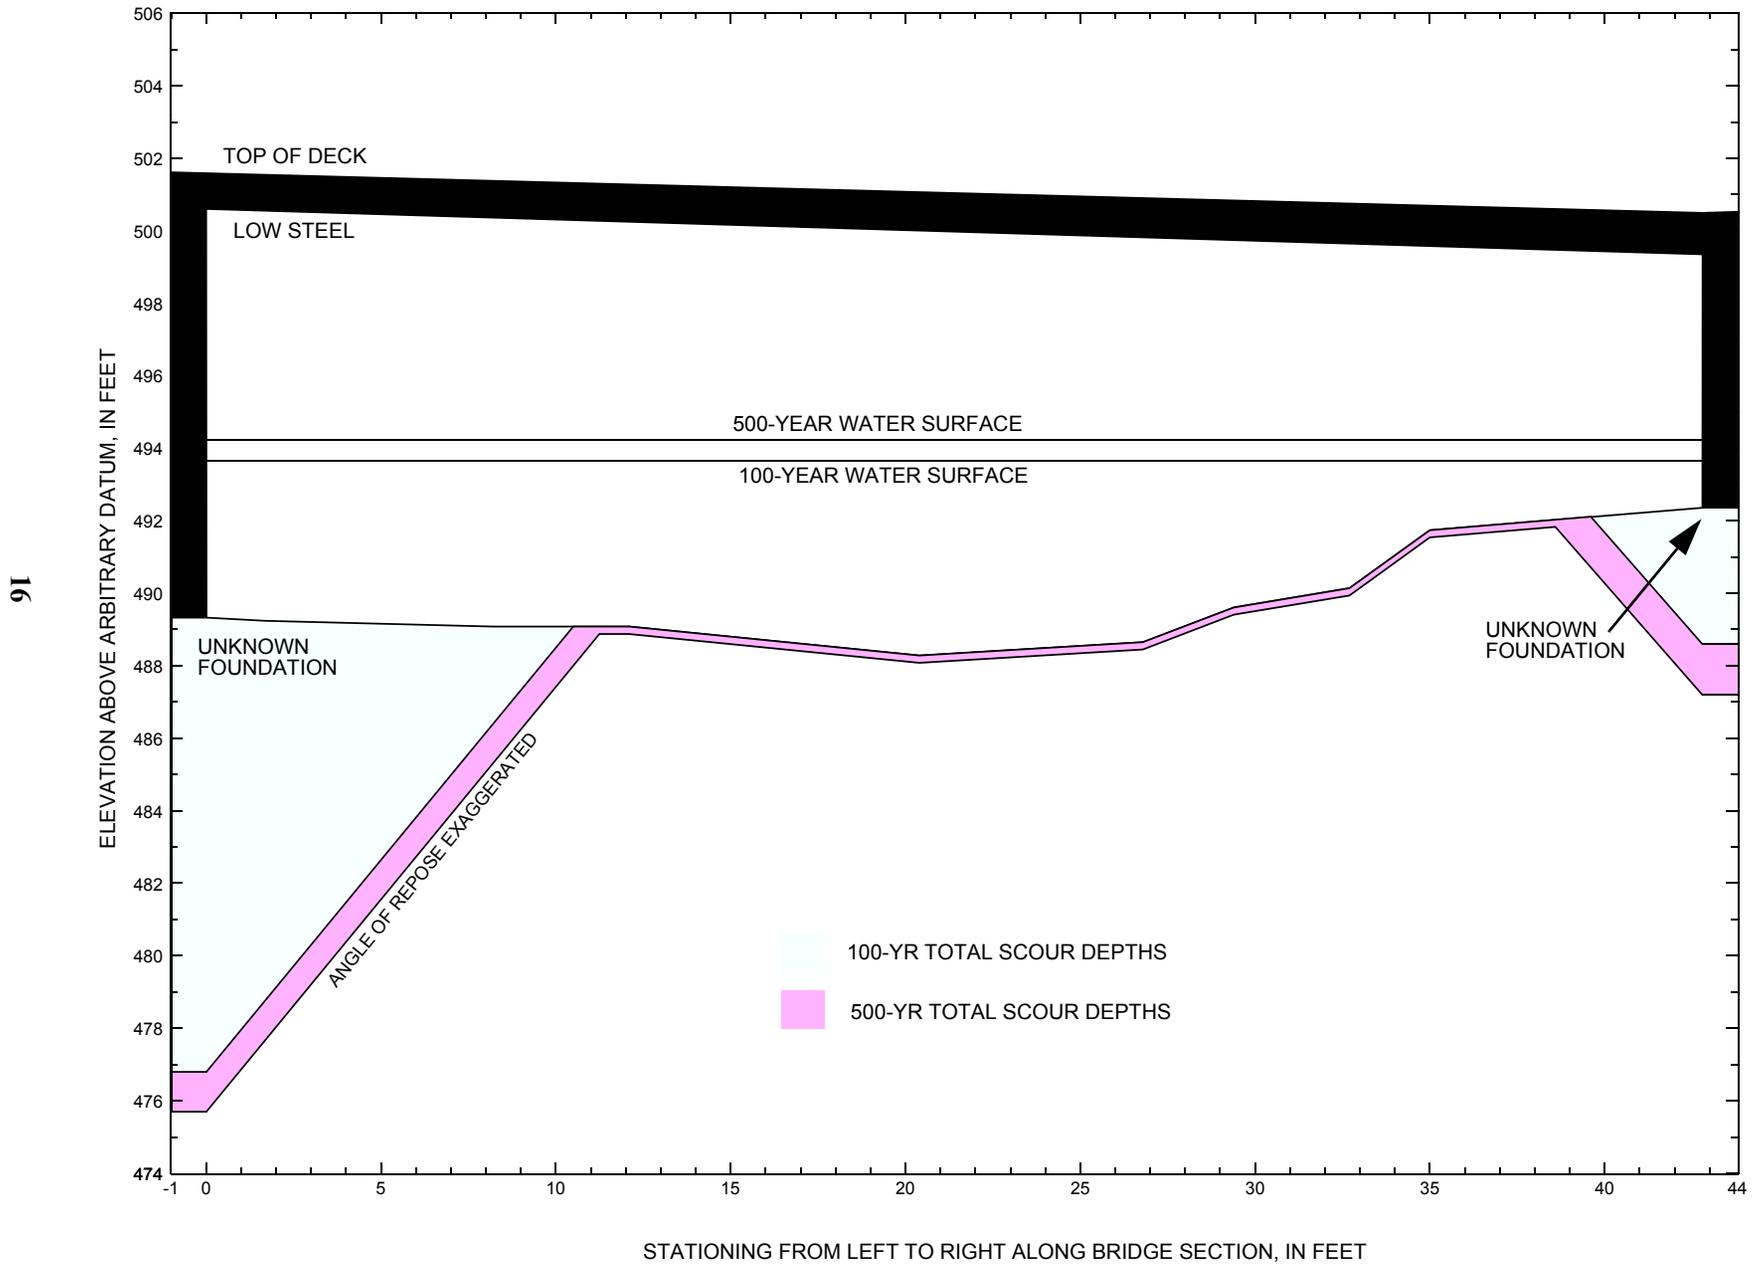
Figure 8. Scour elevations for the 100-yr and 500-yr discharges at structure BRISTH00270020 on Town Highway 27, crossing Little Notch Brook, Bristol, Vermont.

Scour depths were computed using the general guidelines described in Hydraulic Engineering Circular 18 (Richardson and others, 1995). Scour depths were calculated assuming an infinite depth of erosive material and a homogeneous particle-size distribution. The results of the scour analysis are presented in tables 1 and 2 and a graph of the scour depths is presented in figure 8.

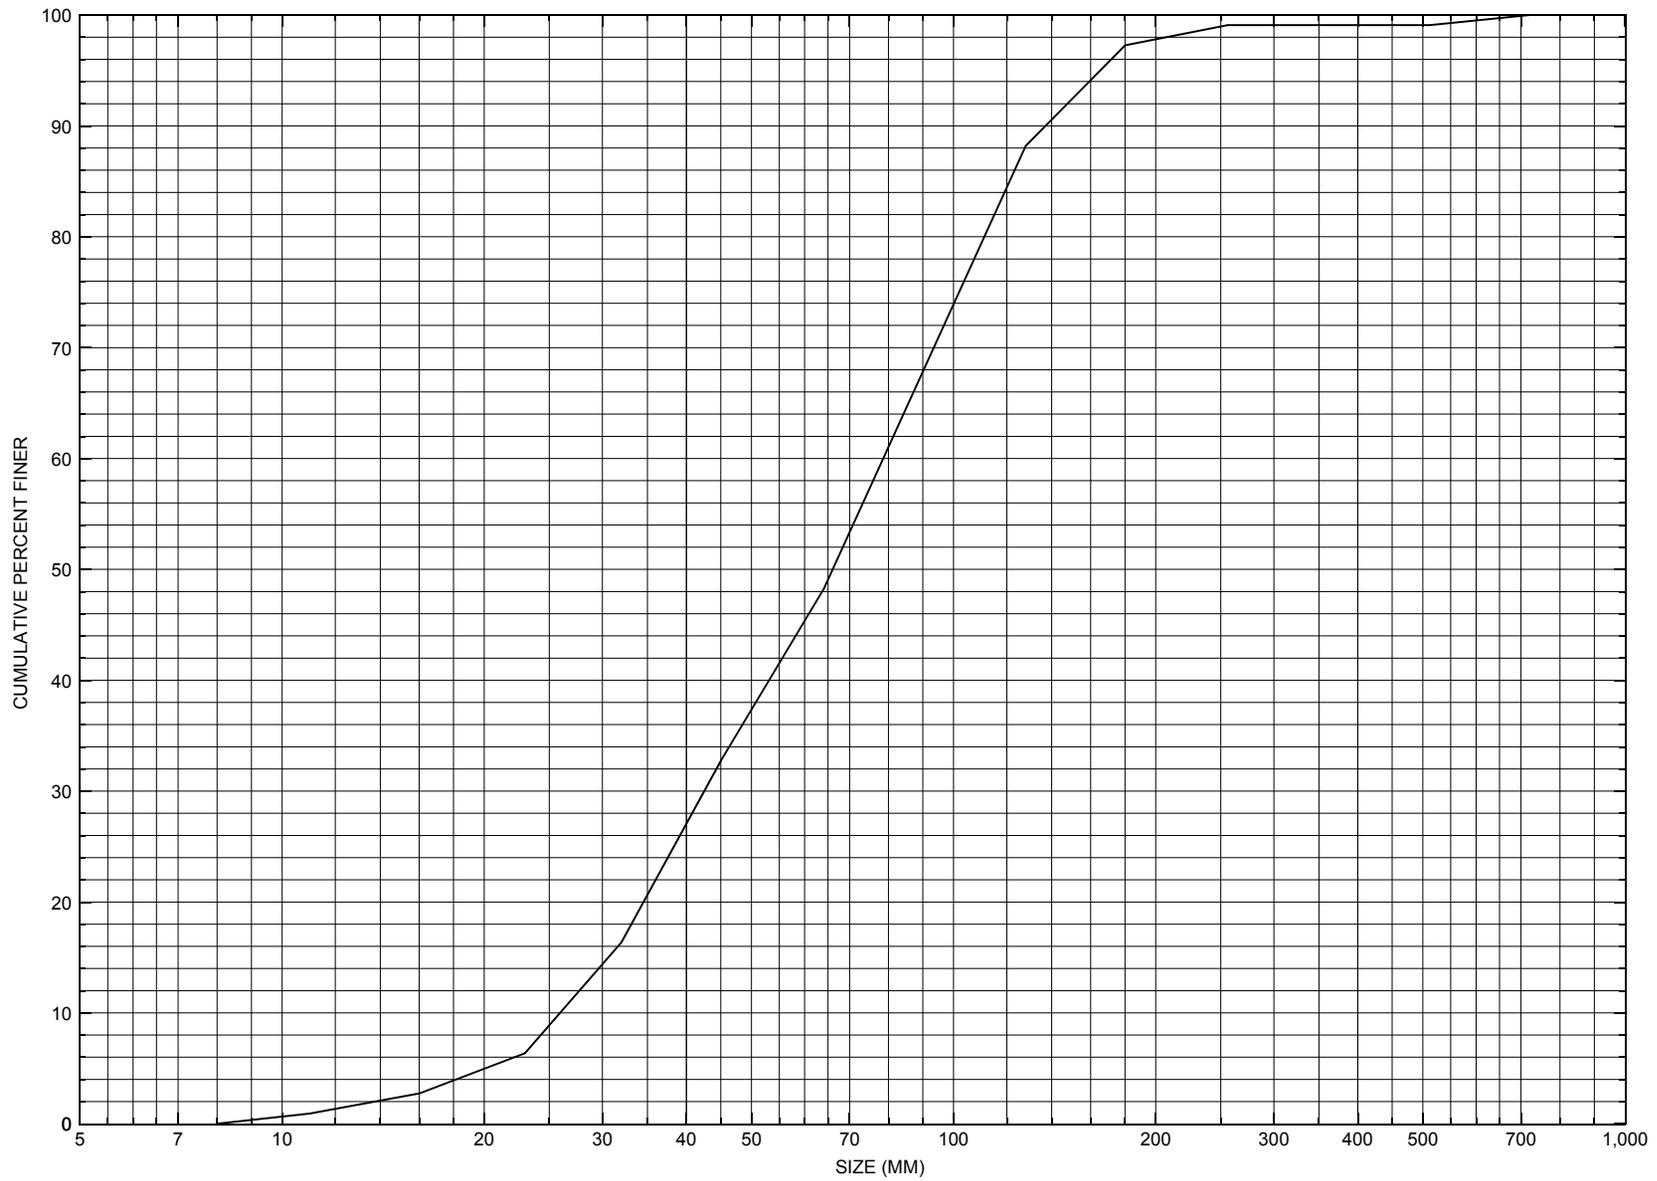
Appendix C. Bed material particle-size distribution for a pebble count in the channel approach of structure BRISTH00270020, in Bristol, Vermont.
