# Physical and Geomorphological Measurements for Selected River Segments in the Carson and Truckee River Basins, Nevada and California, 1993-96

Open-File Report 97-764

Prepared as part of the  
NATIONAL WATER-QUALITY ASSESSMENT PROGRAM

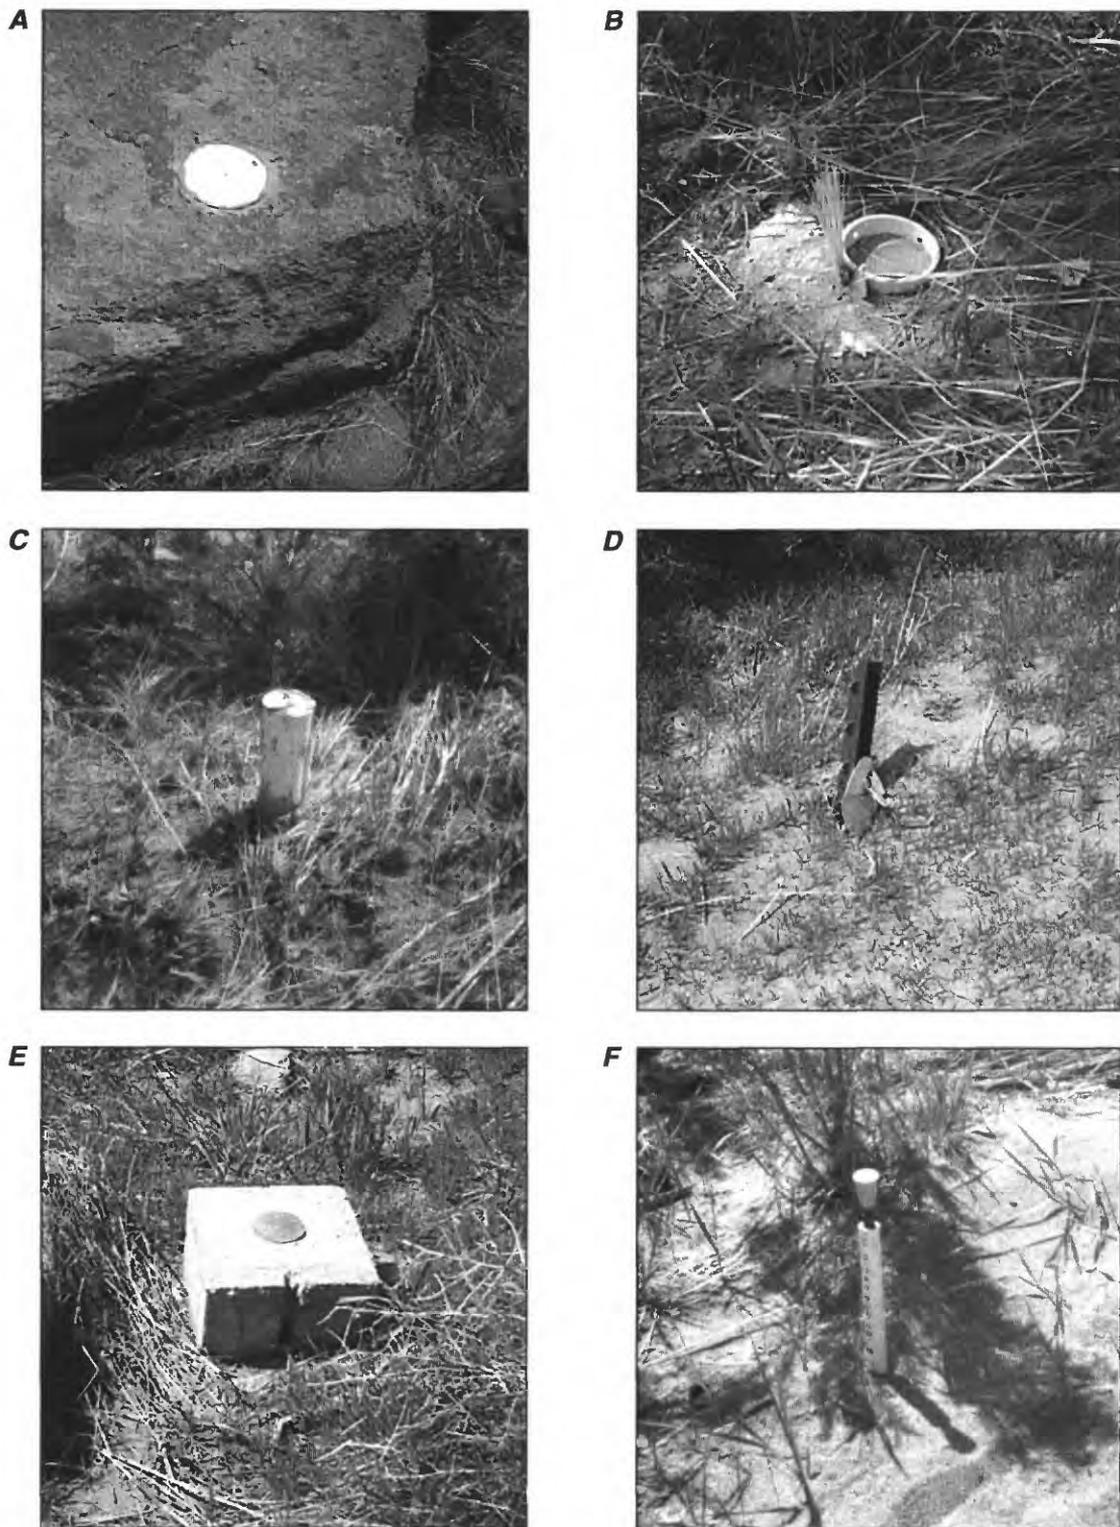
**Figure 2.** Examples of monuments used to mark transects in reaches of Carson and Truckee Rivers. *A.* 4-inch white disk attached to boulder, tree, or railroad tie. *B.* 4-inch polyvinyl-chloride (PVC) pipe topped with brass plate. *C.* 2-inch PVC pipe topped with hardware washer and bolt. *D.* Steel fence post driven into ground and cut to within 12 inches of land surface. *E.* 8-inch by 8-inch concrete block with brass plate. *F.* 1/2-inch yellow-capped rebar driven into ground.

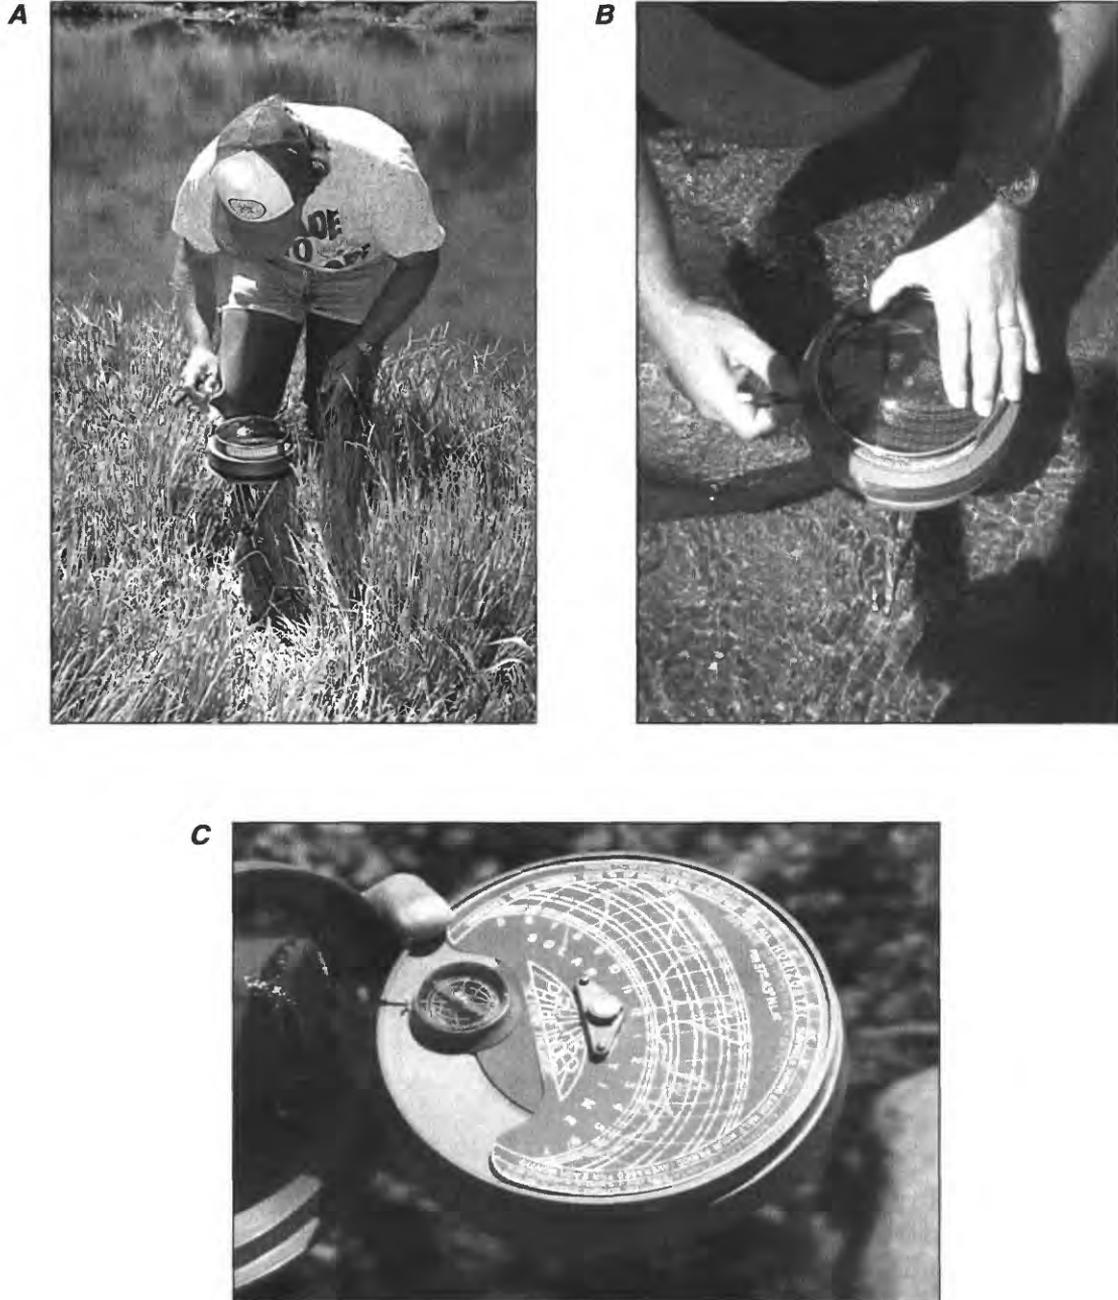
**Figure 3.** Measuring solar isolation at a site by tracing river shading over an annual solar cycle. *A.* Hydrographer measuring solar shading in middle of stream channel. *B.* Tracing shade features from their reflections on clear dome. *C.* Traced pattern on chart of annual solar cycle. Photographs by Ronald P. Collins, U.S. Geological Survey.

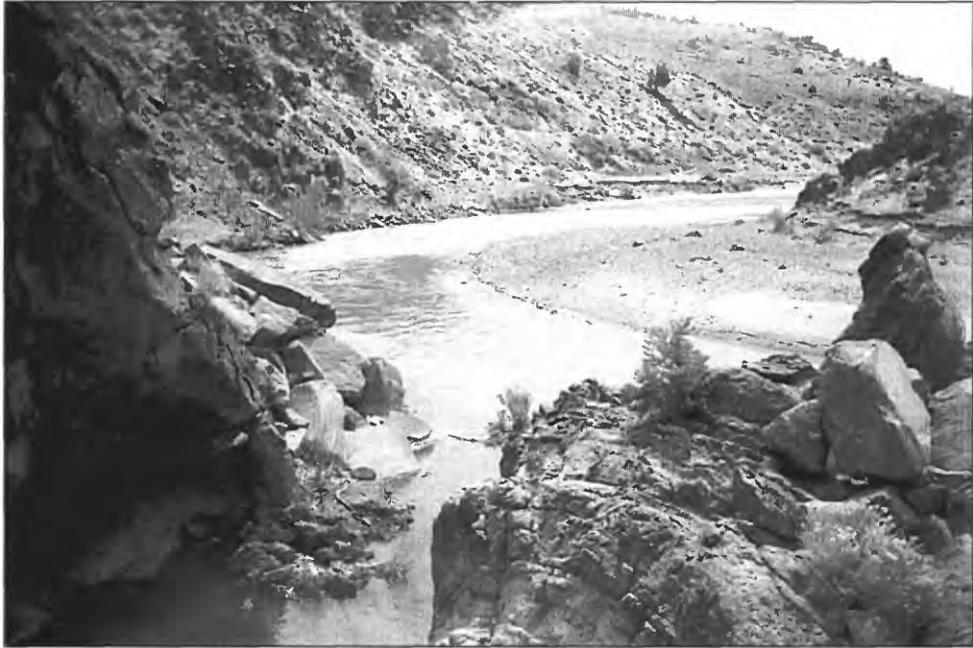
**East Fork Carson River near Dresslerville, Nev.  
(U.S. Geological Survey Station 10309010)**

Upstream view of East Fork Carson River from transect 1, reach C, East Fork Carson River near Dresslerville, Nev. Photograph by Stephen J. Lawrence, U.S. Geological Survey, March 1997.

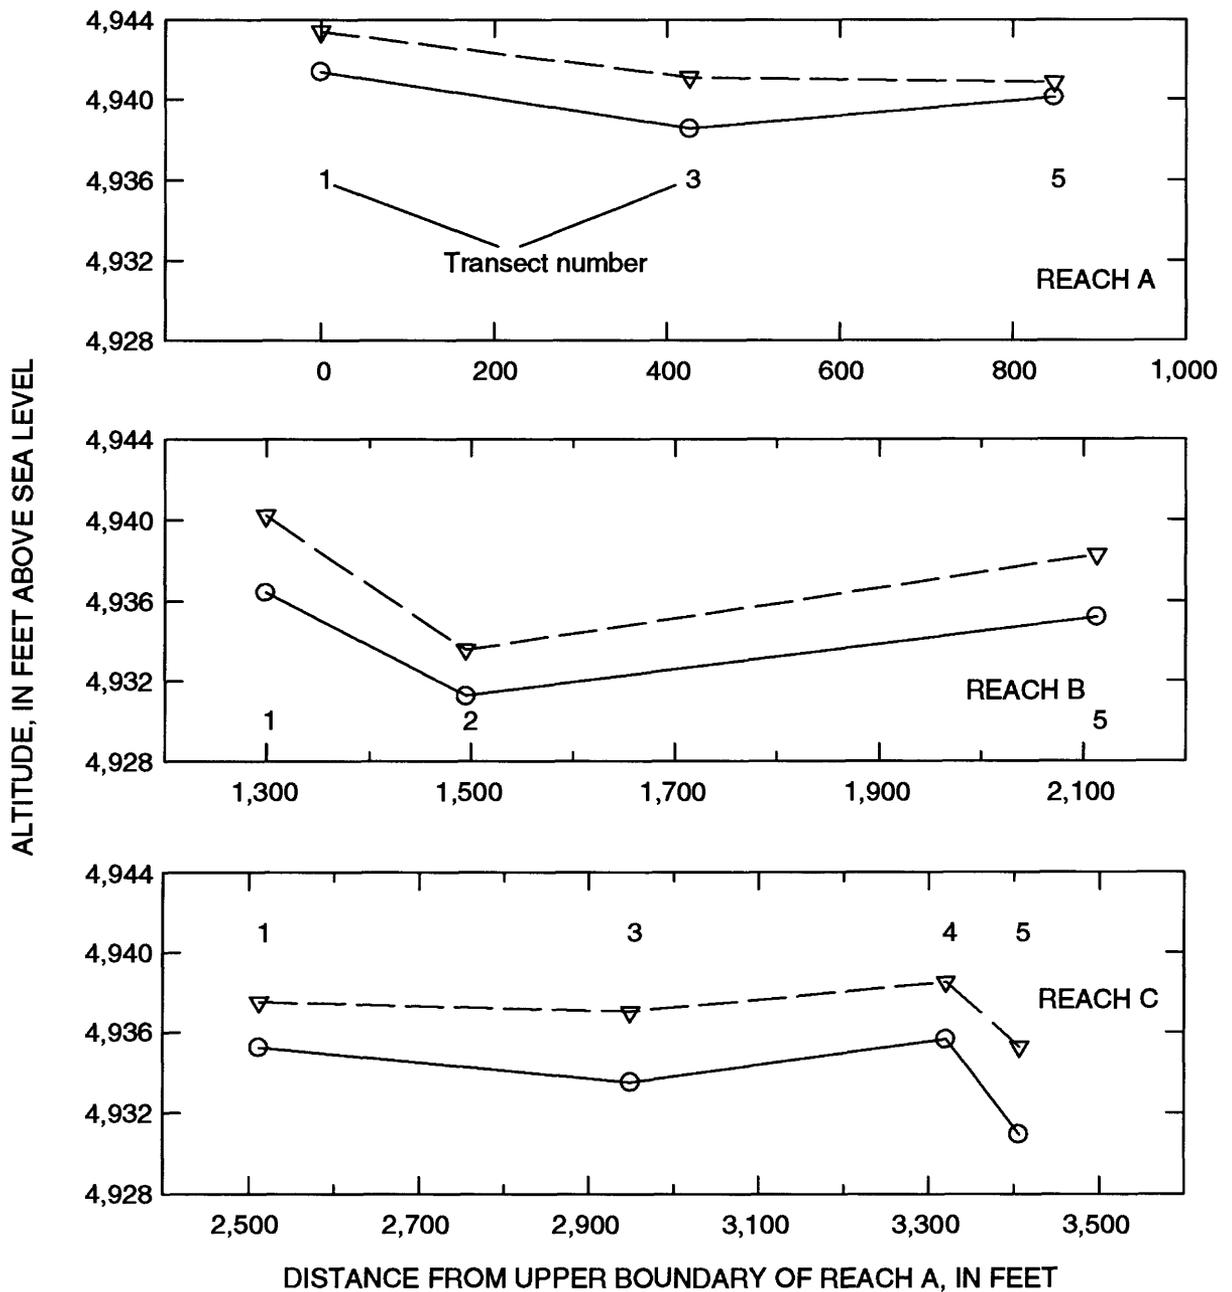
Figure 5. Longitudinal profiles of streambed (○) and water-surface (▽) altitudes measured along the thalweg in reaches A-C, East Fork Carson River near Dresslerville, Nev., October 1994.

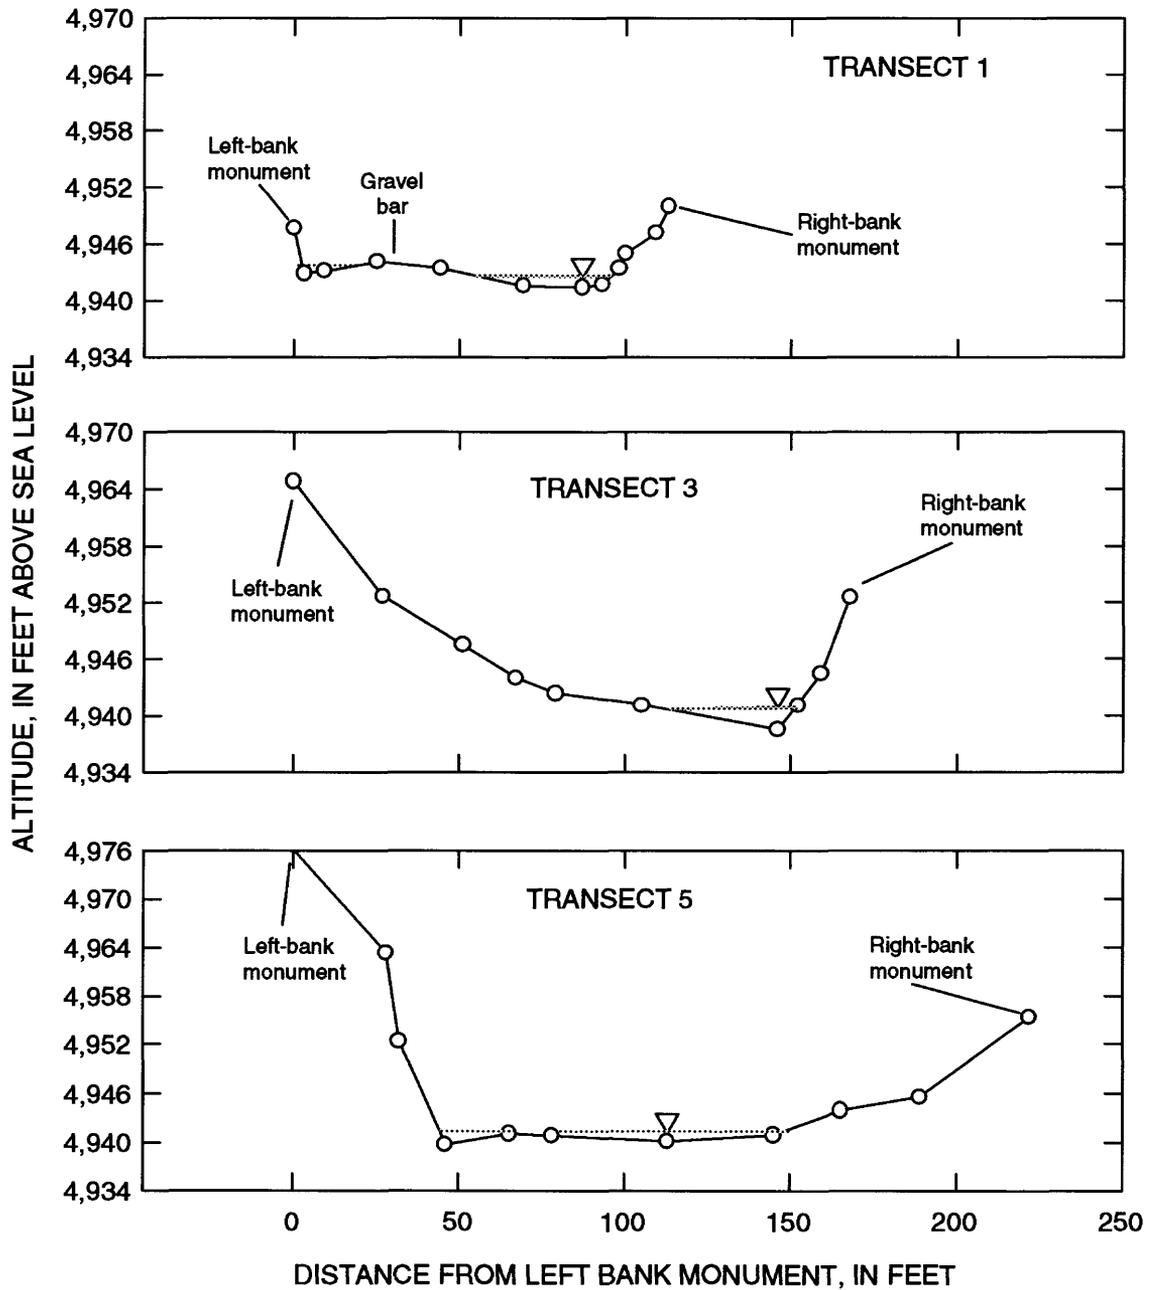
**Figure 6.** Cross sections showing land-surface (○) and water-surface (▽) altitudes for selected transects in reach A, East Fork Carson River near Dresslerville, Nev., October 1994.

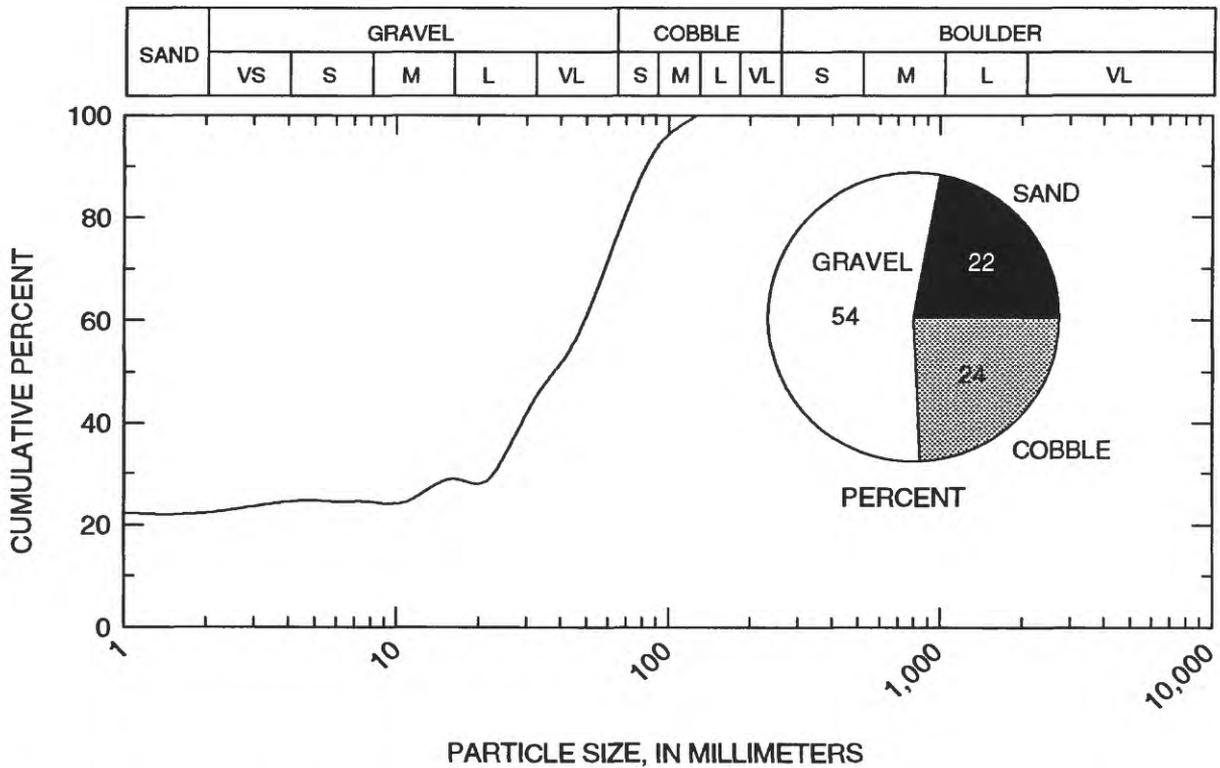
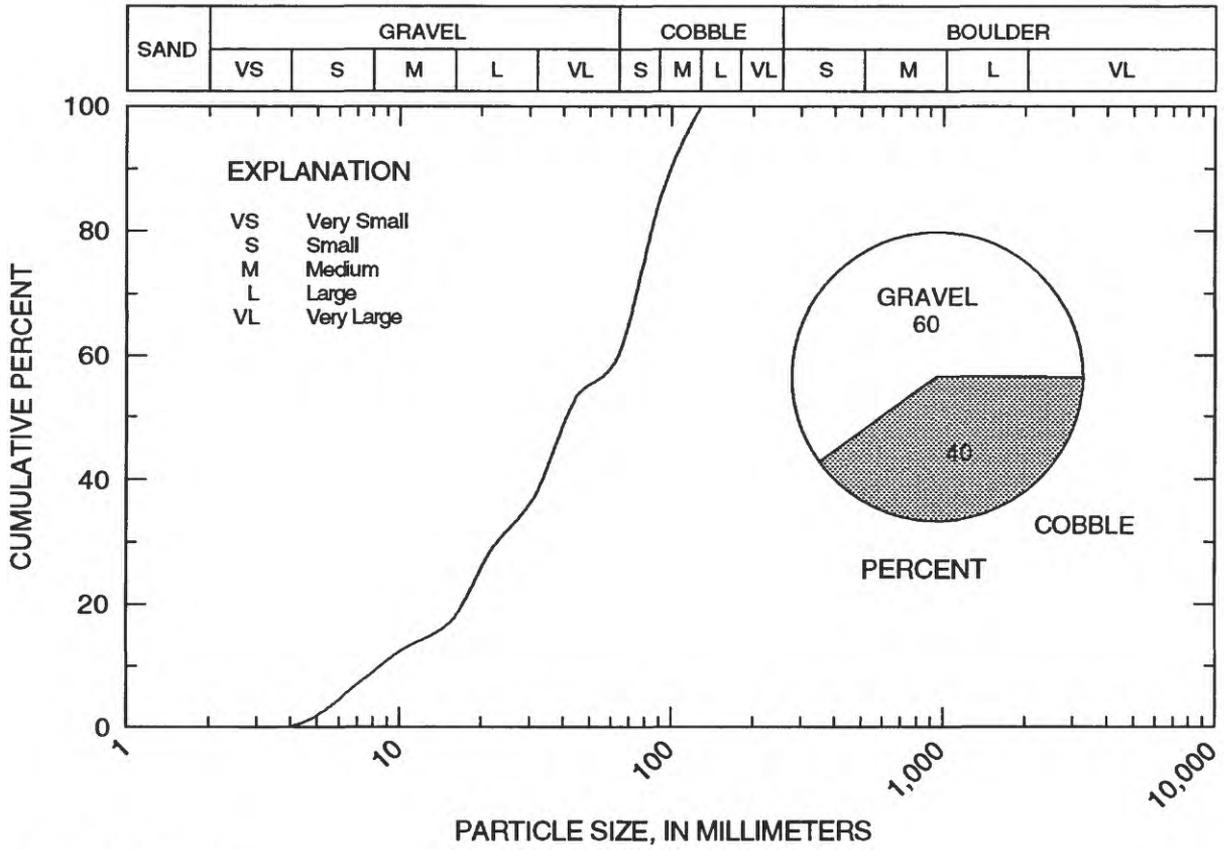
Figure 7. Particle-size distribution of coarse streambed substrate for selected transects in reach A, East Fork Carson River near Dresslerville, Nev., October 1994.

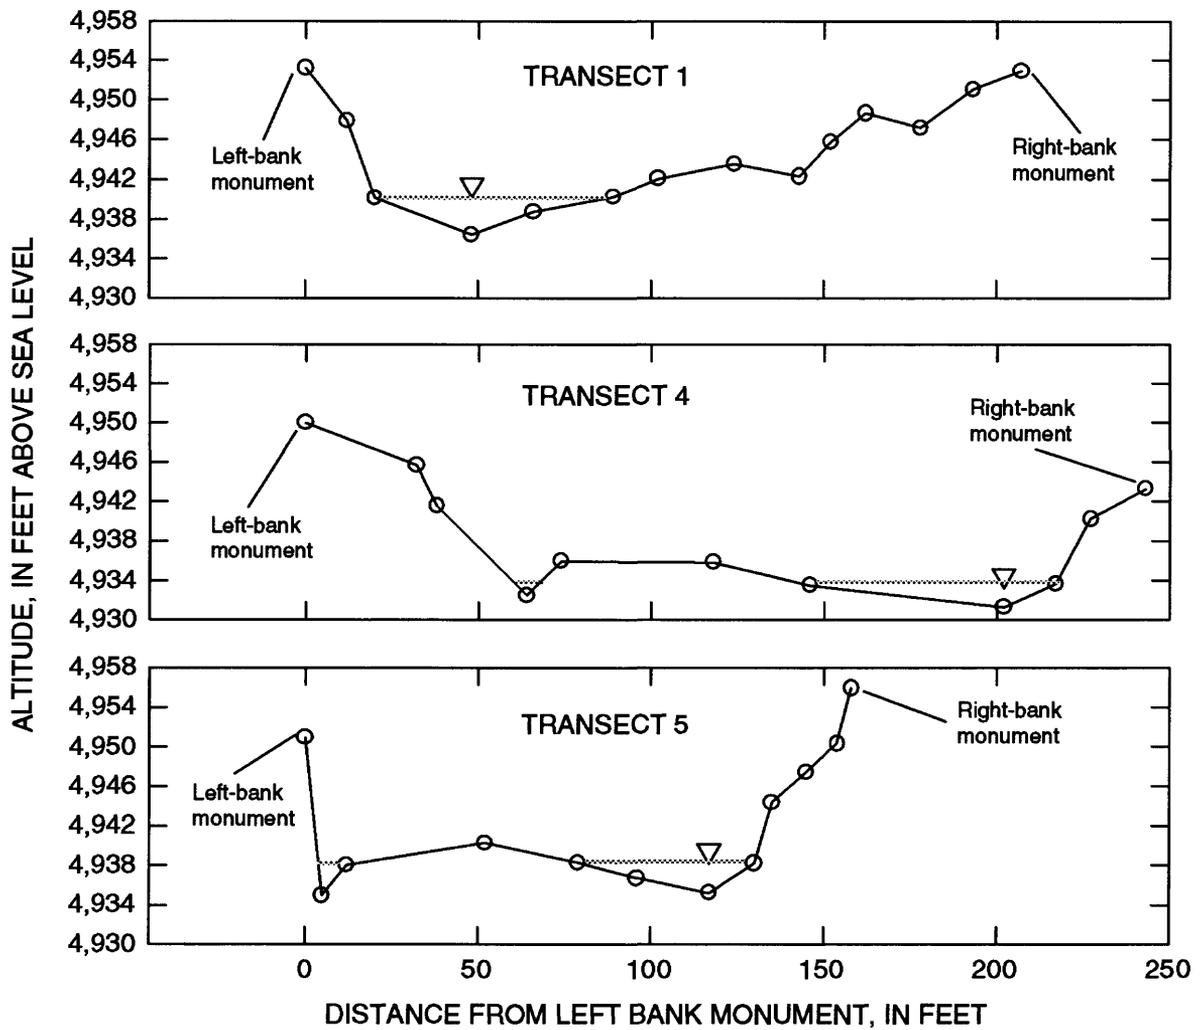
**Figure 8.** Cross sections showing land-surface (○) and water-surface (▽) altitudes for selected transects in reach B, East Fork Carson River near Dresslerville, Nev., October 1994.

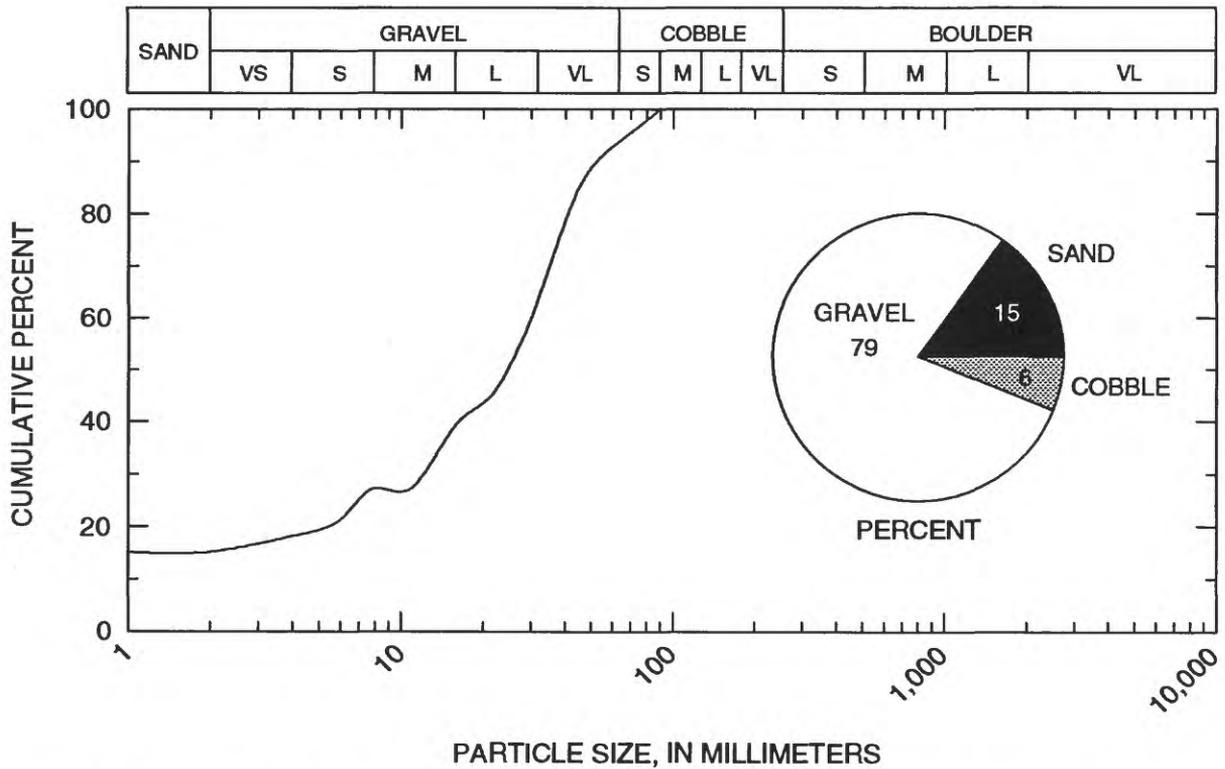
**Figure 9.** Particle-size distribution of coarse streambed substrate for selected transects in reach B, East Fork Carson River near Dresslerville, Nev., October 1994.

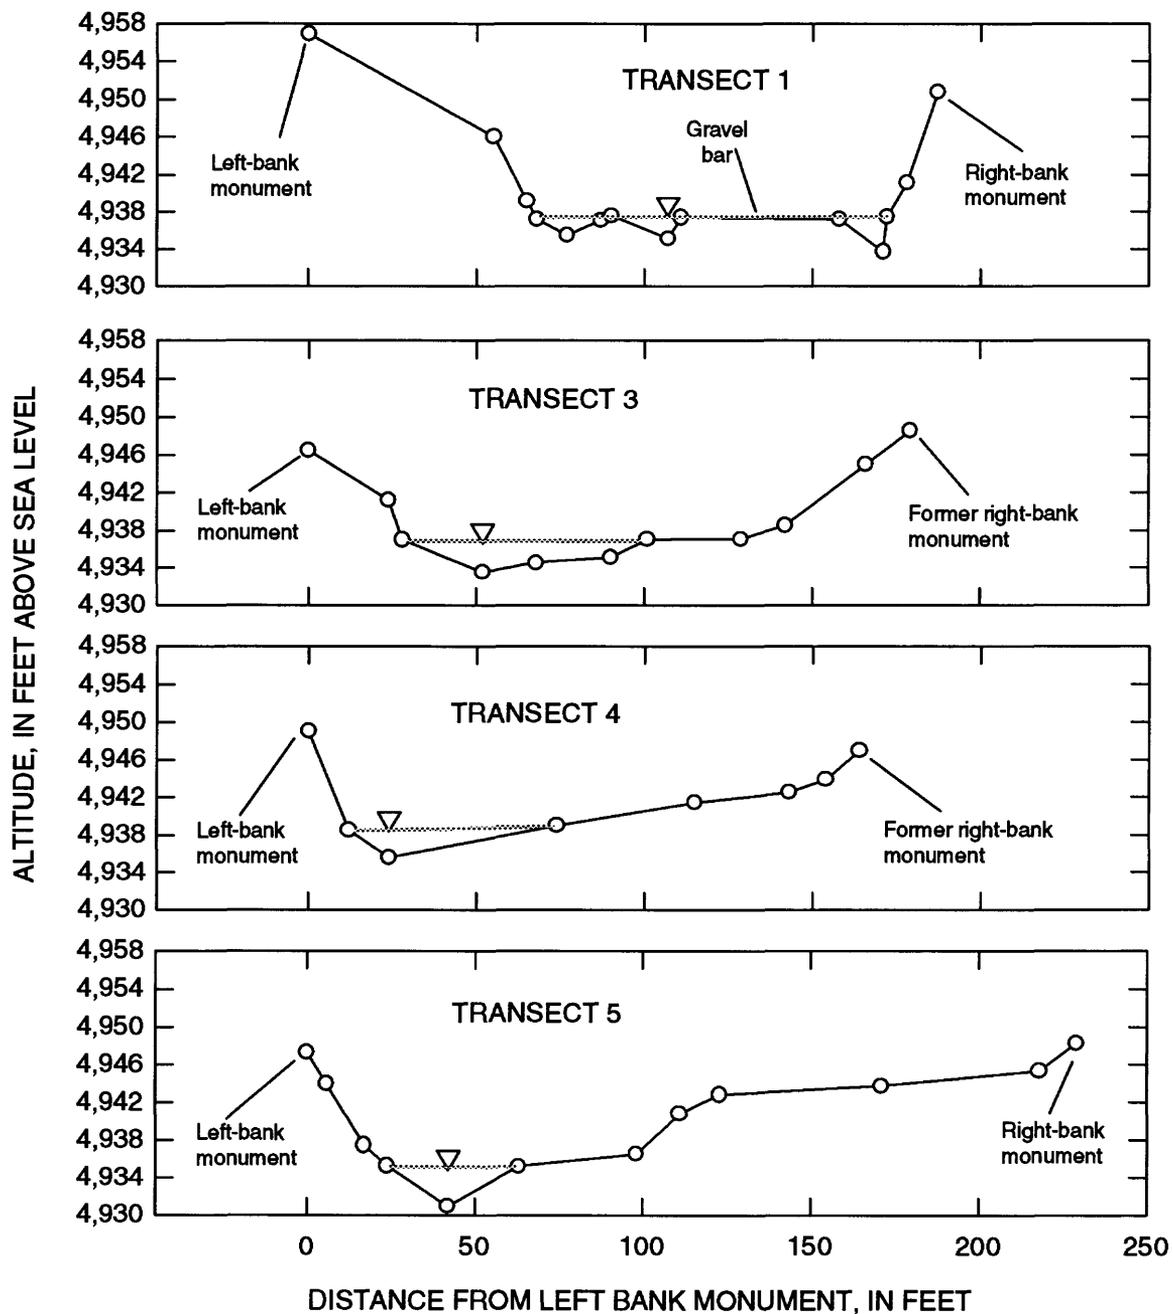
**Figure 10.** Cross sections showing land-surface (O) and water-surface (▽) altitudes for selected transects in reach C, East Fork Carson River near Dresslerville, Nev., October 1994.

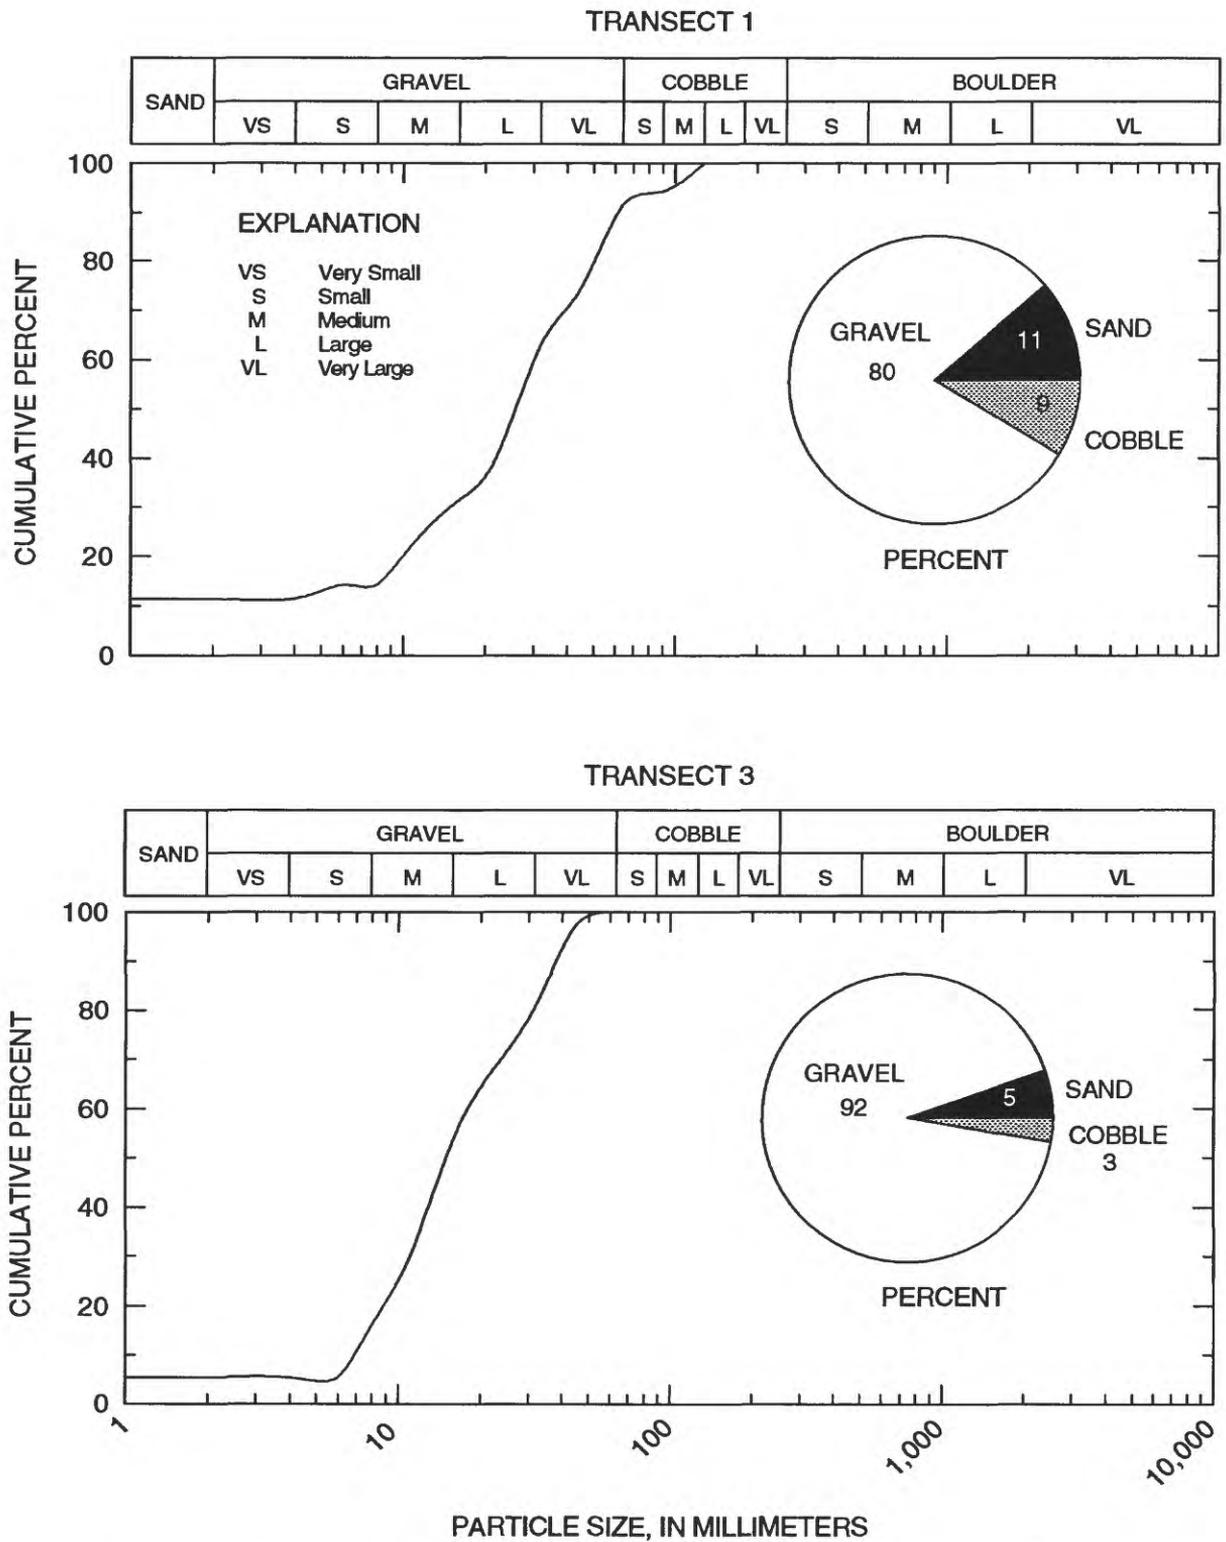
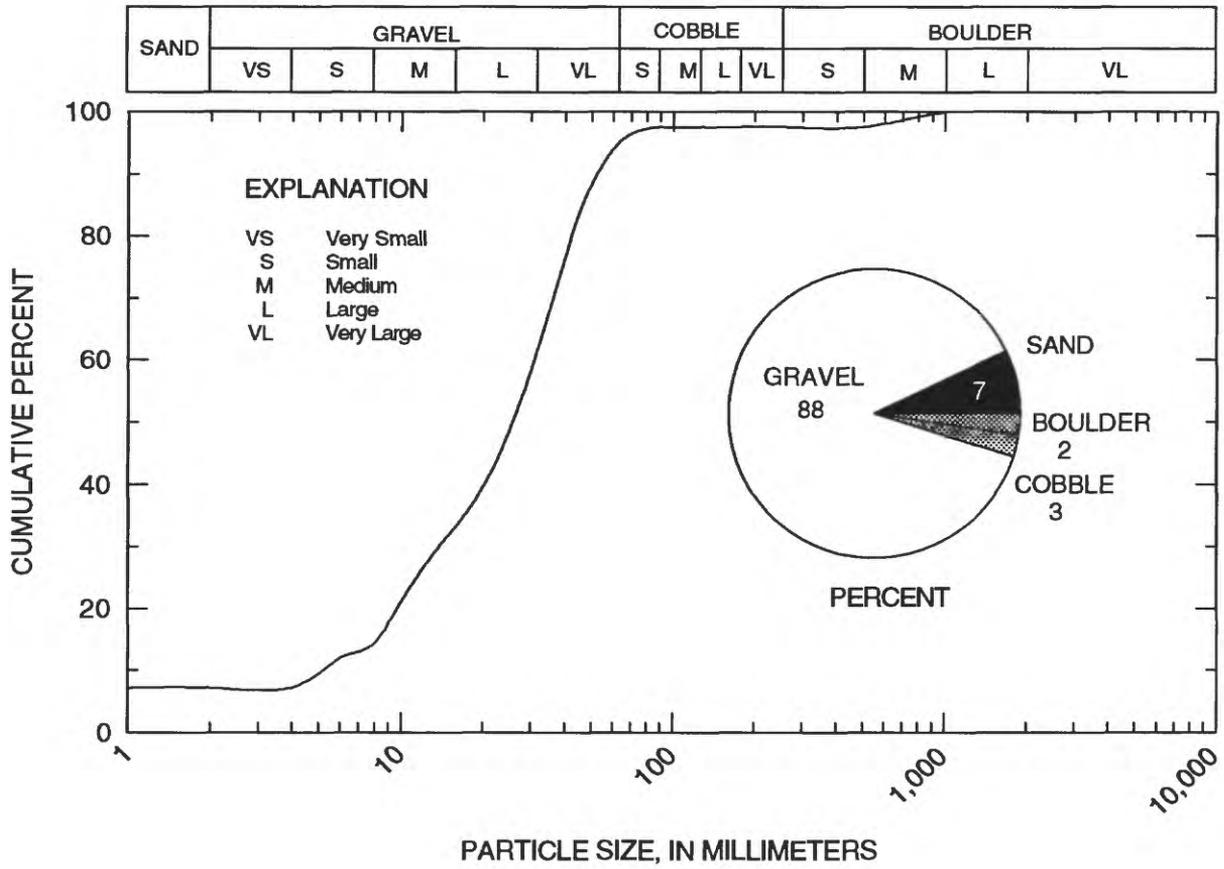
**Figure 11.** Particle-size distribution of coarse streambed substrate for selected transects in reach C, East Fork Carson River near Dresslerville, Nev., October 1994.

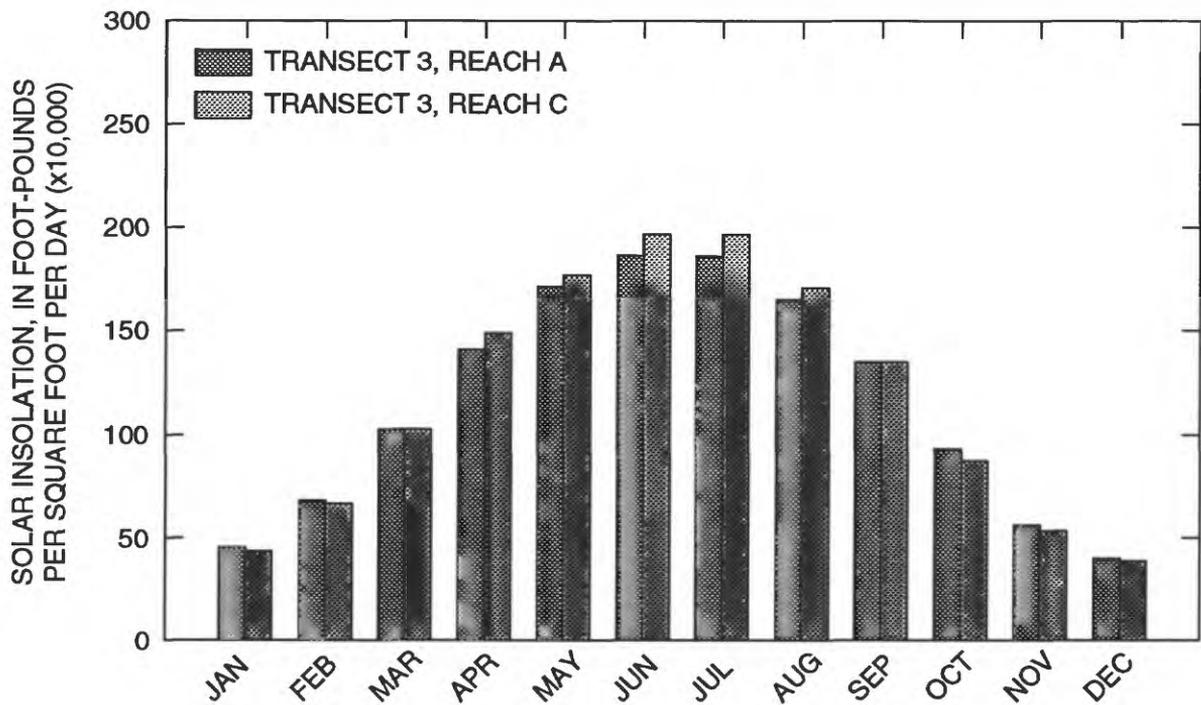
**Figure 12.** Monthly solar insolation midstream at transect 3 in reaches A and C, East Fork Carson River near Dresslerville, Nev.

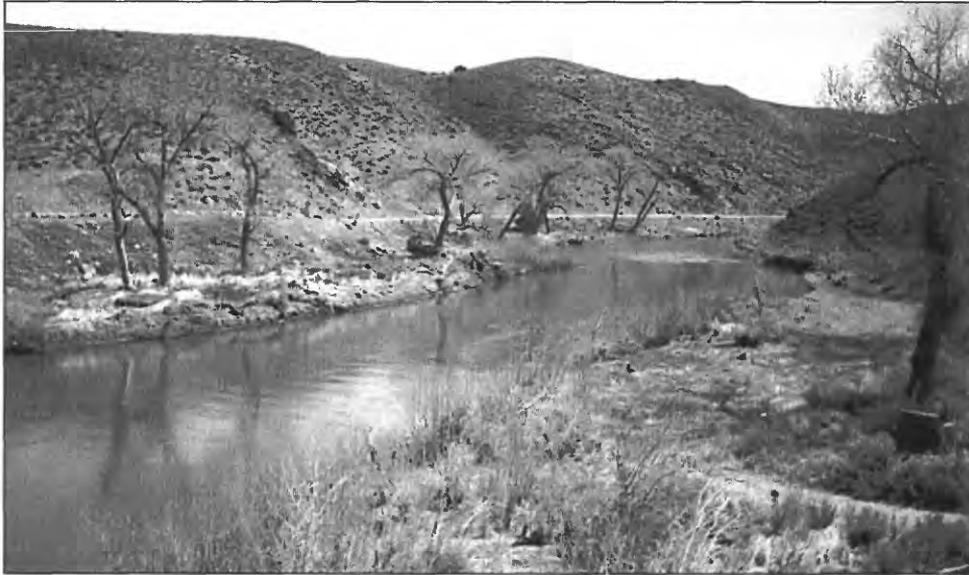
**Carson River at Deer Run Road near Carson City, Nev.  
(U.S. Geological Survey Station 10311400)**

Downstream view of Carson River from Deer Run Road bridge 400 feet upstream from transect 1, reach A, Carson River at Deer Run Road near Carson City, Nev. Photograph by Stephen J. Lawrence, U.S. Geological Survey, March 1997.

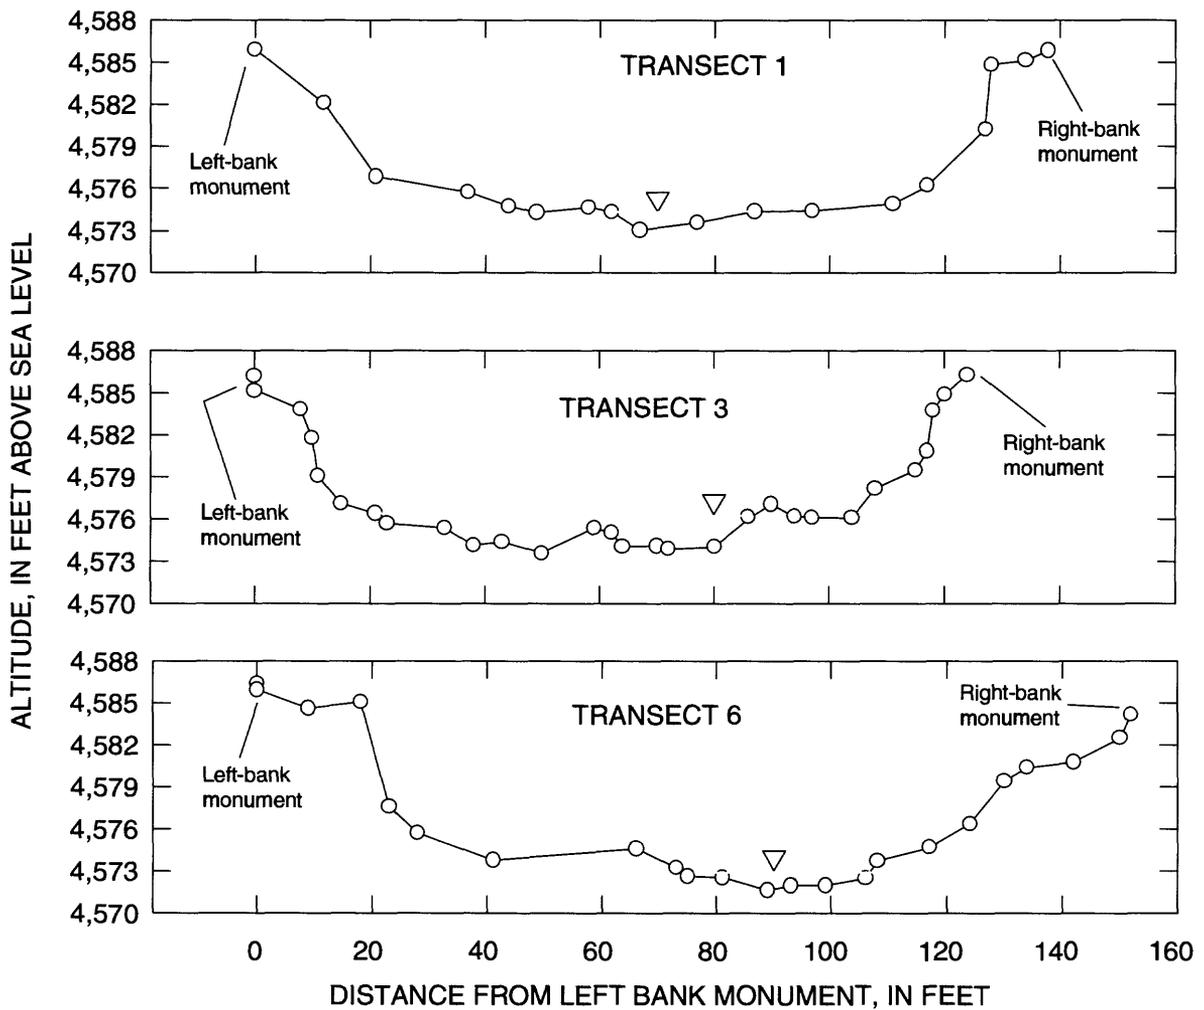
**Figure 15.** Cross sections showing land-surface (O) and water-surface (∇) altitudes for selected transects in reach A, Carson River at Deer Run Road near Carson City, Nev., July 1994.

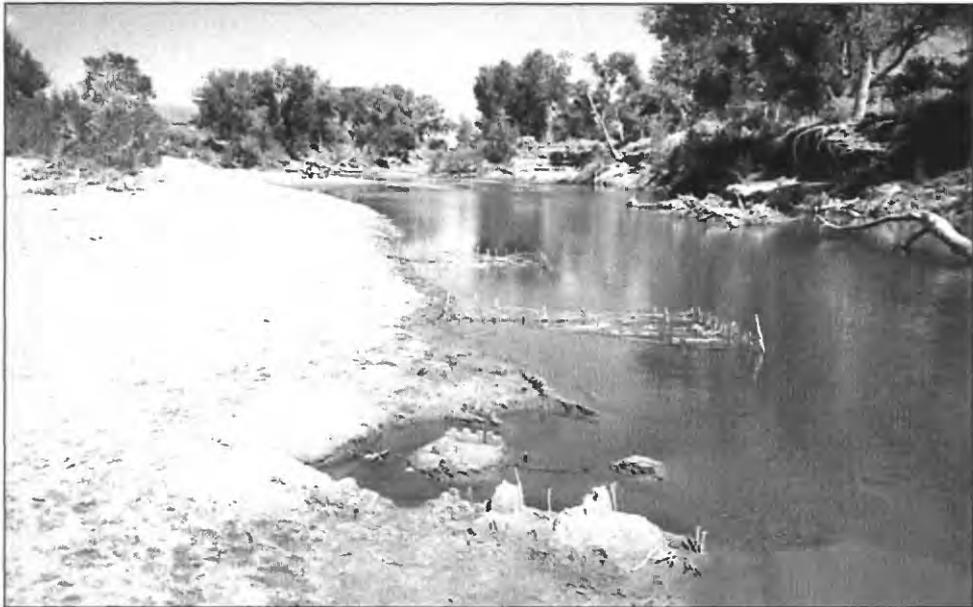
**Carson River at Fort Churchill (State Park), Nev.  
(U.S. Geological Survey Station 10312000)**

Downstream view of Carson River from transect 1, reach B, Carson River at Fort Churchill (State Park), Nev. Photograph by Sonya Vasquez, U.S. Geological Survey, September 1995.

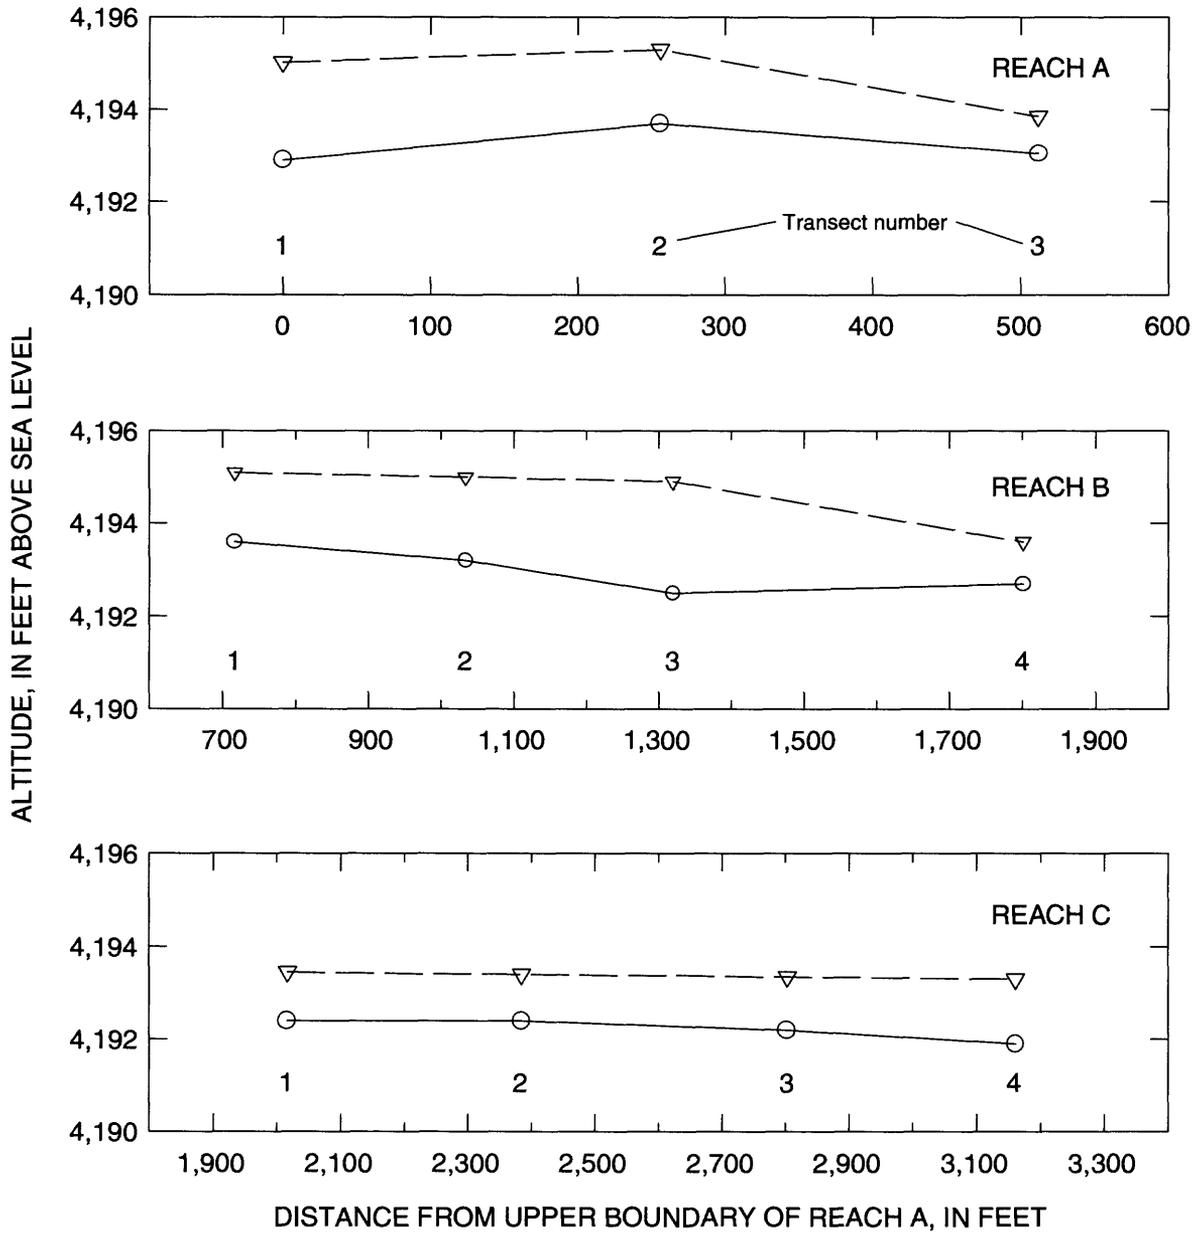
**Figure 18.** Longitudinal profiles of streambed (○) and water-surface (▽) altitudes measured along the thalweg in reaches A-C, Carson River at Fort Churchill (State Park), Nev., October 1993.

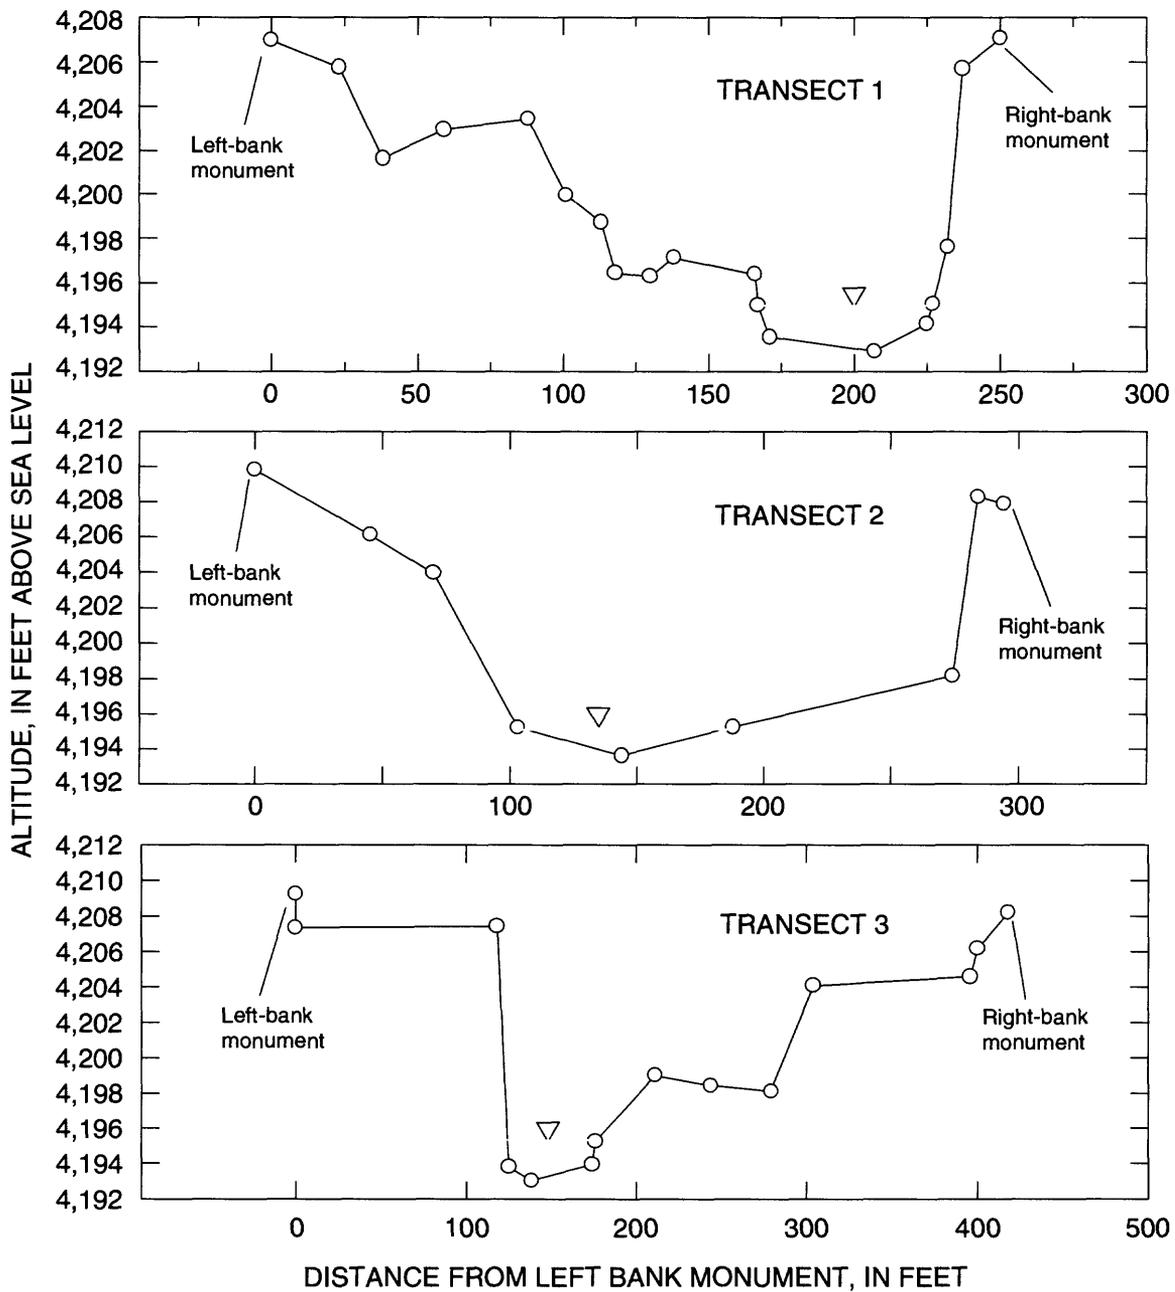
**Figure 19.** Cross sections showing land-surface (O) and water-surface (V) altitudes for selected transects in reach A, Carson River at Fort Churchill (State Park), Nev., October 1993.
