# Physical and Geomorphological Measurements for Selected River Segments in the Carson and Truckee River Basins, Nevada and California, 1993-96

Open-File Report 97-764

Prepared as part of the  
NATIONAL WATER-QUALITY ASSESSMENT PROGRAM

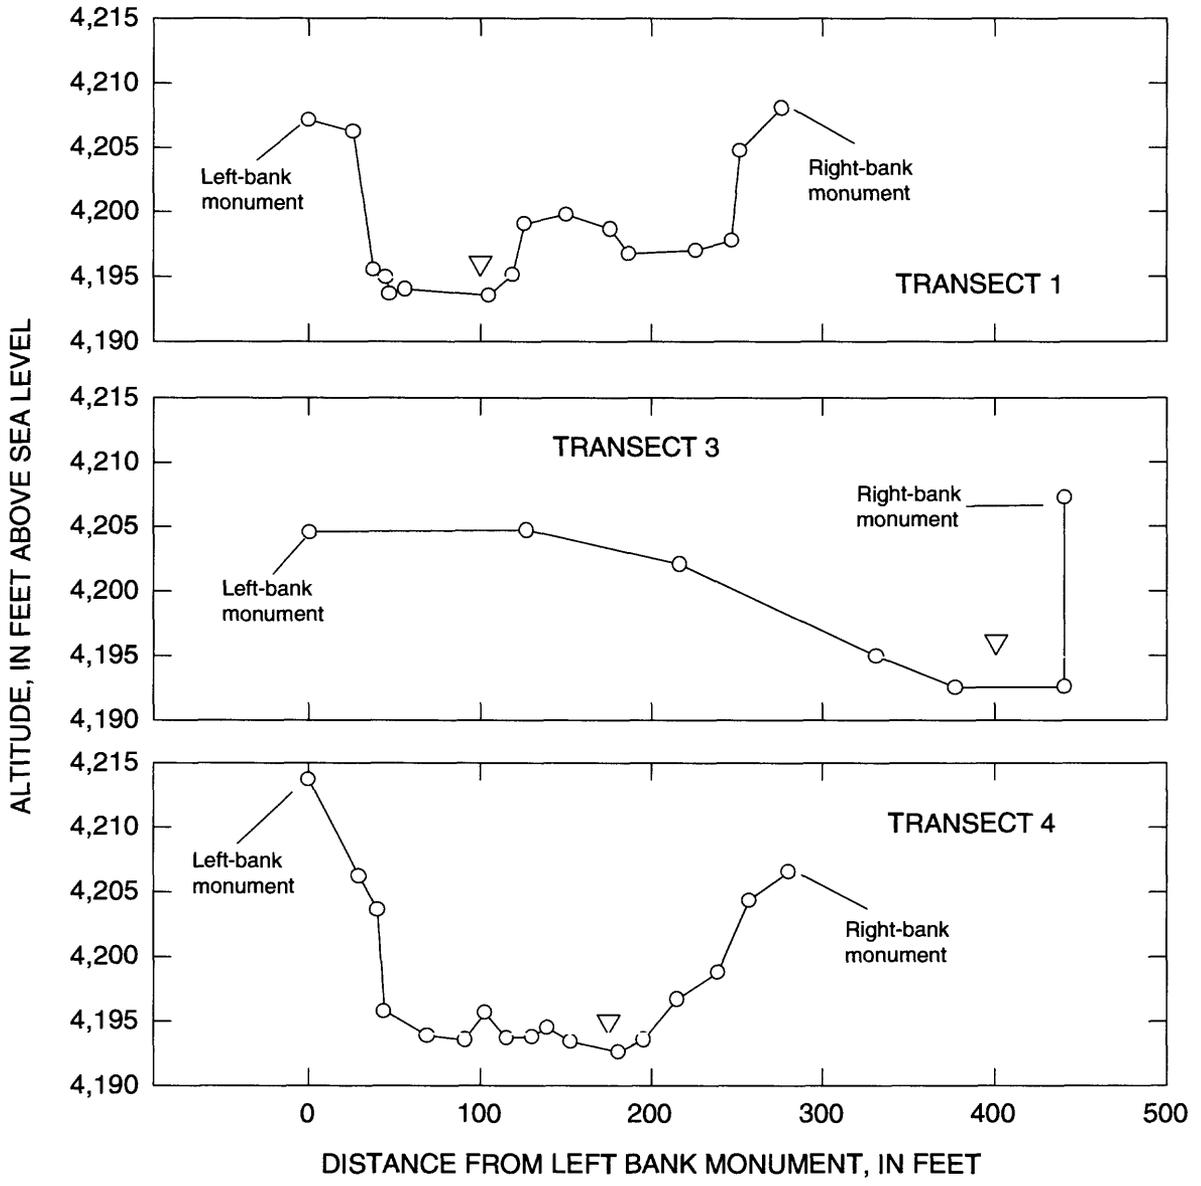
**Figure 20.** Cross sections showing land-surface (○) and water-surface (▽) altitudes for selected transects in reach B, Carson River at Fort Churchill (State Park), Nev., October 1993.

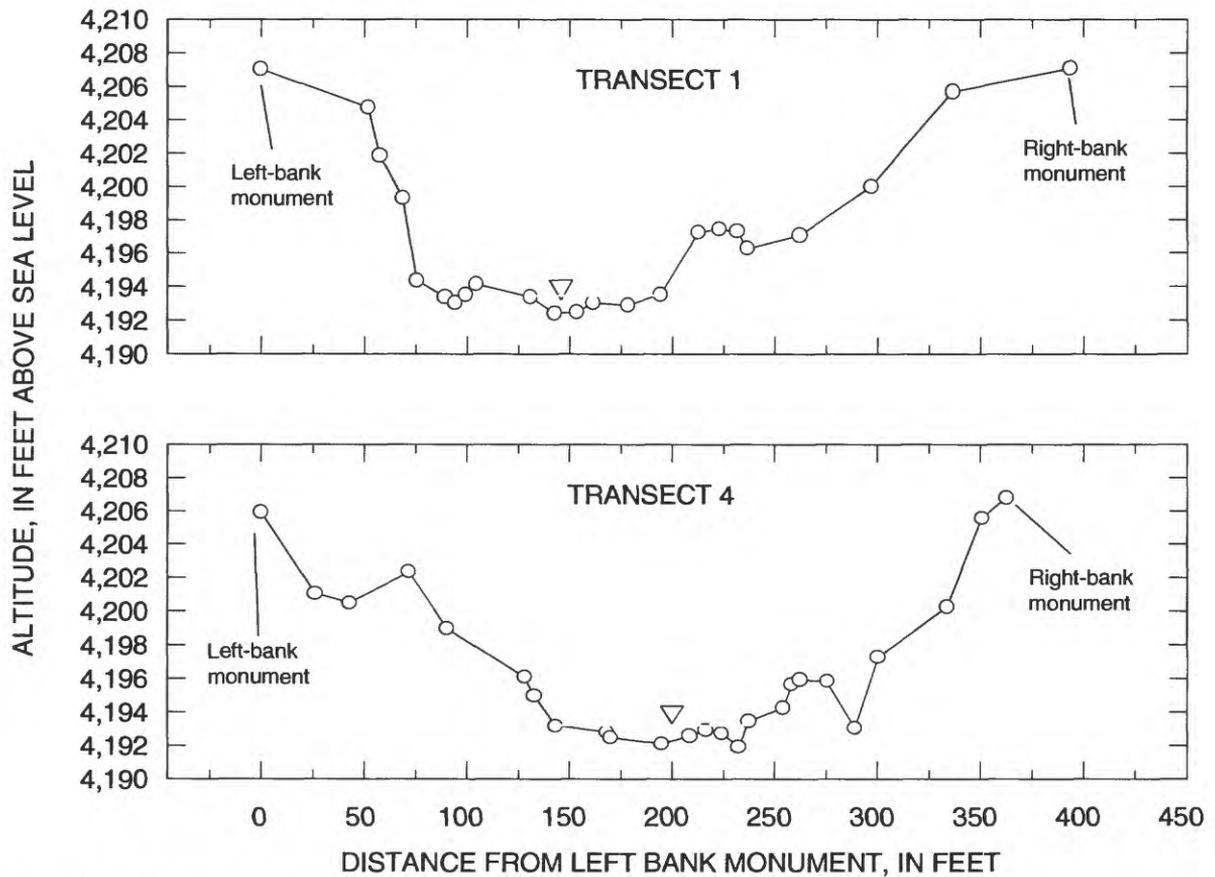
**Figure 21.** Cross sections showing land-surface (○) and water-surface (▽) altitudes for selected transects in reach C, Carson River at Fort Churchill (State Park), Nev., October 1993.

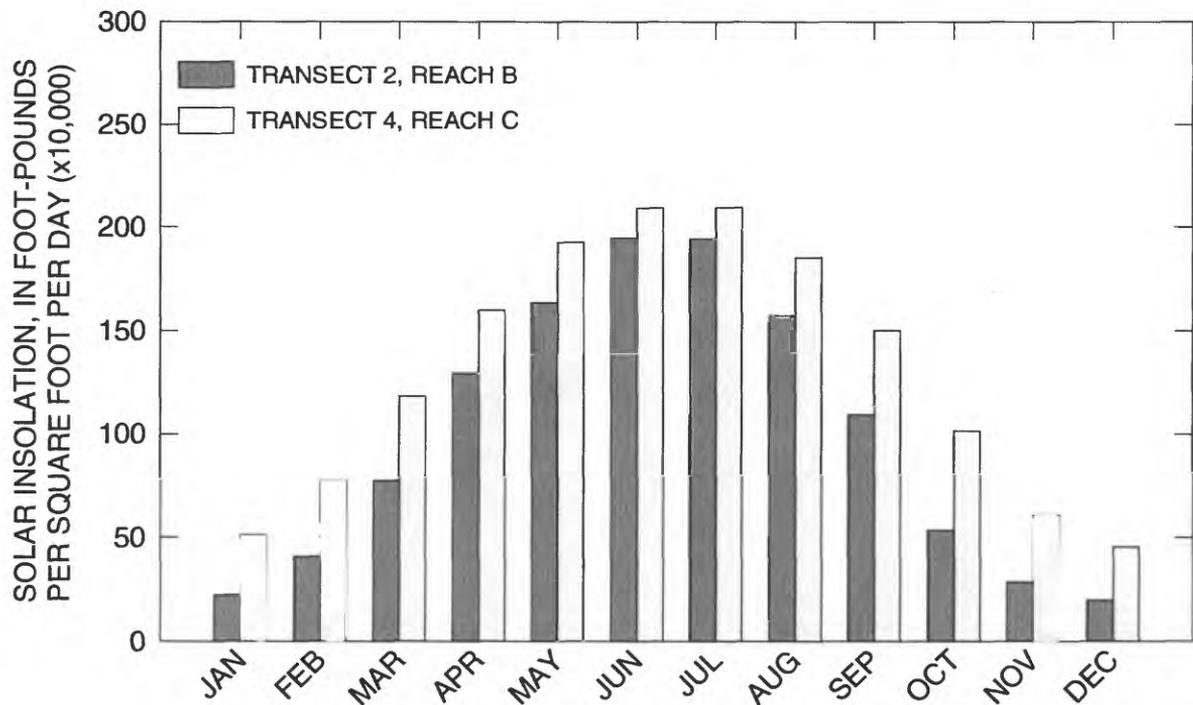
**Figure 22.** Monthly solar insolation midstream at selected transects in reaches B and C, Carson River at Fort Churchill (State Park), Nev.

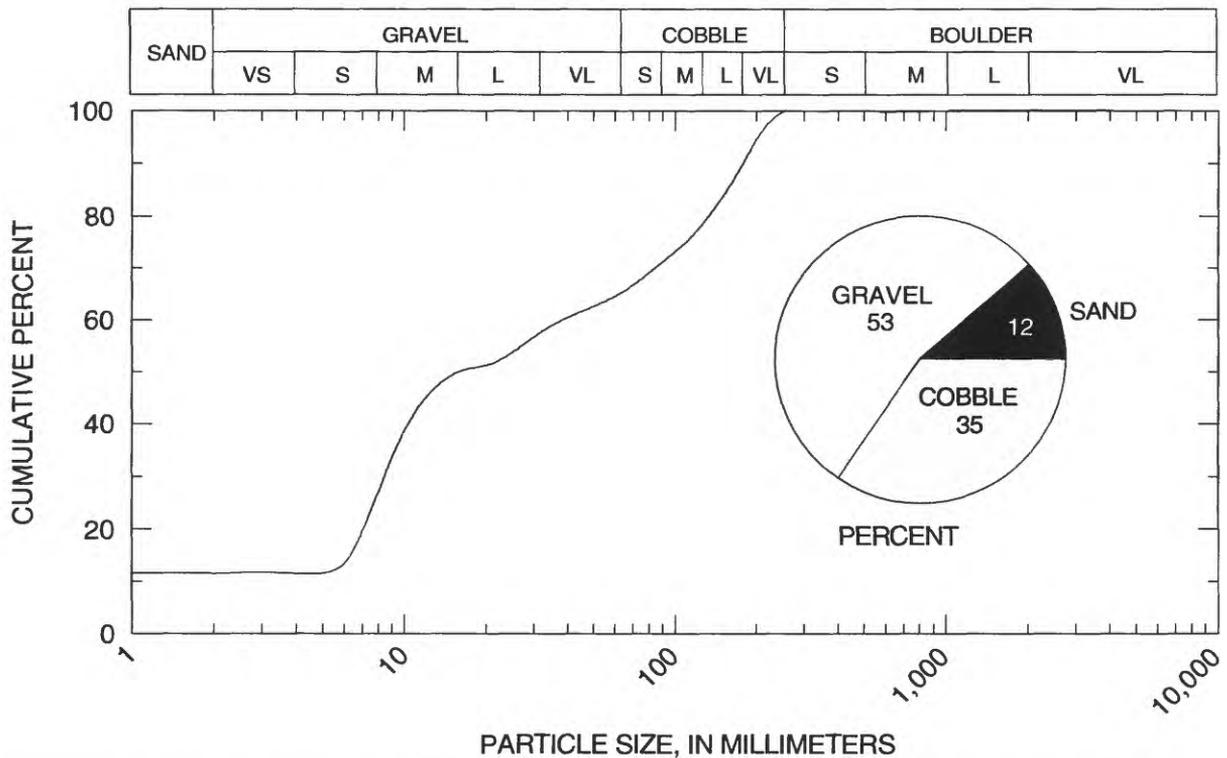
**Figure 23.** Particle-size distribution of coarse streambed substrate at selected transects in reach A, West Fork Carson River above Woodfords, Calif., August 1994.

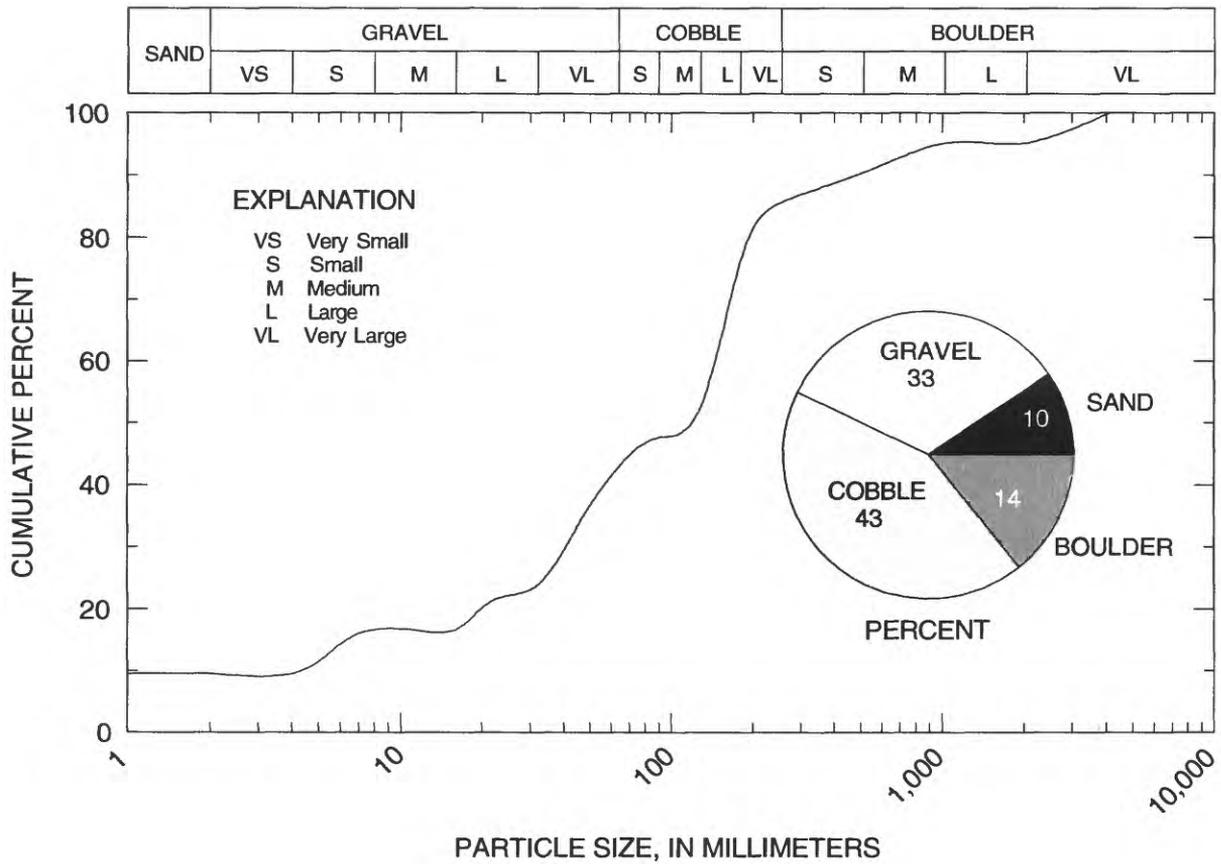
**Figure 24.** Particle-size distribution of coarse streambed substrate in reach A, West Fork Carson River at Paynesville, Calif., August 1994.

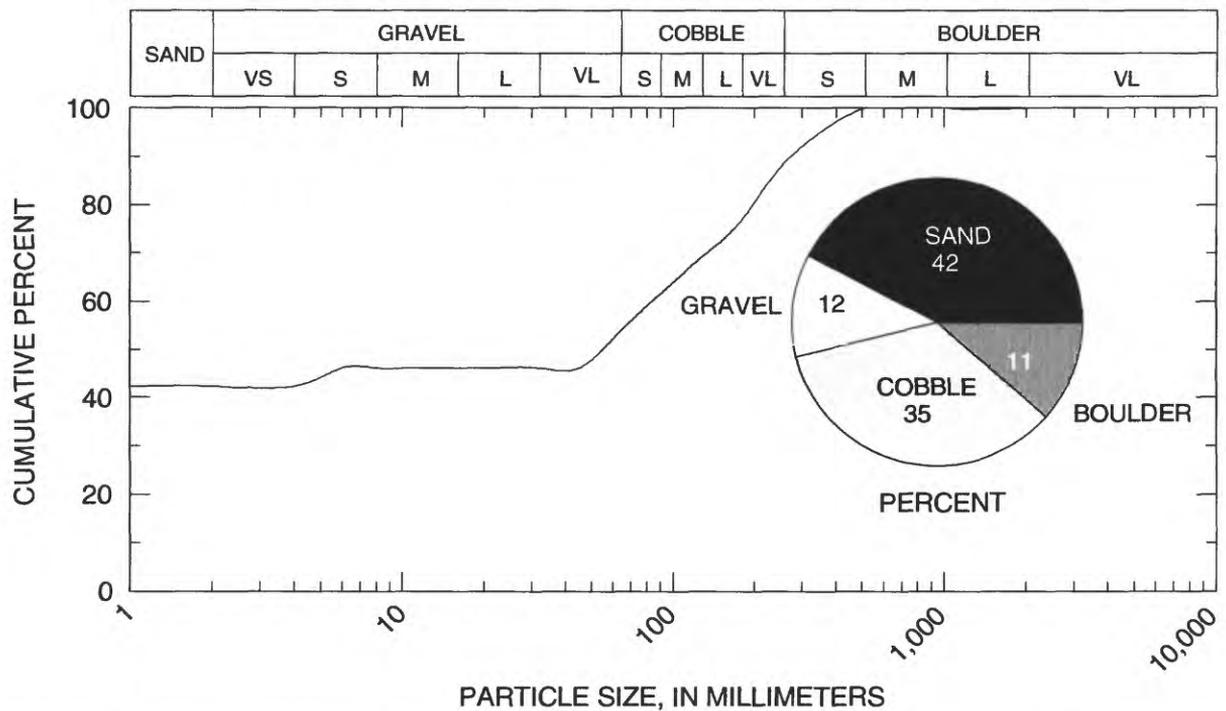
**Figure 25.** Particle-size distribution of coarse streambed substrate in reach A, West Fork Carson River at Muller Lane near Minden, Nev., and Carson River near Carson City, Nev., August 1994.

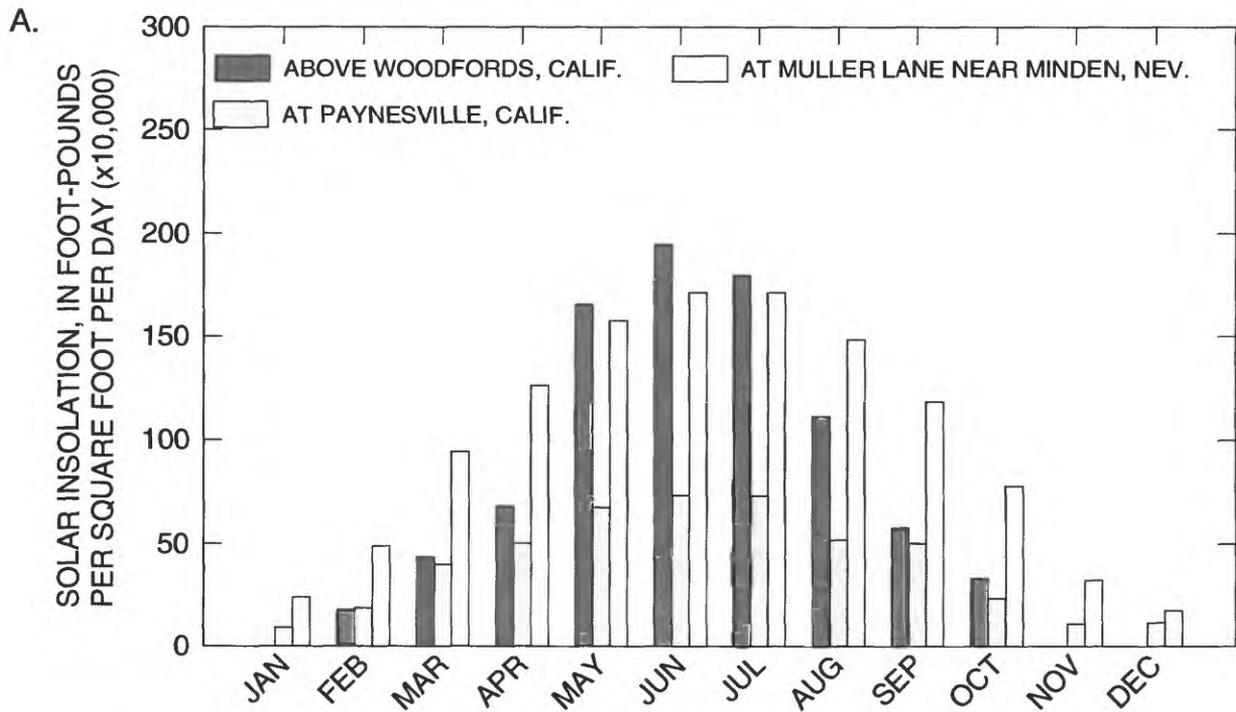
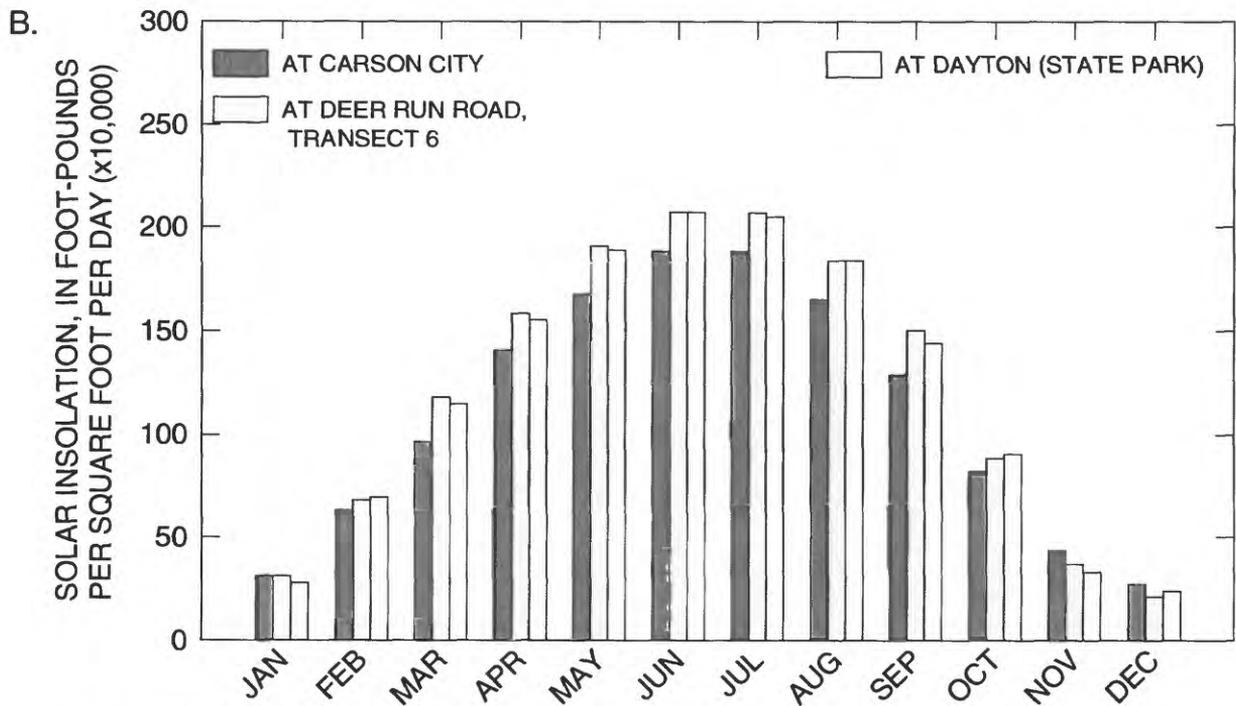
**Figure 26.** Monthly solar insolation midstream, A. West Fork Carson River above Woodfords, Calif.; at Paynesville, Calif.; and at Muller Lane near Minden; and B. Carson River near Carson City, Nev.; at Deer Run Road near Carson City, Nev.; and at Dayton (State Park), Nev.

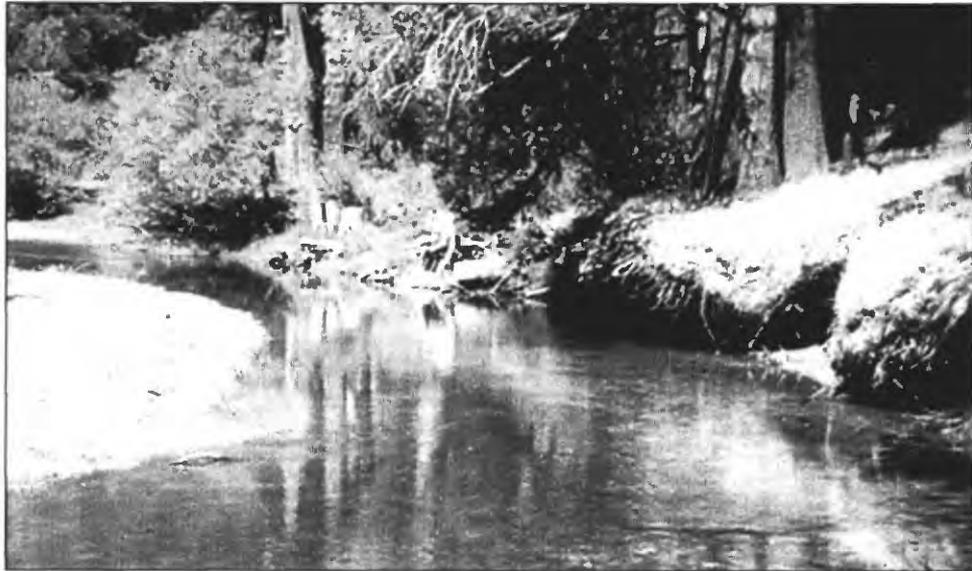
**Upper Truckee River at South Lake Tahoe, Calif.  
(U.S. Geological Survey Station 10336610)**

Downstream view of the Upper Truckee River from transect 1, reach A, Upper Truckee River at South Lake Tahoe, Calif. Photograph by Ronald P. Collins, U.S. Geological Survey, November 1993.

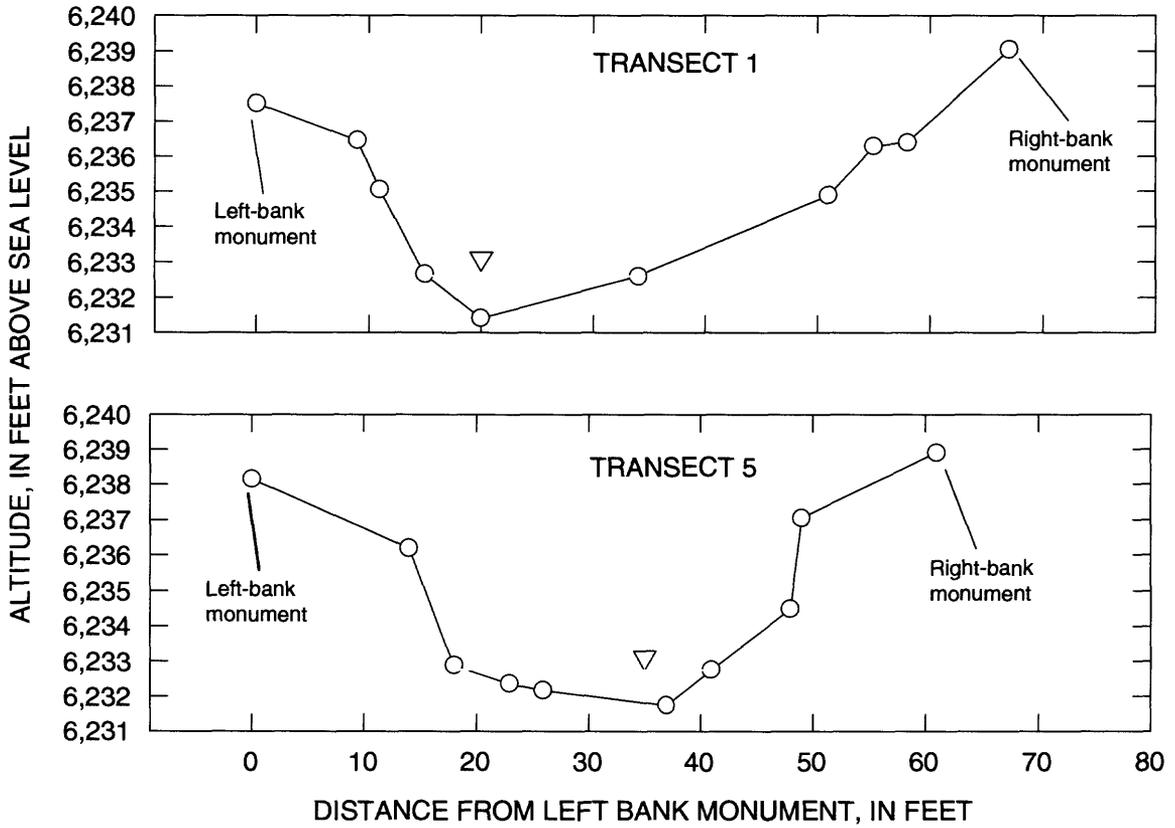
**Figure 28.** Cross section showing land-surface (O) and water-surface (▽) altitudes for selected transects in reach A, Upper Truckee River at South Lake Tahoe, Calif., November 1993.

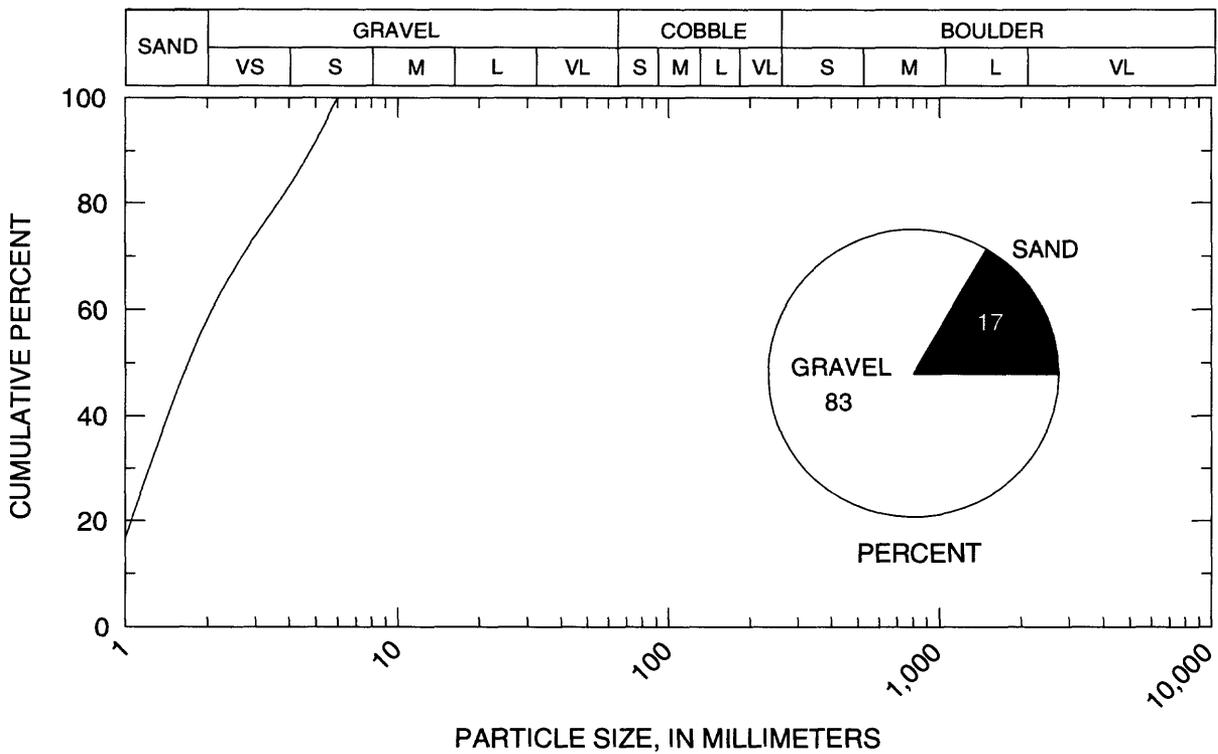
**Figure 29.** Particle-size distribution of coarse streambed substrate at selected transects in reach A, Upper Truckee River at South Lake Tahoe, Calif., August 1994.

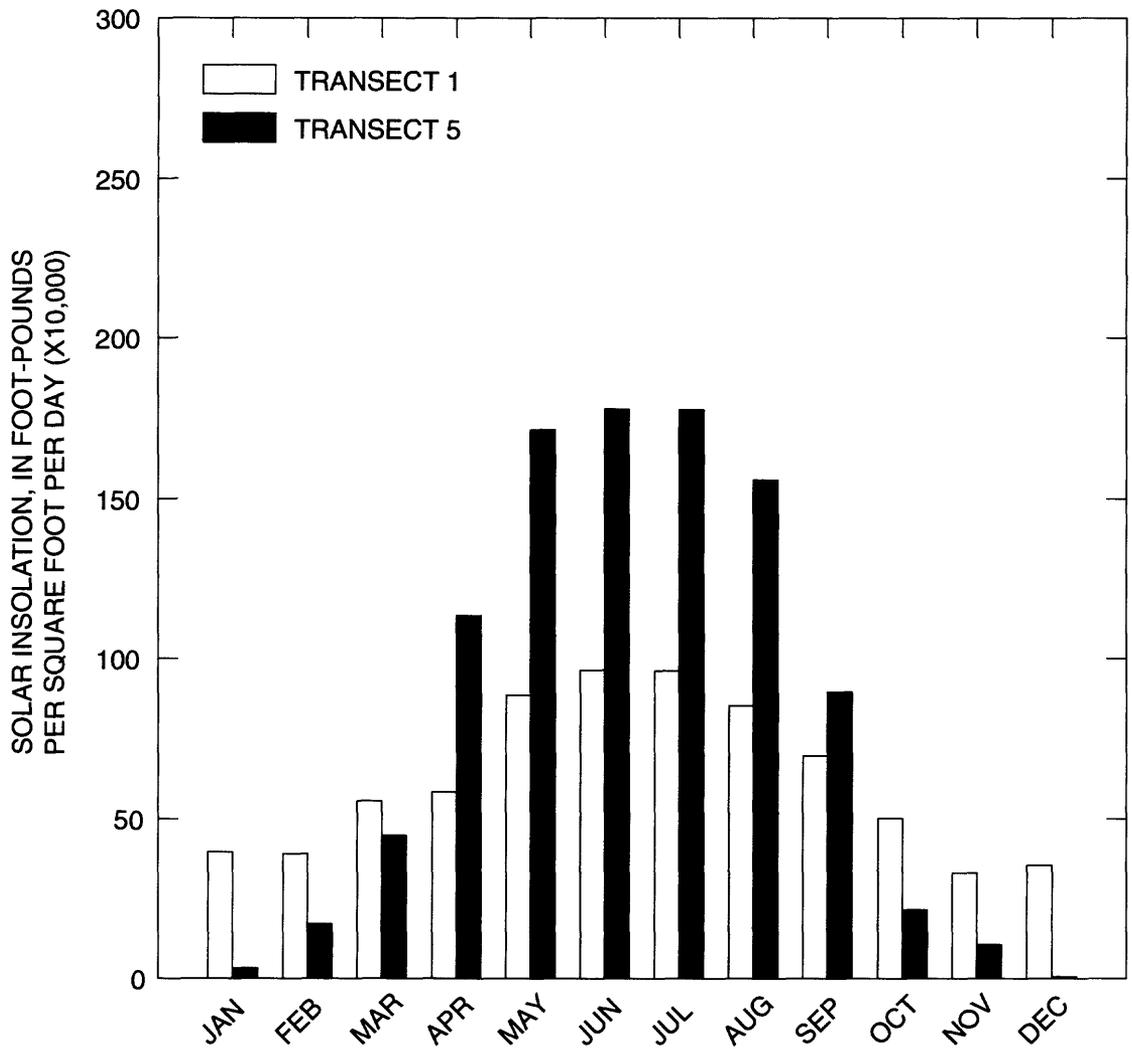
**Figure 30.** Monthly solar insolation midstream at selected transects in reach A, Upper Truckee River at South Lake Tahoe, Calif.

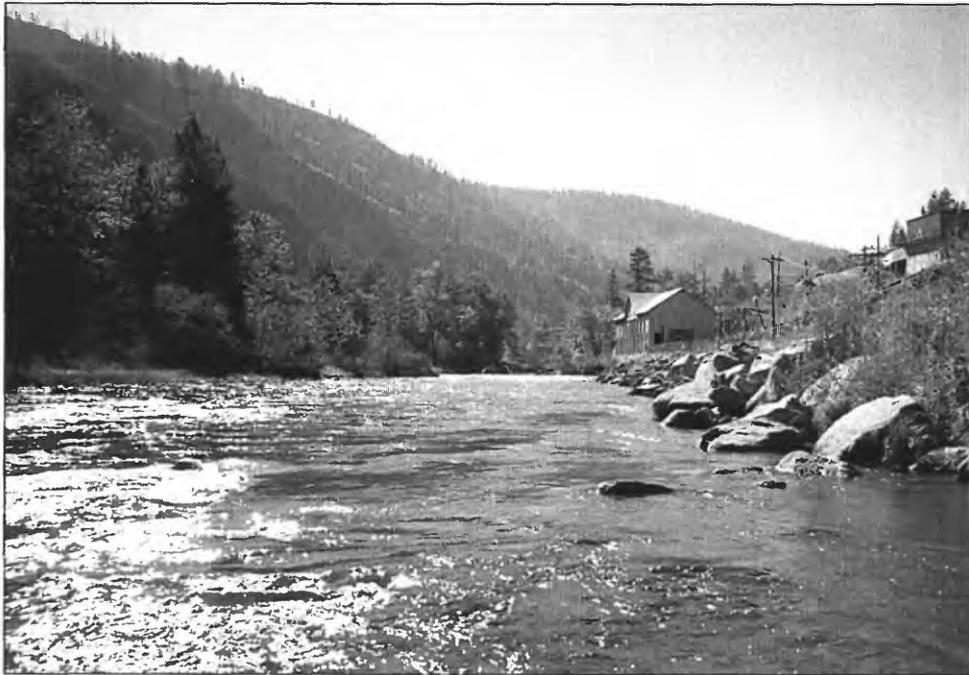
**Truckee River at Farad, Calif.  
(U.S. Geological Survey Station 10346000)**

Upstream view of Truckee River from transect 2, reach A, Truckee River at Farad, Calif. Building at right center of photograph is hydroelectric power plant operated by Sierra Pacific Power Company. Photograph by Sonya Vasquez, U.S. Geological Survey, September 1995.

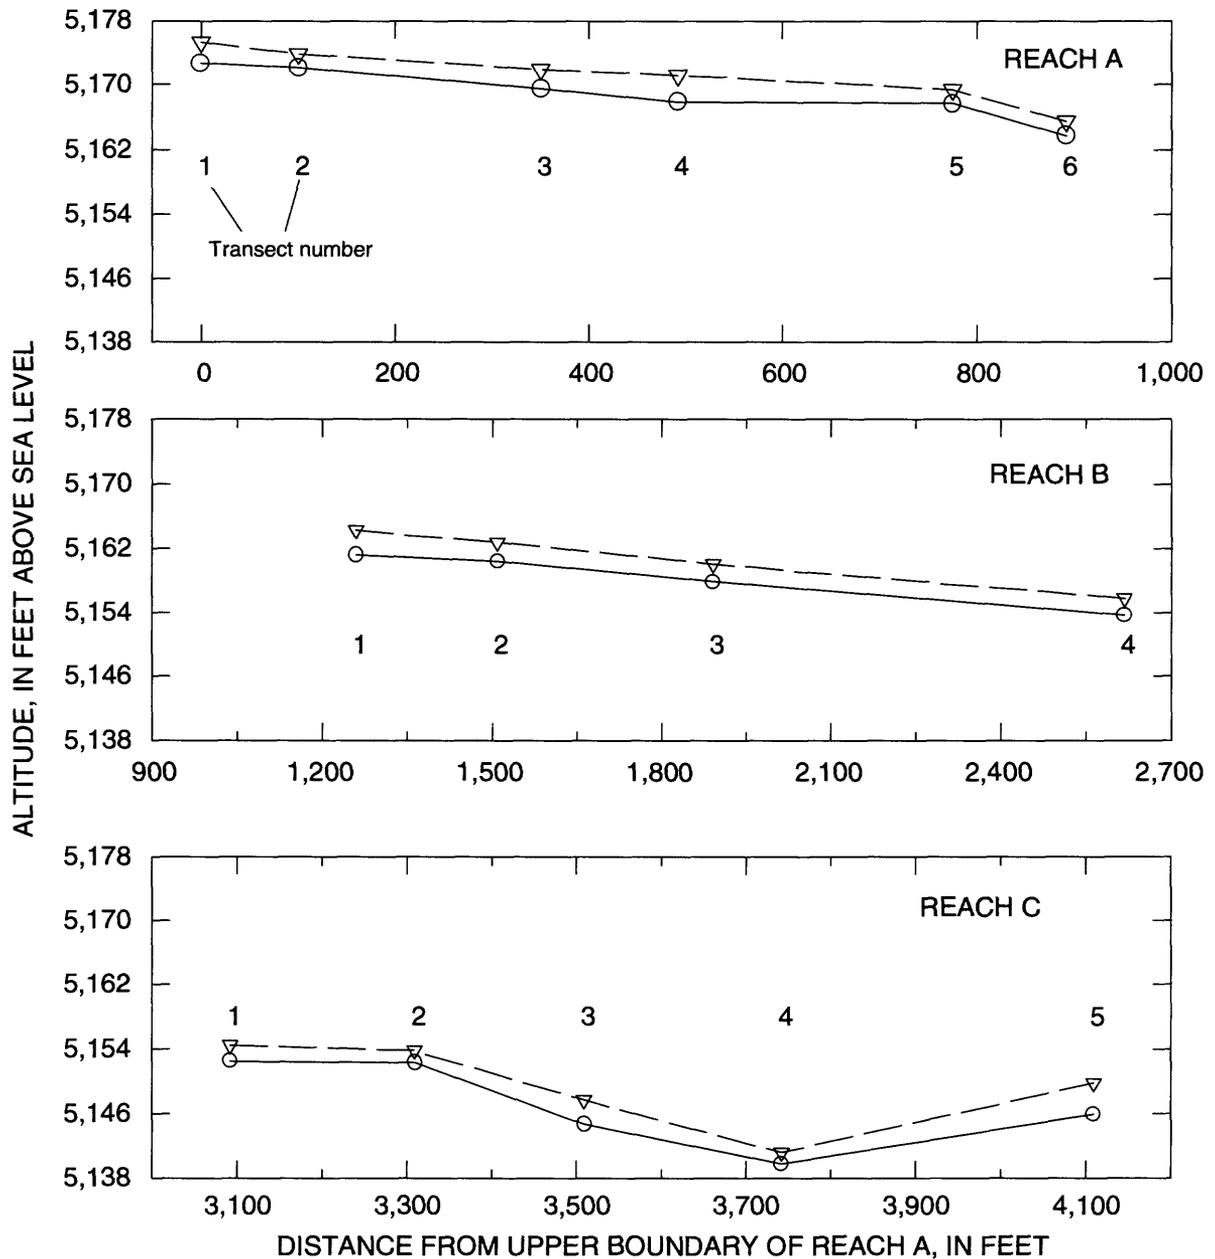
**Figure 32.** Longitudinal profiles of streambed (○) and water-surface (▽) altitudes measured along the thalweg in reaches A-C, Truckee River at Farad, Calif., October 1993.

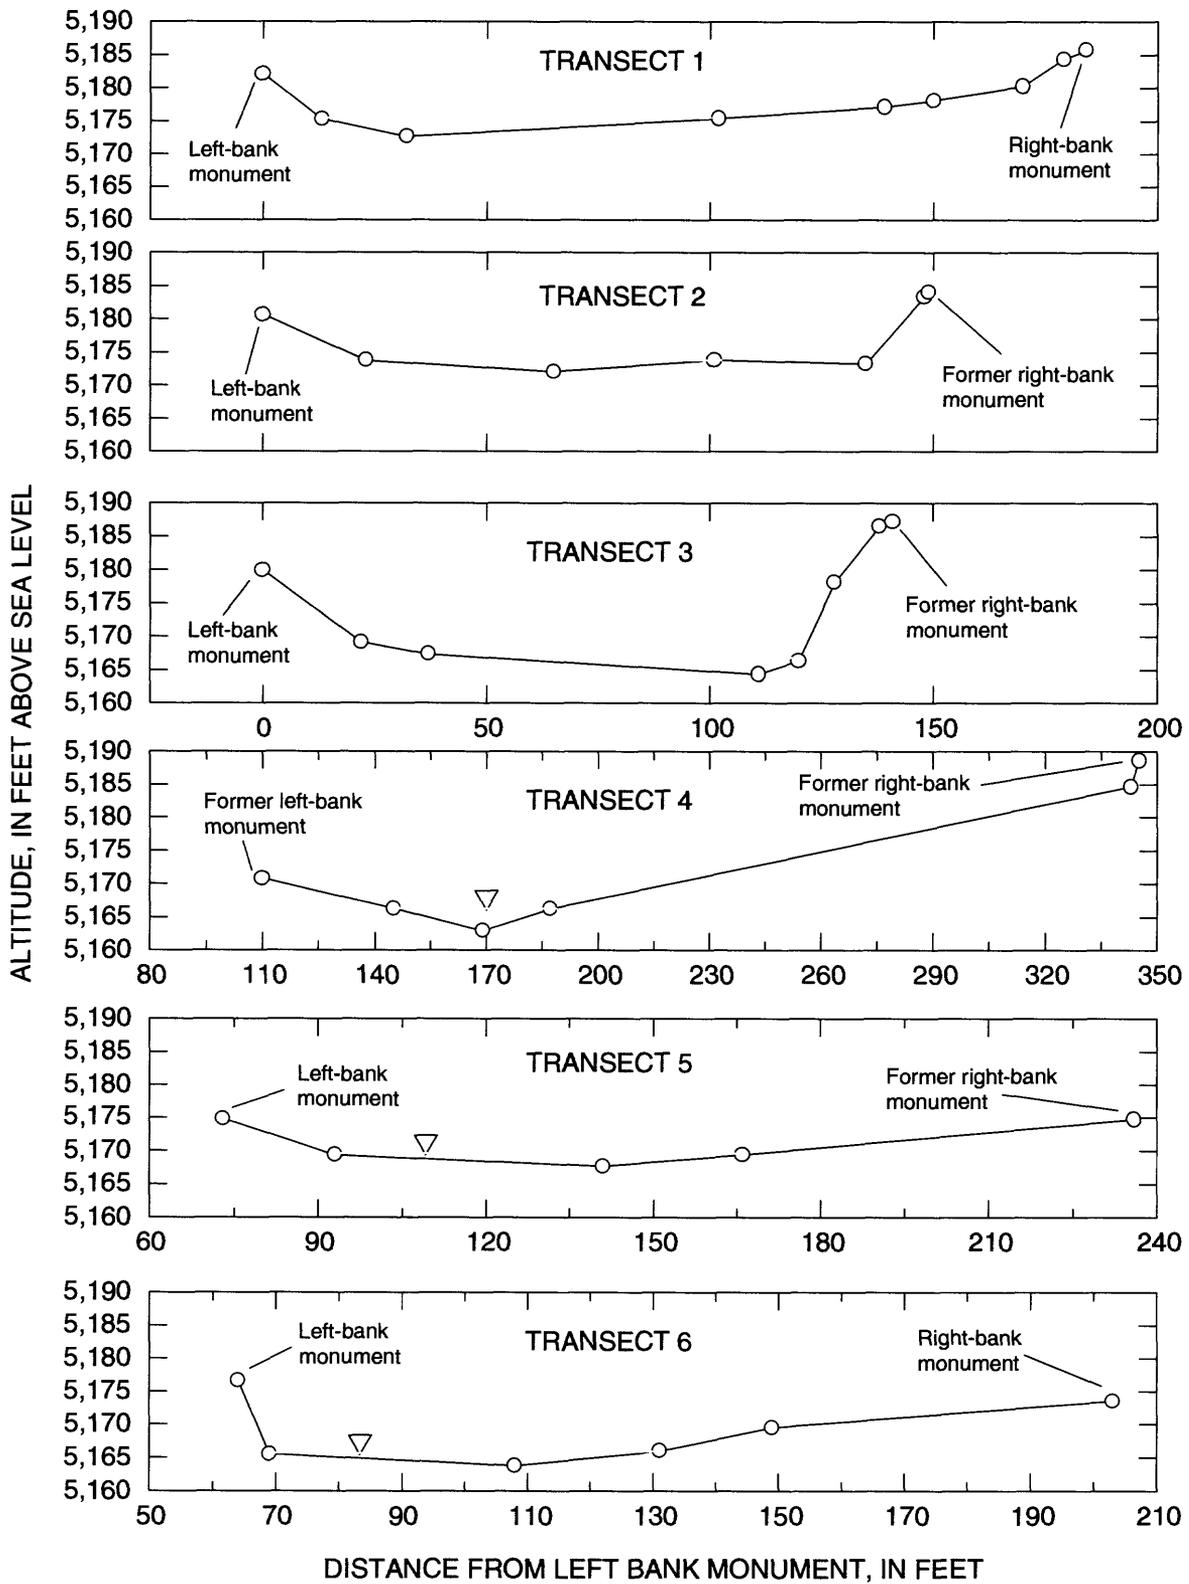
**Figure 33.** Cross sections showing land-surface (O) and water-surface (∇) altitudes for selected transects in reach A, Truckee River at Farad, Calif., October 1993.

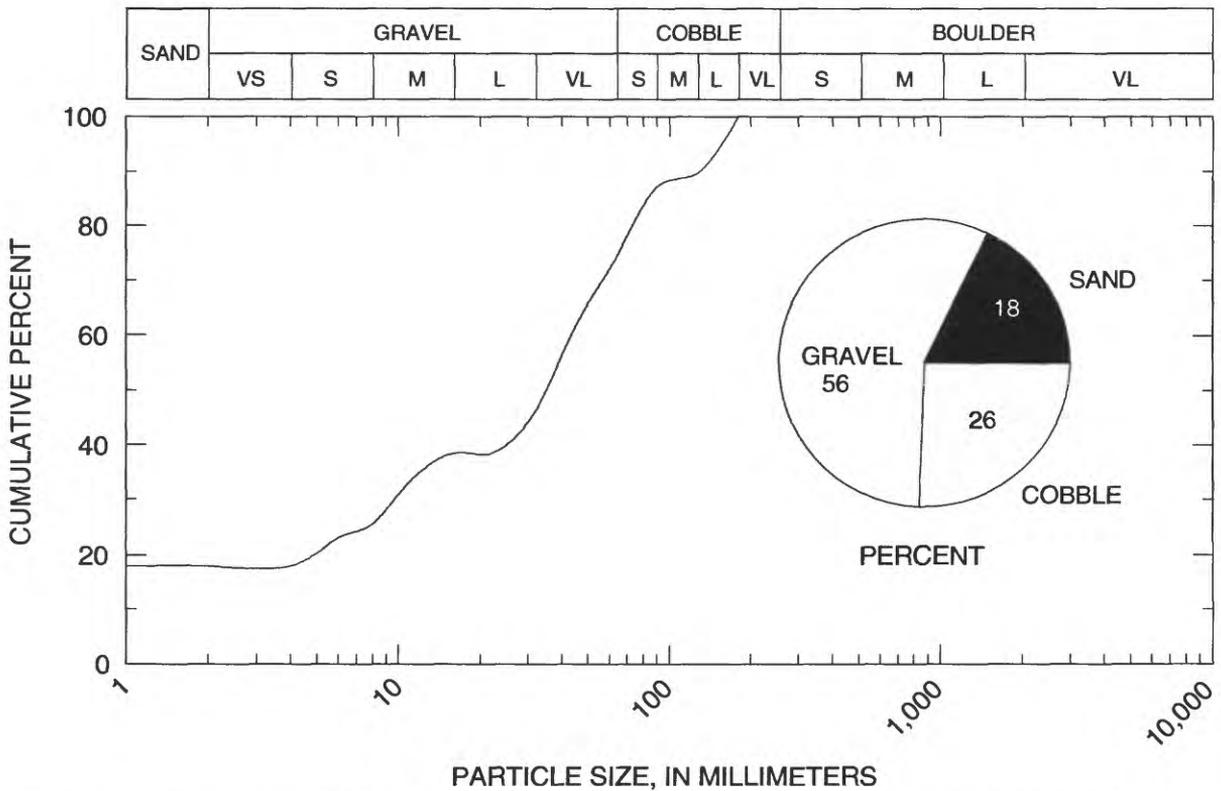
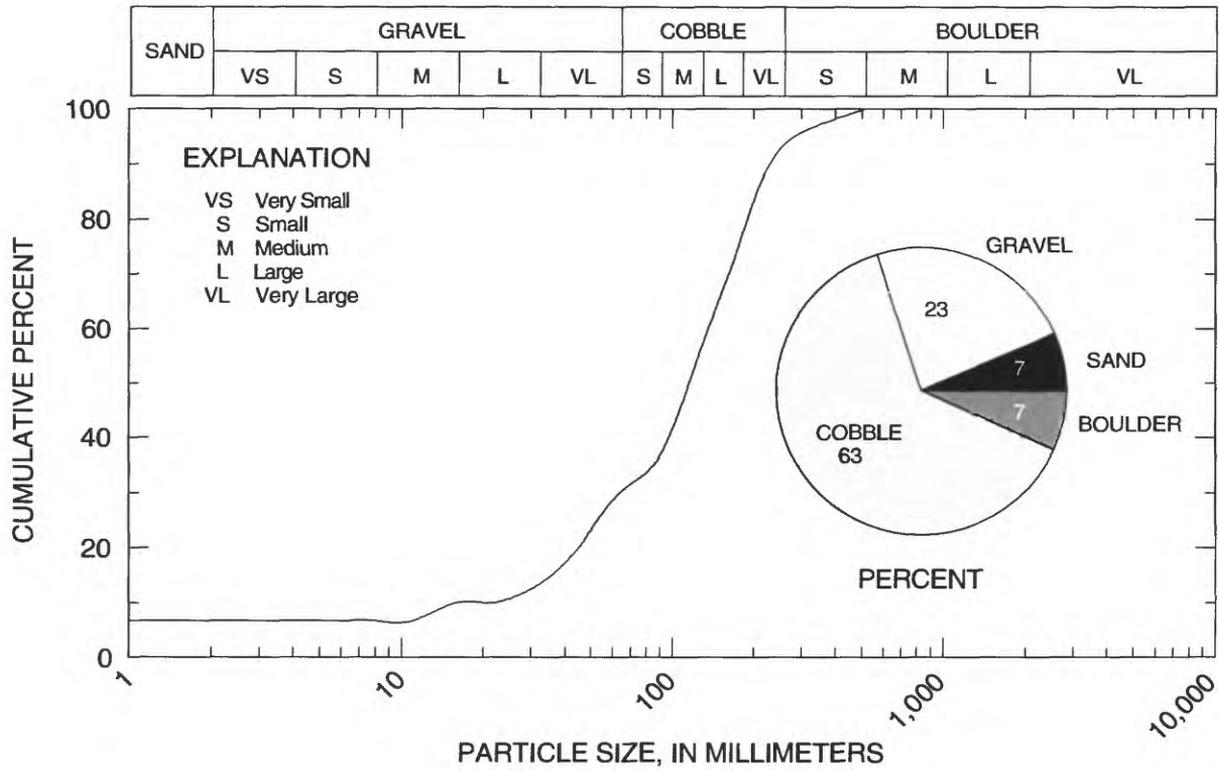
**Figure 34.** Particle-size distribution of coarse streambed substrate for selected transects in reach A, Truckee River at Farad, Calif., September 1994.

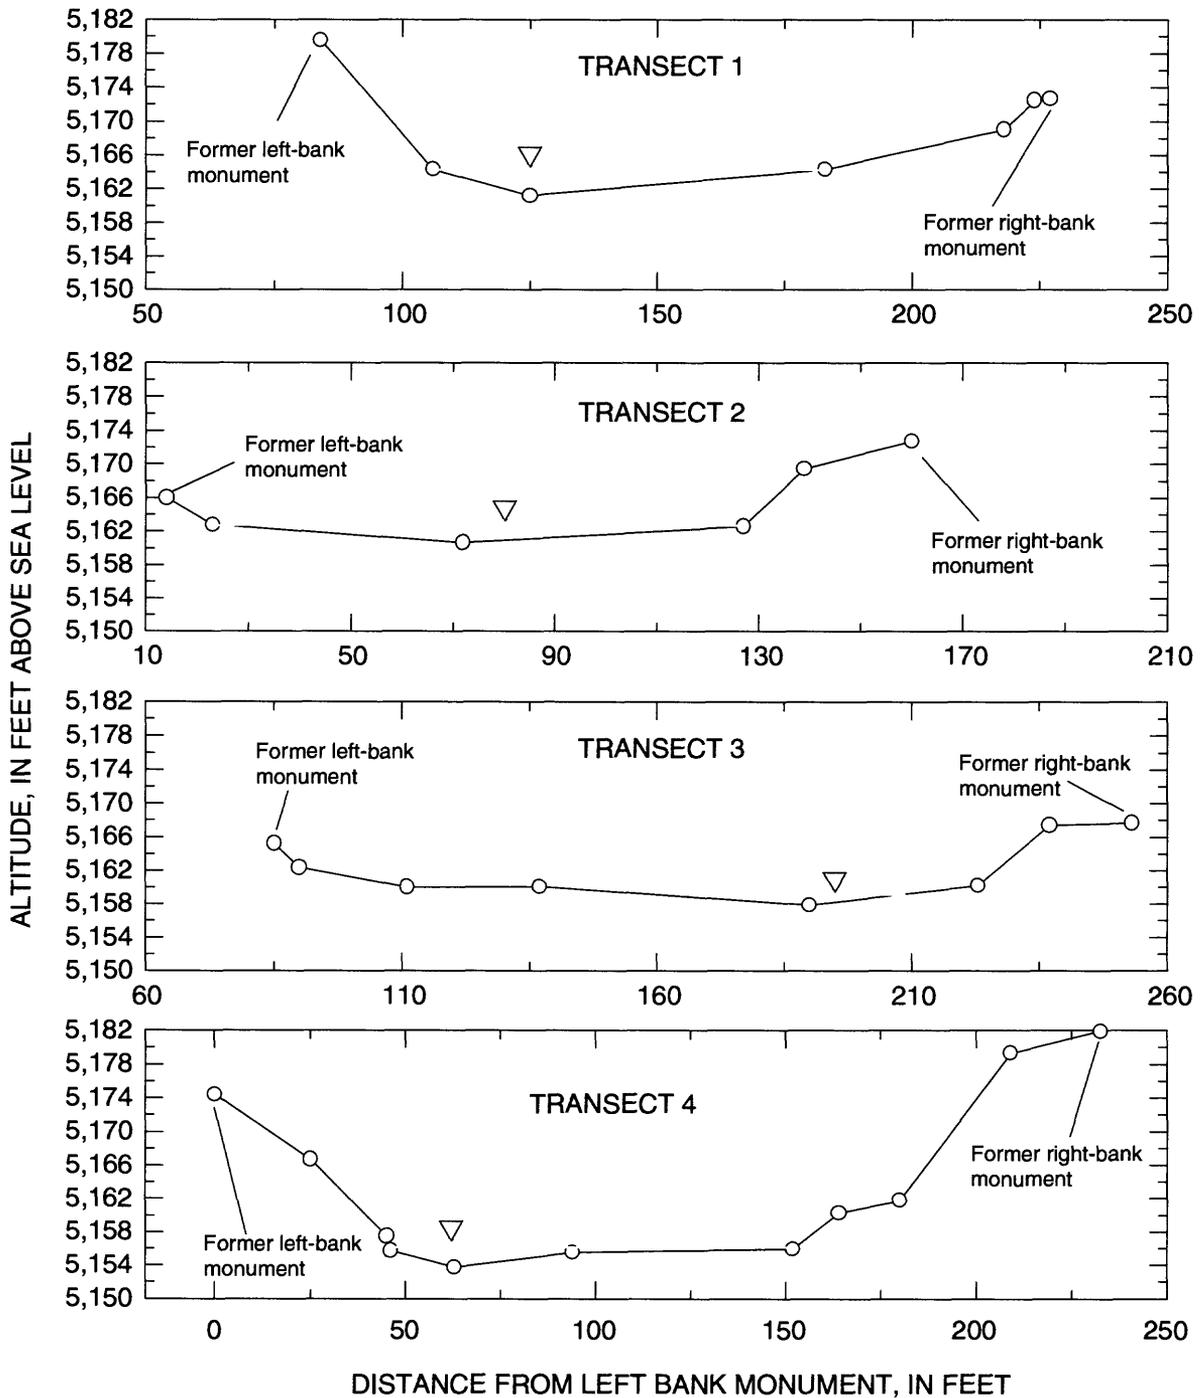
**Figure 35.** Cross sections showing land-surface (O) and water-surface (∇) altitudes for selected transects in reach B, Truckee River at Farad, Calif., October 1993.

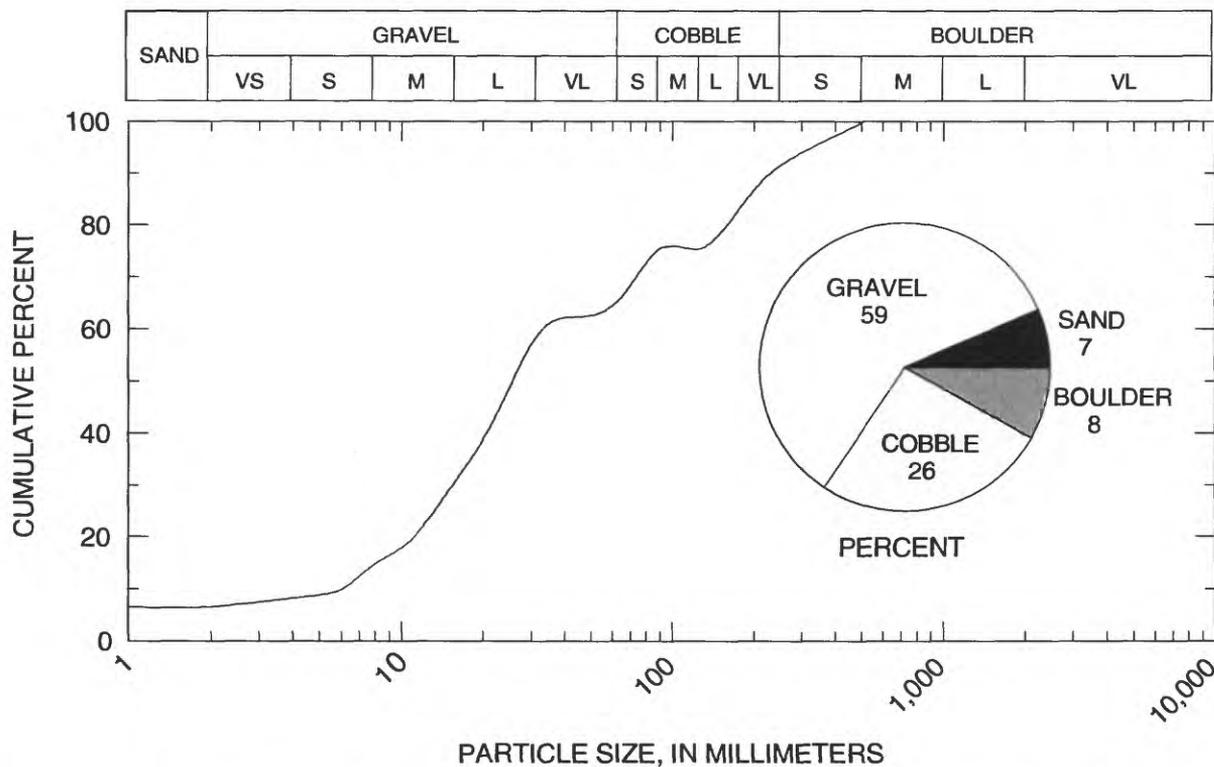
**Figure 36.** Particle-size distribution of coarse streambed substrate for selected transects in reach B, Truckee River at Farad, Calif., September 1994.

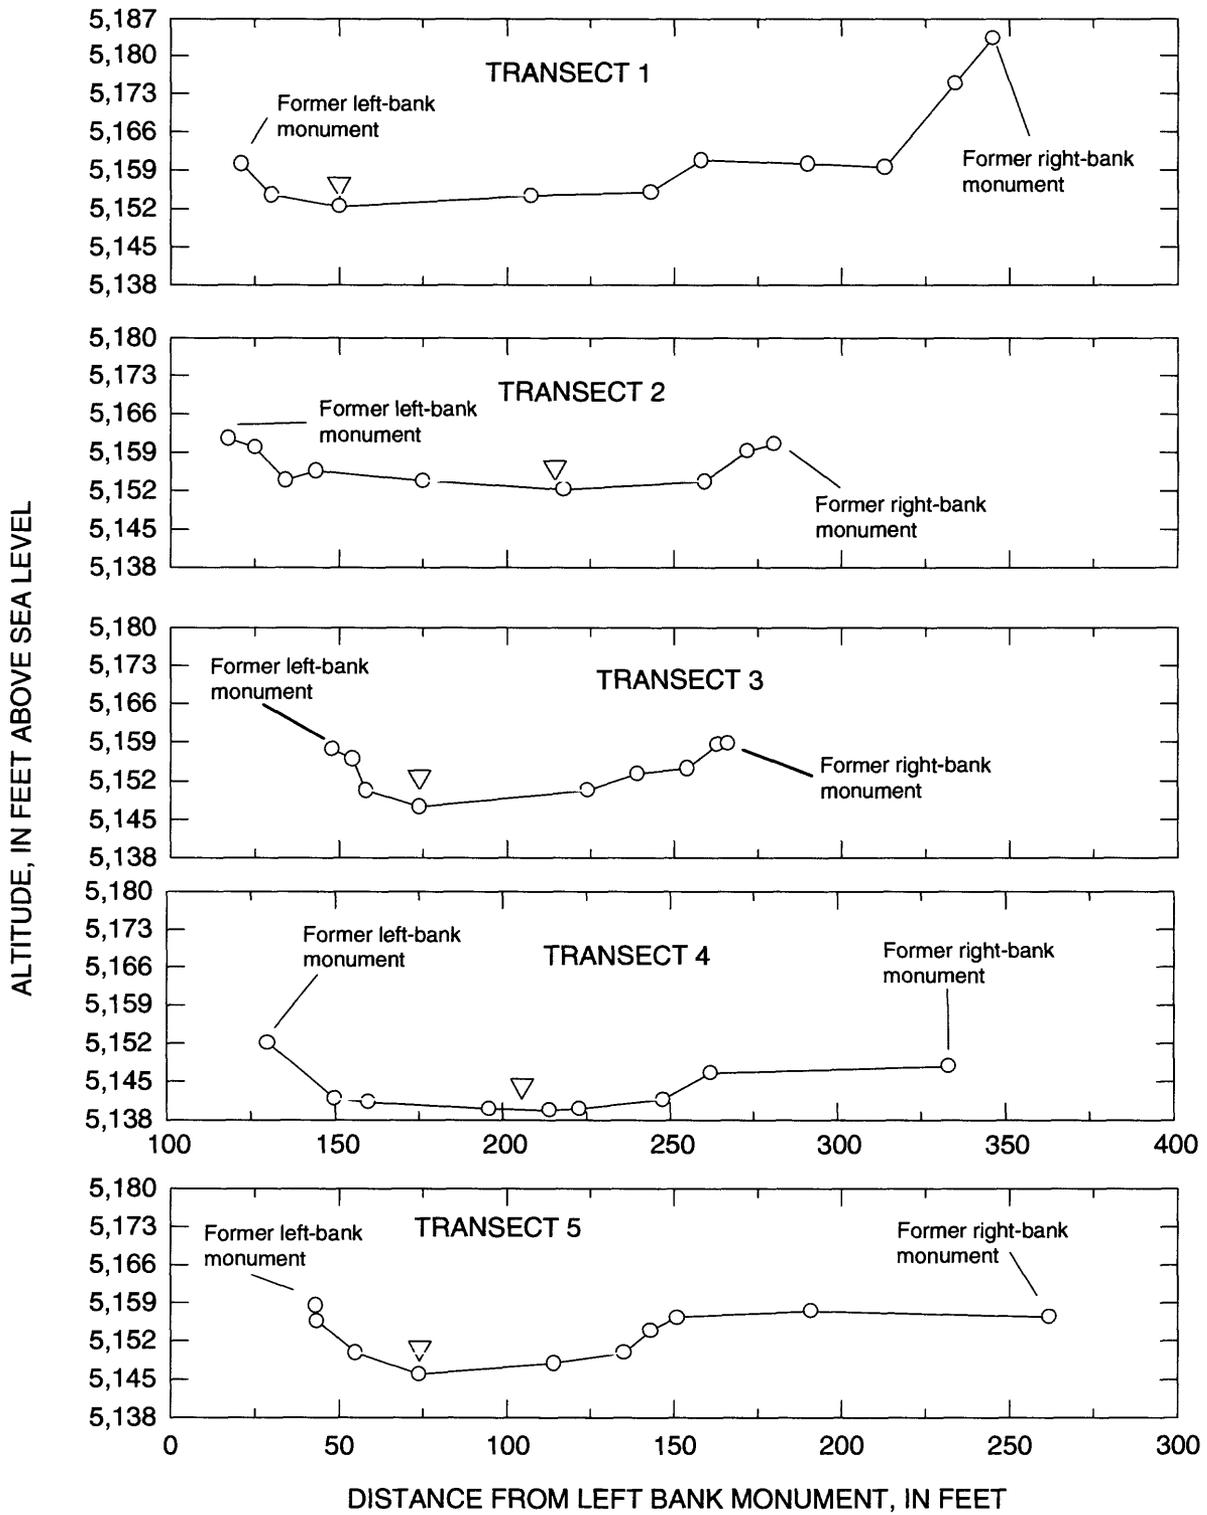
**Figure 37.** Cross sections showing land-surface (O) and water-surface (∇) altitudes for selected transects in reach C, Truckee River at Farad, Calif., October 1993.
