# Physical and Geomorphological Measurements for Selected River Segments in the Carson and Truckee River Basins, Nevada and California, 1993-96

Open-File Report 97-764

Prepared as part of the  
NATIONAL WATER-QUALITY ASSESSMENT PROGRAM

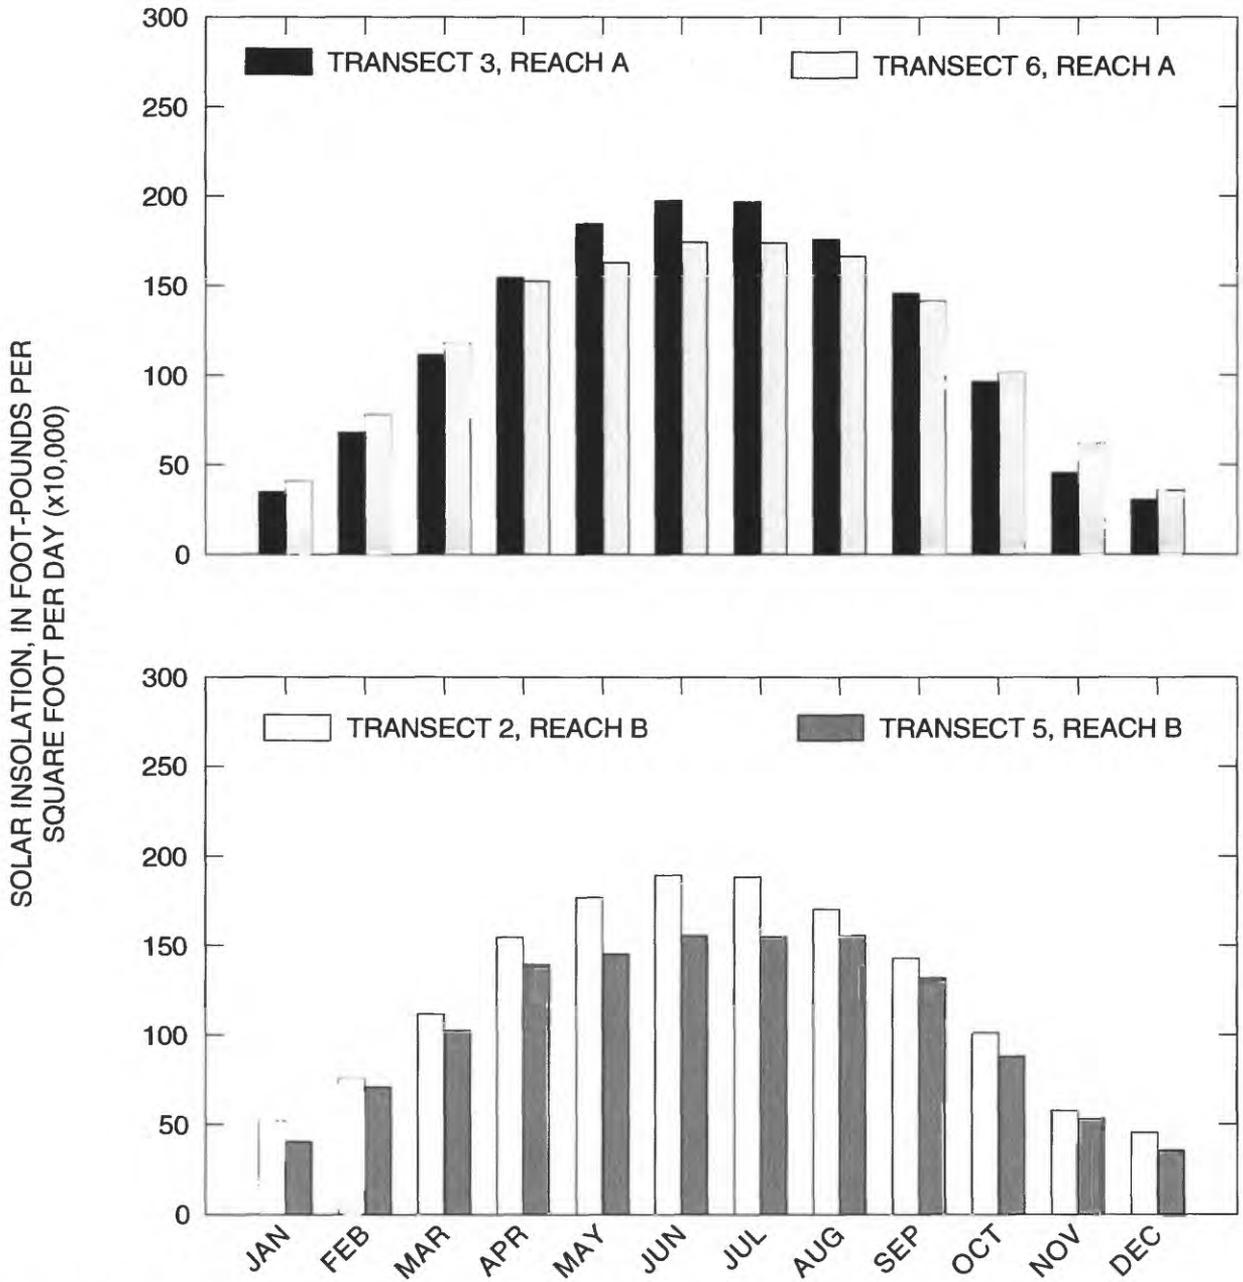
**Figure 38.** Monthly solar insolation midstream at selected transects in reaches A and B, Truckee River at Farad, Calif.

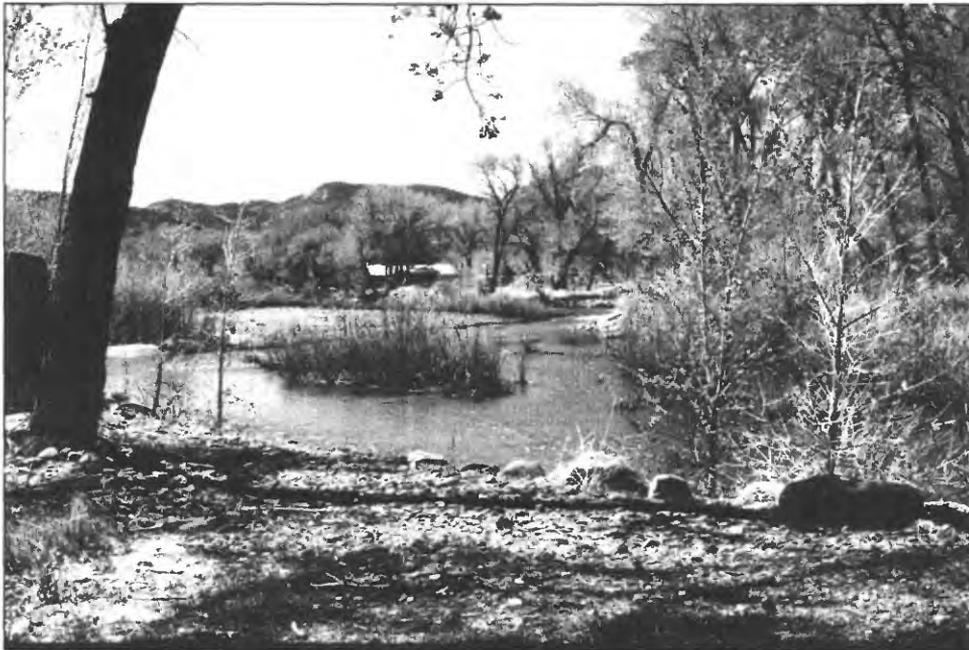
**Truckee River near Sparks, Nev.  
(U.S. Geological Survey Station 10348200)**

Downstream view of Truckee River from transect 5, reach A, Truckee River near Sparks, Nev. Photograph by Ronald P. Collins, U.S. Geological Survey, September 1993.

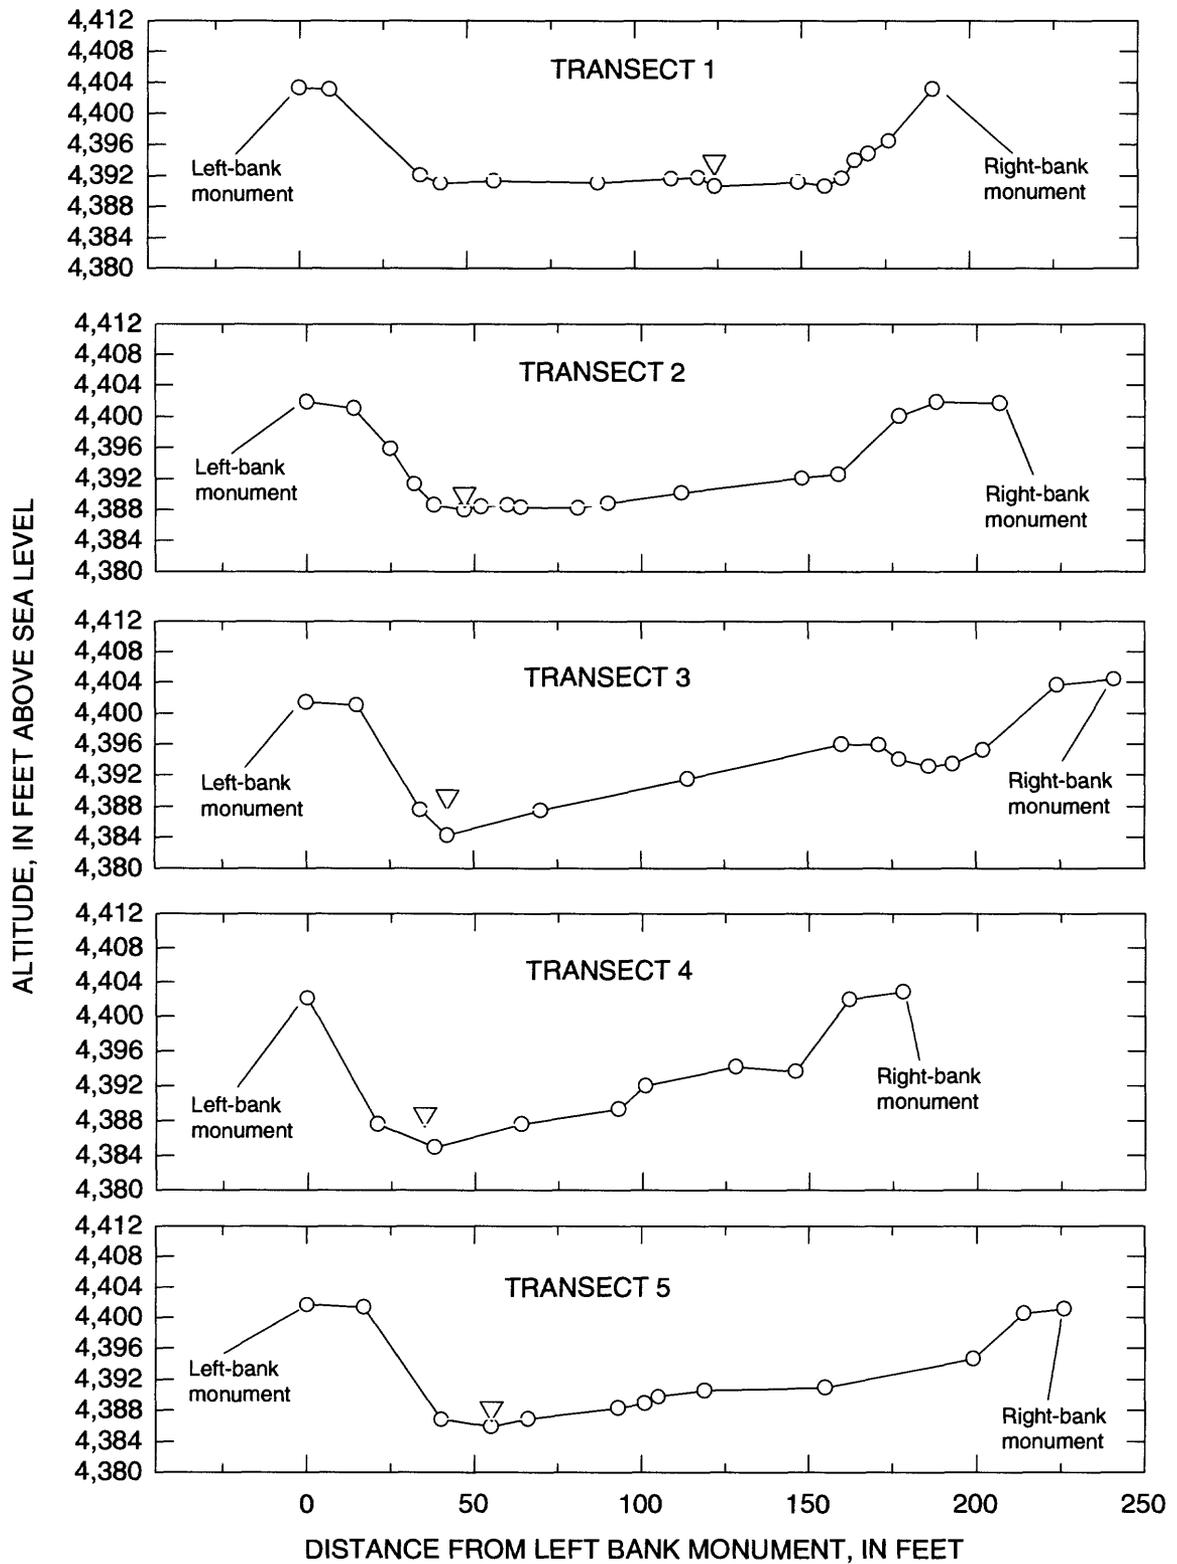
**Figure 41.** Cross sections showing land-surface (O) and water-surface (V) altitudes for selected transects in reach A, Truckee River near Sparks, Nev., October 1994.

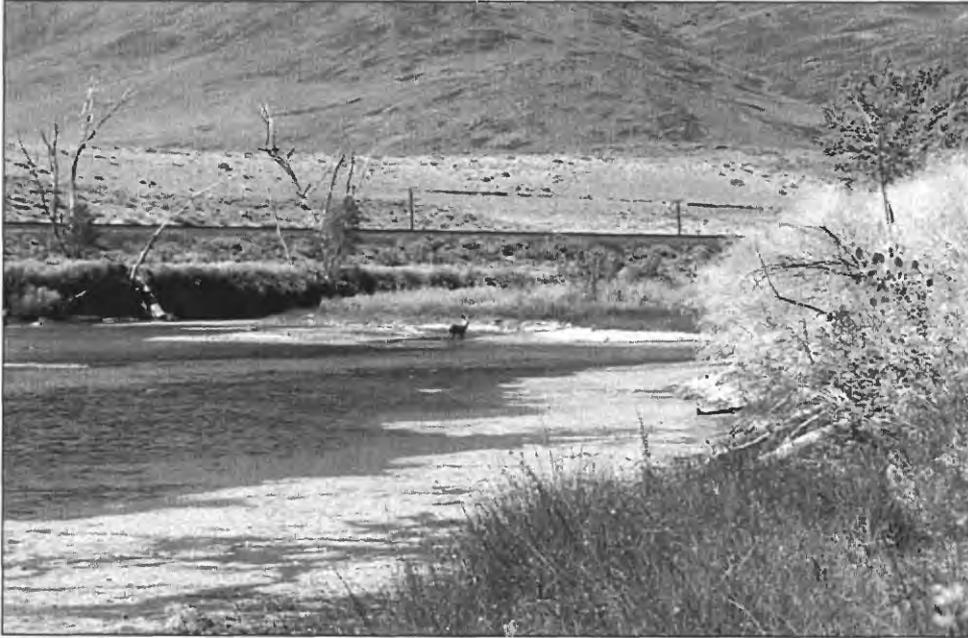
**Truckee River at Clark, Nev.  
(U.S. Geological Survey Station 10350500)**

Upstream view of Truckee River from transect 5, reach C, Truckee River at Clark, Nev.  
Photograph by Sonya Vasquez, U.S. Geological Survey, September 1995.

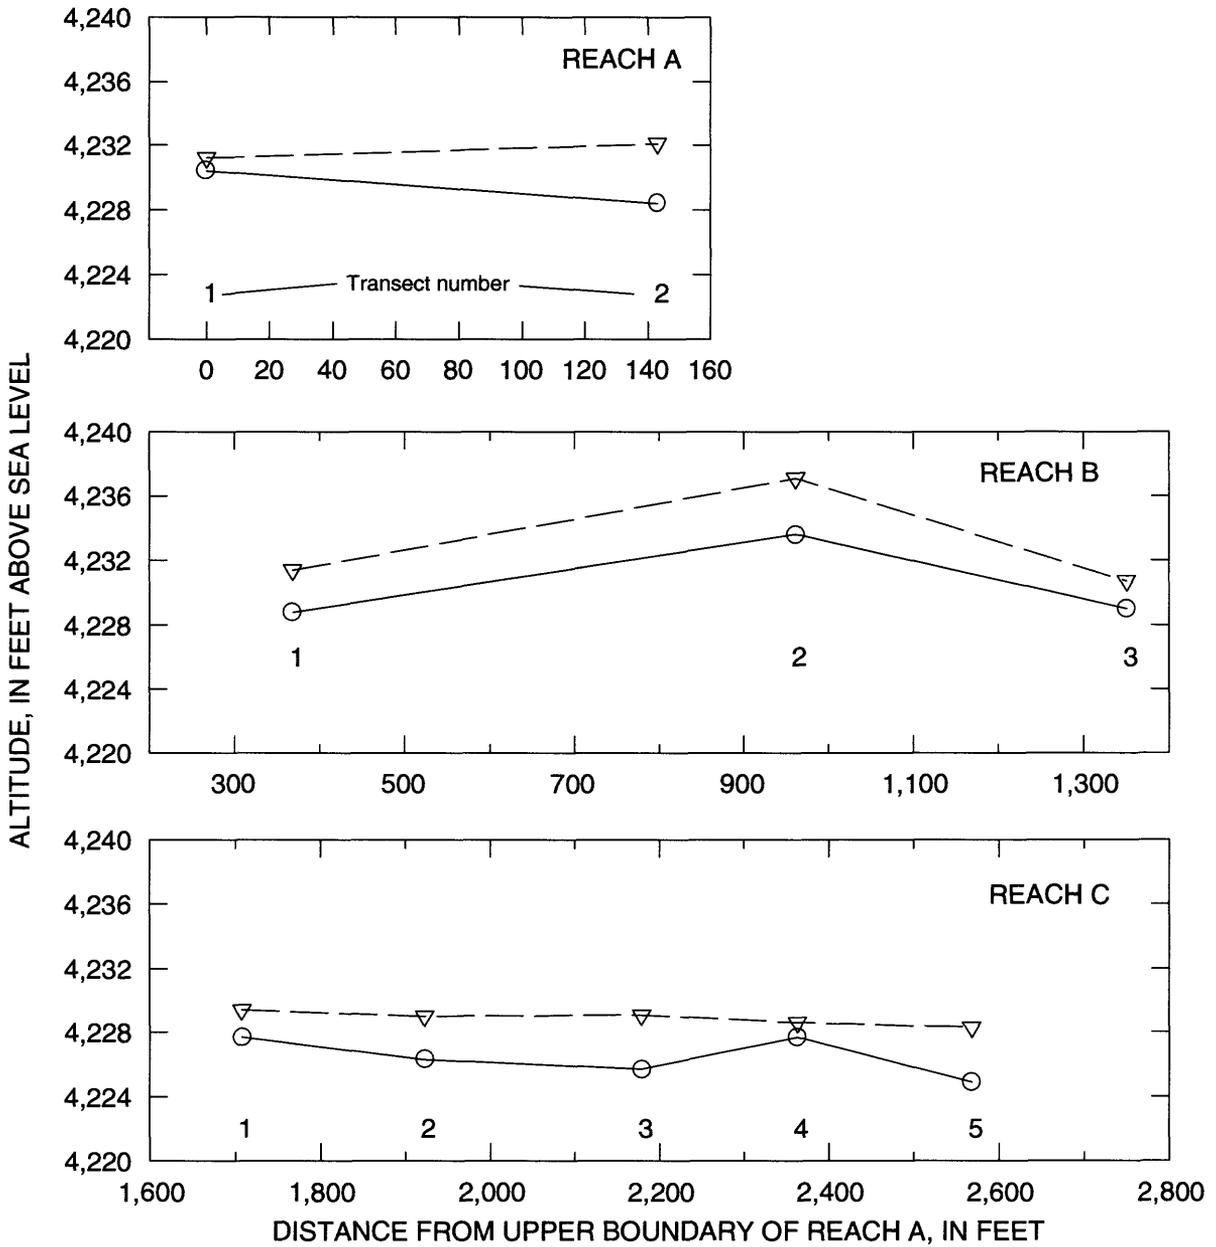
**Figure 44.** Longitudinal profiles of streambed (○) and water-surface (▽) altitudes measured along the thalweg in reaches A-C, Truckee River at Clark, Nev., October 1993.

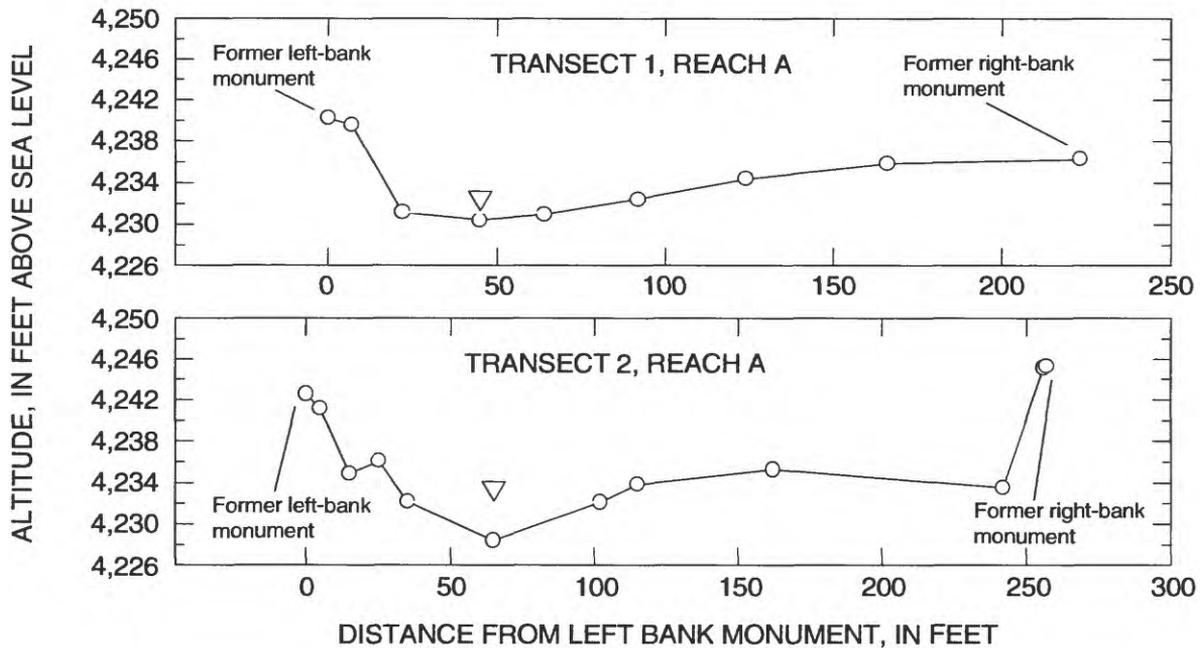
**Figure 45.** Cross sections showing land-surface (O) and water-surface (∇) altitudes for selected transects in reach A, Truckee River at Clark, Nev., October 1993.

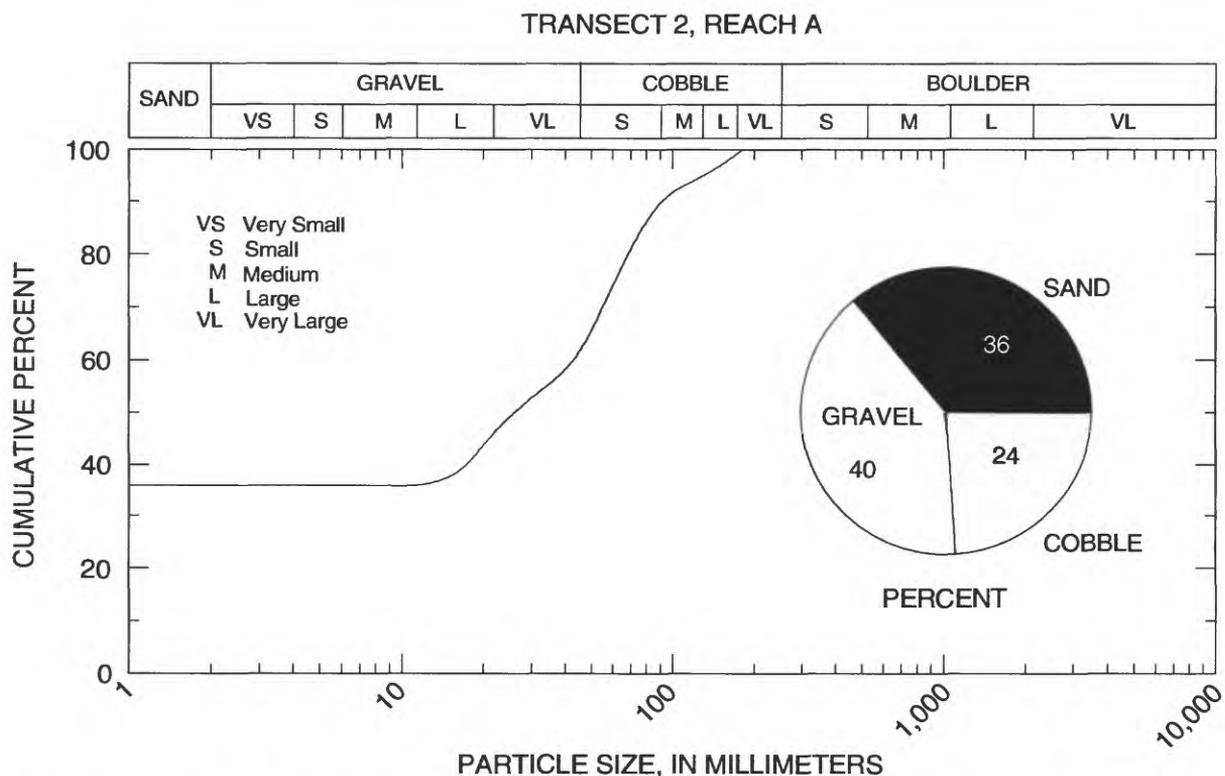
**Figure 46.** Particle-size distribution for coarse streambed substrate at selected transects in reach A, Truckee River at Clark, Nev., September 1994

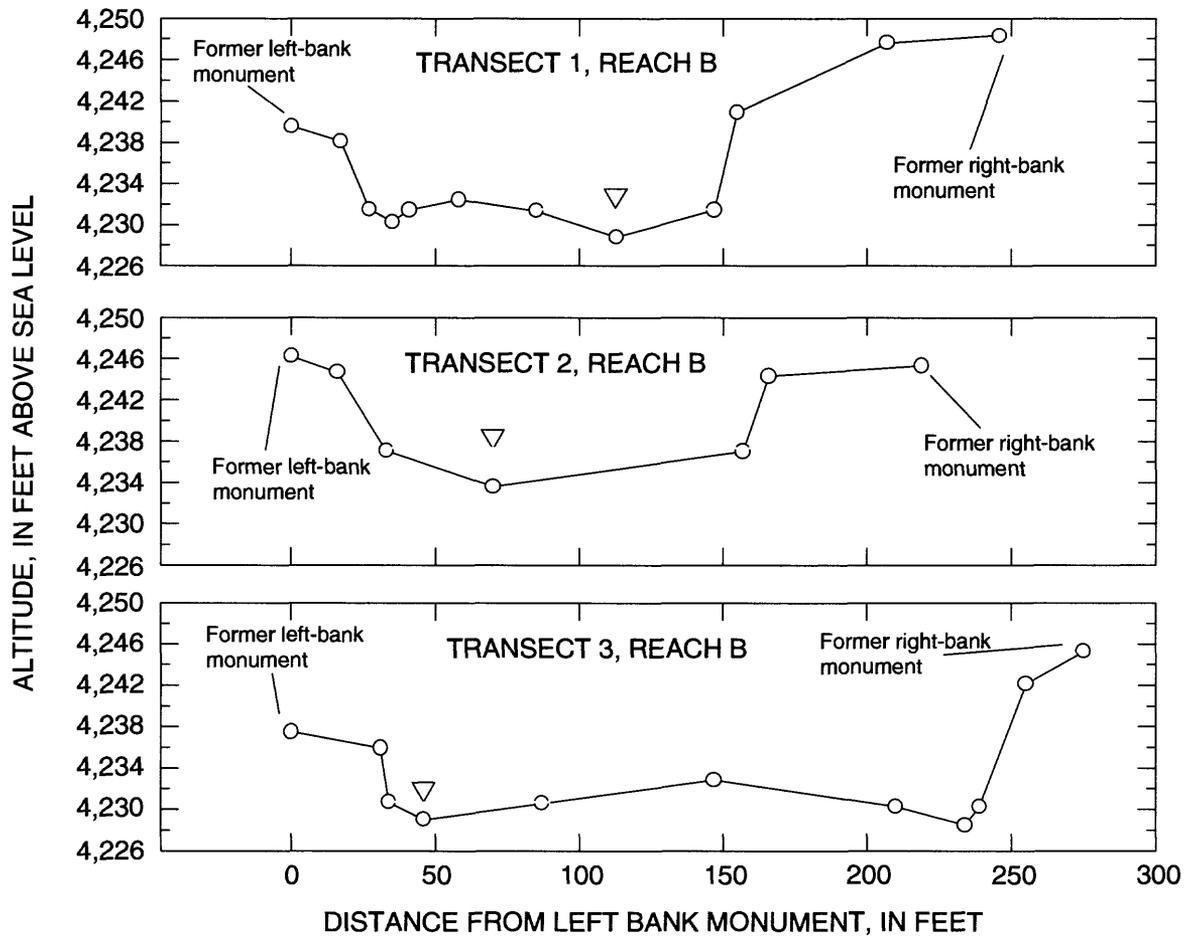
**Figure 47.** Cross sections showing land-surface (O) and water-surface (∇) altitudes for selected transects in reach B, Truckee River at Clark, Nev., October 1993.

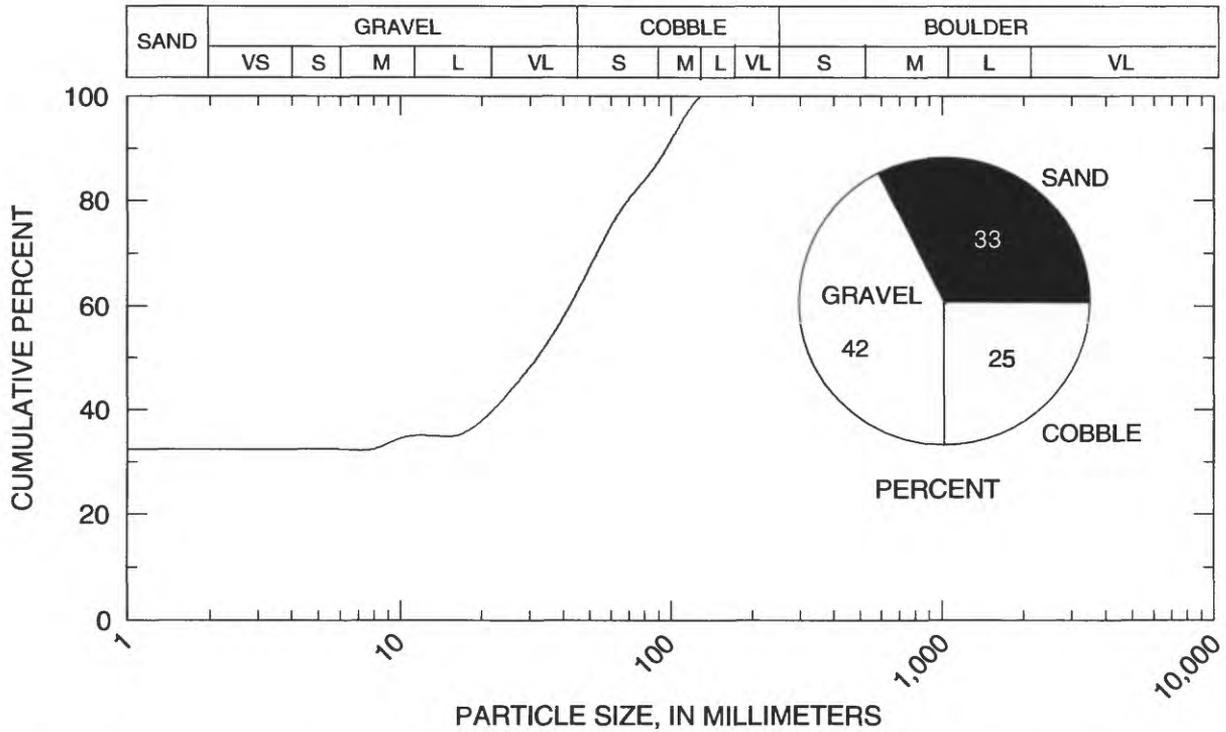
**Figure 48.** Particle-size distribution for coarse streambed substrate at transect 3 in reach B, Truckee River at Clark, Nev., September 1994

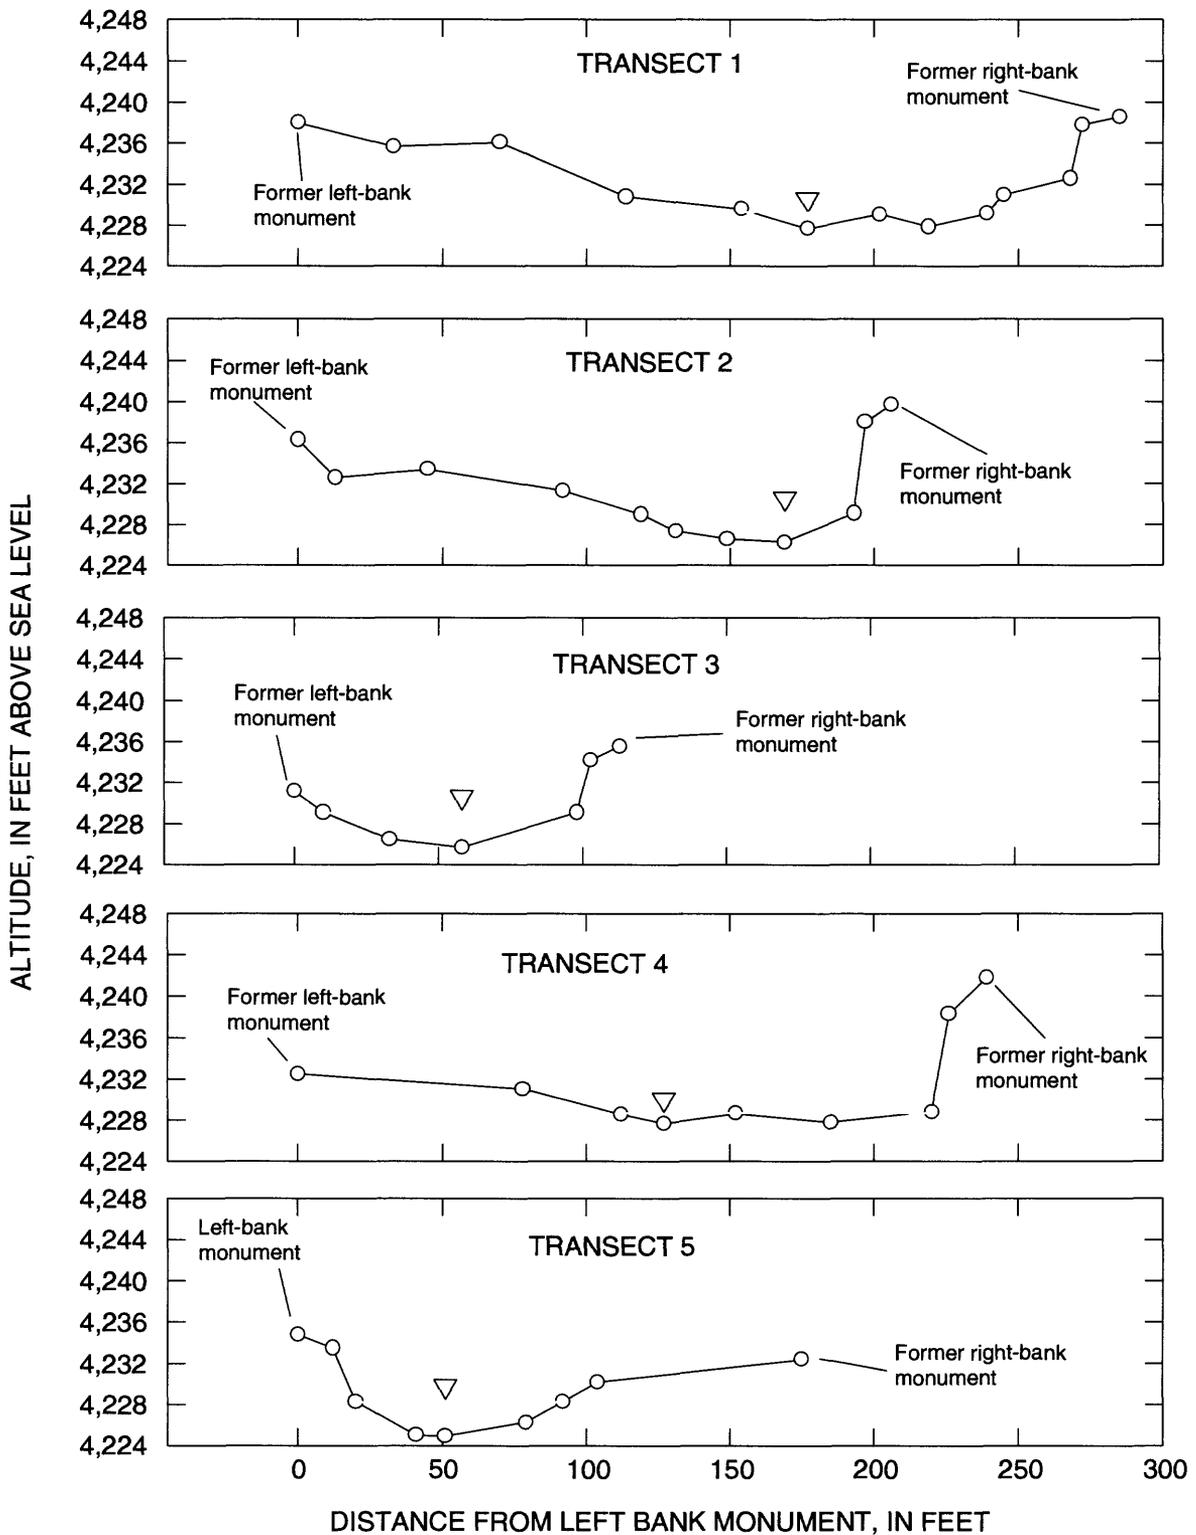
**Figure 49.** Cross sections showing land-surface (○) and water-surface (▽) altitudes for selected transects in reach C, Truckee River at Clark, Nev., October 1993.

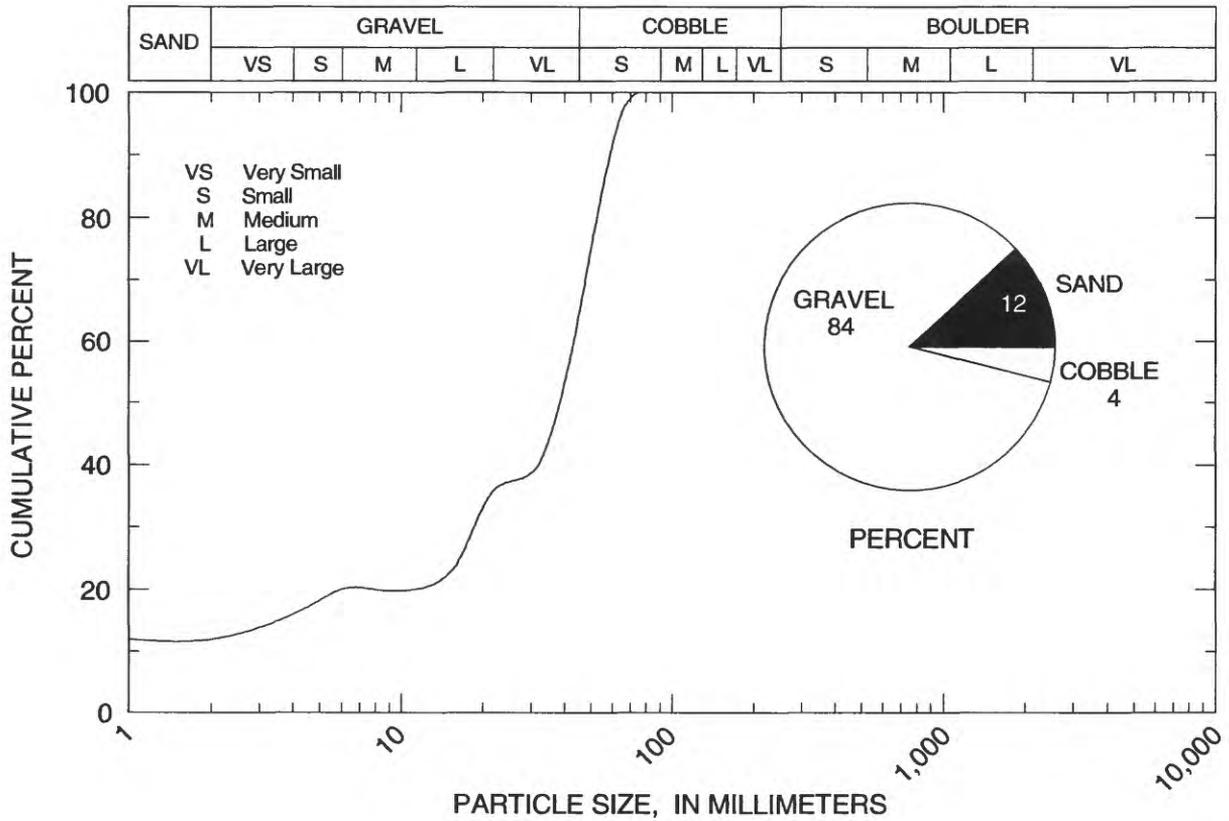
Figure 50. Particle-size distribution for coarse streambed substrate at transect 4 in reach C, Truckee River at Clark, Nev., September 1994

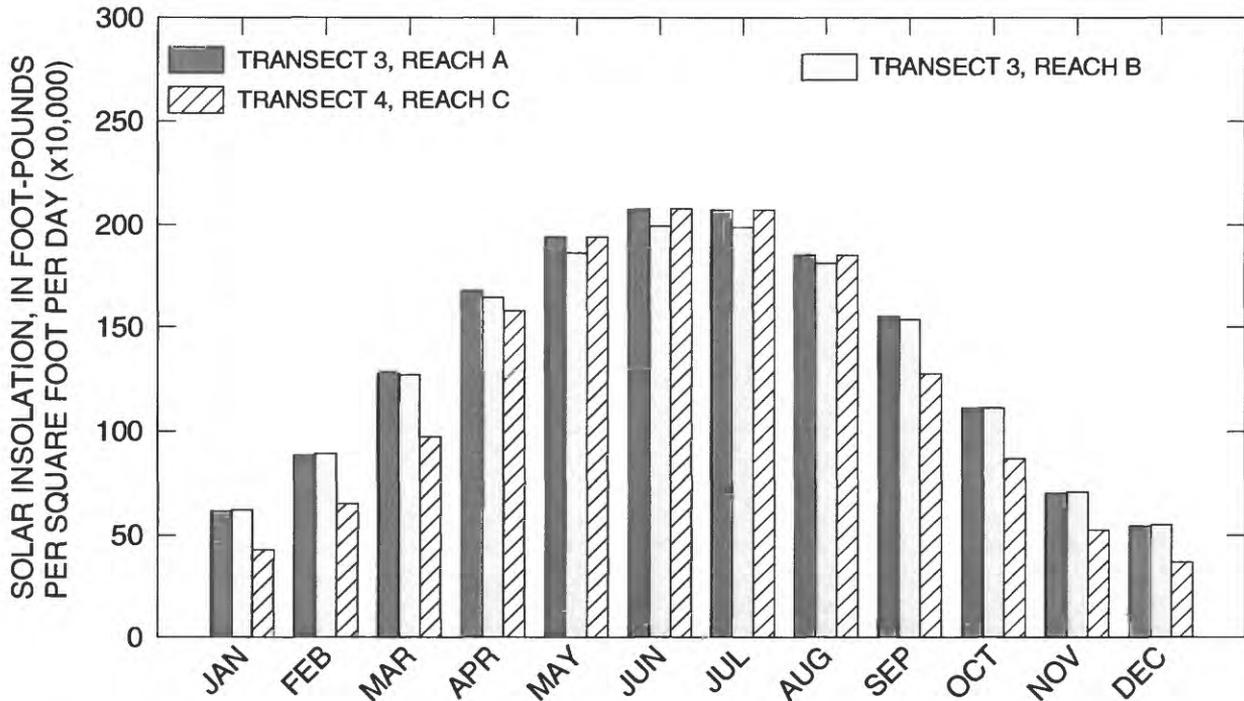
Figure 51. Monthly solar insolation midstream at selected transects in reaches A-C, Truckee River at Clark, Nev.

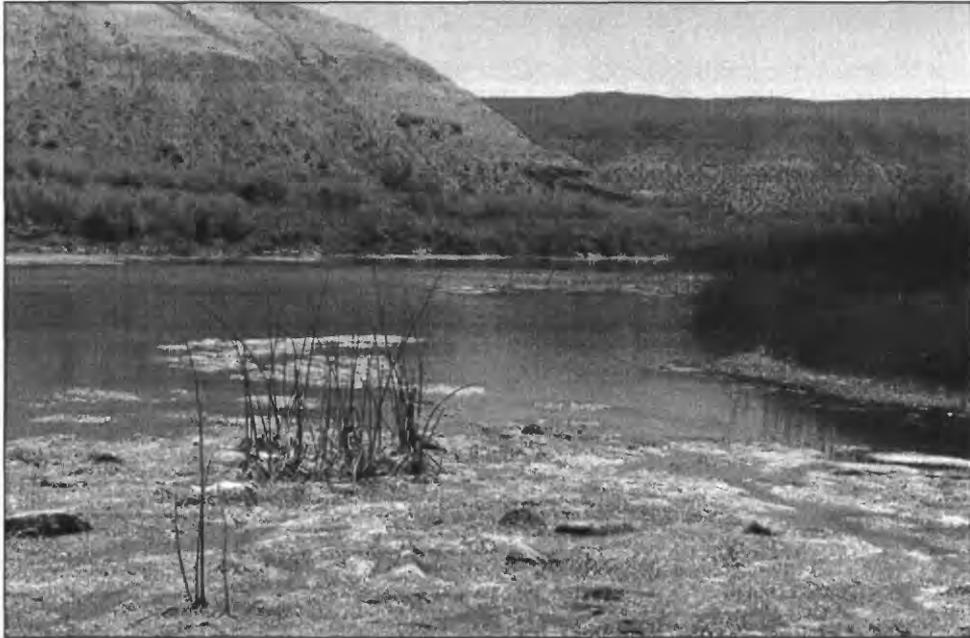
**Truckee River at Dead Ox Wash near Nixon, Nev.  
(U.S. Geological Survey Station 10351690)**

Upstream view of Truckee River from transect 1, reach A, Truckee River at Dead Ox Wash near Nixon, Nev. Photograph by Sonya Vasquez, U.S. Geological Survey, September 1995.

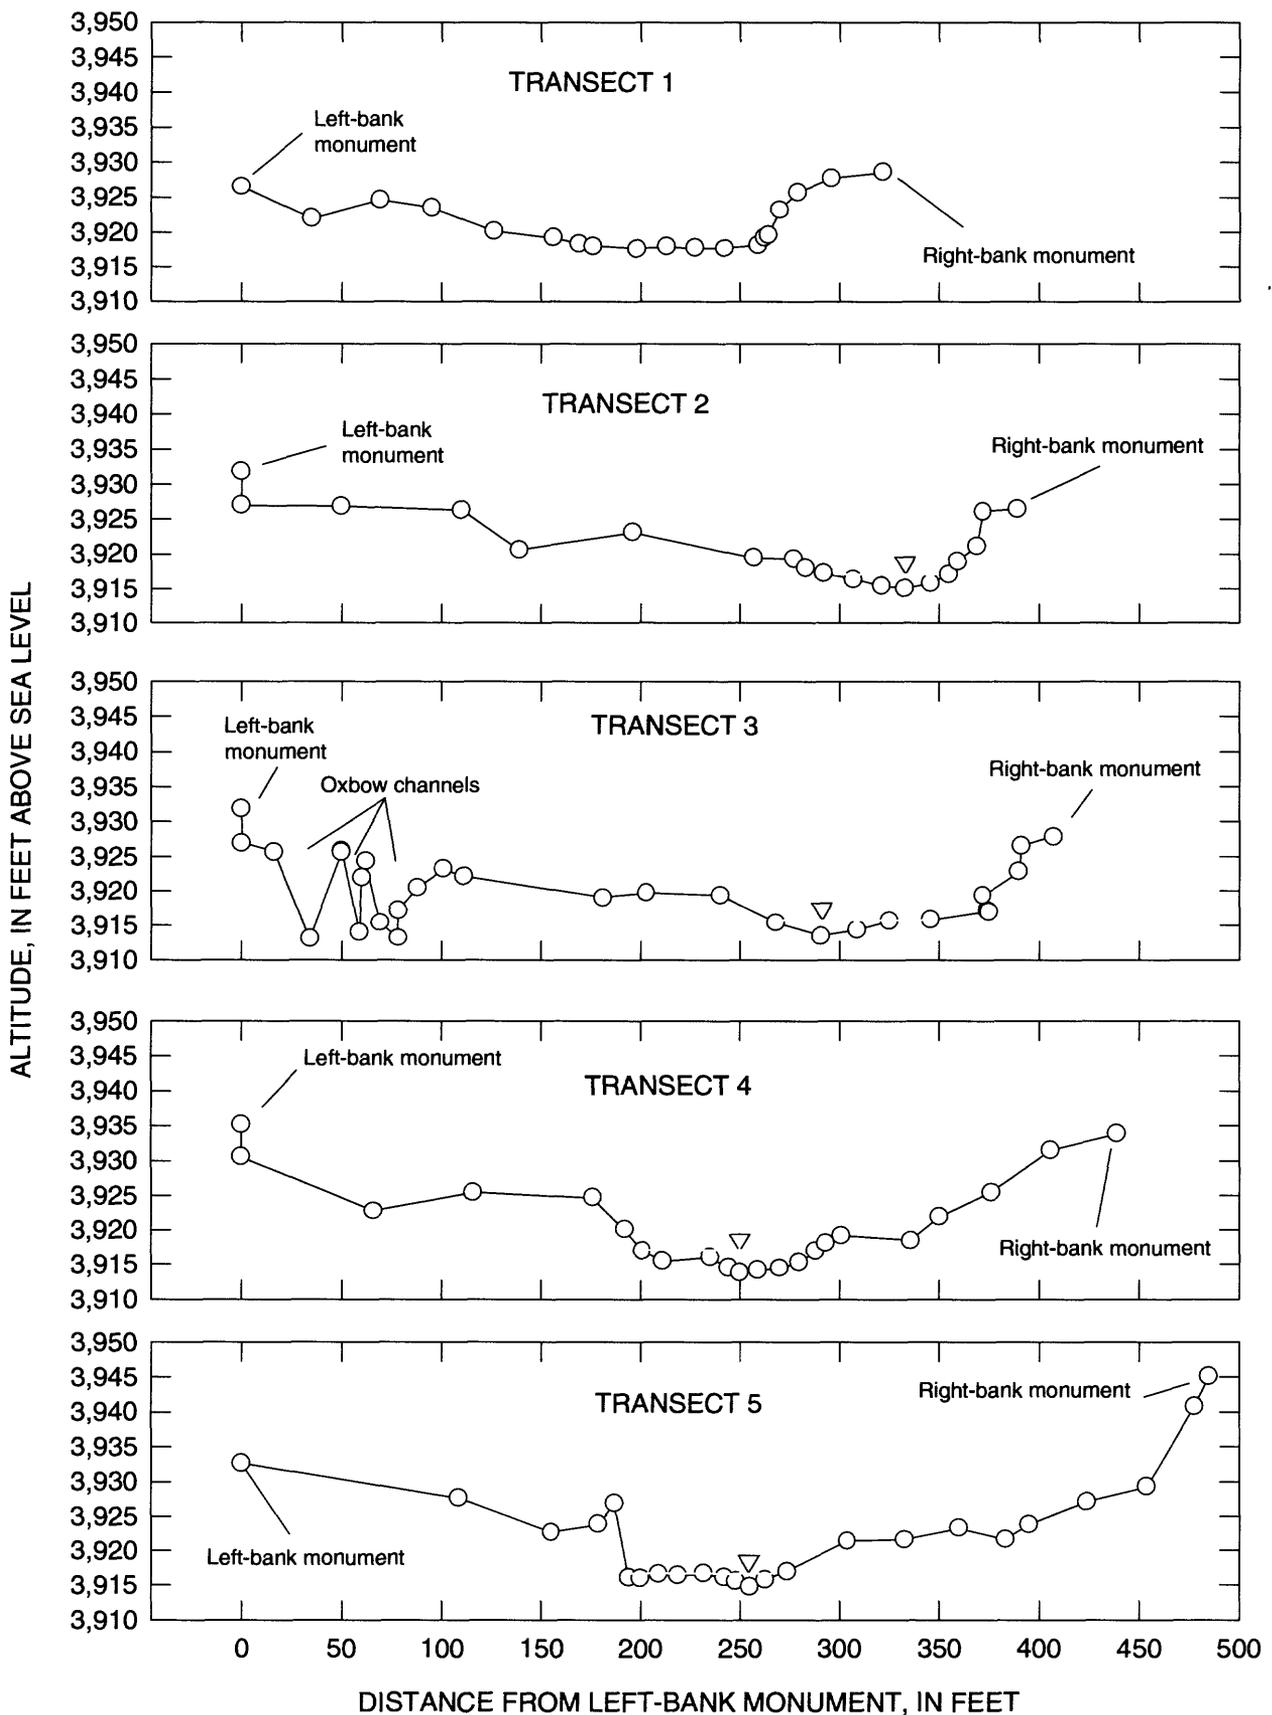
**Figure 54.** Cross sections showing land-surface (O) and water-surface (▽) altitudes for selected transects in reach A, Truckee River at Dead Ox Wash near Nixon, Nev., October 1994.

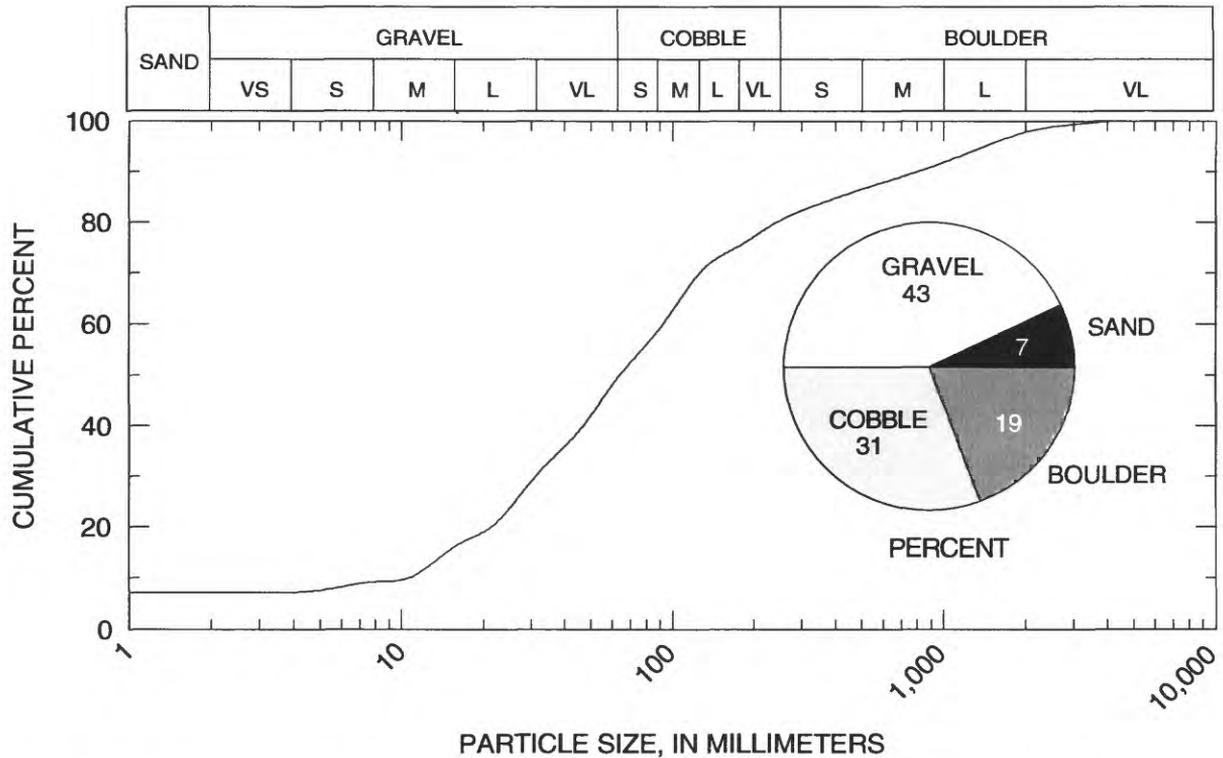
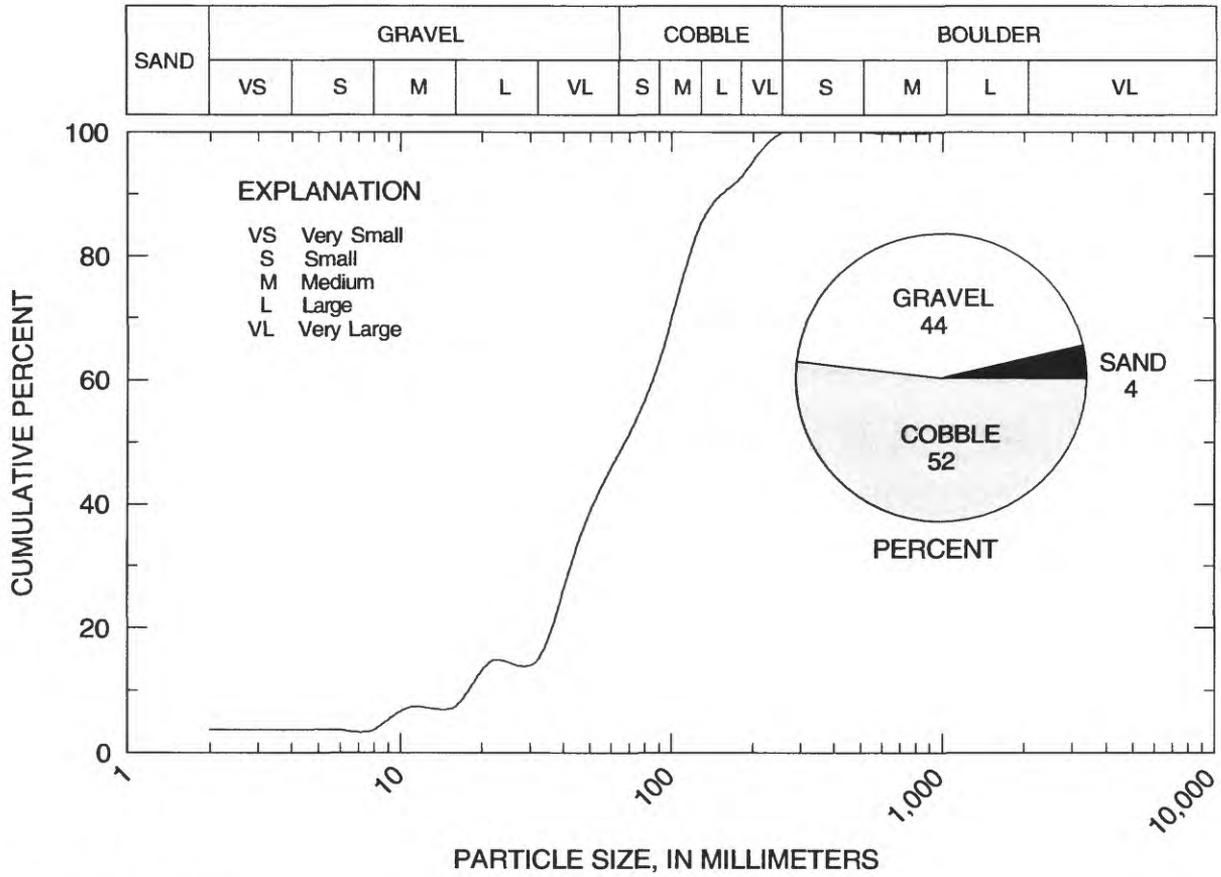
**Figure 55.** Particle-size distribution of coarse streambed substrate, Truckee River at Circle C Ranch near Lawton, Nev.; at Idlewild Park at Reno, Nev.; and at Lockwood, Nev., August 1994.

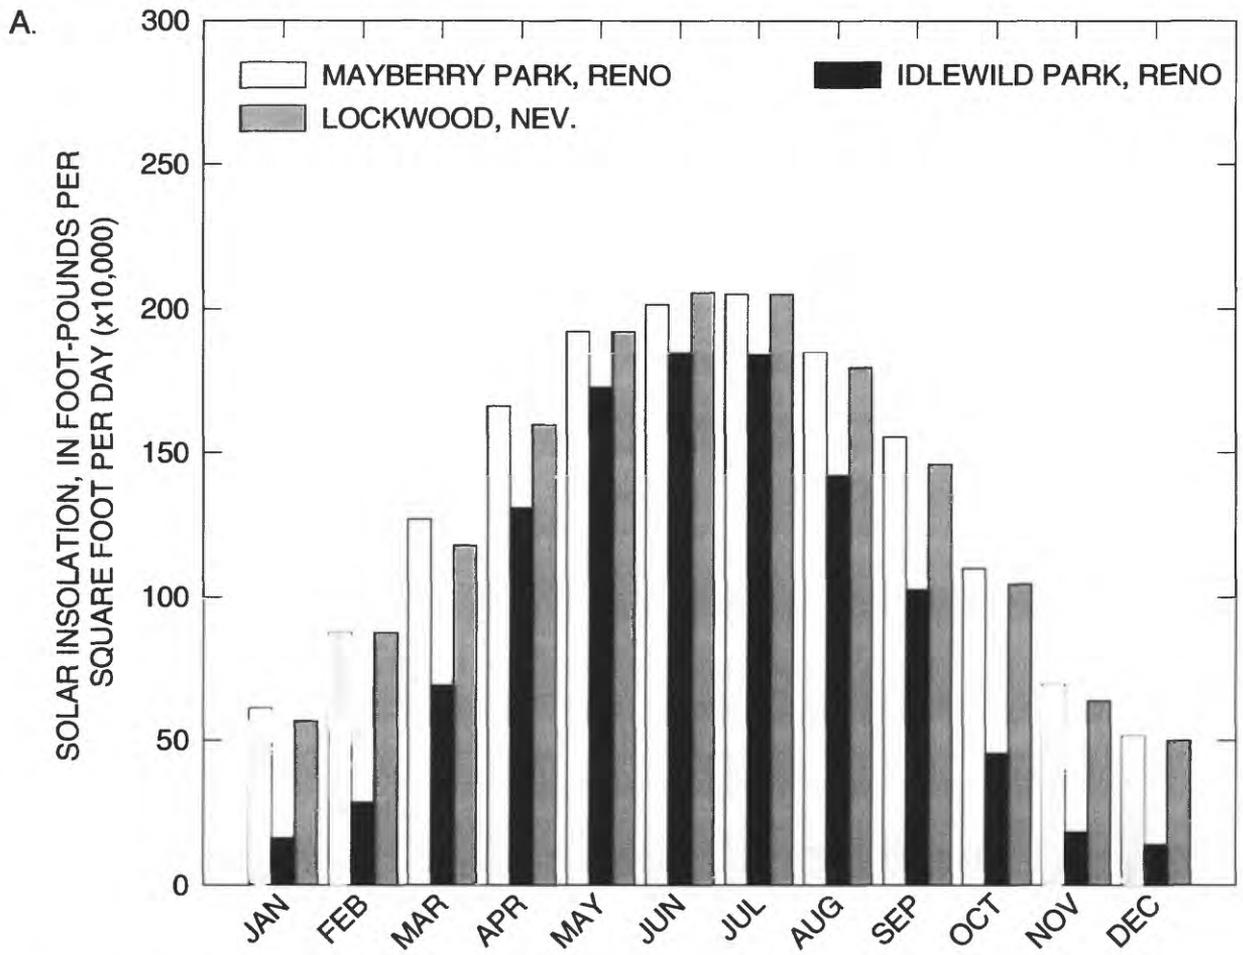
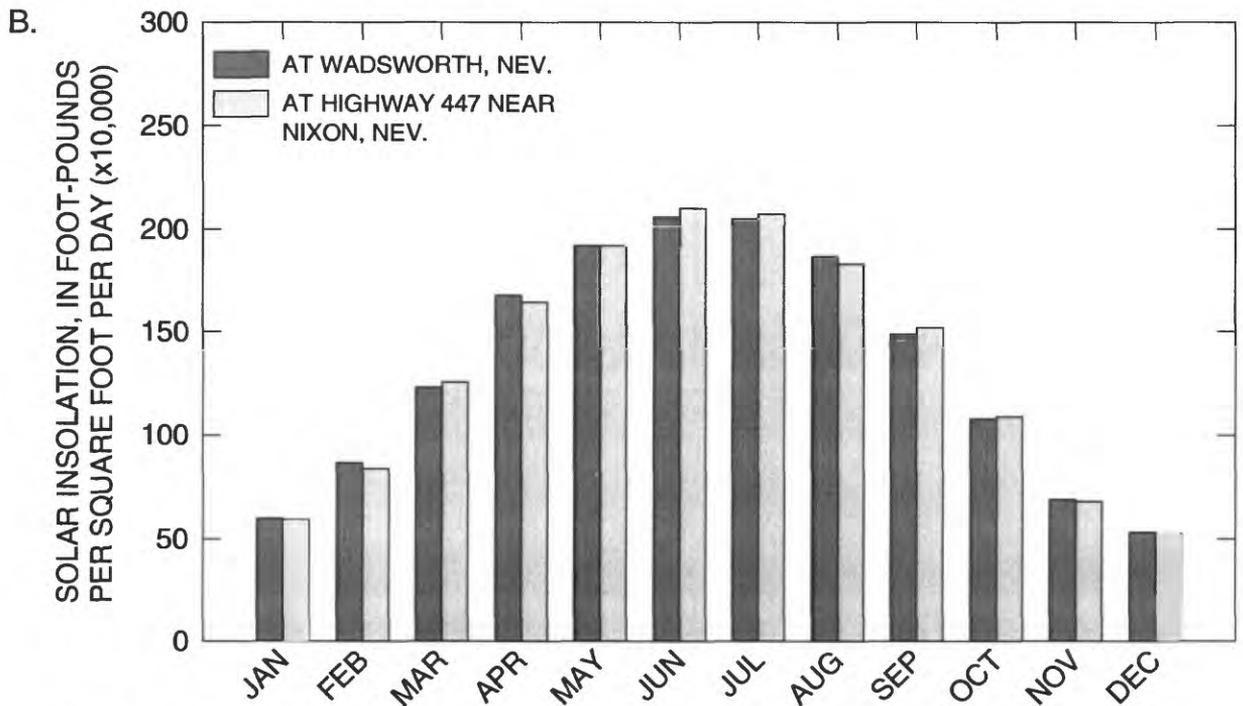
**Figure 56.** Monthly solar insolation midstream (A) Truckee River at Circle C Ranch near Lawton, Nev., at Idlewild Park at Reno, Nev., and at Lockwood, Nev.; and (B) Truckee River at Wadsworth, Nev., and Highway 447 near Nixon, Nev.

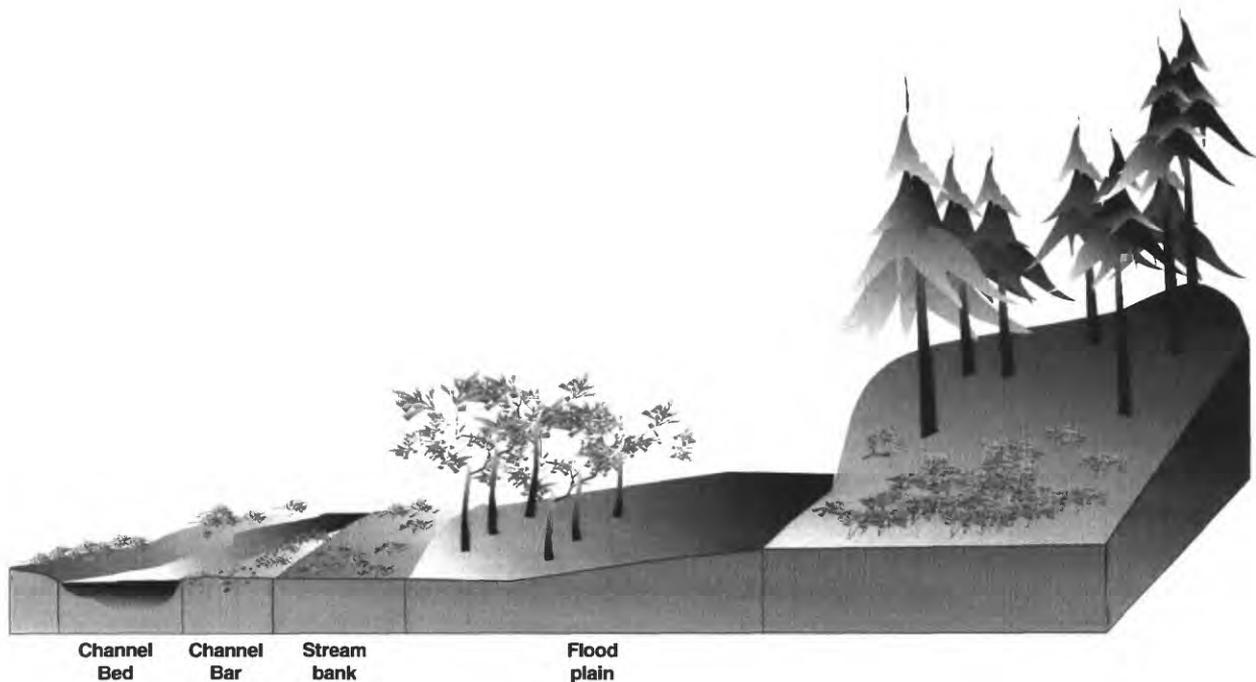
**Figure 57.** Idealized river cross sections showing the parts of a river or stream channel (modified from Hupp, 1986).

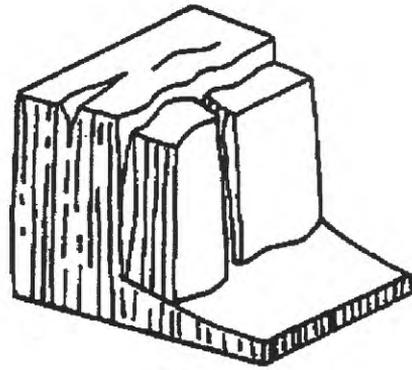
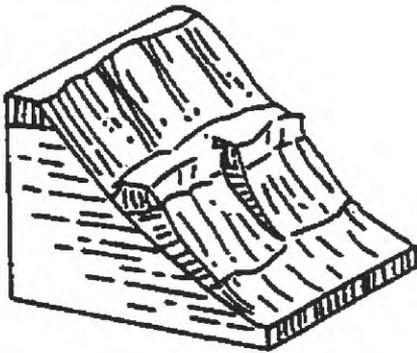
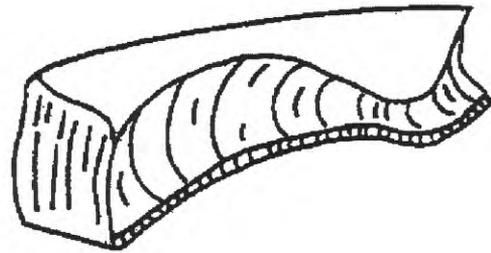
Slab failure

Rotational failure

Cut-bank scalloping

**Streambank Erosion.** A subjective measure of the type of bank erosion. Types: cut-bank scalloping, slab failure, debris avalanche, or rotational failure (see fig. 58).
