# LEVEL II SCOUR ANALYSIS FOR BRIDGE 53 (CHESTH01180053) on TOWN HIGHWAY 118, crossing the WILLIAMS RIVER, CHESTER, VERMONT

Open-File Report 97-769

By LORA K. STRIKER AND LAURA MEDALIE

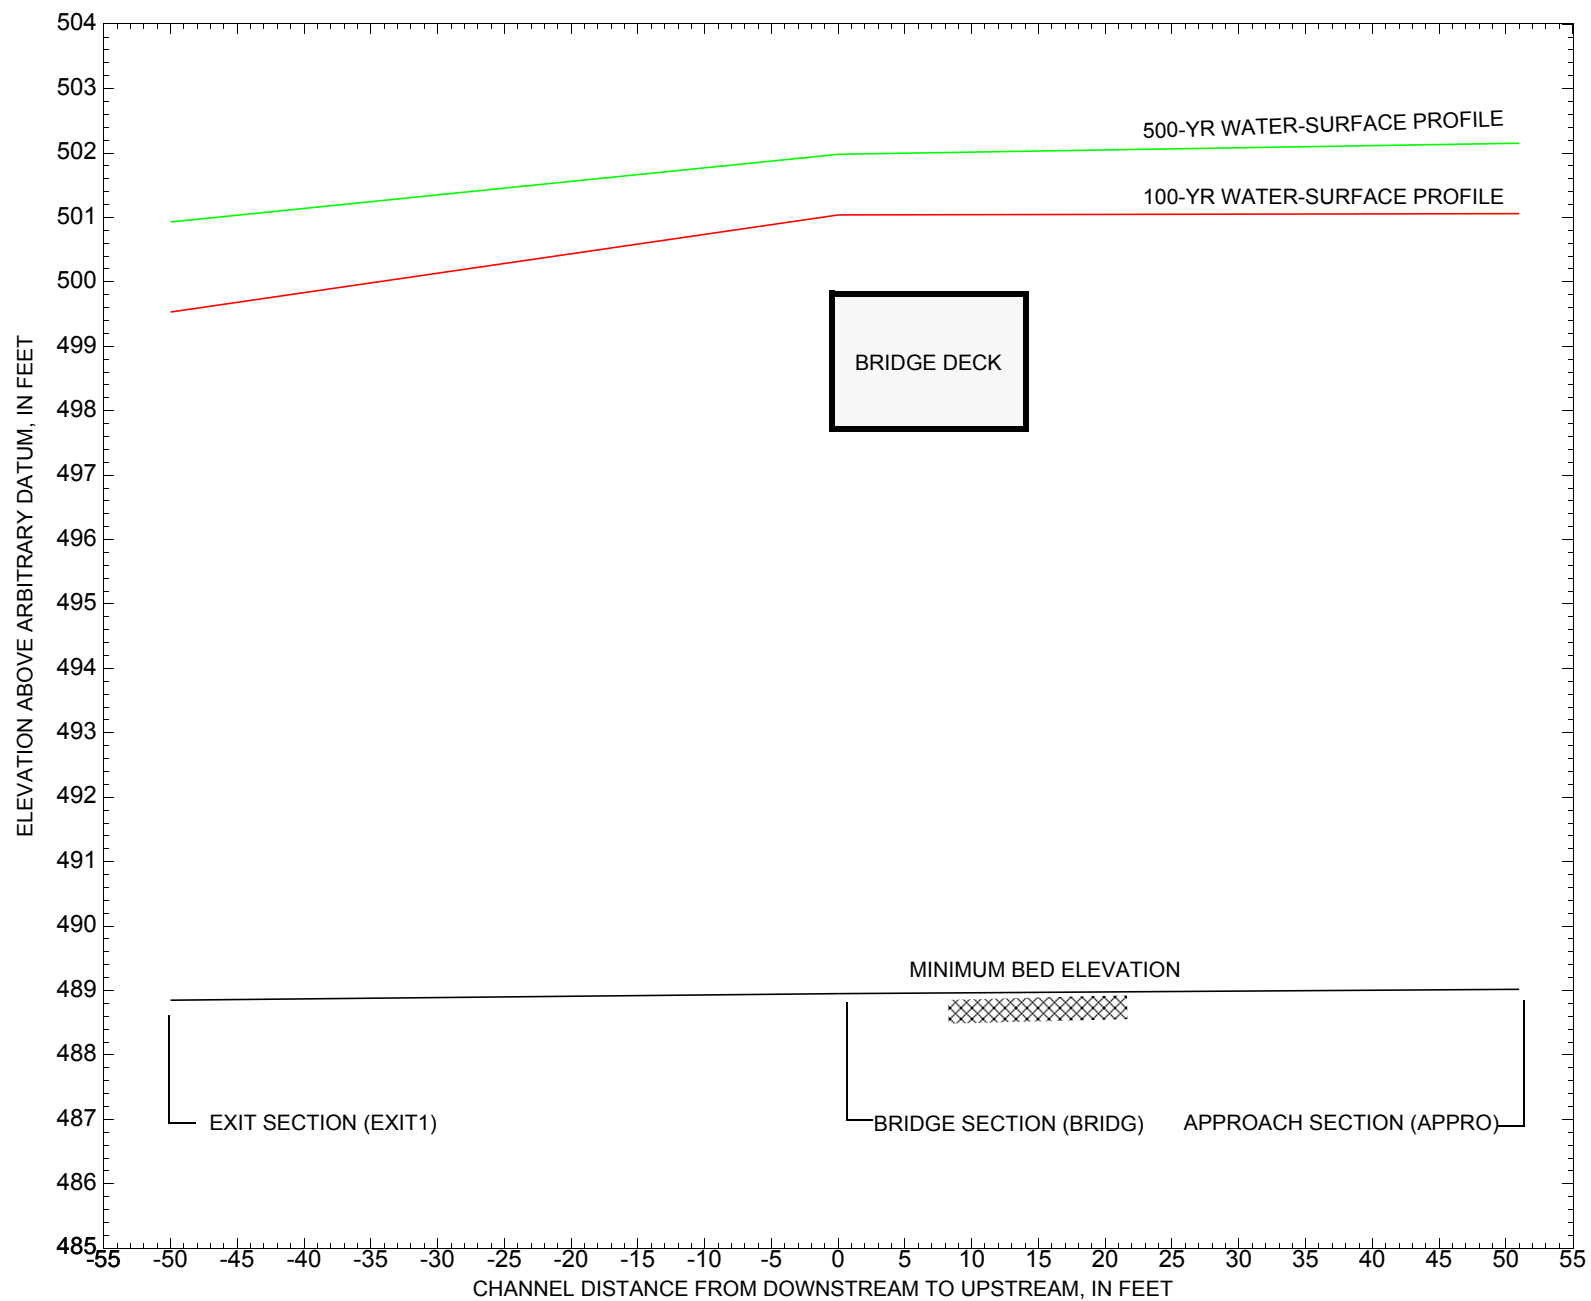
Figure 7. Water-surface profiles for the 100- and 500-year discharges at structure CHESTH01180053 on Town Highway 118, crossing the Williams River, Chester, Vermont.

Hydraulic analyses of the reach were done by use of the Federal Highway Administration's WSPRO step-backwater computer program (Shearman and others, 1986, and Shearman, 1990). The analyses reported herein reflect conditions existing at the site at the time of the study. Furthermore, in the development of the model it was necessary to assume no accumulation of debris or ice at the site. Results of the hydraulic model are presented in the Bridge Hydraulic Summary, Appendix B, and figure 7.

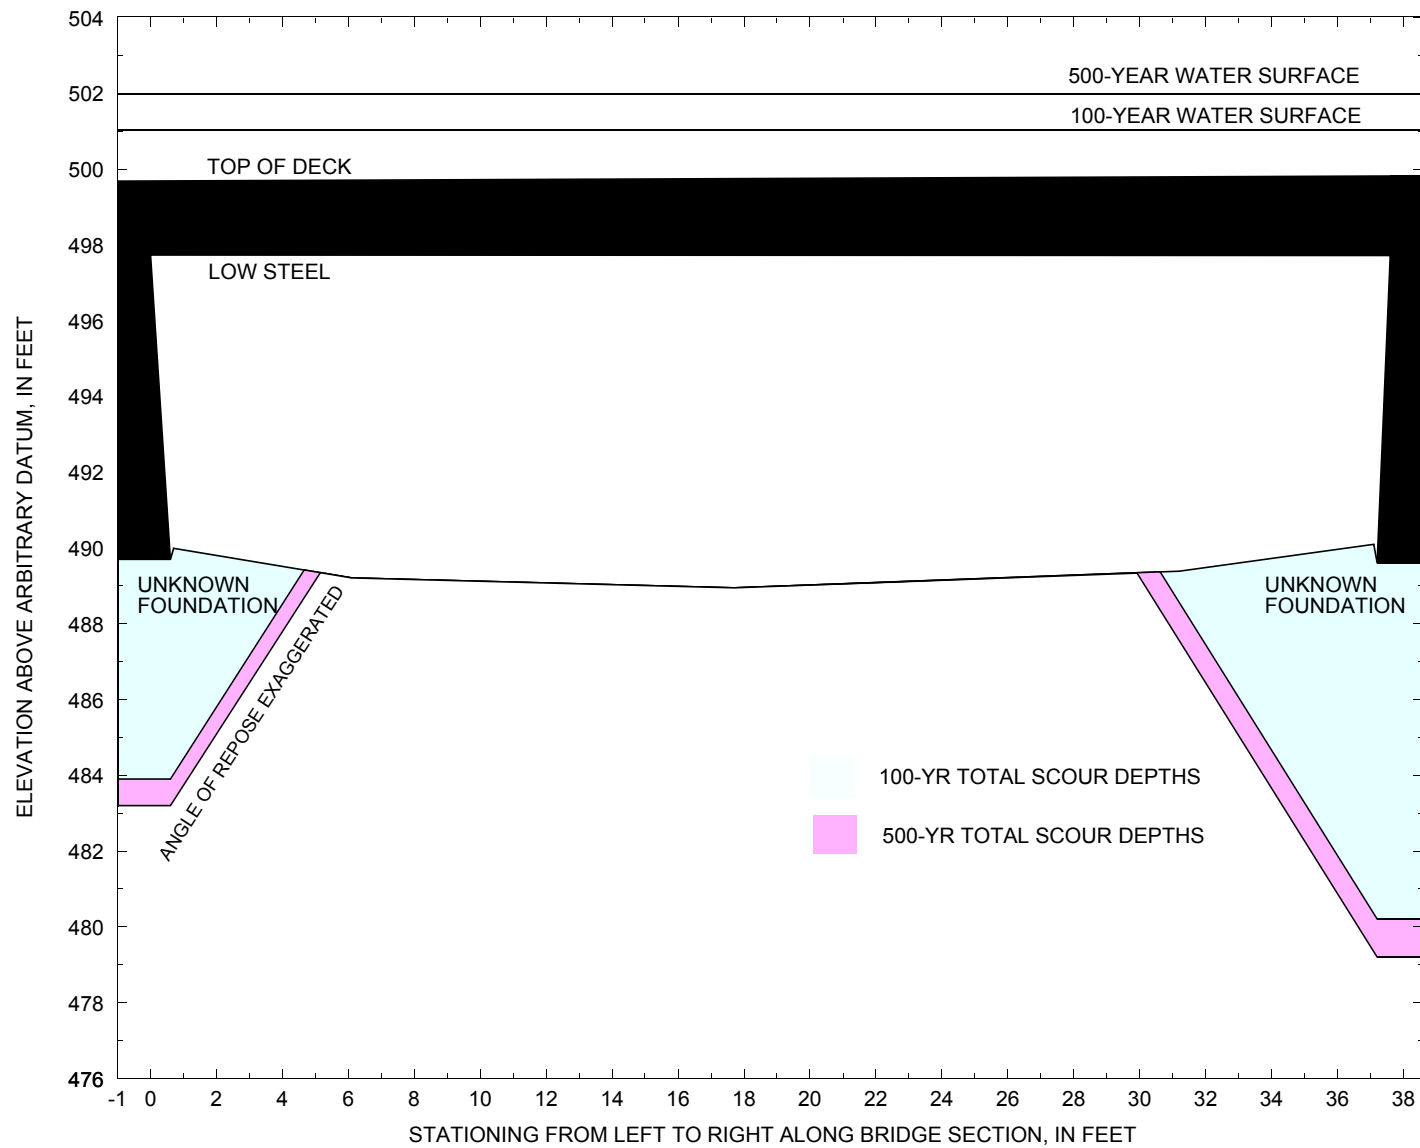
Figure 8. Scour elevations for the 100-year and 500-year discharges at structure CHESTH01180053 on Town Highway 118, crossing the Williams River, Chester, Vermont.

Contraction scour for all modelled flows was 0.0 ft. Abutment scour ranged from 5.8 to 6.8 ft at the left abutment and 9.4 to 14.4 ft at the right abutment. The worst-case abutment scour occurred at the incipient roadway-overtopping discharge. Additional information on scour depths and depths to armoring are included in the section titled “Scour Results”. Scoured-streambed elevations, based on the calculated scour depths, are presented in tables 1 and 2. A cross-section of the scour computed at the bridge is presented in figure 8. Scour depths were calculated assuming an infinite depth of erosive material and a homogeneous particle-size distribution.

Scour depths were computed using the general guidelines described in Hydraulic Engineering Circular 18 (Richardson and others, 1995). Scour depths were calculated assuming an infinite depth of erosive material and a homogeneous particle-size distribution. The results of the 100- and 500-year scour analyses are presented in tables 1 and 2 and a graph of the scour depths is presented in figure 8.

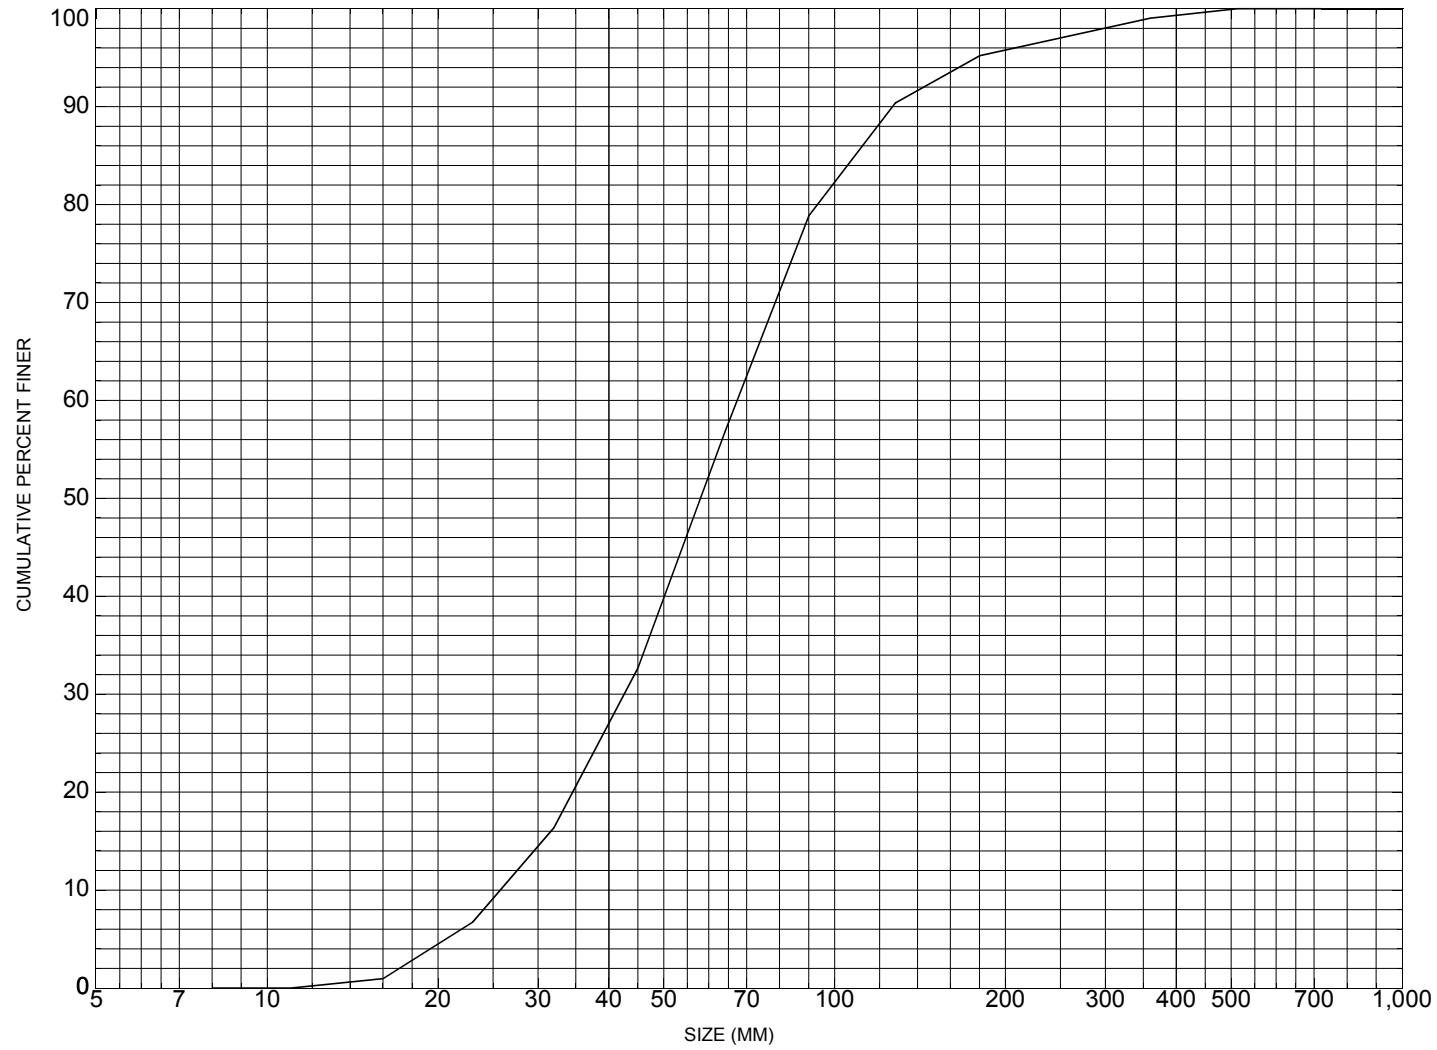
Appendix C. Bed material particle-size distribution for a pebble count in the channel approach of structure CHESTH01180053, in Chester, Vermont.
