LEVEL II SCOUR ANALYSIS FOR
BRIDGE 18 (SHEFTH00410018) on
TOWN HIGHWAY 41, crossing
MILLERS RUN,
SHEFFIELD, VERMONT

Open-File Report 97-772

Prepared in cooperation with
VERMONT AGENCY OF TRANSPORTATION
and
FEDERAL HIGHWAY ADMINISTRATION

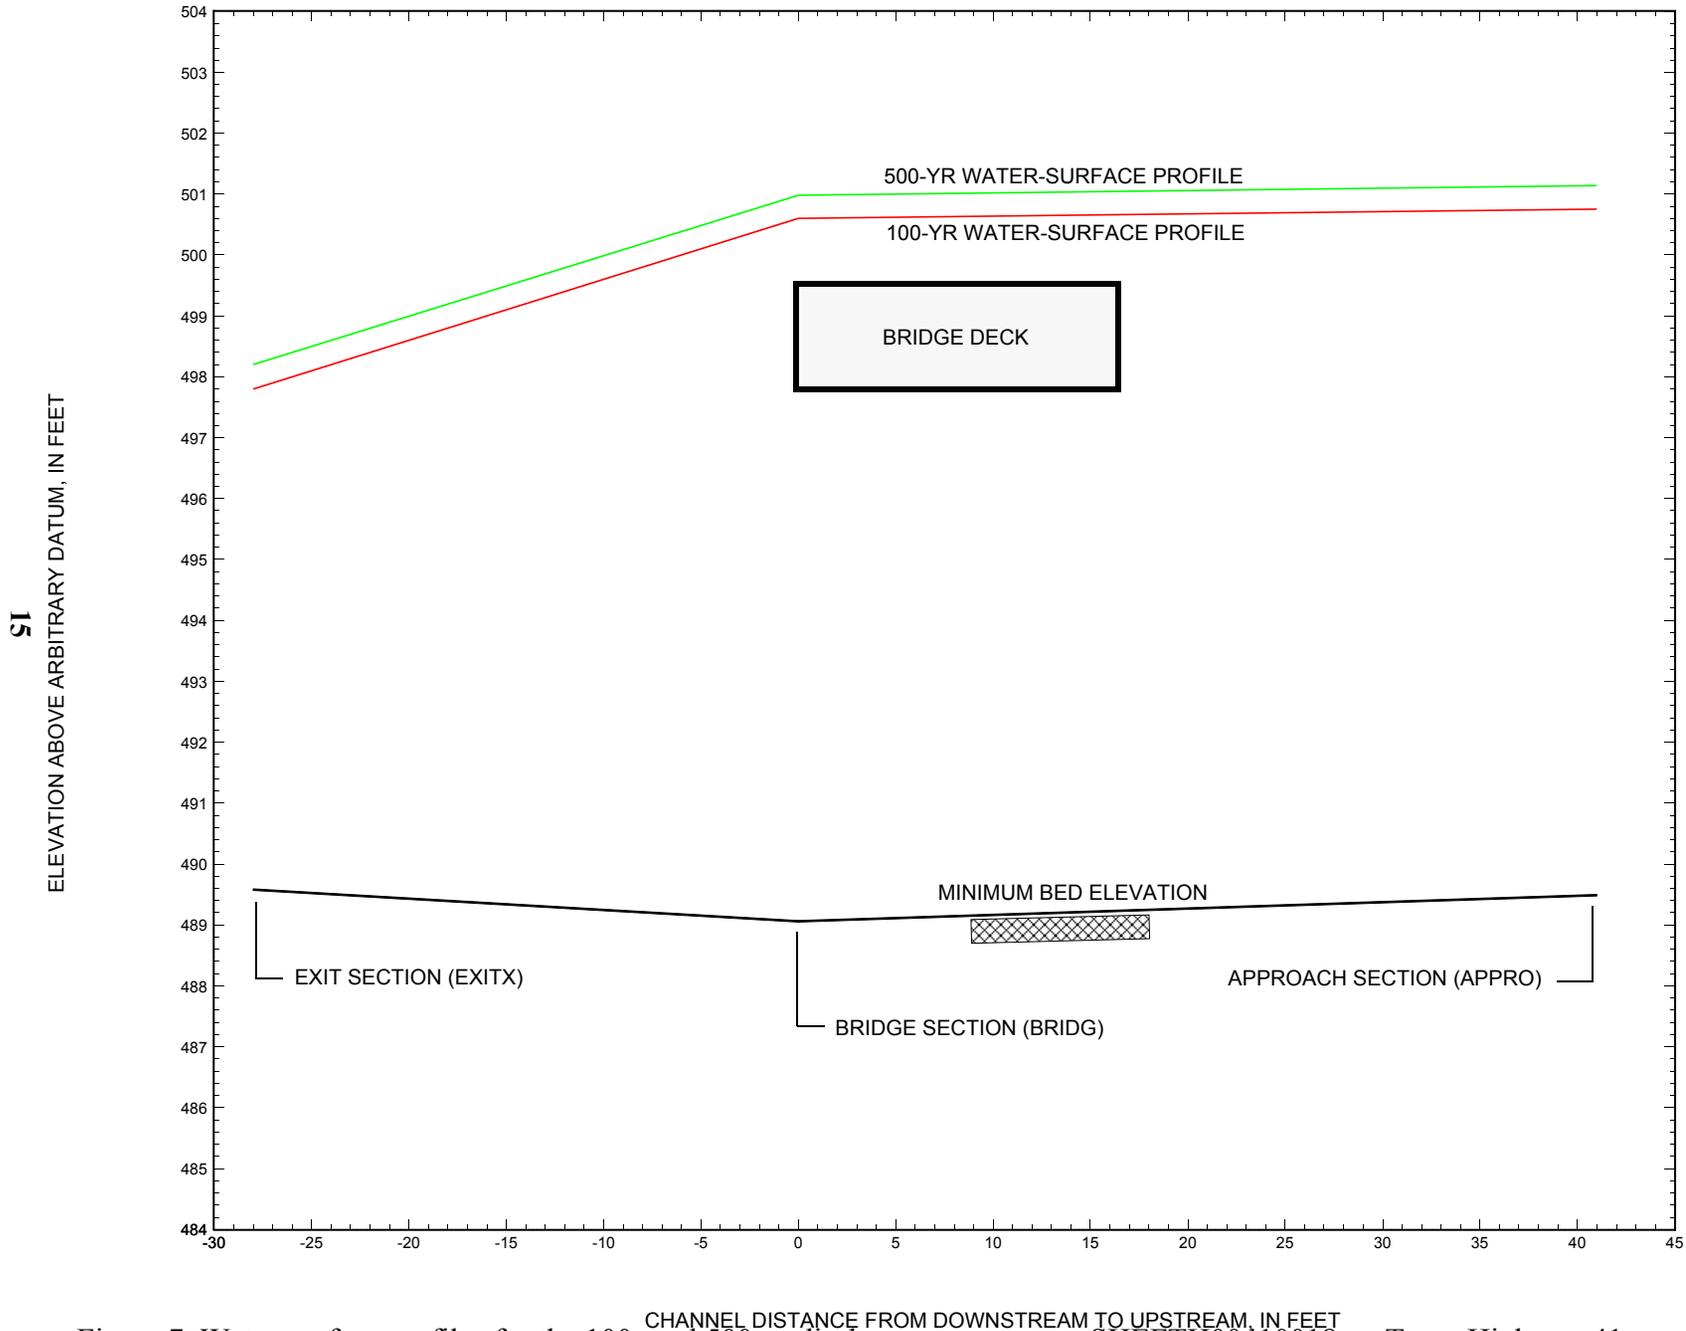
Figure 7. Water-surface profiles for the 100- and 500-yr discharges at structure SHEFTH00410018 on Town Highway 41, crossing Millers Run, Sheffield, Vermont.

Hydraulic analyses of the reach were done by use of the Federal Highway Administration's WSPRO step-backwater computer program (Shearman and others, 1986, and Shearman, 1990). The analyses reported herein reflect conditions existing at the site at the time of the study. Furthermore, in the development of the model it was necessary to assume no accumulation of debris or ice at the site. Results of the hydraulic model are presented in the Bridge Hydraulic Summary, Appendix B, and figure 7.

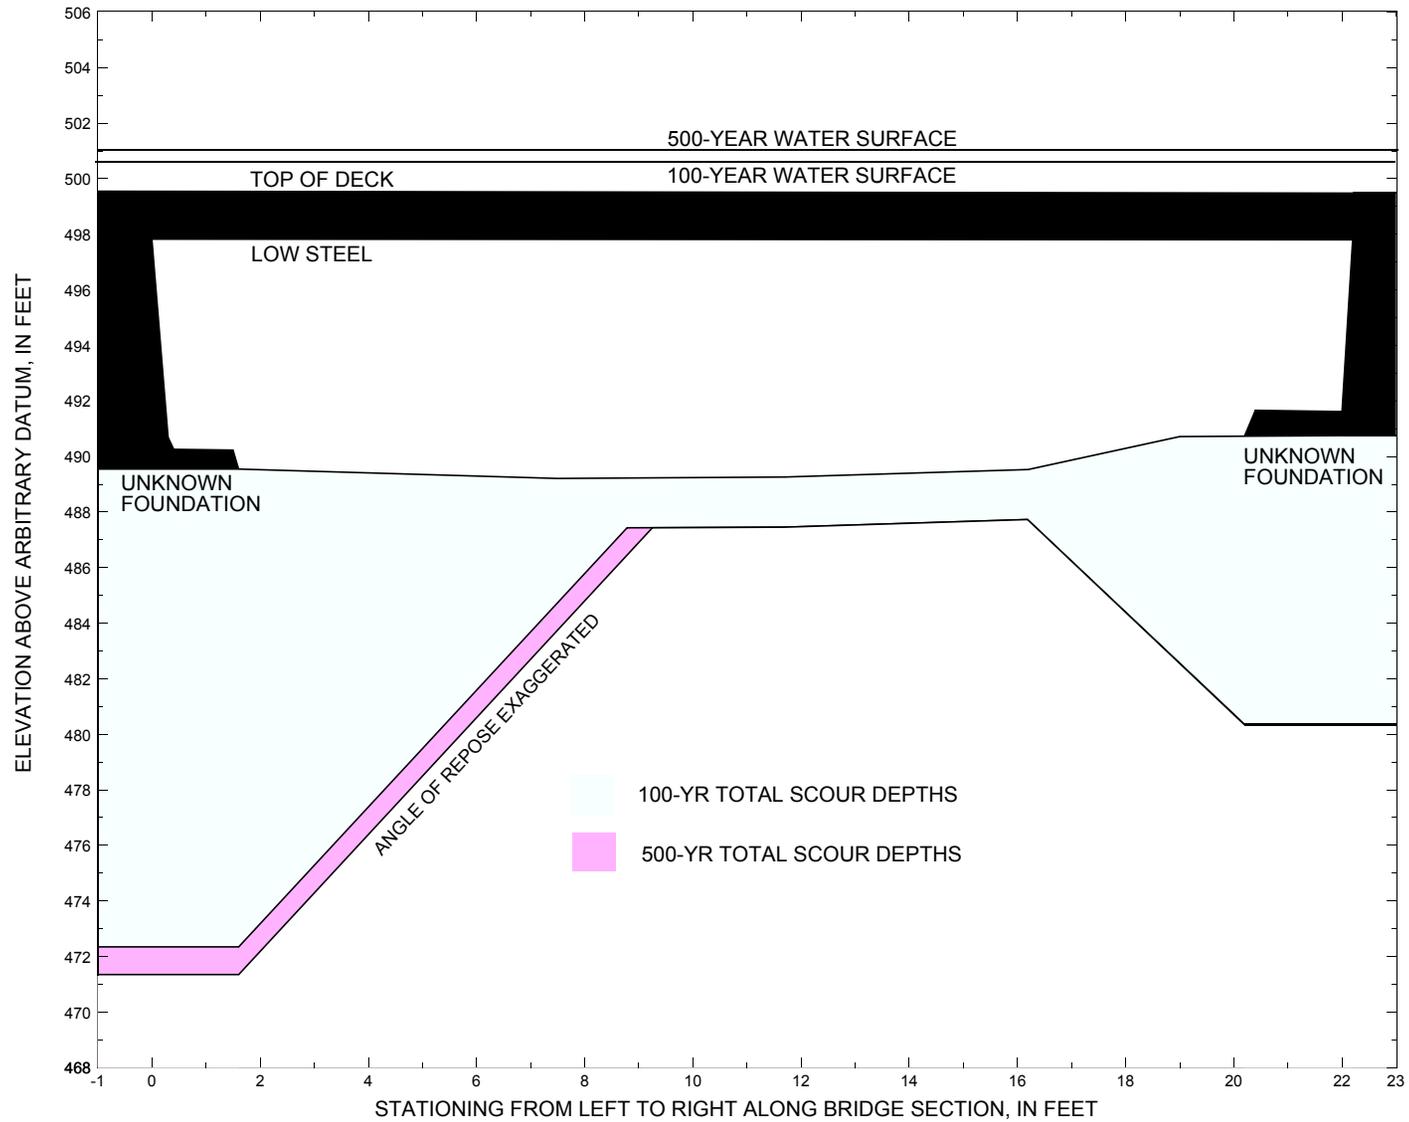
Figure 8. Scour elevations for the 100-yr and 500-yr discharges at structure SHEFTH00410018 on Town Highway 41, crossing Millers Run, Sheffield, Vermont.

Scour depths were computed using the general guidelines described in Hydraulic Engineering Circular 18 (Richardson and others, 1995). Scour depths were calculated assuming an infinite depth of erosive material and a homogeneous particle-size distribution. The results of the scour analysis are presented in tables 1 and 2 and a graph of the scour depths is presented in figure 8.

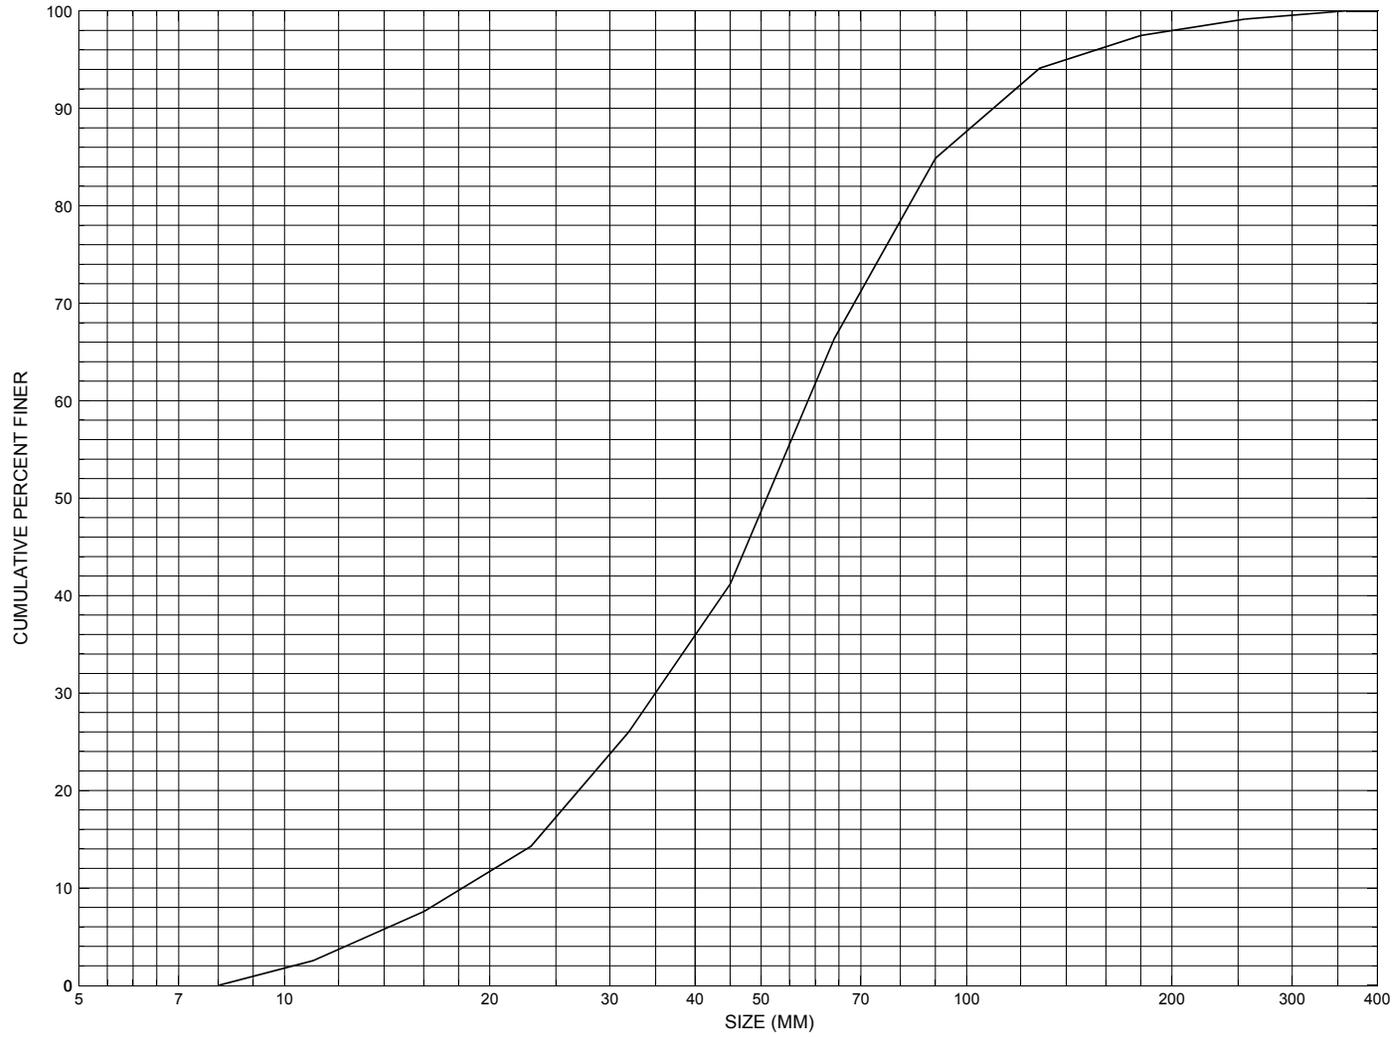
Appendix C. Bed material particle-size distribution for a pebble count in the channel approach of structure SHEFTH00410018, in Sheffield, Vermont.
