LEVEL II SCOUR ANALYSIS FOR BRIDGE 29 (DORSTH00100029) on TOWN HIGHWAY 10, crossing the METTAWEE RIVER, DORSET, VERMONT

Open-File Report 97-774

Prepared in cooperation with
VERMONT AGENCY OF TRANSPORTATION
and
FEDERAL HIGHWAY ADMINISTRATION

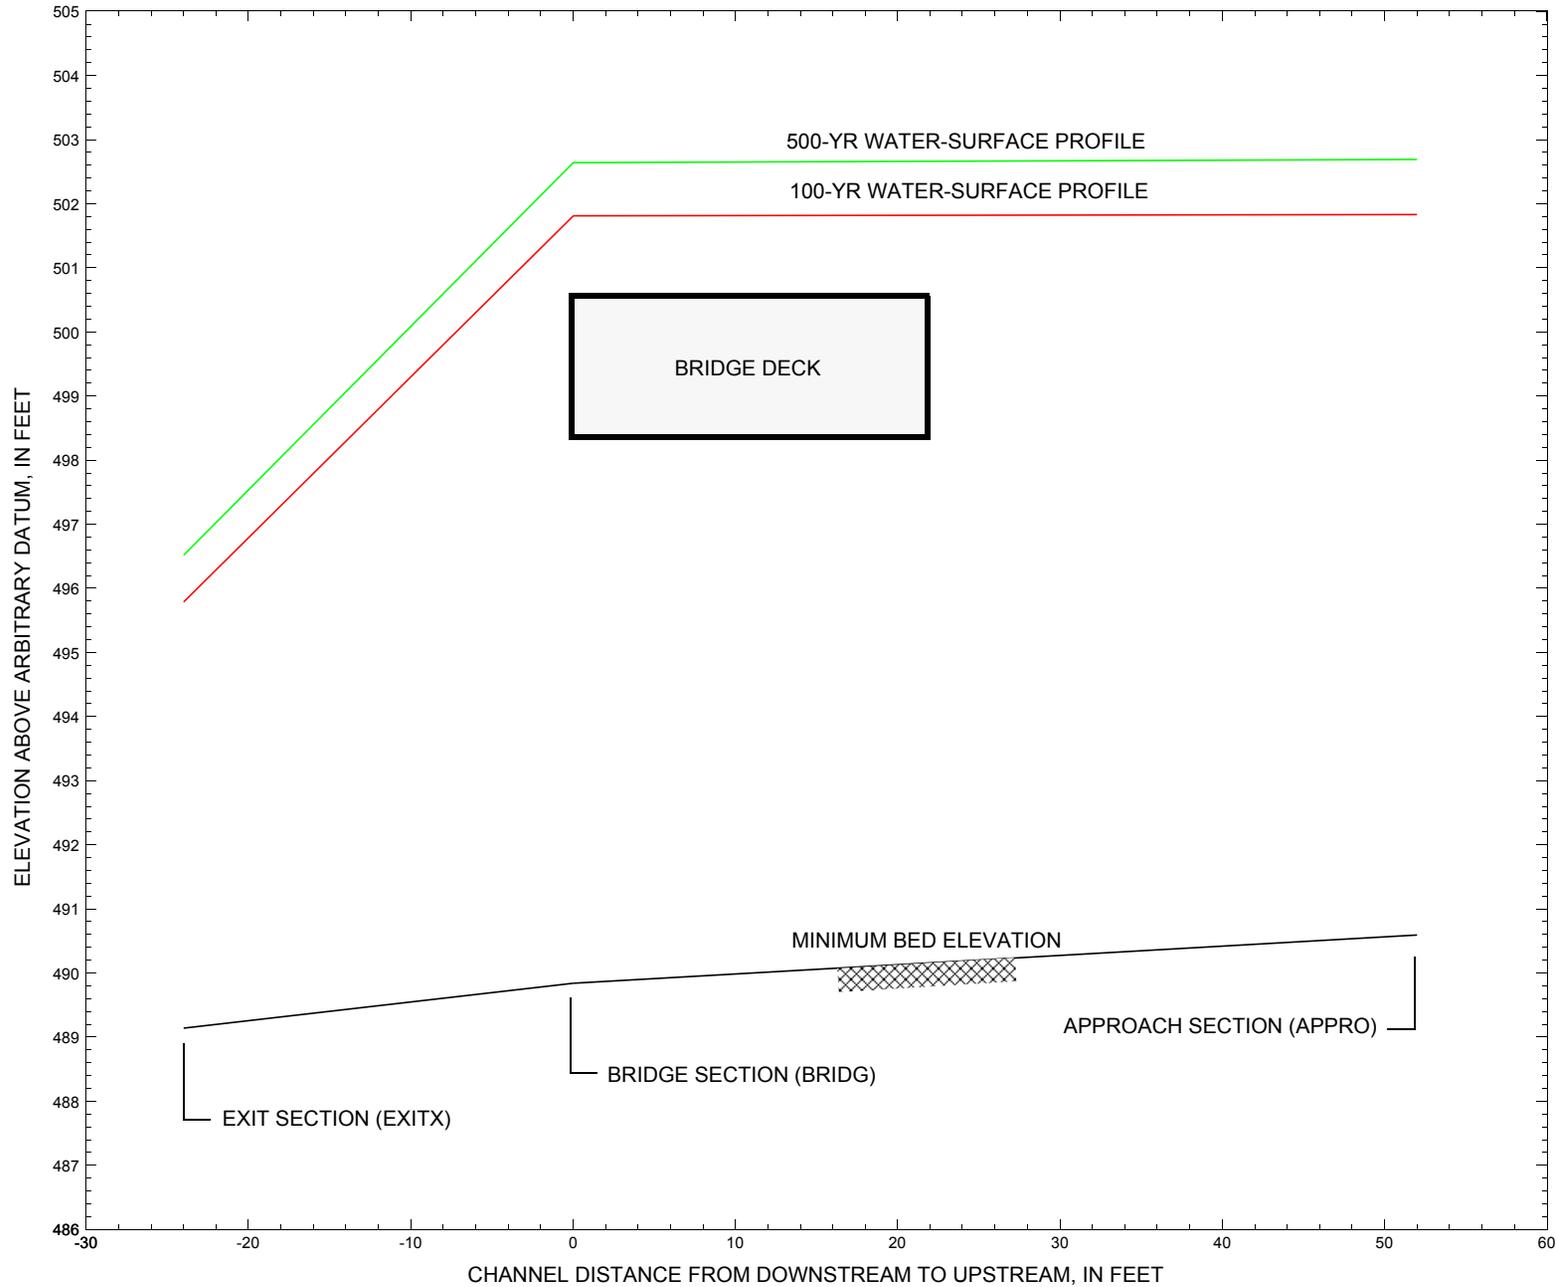
Figure 7. Water-surface profiles for the 100- and 500-yr discharges at structure DORSTH00100029 on Town Highway 10, crossing the Mettawee River, Dorset, Vermont.

Hydraulic analyses of the reach were done by use of the Federal Highway Administration's WSPRO step-backwater computer program (Shearman and others, 1986, and Shearman, 1990). The analyses reported herein reflect conditions existing at the site at the time of the study. Furthermore, in the development of the model it was necessary to assume no accumulation of debris or ice at the site. Results of the hydraulic model are presented in the Bridge Hydraulic Summary, Appendix B, and figure 7.

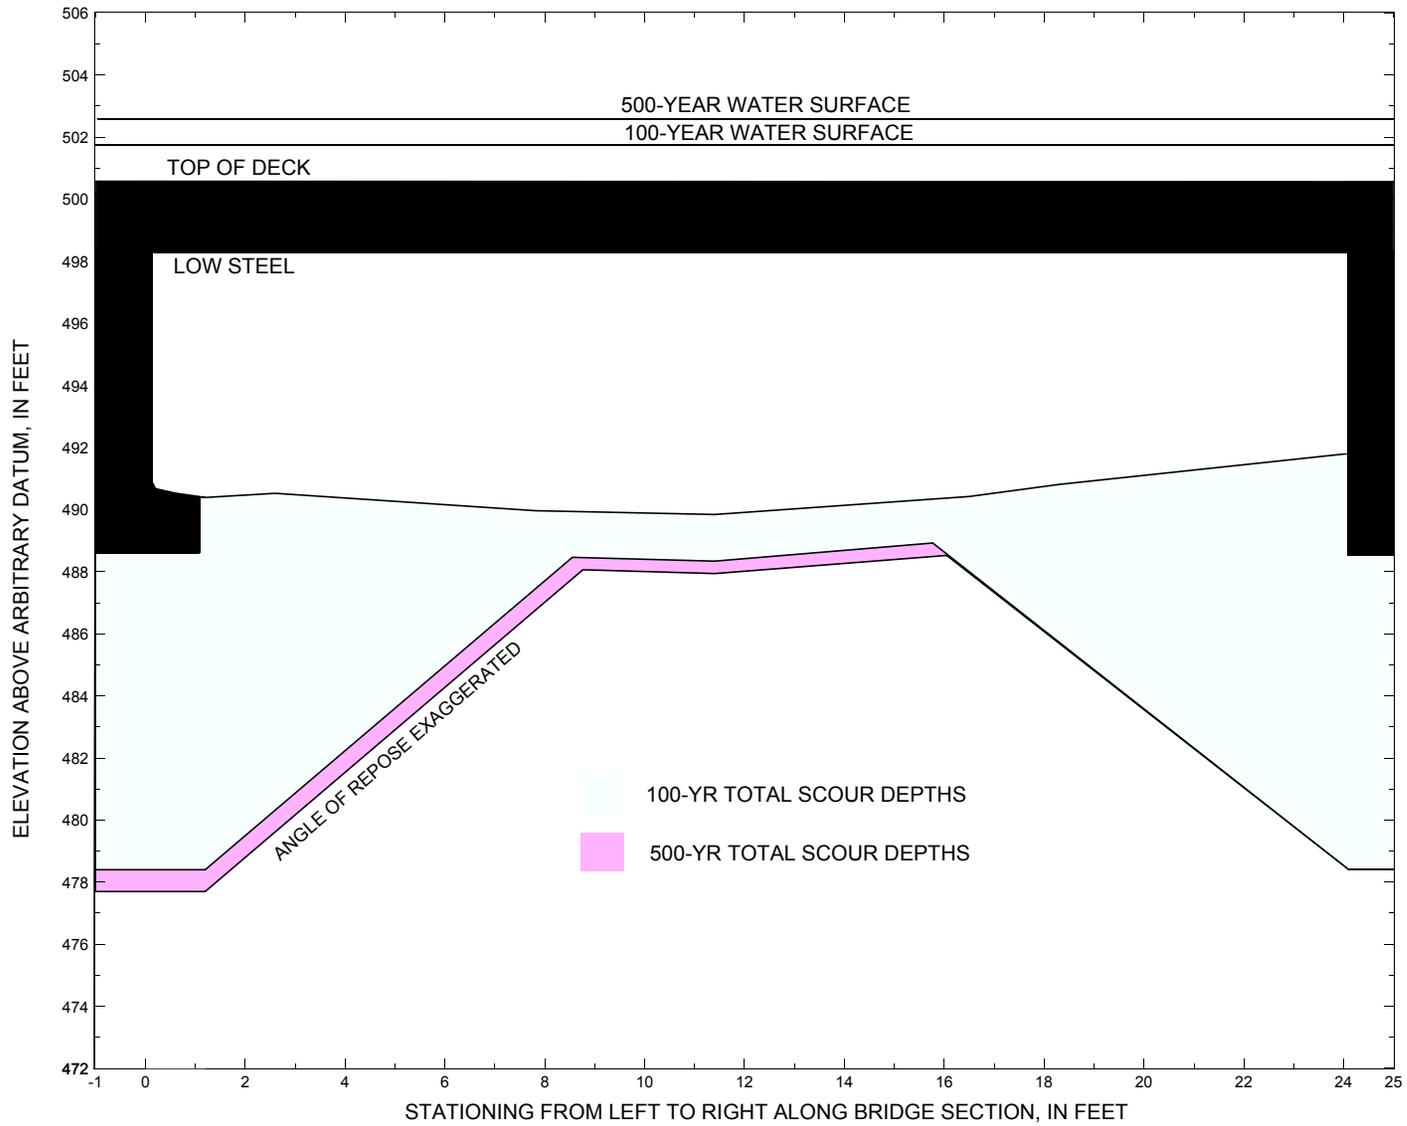
Figure 8. Scour elevations for the 100-yr and 500-yr discharges at structure DORSTH00100029 on Town Highway 10, crossing the Mettawee River, Dorset, Vermont.

Scour depths were computed using the general guidelines described in Hydraulic Engineering Circular 18 (Richardson and others, 1995). Scour depths were calculated assuming an infinite depth of erosive material and a homogeneous particle-size distribution. The results of the 100-year and 500-year scour analysis are presented in tables 1 and 2 and a graph of the scour depths is presented in figure 8.

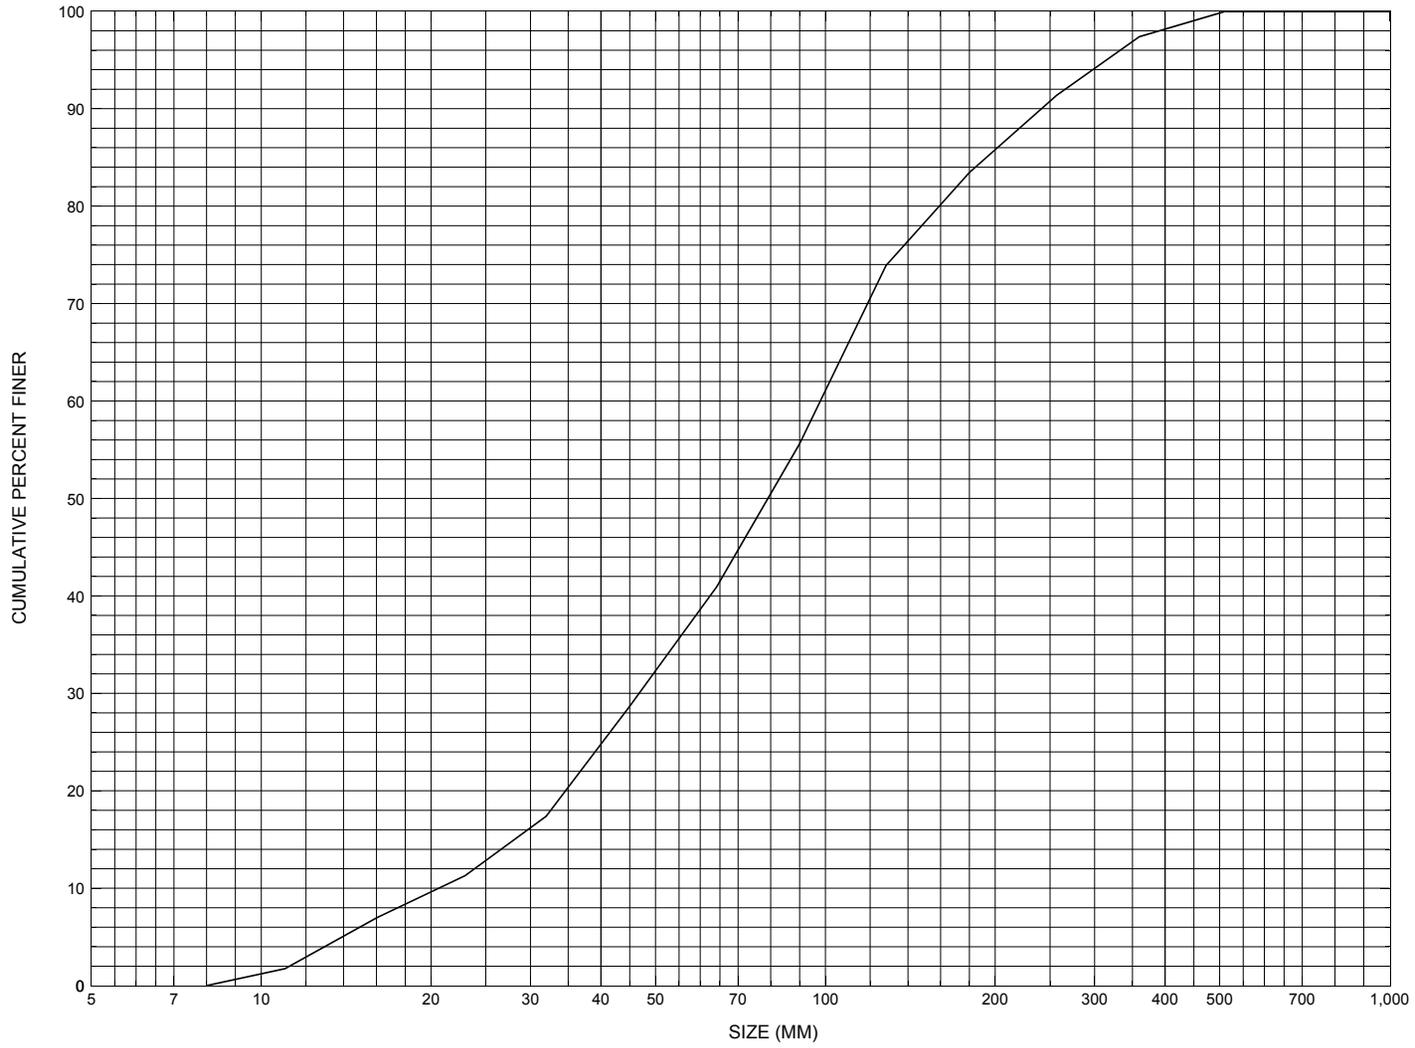
Appendix C. Bed material particle-size distribution for a pebble count in the channel approach of structure DORSTH00100029, in Dorset, Vermont.
