LEVEL II SCOUR ANALYSIS FOR BRIDGE 33 (TUNBTH00450033) on TOWN HIGHWAY 45, crossing the FIRST BRANCH WHITE RIVER, TUNBRIDGE, VERMONT

Open-File Report 97-803

Prepared in cooperation with
VERMONT AGENCY OF TRANSPORTATION
and
FEDERAL HIGHWAY ADMINISTRATION

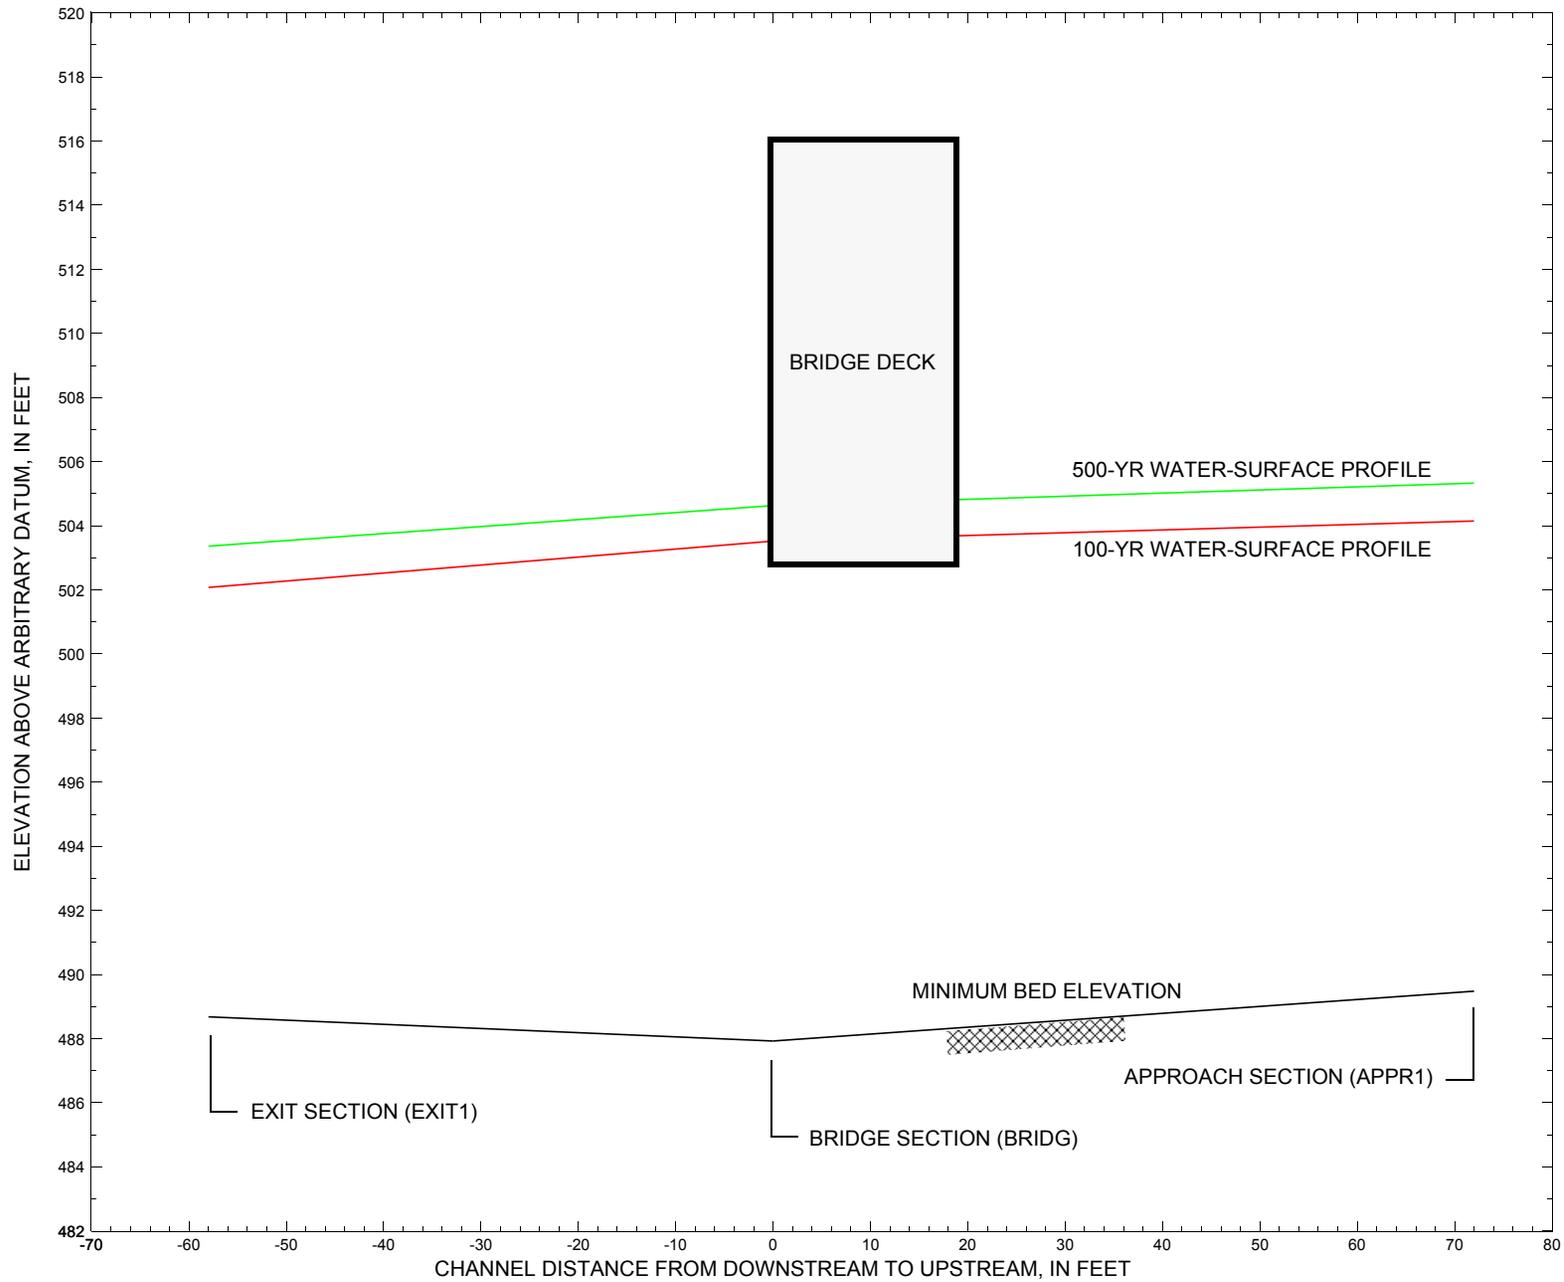
Figure 7. Water-surface profiles for the 100- and 500-yr discharges at structure TUNBTH00450033 on Town Highway 45, crossing the First Branch White River, Tunbridge, Vermont.

Hydraulic analyses of the reach were done by use of the Federal Highway Administration's WSPRO step-backwater computer program (Shearman and others, 1986, and Shearman, 1990). The analyses reported herein reflect conditions existing at the site at the time of the study. Furthermore, in the development of the model it was necessary to assume no accumulation of debris or ice at the site. Results of the hydraulic model are presented in the Bridge Hydraulic Summary, Appendix B, and figure 7.

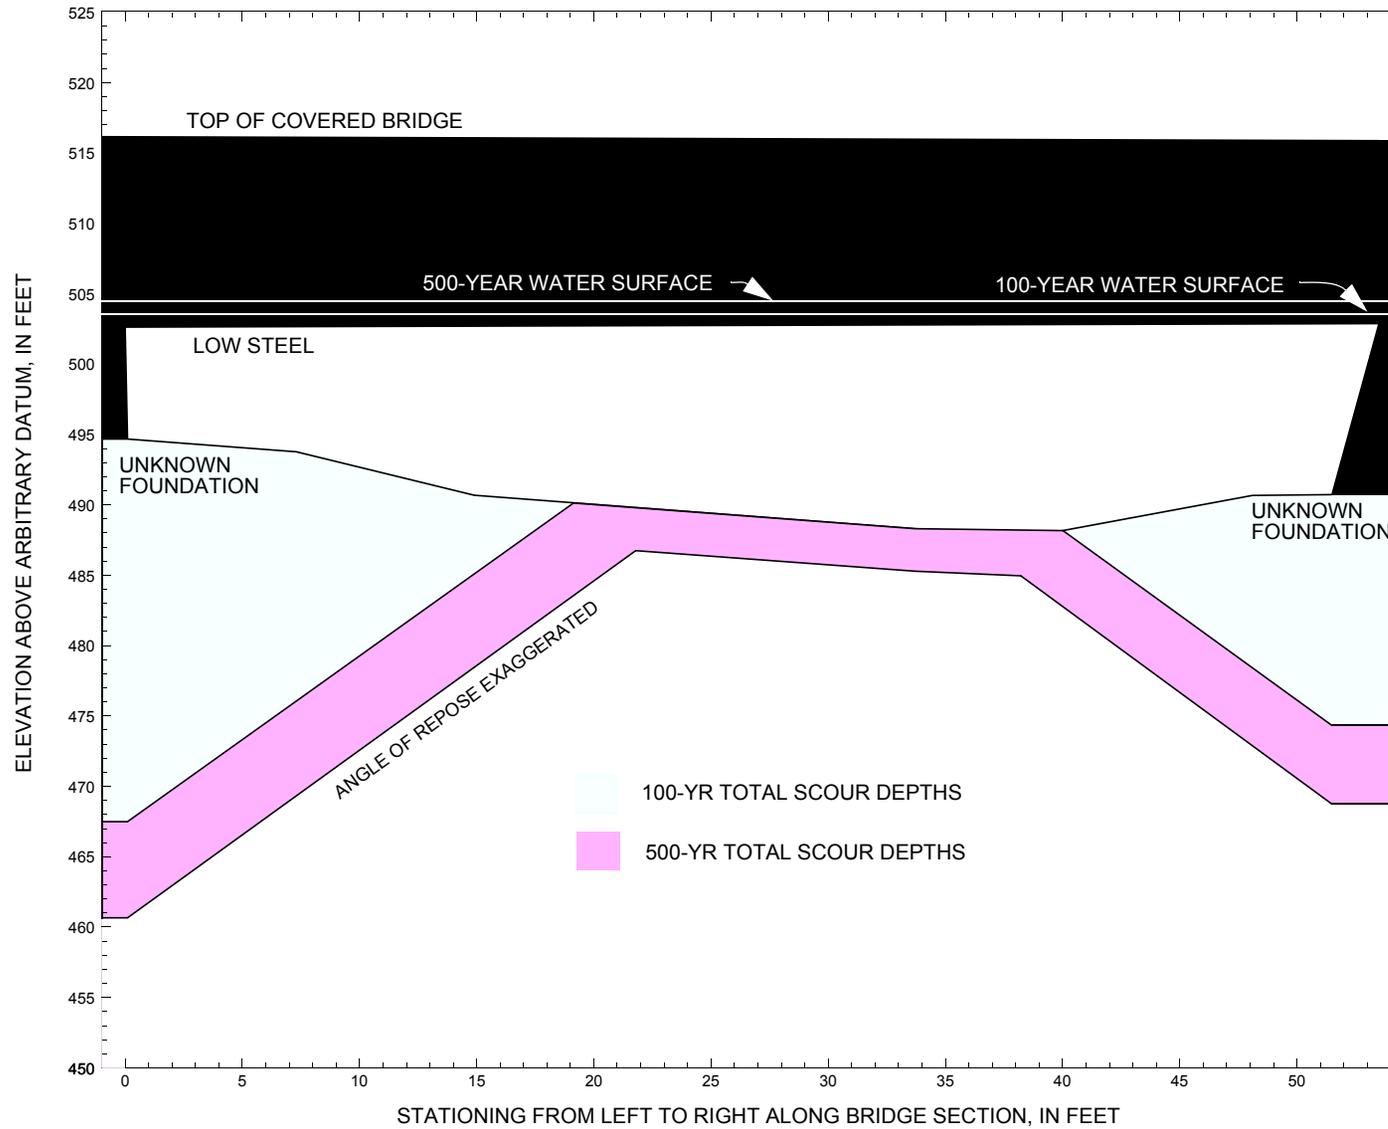
Figure 8. Scour elevations for the 100-yr and 500-yr discharges at structure TUNBTH00450033 on Town Highway 45, crossing the First Branch White River, Tunbridge, Vermont.

Scour depths were computed using the general guidelines described in Hydraulic Engineering Circular 18 (Richardson and others, 1995). Scour depths were calculated assuming an infinite depth of erosive material and a homogeneous particle-size distribution. The results of the 100-year and 500-year scour analysis are presented in tables 1 and 2 and a graph of the scour depths is presented in figure 8.

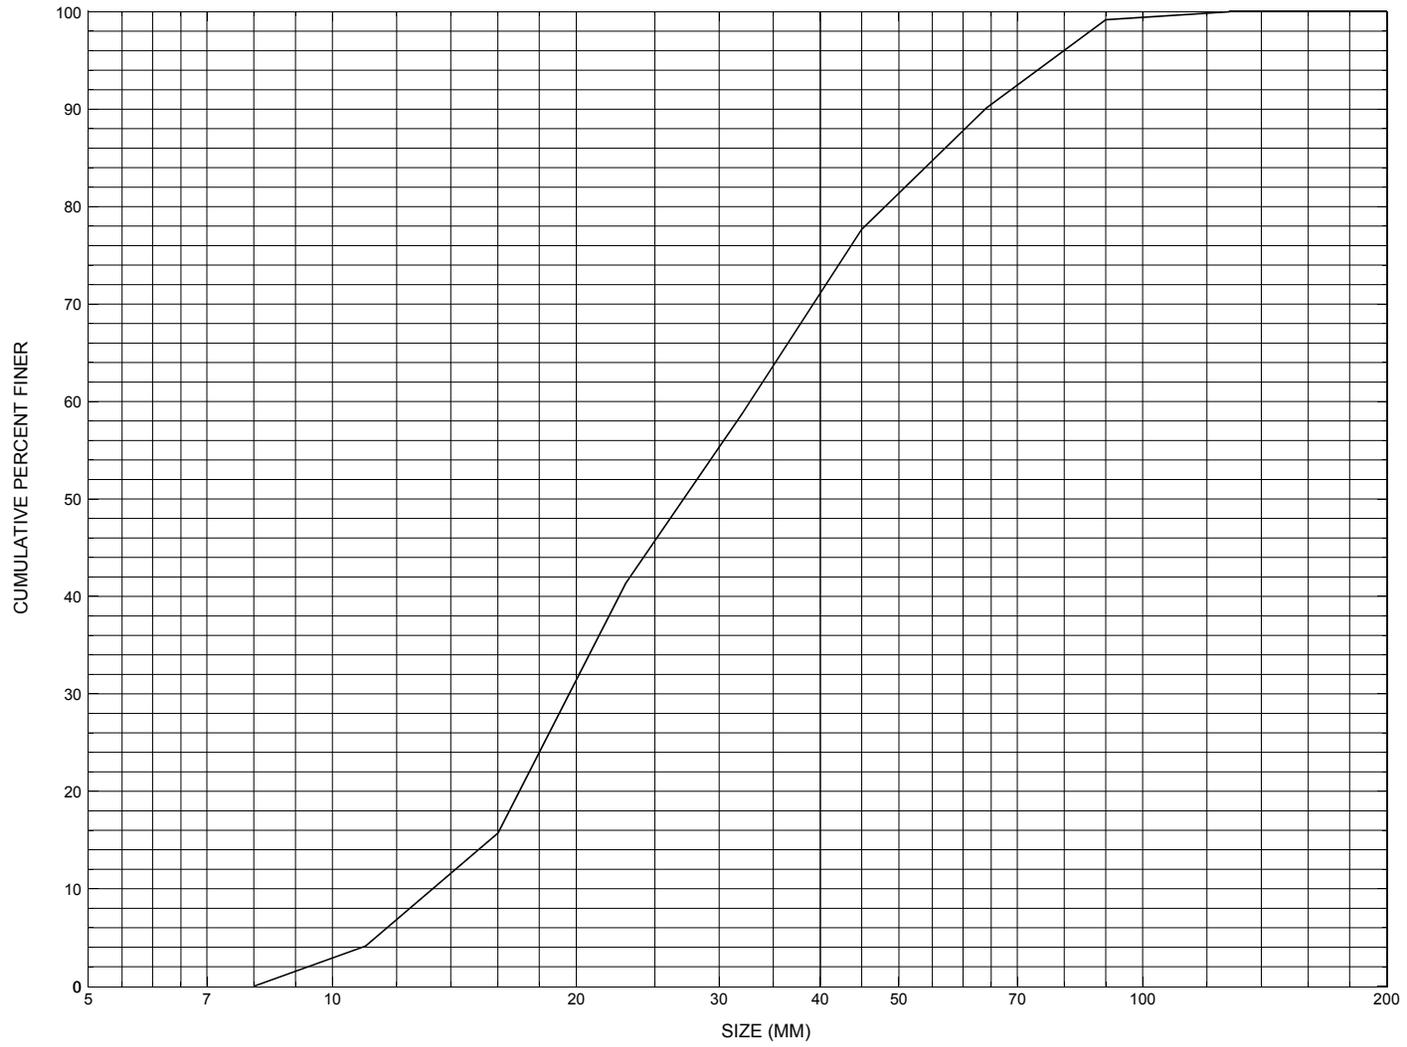
Appendix C. Bed material particle-size distribution for a pebble count in the channel approach of structure TUNBTH00450033, in Tunbridge, Vermont.
